Report No. 052010/2

## **SURFACE EROSION AND STABILITY ANALYSIS QUESTA TAILINGS FACILITY, NEW MEXICO**

July 2000

**SURFACE EROSION AND STABILITY ANALYSIS**  
**QUESTA TAILINGS FACILITY, NEW MEXICO**  
**(MINE CLOSEOUT PLAN PROGRAM TASK B – SUBTASK B1)**

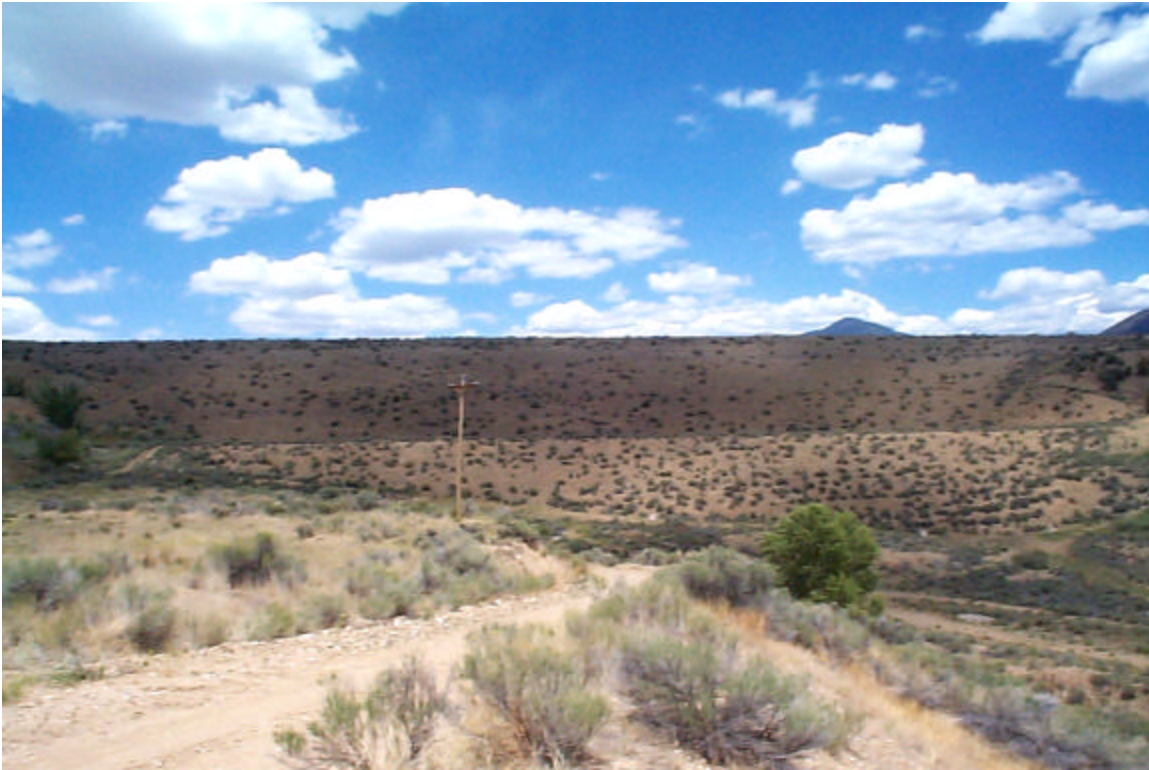
Vegetation including shrubs, grasses and scattered pinons exist intermittently across the entire downstream slope of Dam 1 (Photo 1). The vegetation species observed on the embankment include rabbitbrush, sagebrush, wheatgrass and yellow sweetclover (*Melilotus officinalis*). Photo 5 shows the different vegetation types and species on the downstream slope of Dam 1.

Photo 1: Looking north showing the downstream face of Dam 1.

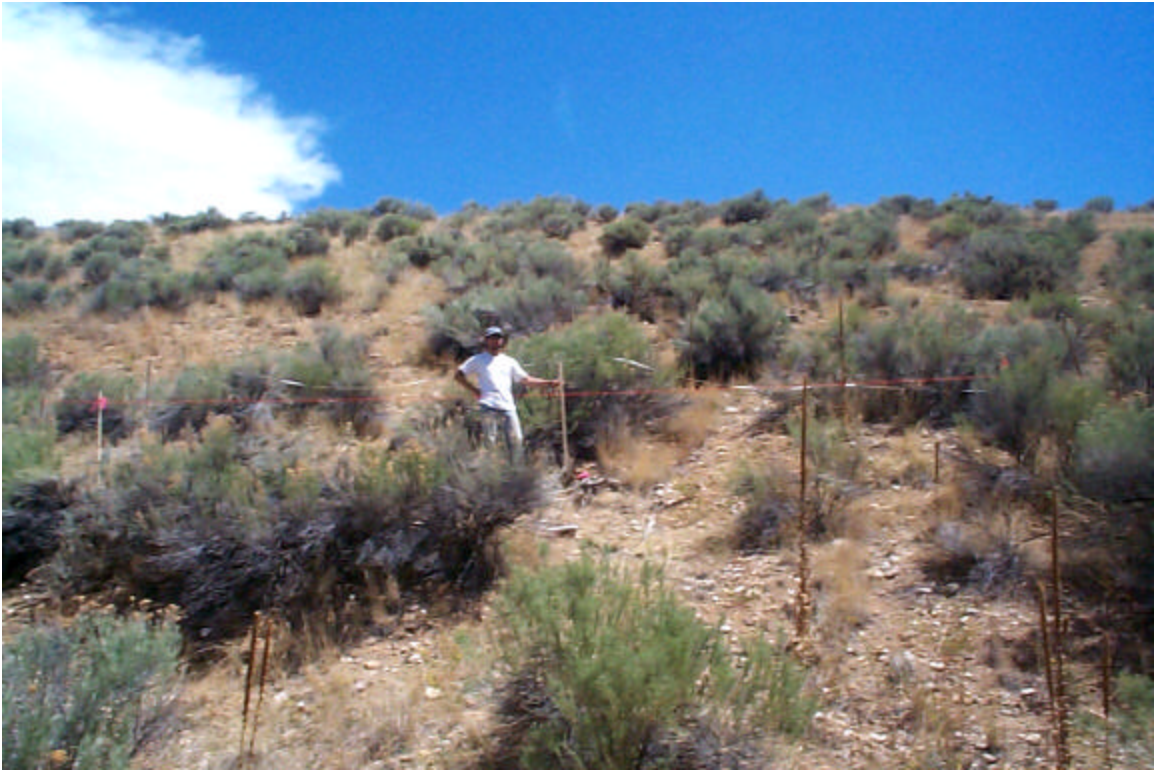
The locations of the test plots developed on the downstream slope of Dam 1 are shown in Figure 3. The test plots were situated over small gullies observed during the reconnaissance survey of the downstream slope to evaluate “more advanced” erosive conditions. The surface of the upper and lower test plots are very similar in appearance. Photo 5 shows the lower test plot.

Photo 5: The 30 ft x 15 ft test plot near the toe of Dam 1.

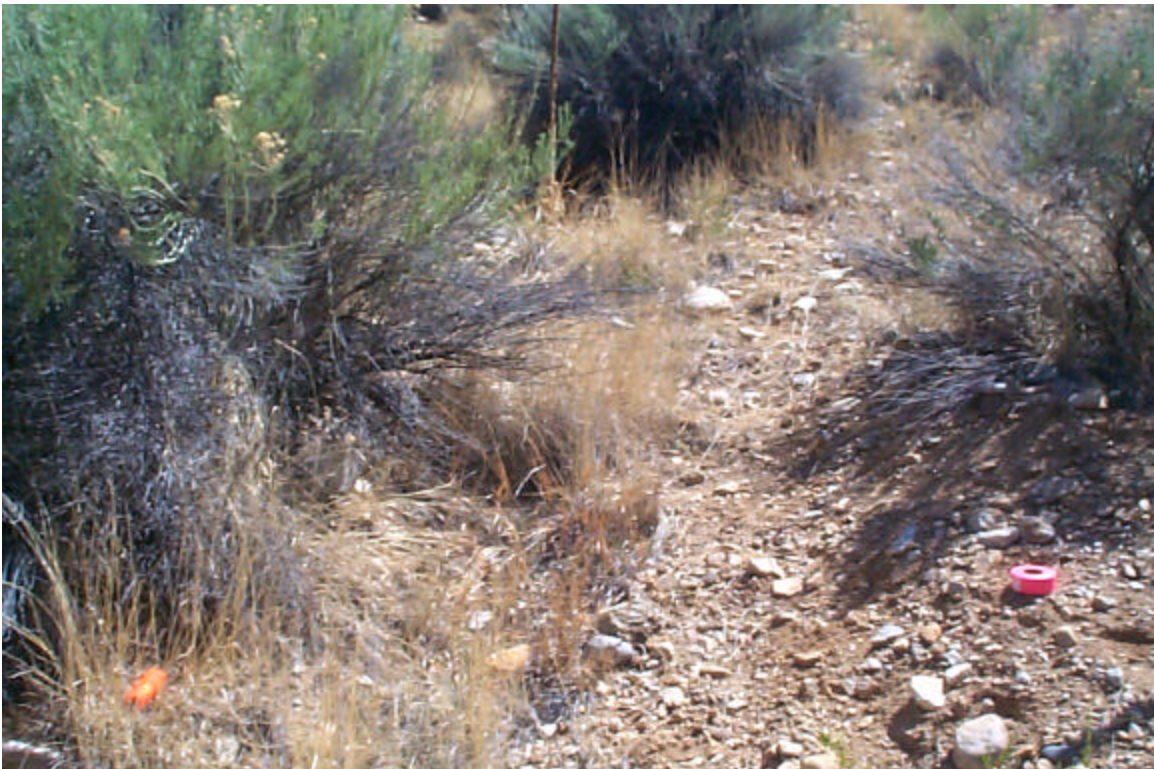
Two relatively small gullies were found on the downstream face of each bench of Dam 1. These gullies are similar in nature with the apparent cause of the erosion being water; however, water channels do not lead to the top of the area. Vegetation has established in the gullies and the gullies have coarse rock distributed within them, but do not appear to be deeper than 6 to 8 inches and 18 inches wide (Photo 6).

Photo 6: Small gully near the toe of Dam 1; pink flagging tape at the edge of the gully.

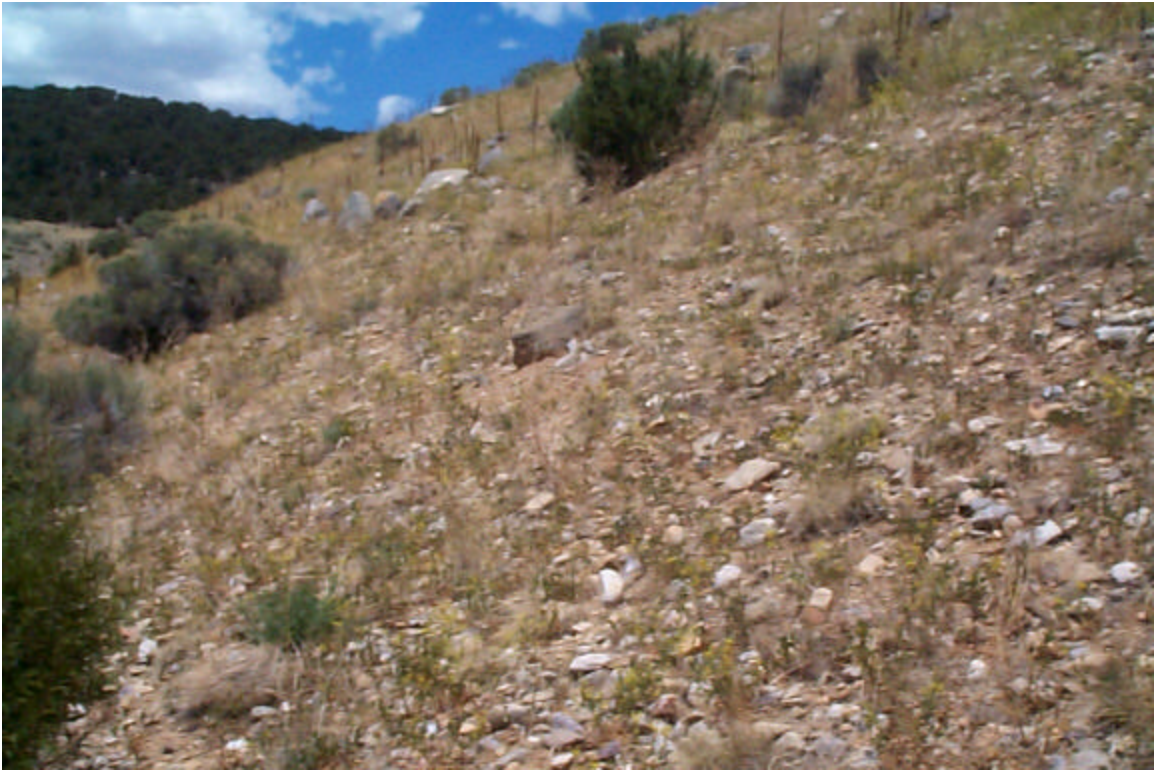
Coarse rock exists sporadically on the surface of the downstream face of Dam 4 (Photo 9), with the exception of the dam toe (Photo 10). Excluding the layer of coarse rock along the toe of Dam 4, the coarse rock coverage is only about half that observed on the downstream slope of Dam 1. In addition, the average size of coarse rock on the slope surface is smaller compared to the coarse rock observed on the Dam 1 slope surface.

Photo 9: Mid-slope of Dam 4 looking west.

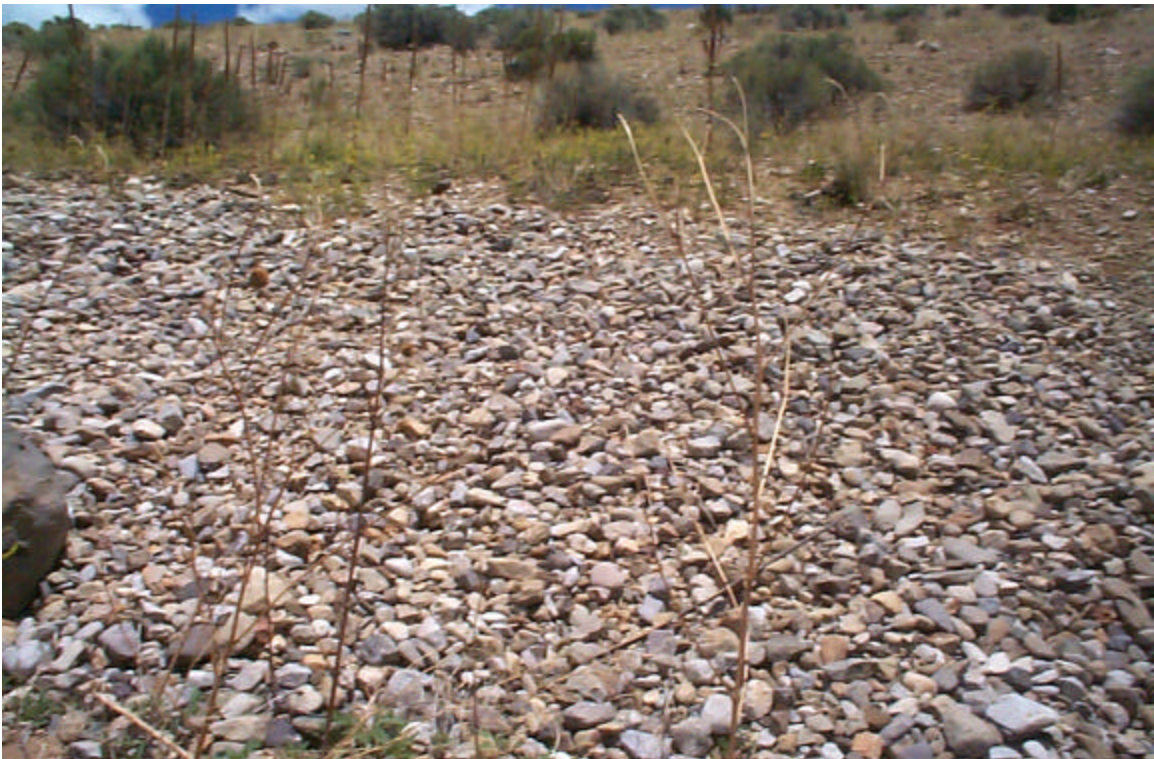
Photo 10: Close-up of the coarse rock layer at the toe of Dam 4.

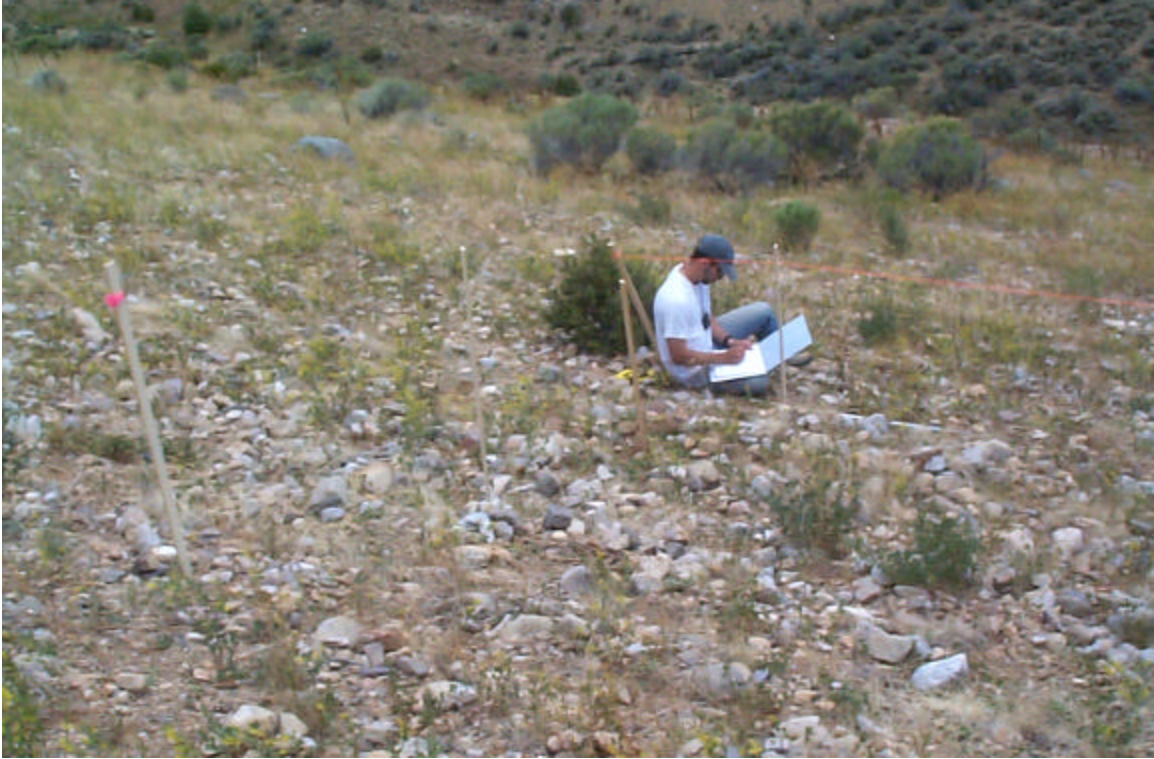
The locations of the test plots developed on the downstream slope of Dam 4 are shown in Figure 3. The test plots were situated based on observations from the reconnaissance survey of the downstream slope to evaluate “typical” erosive conditions. The surface of the upper and lower test plots are very similar in appearance. Photo 13 shows the upper test plot.

Photo 13: The 30 ft x 15 ft test plot near the crest of Dam 4.

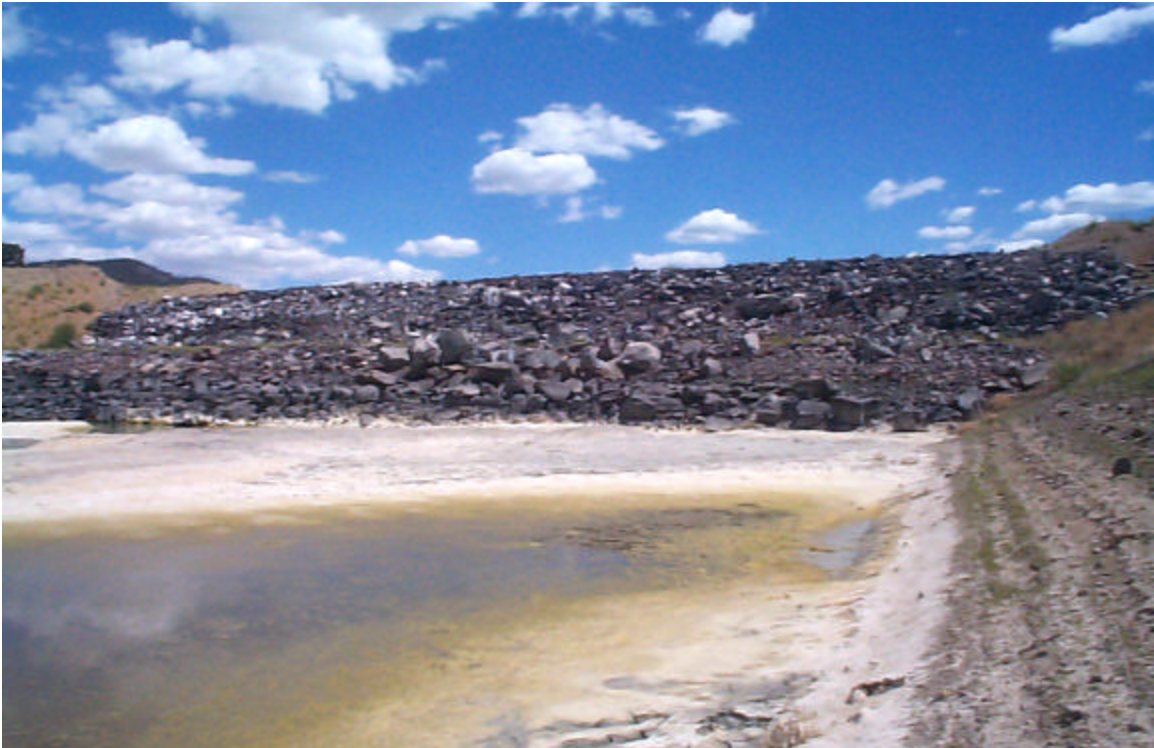
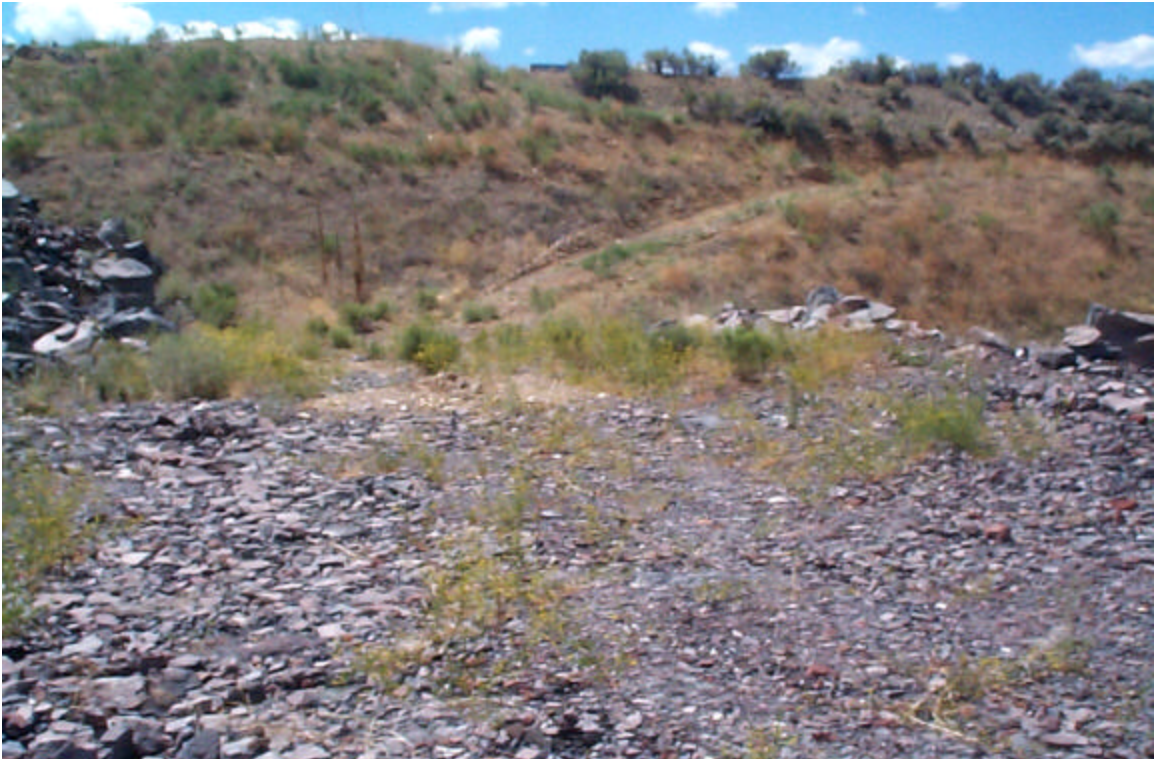
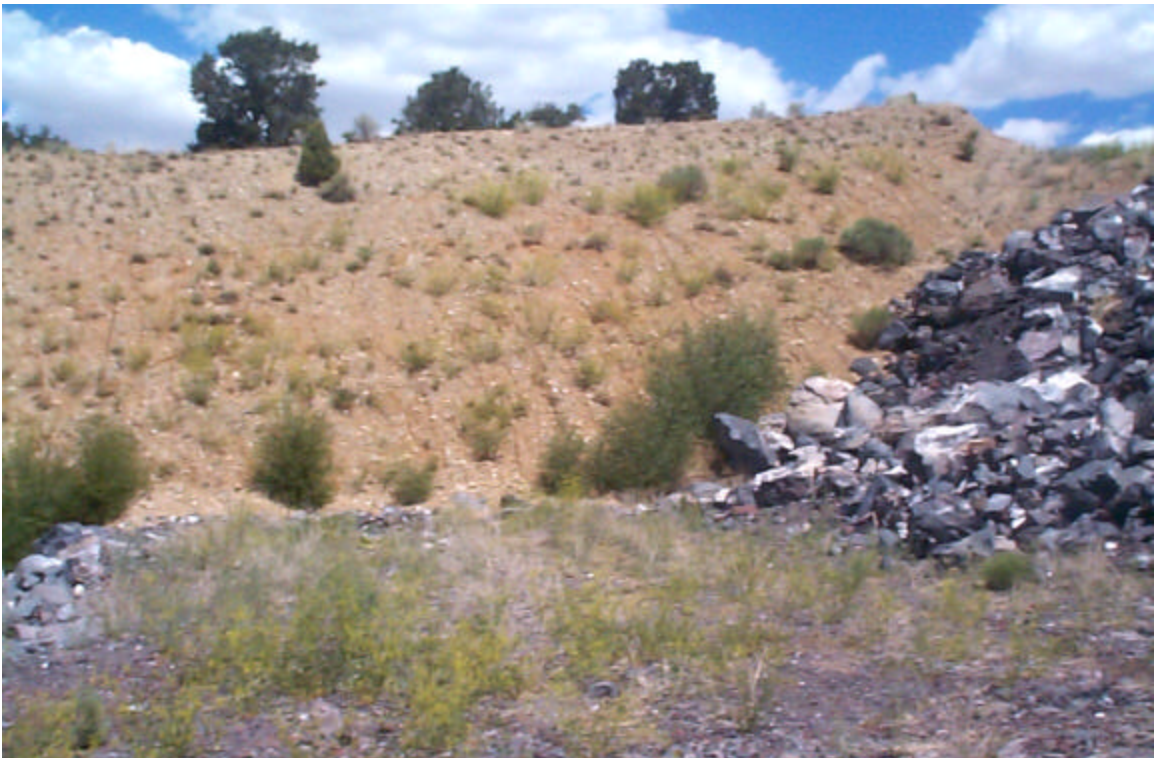
A reconnaissance survey of the downstream slope and abutments of Dam 5A was performed on June 11, 2000. The downstream face of Dam 5A and the east and west abutment walls of the rockfill dam are shown in Photos 14, 15, and 16, respectively. No evidence of surface erosion from wind or water was observed during the survey, even at the contact between the rockfill and granular abutment walls. Considering the construction of Dam 5A and the minimal potential for future surface erosion, Dam 5A is not considered any further in the surface erosion analysis.

Photo 14: Looking north showing the downstream face of Dam 5A.

Photo 15: East abutment wall of Dam 5A.

Photo 16: West abutment wall of Dam 5A.

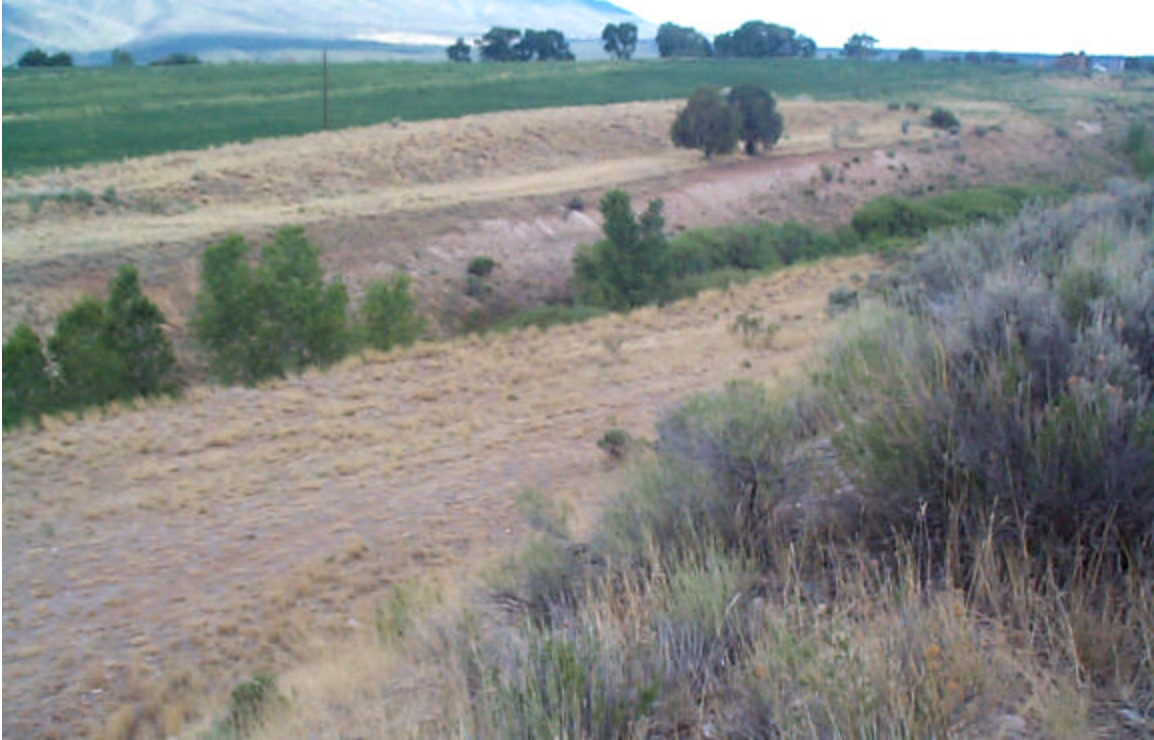
Stop E-1: The ditch is approximately 15 feet deep at the starting point (Photo 17). Heavy vegetation exists on both sides of the ditch; grass dominates the side-slopes and bushes and shrubs line the channel bottom. Coarse rock is visible on the side-slopes, covering about 20-30% of the area. No signs of erosion were observed in this area.

Photo 17: Looking north at the north end of the East Diversion Ditch from the tailings area (survey stop E-1).

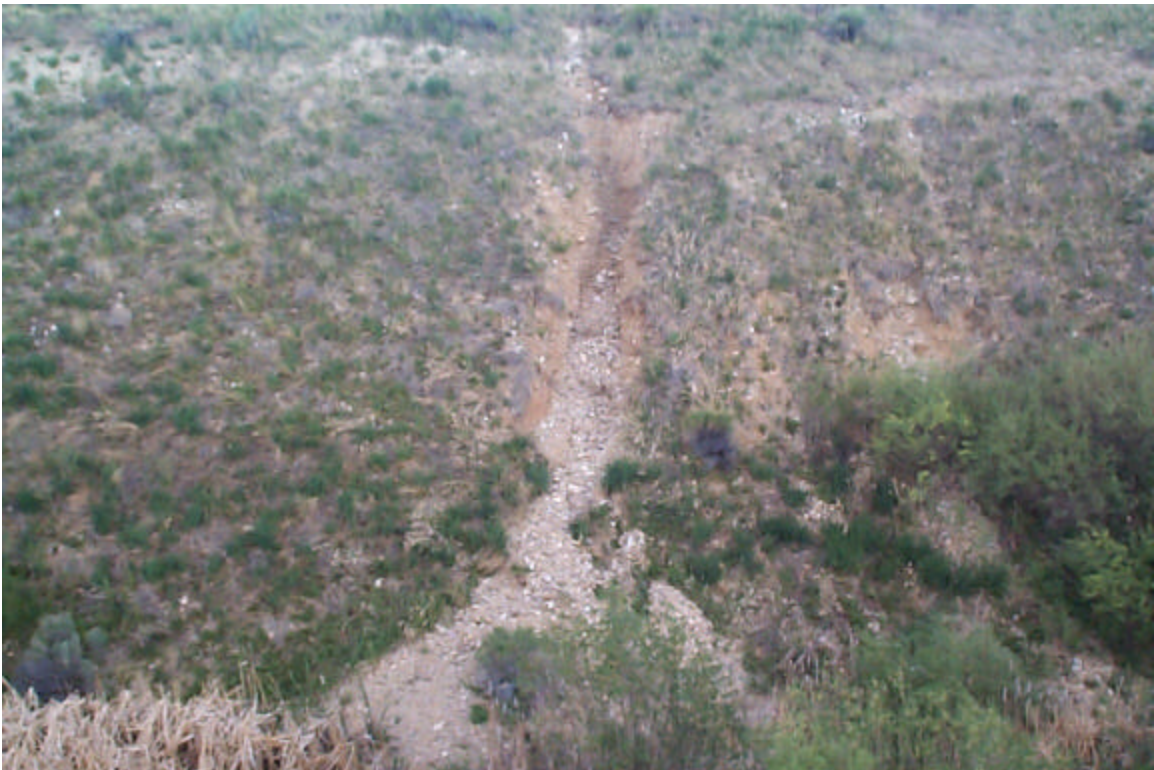
Stop E-2: A small gully is visible in the east slope of the diversion ditch (Photo 18). It occurs in well-vegetated gravelly soil; coarse rock can be seen in and around the gully. No other signs of erosion are visible to either side.

Photo 18: Small gully in the east slope of the East Diversion Ditch at survey stop E-2.

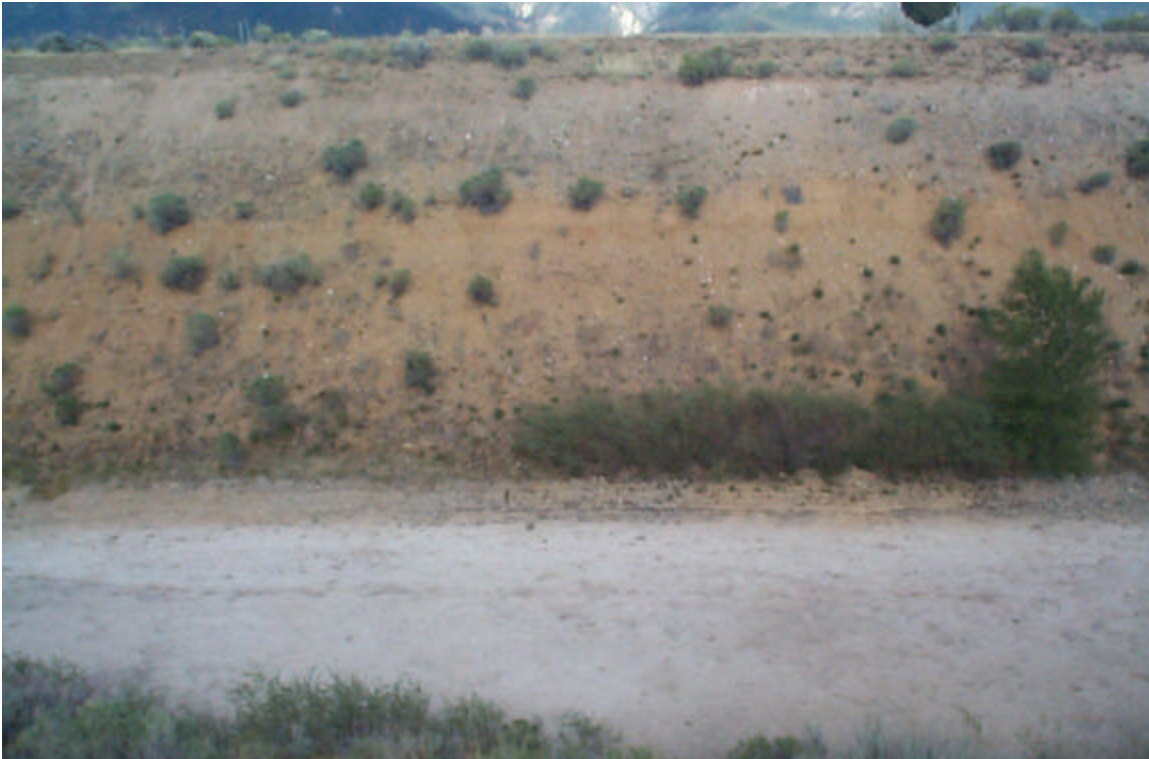
Stop E-3: The eastern slope is not as well vegetated compared to the previous two stops (Photo 19). No signs of erosion were observed. Possibly, small rills can be seen at mid-slope (only 2 feet long and 2 inches deep at most). The east slope is not as coarse as the slope has been to this point. The west slope is coarser and holds more vegetation. The channel bottom is sandy and dry.

Photo 19: East slope of the East Diversion Ditch at survey stop E-3 (no erosion; dry channel bottom).

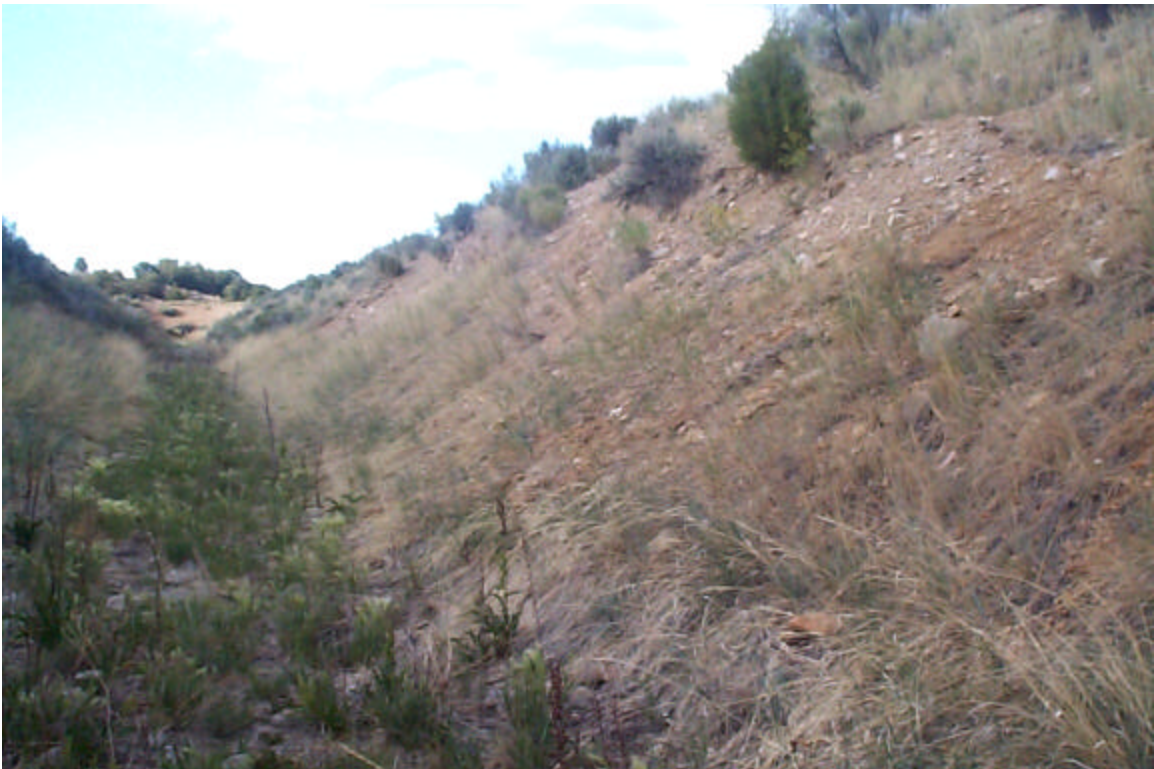
Stop E-6: This area is much the same as Stop E-5; the east slope has more grass and the slope is slightly flatter. Grass is growing on the channel bottom (Photo 22). No signs of erosion were observed.

Photo 22: Looking north at the east slope of the East Diversion Ditch from survey stop E-6.

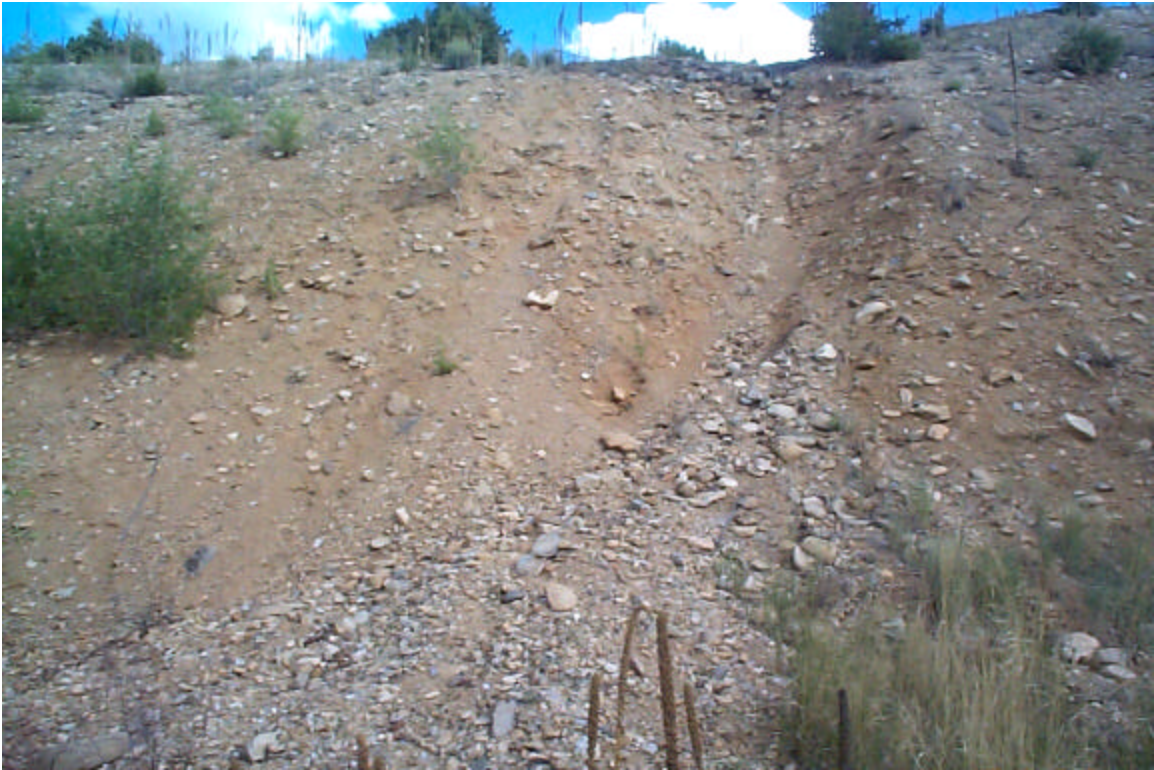
Stop E-7: A small gully was observed in the coarse rock face in the east slope (Photo 23). No vegetation exists next to the gully, which is the only one encountered in the area. No other signs of erosion were observed around the gully.

Photo 23: Small gully in the east slope of the East Diversion Ditch at survey stop E-7.

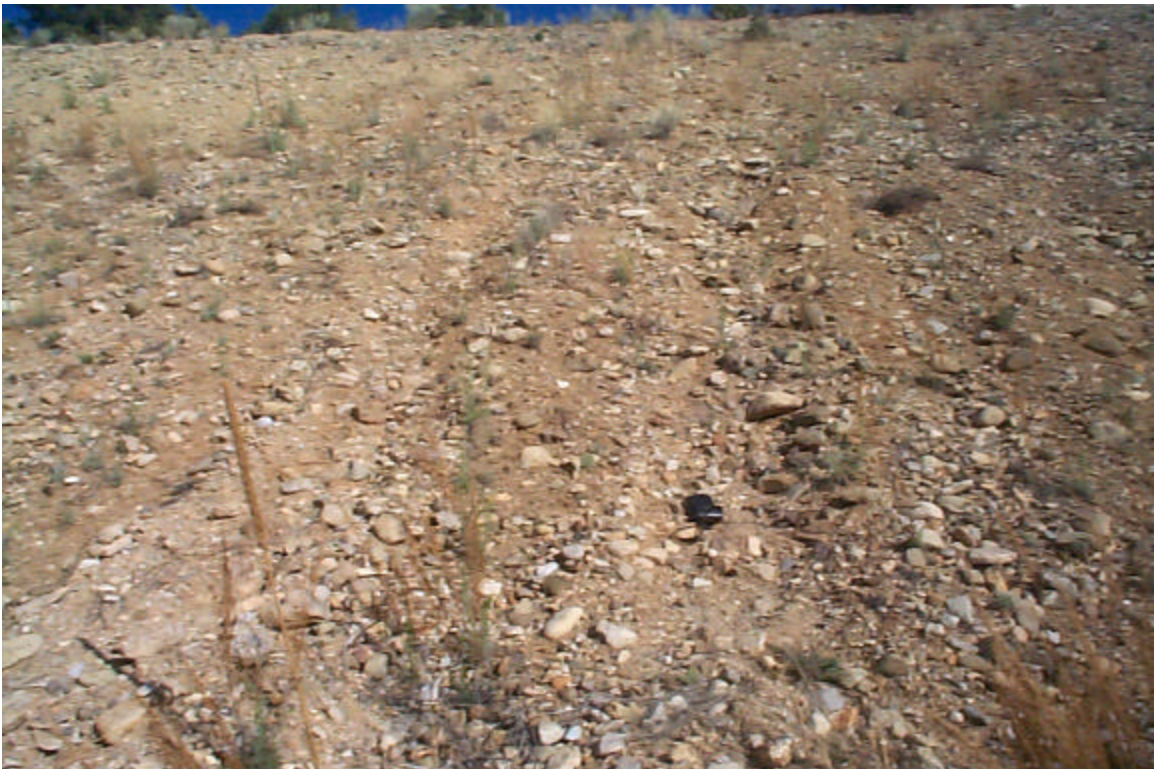
Photo 24: Moderate gullies in the east slope of the East Diversion Ditch at survey stop E-8.

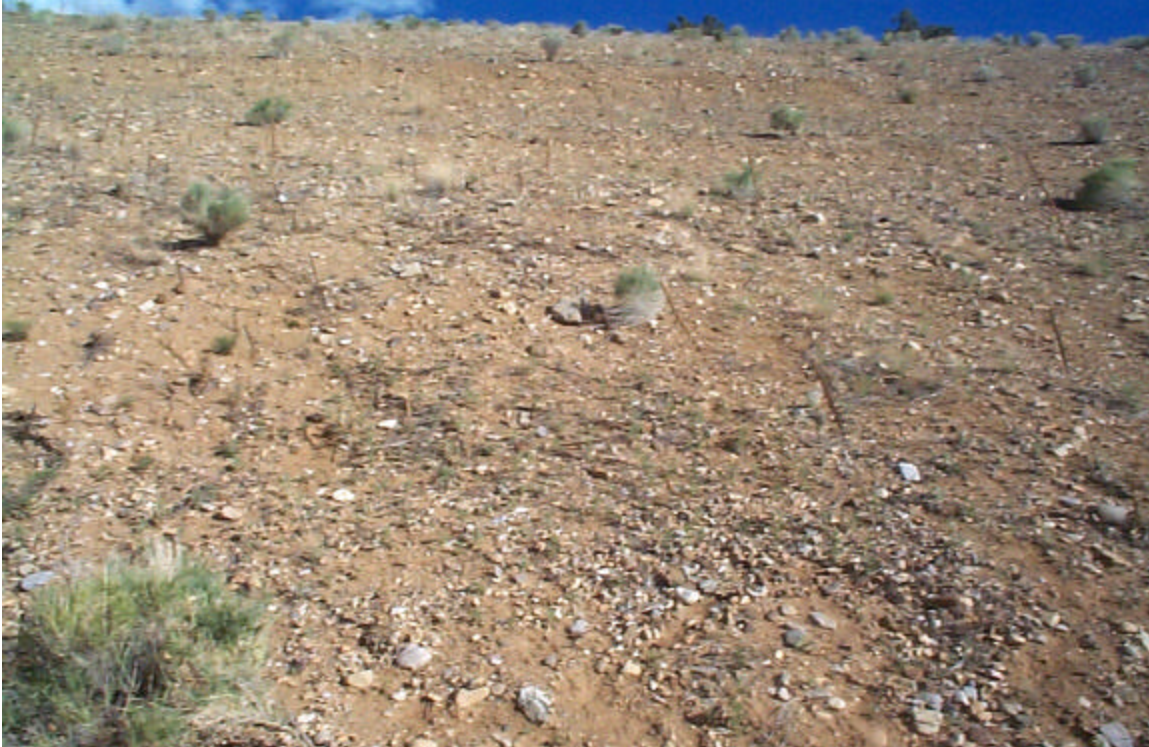
Stop E-13: No evidence of erosion was observed in this area (Photo 25).

Photo 25: East/south slope of the East Diversion Ditch at survey stop E-10 (no erosion).

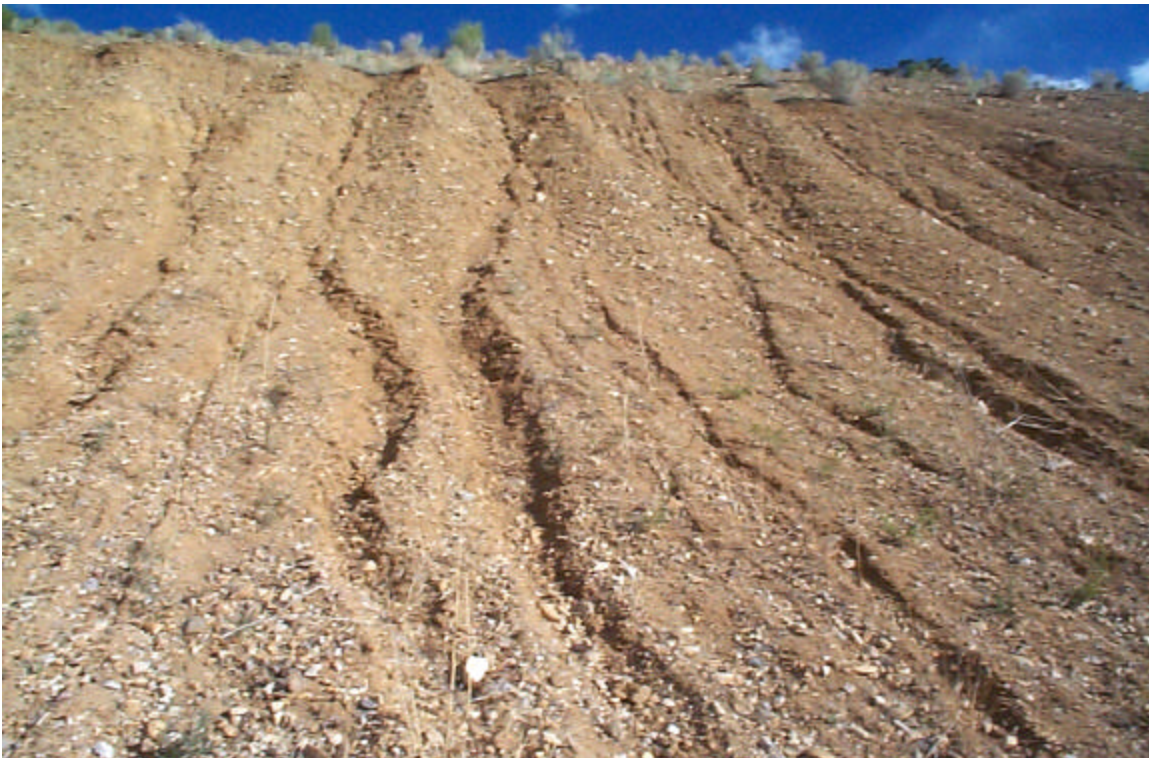
Stop E-14: This is the end of the East Diversion Ditch. Small to moderate erosion gullies are present on the east/south slope for 150 feet in each direction (Photo 26). The surface material is quite fine, only 15% is covered with coarse rock; it is the finest material found in the survey of the East Diversion Ditch. Gullies are 4-6 inches deep and 8 inches wide, spaced every 2-3 feet. The debris fans have both coarse and fine material. The west/north slope shows no signs of erosion. Minimal vegetation was observed on either slope at this stop.

Photo 26: Small to moderate gullies in the east/south slope of the East Diversion Ditch at survey stop E-14.

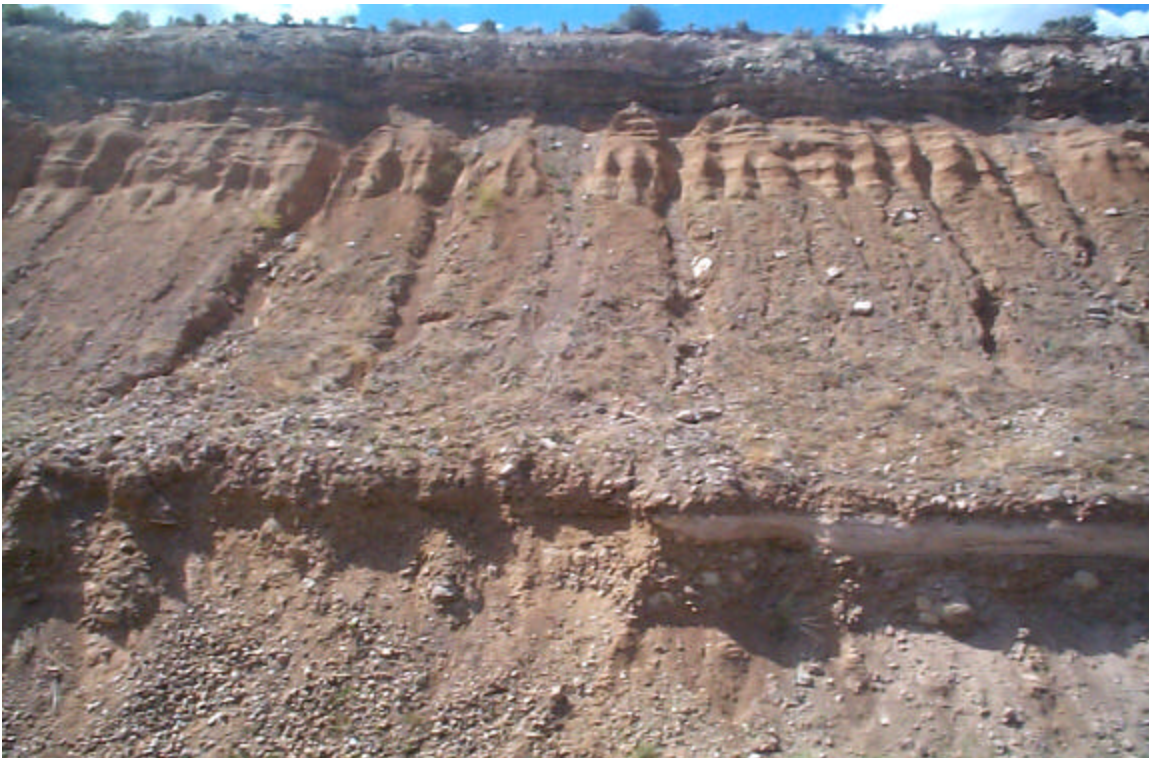
Photo 28: Moderate gullies in the west slope of the West Diversion Ditch at survey stop D-1.

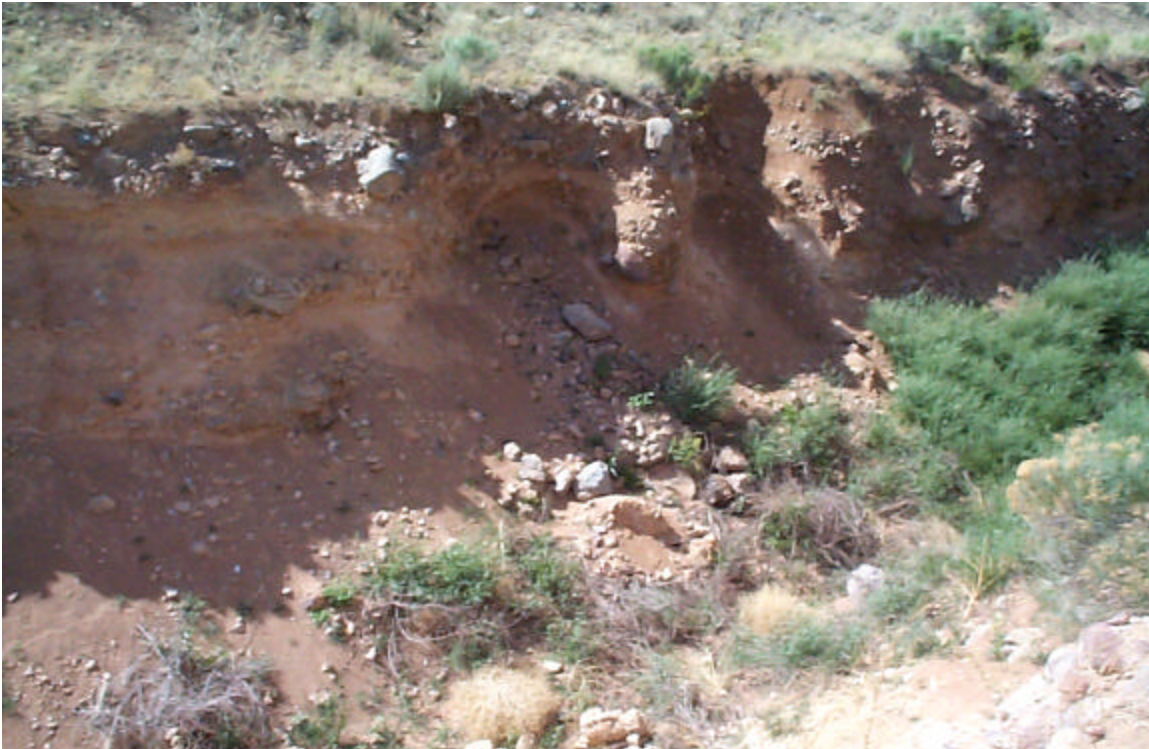
Stop D-2: The ditch slopes have the same shape as discussed in Stop D-1. Small surface failures or “cave-ins” were observed on the west slope (Photo 29). The small cave-ins extend to the top of the slope and consequently, clumps of grass exist in the channel bottom. The channel bottom has large boulders; most likely the boulders were within the matrix of the channel walls and the fines around them were removed causing the boulders to fall.

Photo 29: Cave-ins on the west slope of the West Diversion Ditch and fallen debris in the channel bottom at survey stop D-2.

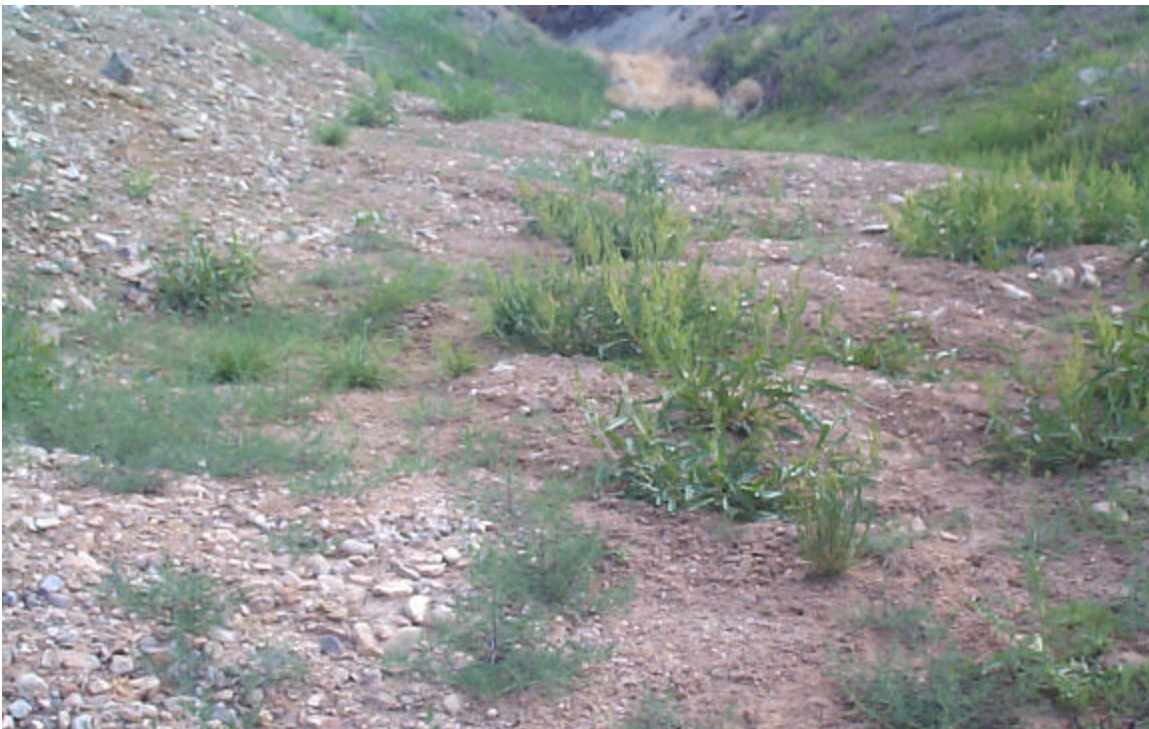
Photo 30: Earth flows originating from gullies in the east slope of the West Diversion Ditch at survey stop D-4.

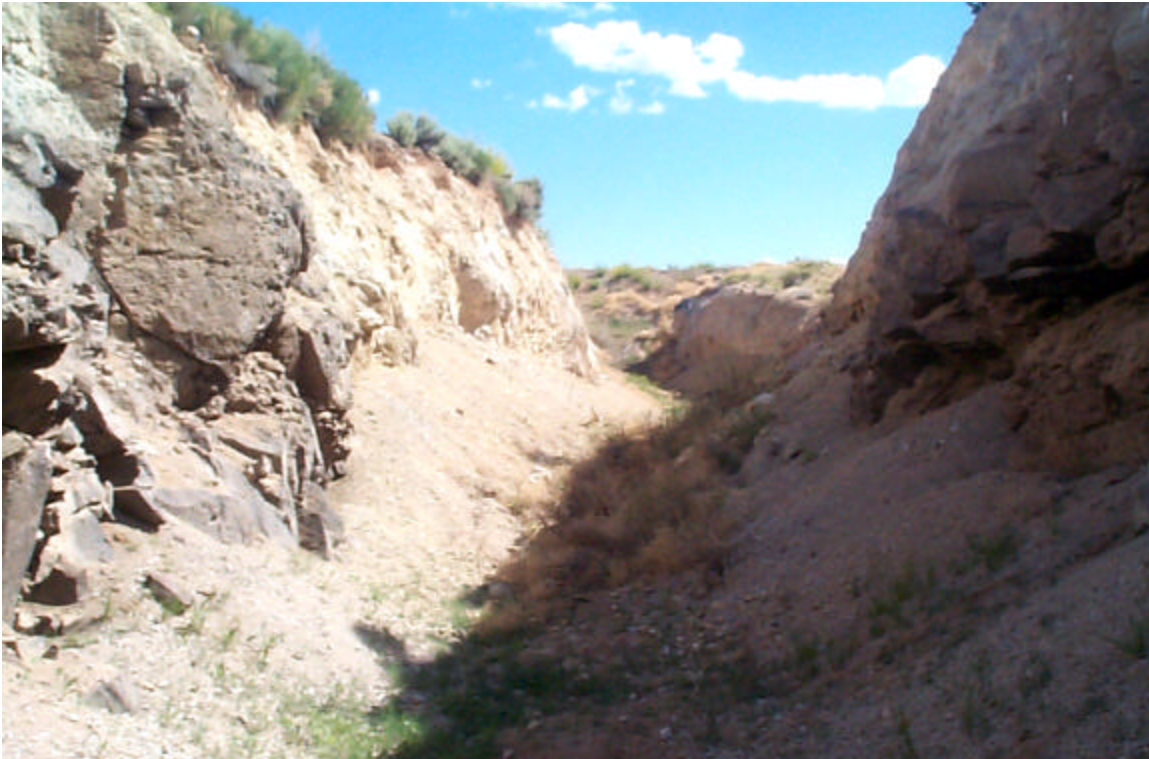
Stop D-5: The area is in bedrock outcrops with the slopes standing close to vertical (Photo 31). Loose fill has accumulated at the toe of the slope as a result of falling material from the upper part of the slope. Another possible theory is that wind has deposited some of the fill due to sediment being picked up as the wind descends the mountains to the west. Only weeds are present on the dry channel floor.

Photo 31: West Diversion Ditch looking south near survey stop D-5 (near vertical side-slopes).

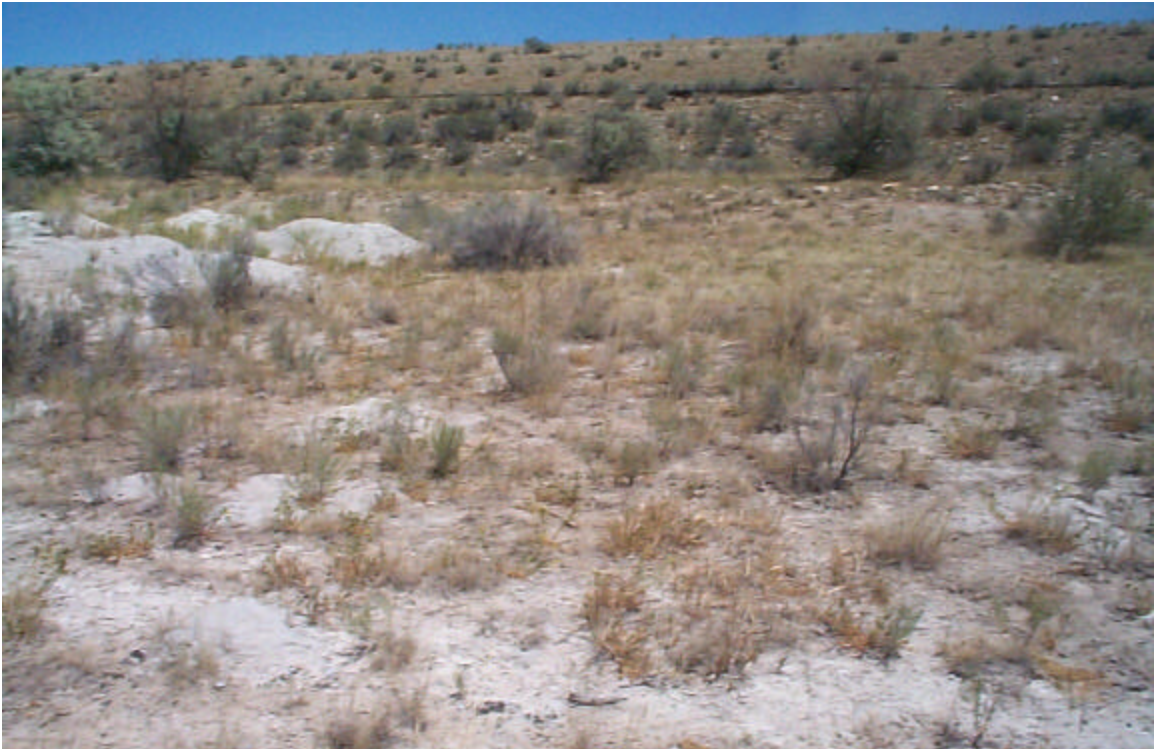
Photo 33: Tailings on top of interim cover material near the toe of Dam 1C.

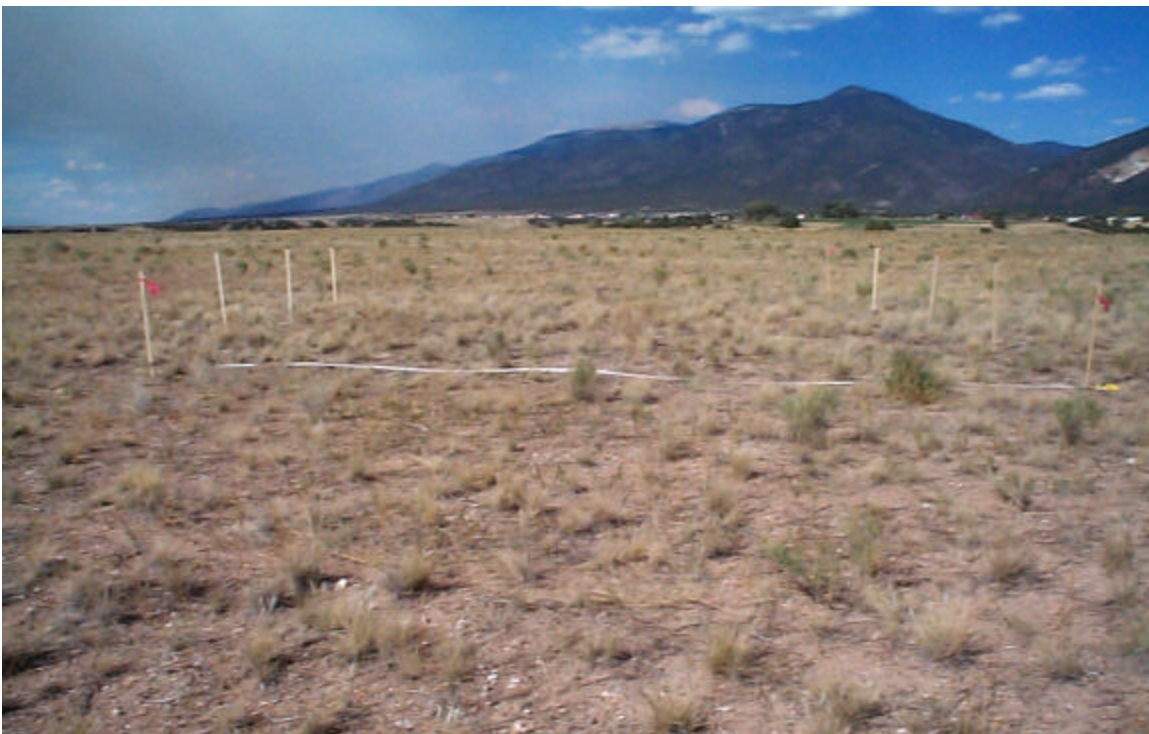
The surface of these two tailings areas (covered and seeded in 1993) consist of a sandy-gravel matrix (interim cover borrow material) and relatively well-established vegetation (Photo 36 and 38). In general, the vegetation in the Dam 4 tailings area is less dense than that observed in the Dam 1 tailings area. This could be a result of the winter grazing of sheep that occurs in this area.

Photo 36: The 30 ft x 30 ft test plot representative of “typical” conditions on the surface of a tailings area covered and revegetated in 1993 (Dam 1 tailings area).
