Report No. 052010/2

## **SURFACE EROSION AND STABILITY ANALYSIS QUESTA TAILINGS FACILITY, NEW MEXICO**

July 2000

**SURFACE EROSION AND STABILITY ANALYSIS**  
**QUESTA TAILINGS FACILITY, NEW MEXICO**  
**(MINE CLOSEOUT PLAN PROGRAM TASK B – SUBTASK B1)**

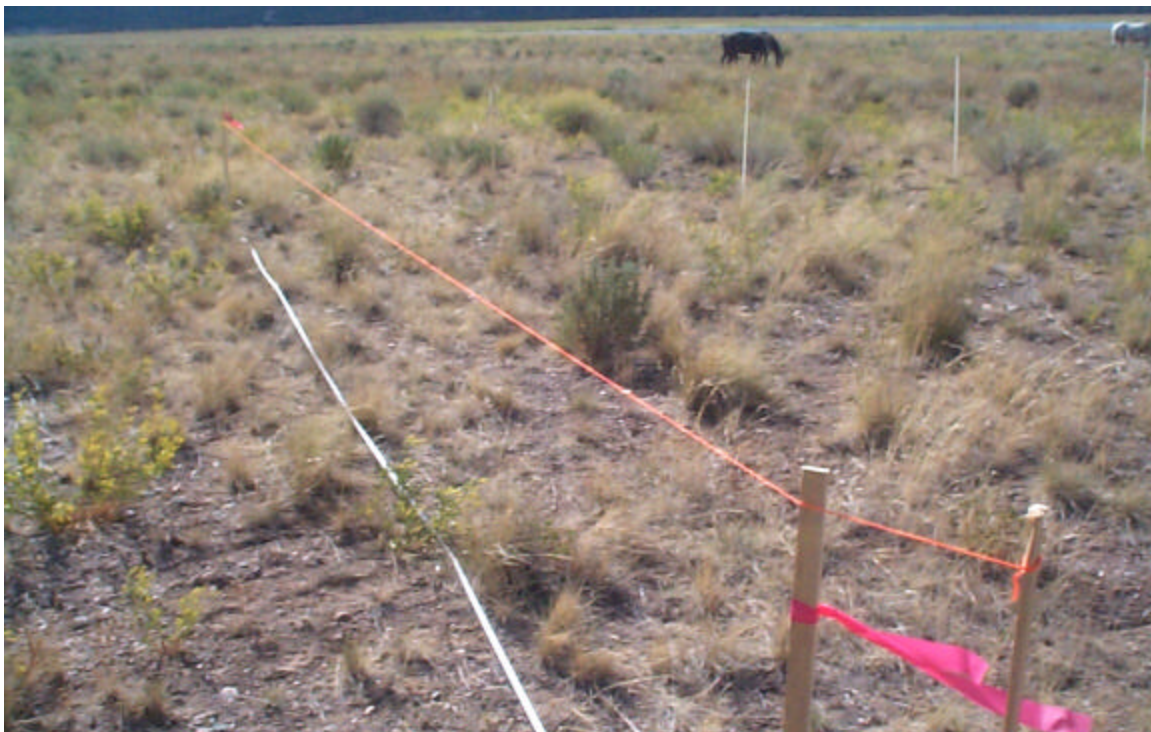
The surface of these two tailings areas (covered and seeded in 1993) consist of a sandy-gravel matrix (interim cover borrow material) and relatively well-established vegetation (Photo 36 and 38). In general, the vegetation in the Dam 4 tailings area is less dense than that observed in the Dam 1 tailings area. This could be a result of the winter grazing of sheep that occurs in this area.

Photo 38: The 30 ft x 30 ft test plot representative of “more erosive” conditions on the surface of a tailings area covered and revegetated in 1993 (Dam 1 tailings area).
