Abandoned Uranium Mine Field Survey Project

prepared for
New Mexico Energy, Minerals and Natural Resources Department
Mining and Minerals Division

July 18, 2008

RE: Final Report - Abandoned Uranium Mine Field Survey Project

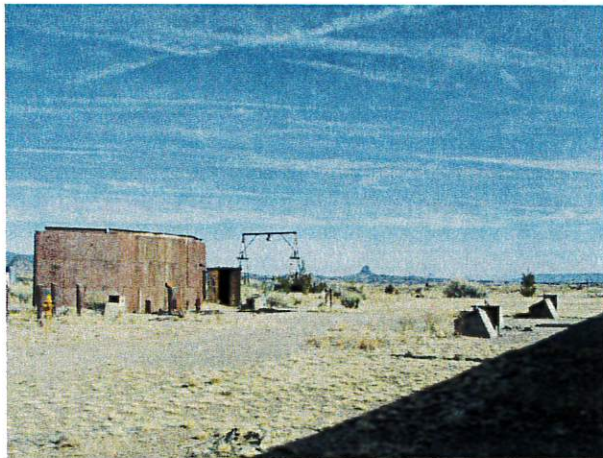
Headframe area

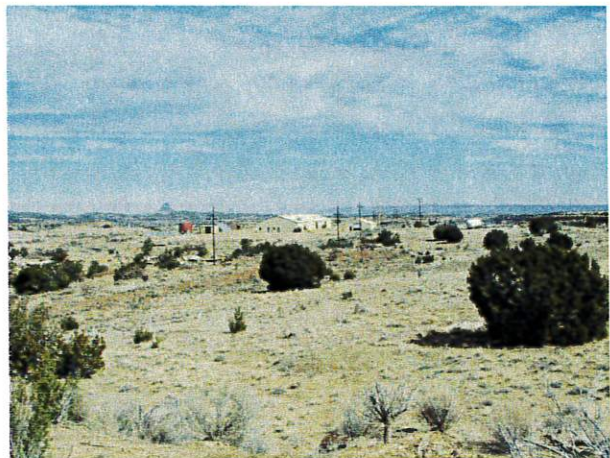
Site view

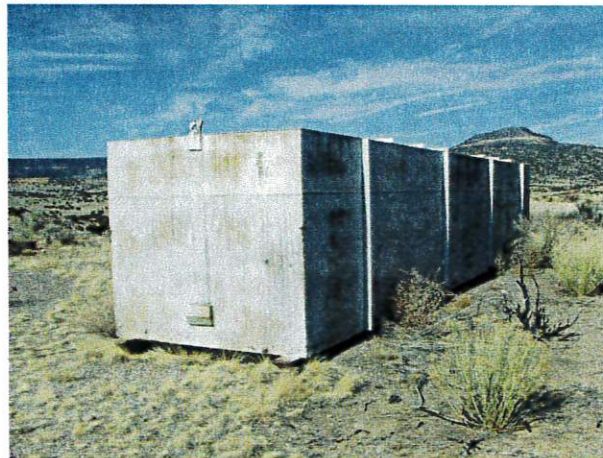
Storage containers

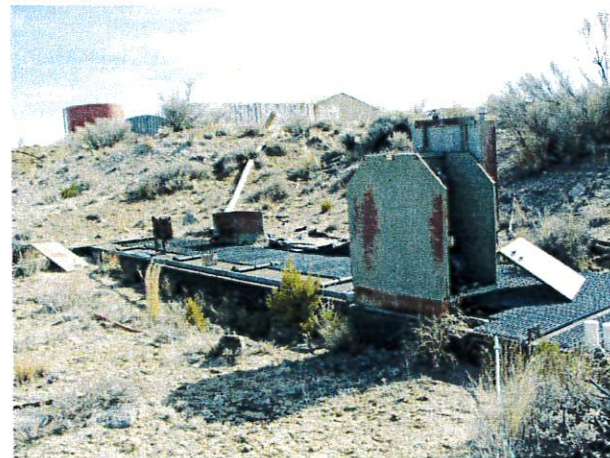
Pump station

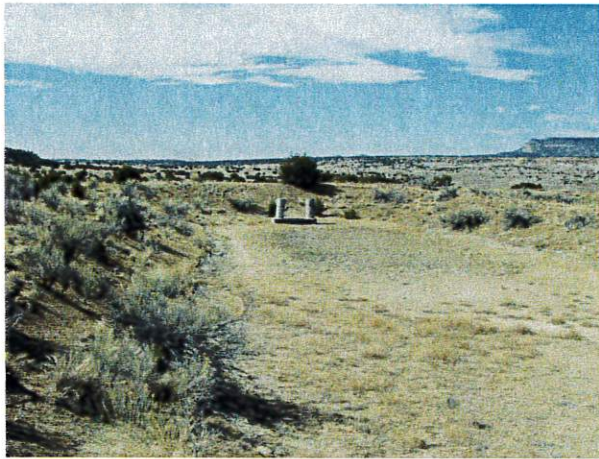
View south into eastern-most pond

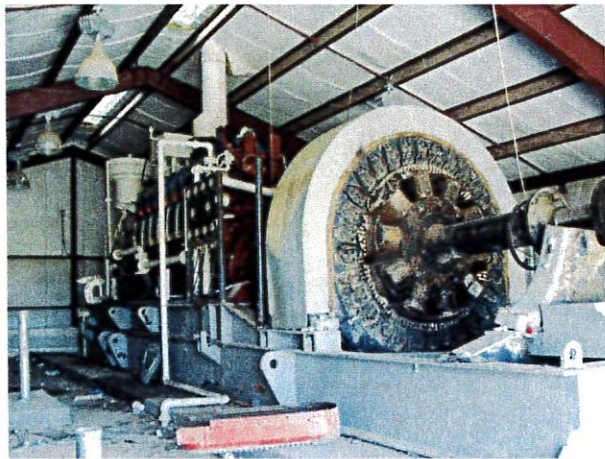
Interior of building

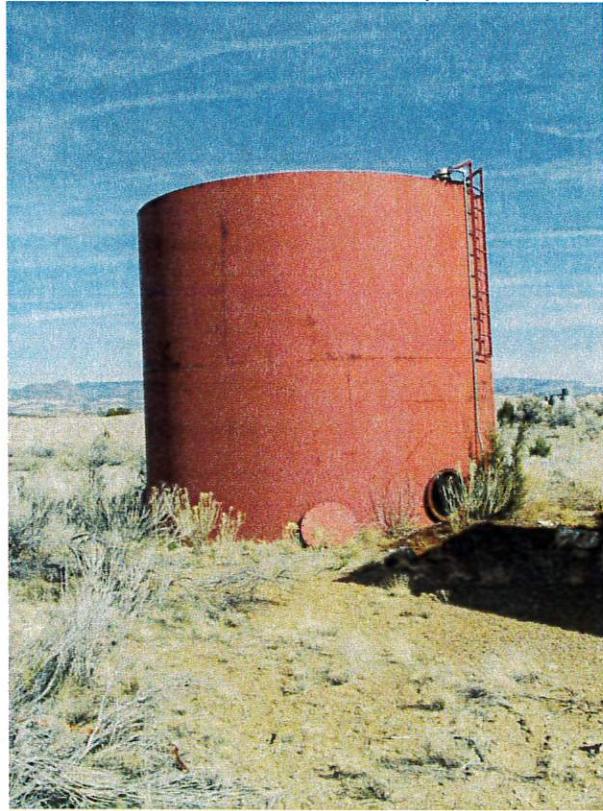
Water tank

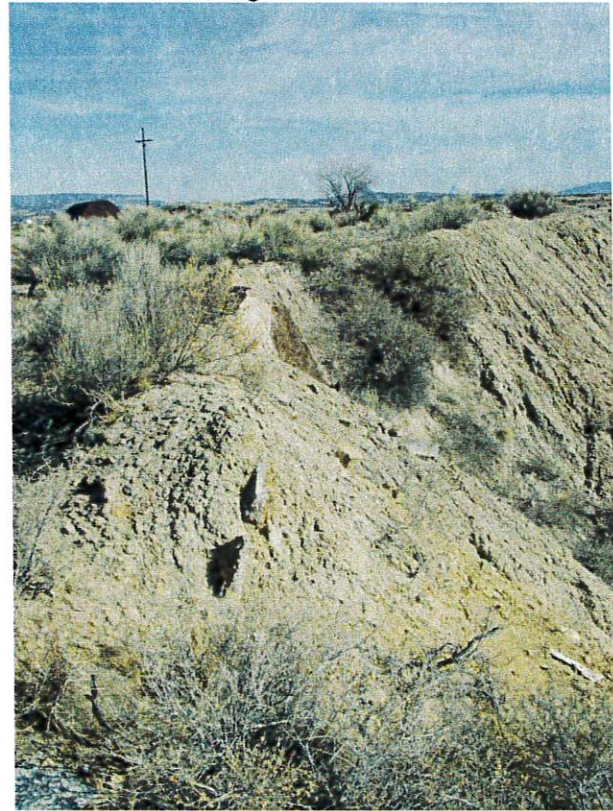
Rock piles

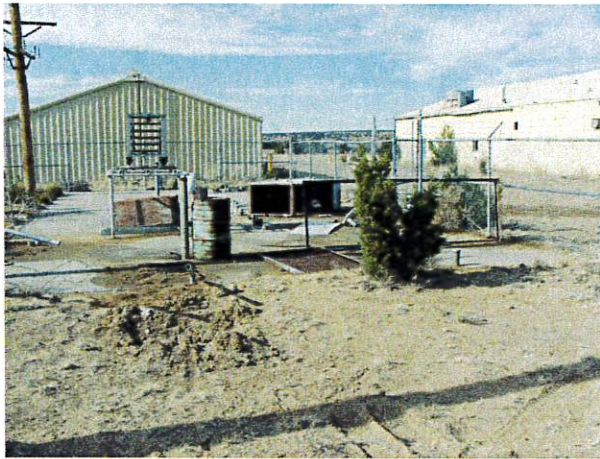
Electrical yard with transformer oil spill

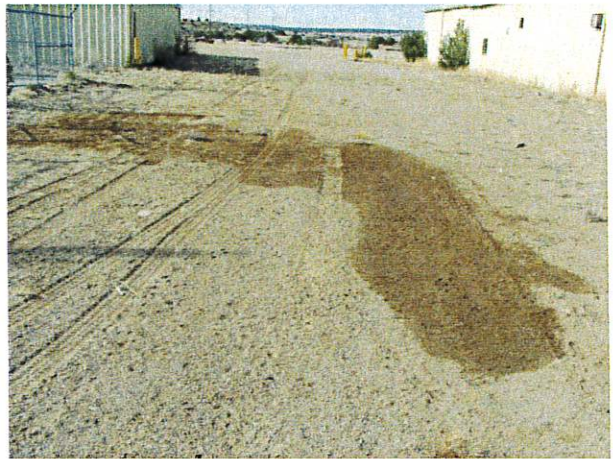
2. Human Activity: Fresh tire tracks indicate recent human access to the site.

Transformer oil spill, recent tire tracks
