ABANDONED OR INACTIVE URANIUM
MINES IN NEW MEXICO

New Mexico Bureau of Mines and
Mineral Resources
Open-File Report 148

Mine name(s) Merry Widow County Grant
Section S $\frac{1}{2}$ 22 Twنش. 20 S R. 15 W
Quadrangle sheet Burro Peak 7 $\frac{1}{2}$ '
Mining district White Signal
Elevation 6,140'
Nearest city and/or dwellings White Signal, 1.2 miles east

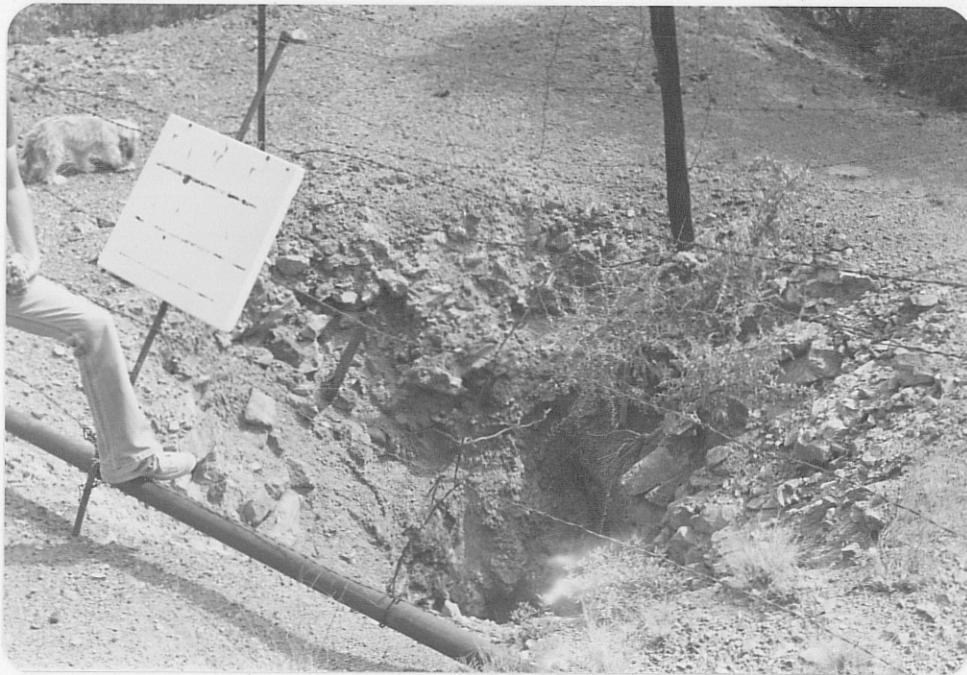
The workings consist of a 6' x 6' vertical shaft open down to about the 40' level. It was originally a 150' deep shaft, one of the deepest in the district (Gillerman, 1964), with levels at 40', 60', 90', and 130' which explored the ore body. Host or country rock is a granite; mineralization has occurred where an east trending fault has cut and displaced two diabase dikes. Ore minerals consist of chalcopyrite, pyrite, hematite, autunite, and torbernite (Gillerman, 1964). Mine was opened in 1910 for gold. Uranium minerals were discovered in the tailings dump in 1919 and subsequently the mine produced most of the radium in the district during the "radium boom" of the 1920's.

Photo (a) Merry Widow Mine shaft; 6' x 6' shaft is open down to about 40'. Fence is deteriorating but still effective. Sign is no longer legible.

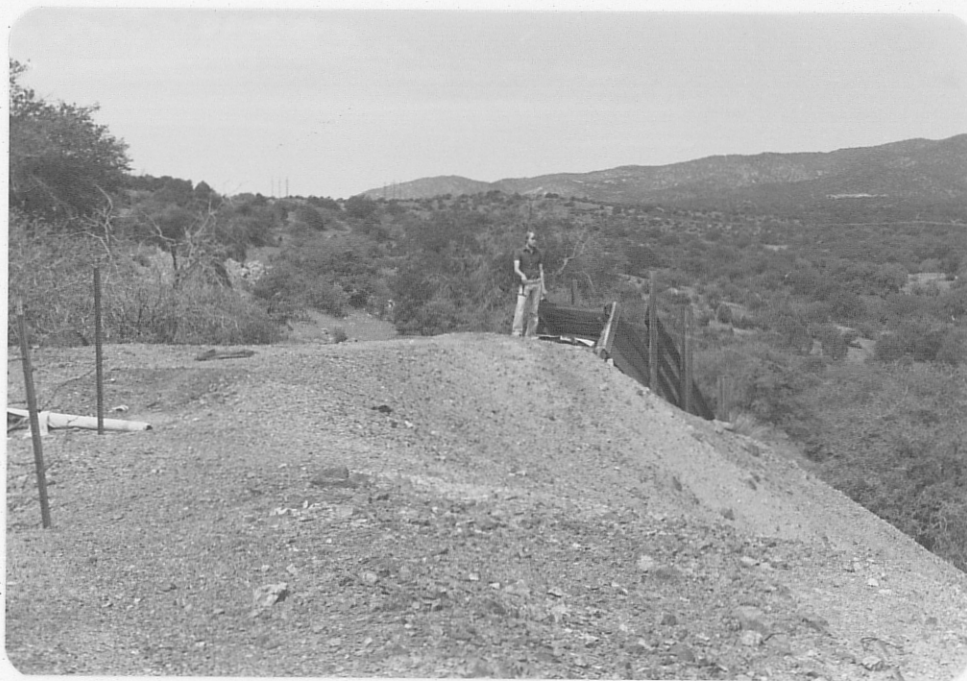
photo (b) Tailings dump and ore chute just west of shaft, looking west.

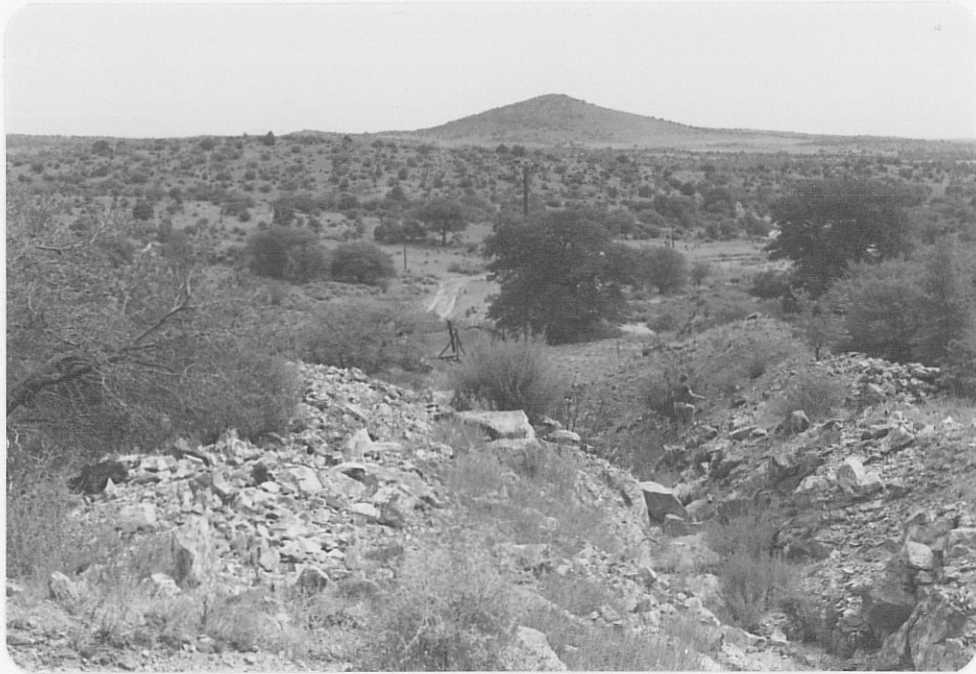
Photo (c) Trenching just southwest of Merry Widow shaft exploring mineralization along east trending fault where it cuts and displaces a diabase dike.
