Abandoned Uranium Mine Site Assessment for the Varnum Site (NM0116)

FINAL REPORT

March 24, 2010

NM0116

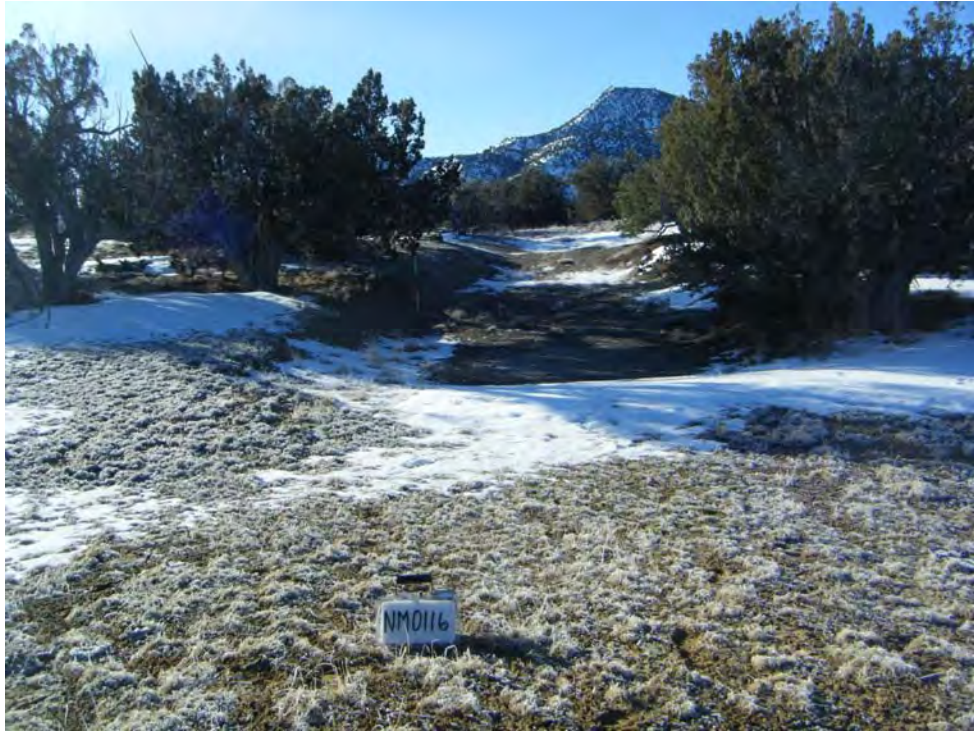
One shallow open cut (Cut-1) was found onsite. No bedrock was found inside the cut, although infilling due to erosion may have obscured the original target of excavation. A gamma reading conducted inside Cut-1 found 14 $\mu\text{R/hr}$, which is approximately equivalent to background level for the Site.

Photo 1-Site photo and view of Cut-1 in background, looking south (point Photo-1).

Photo 1 - cut 1, looking S

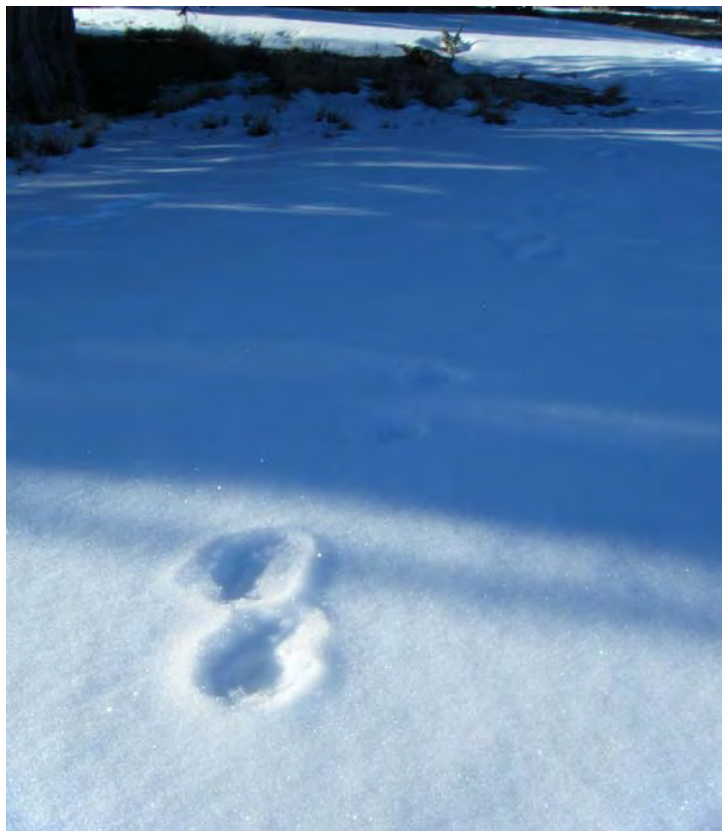
Deer or elk tracks were noted in the snow (see Photo 2 in Appendix A). Possible rodent nests were also observed.

Photo 2-Animal tracks at the AUM Site.

Photo 2 - animal tracks, probably deer

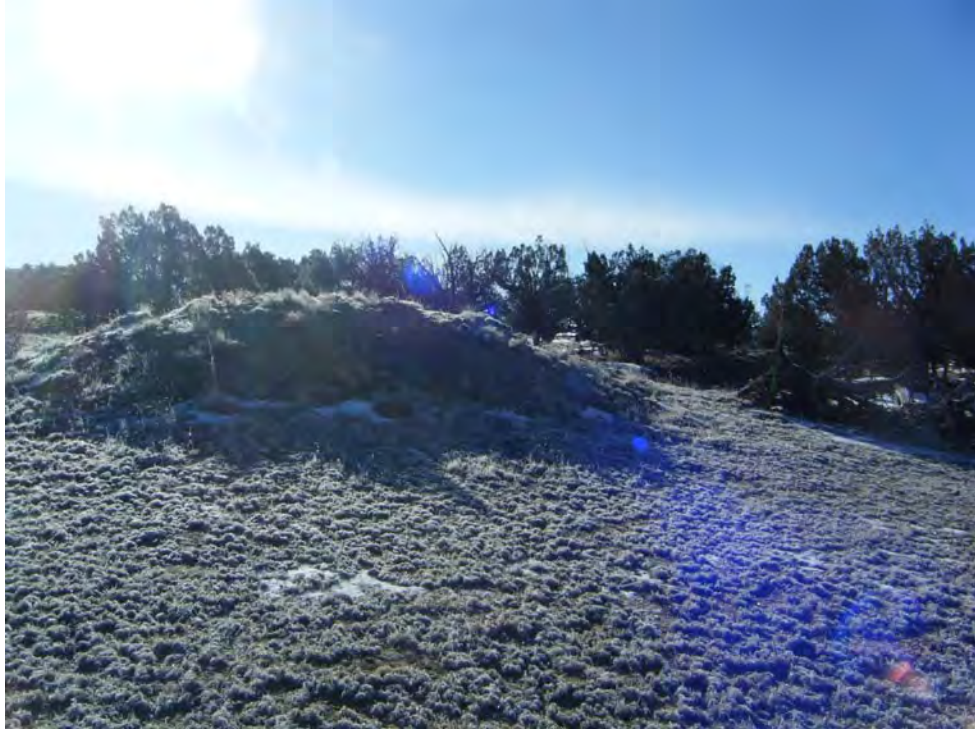
Two piles were discovered at the AUM Site. One pile (PilePly-1) probably represents material excavated from Cut-1. PilePly-1 consists of mostly soil with scattered rocks about a foot in diameter. The other pile (PilePly-2) is a low mound of broken rocks. Neither pile showed gamma readings above background for the Site.

Photo 3-Looking southeast at PilePly-1.

Photo 3 - pile 1, cut 1 is in background,
looking SE

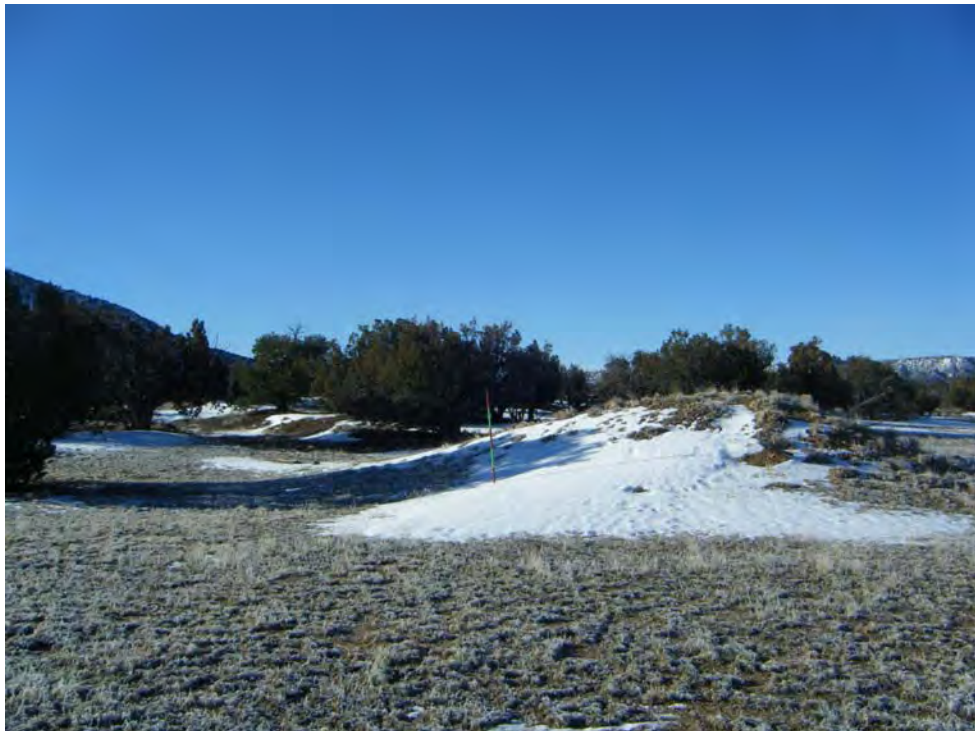
Photo 4-Looking southwest at PilePly-1 (foreground) and Cut-1 (background).

Photo 4 - pile 1, cut 1 in background,
looking SW

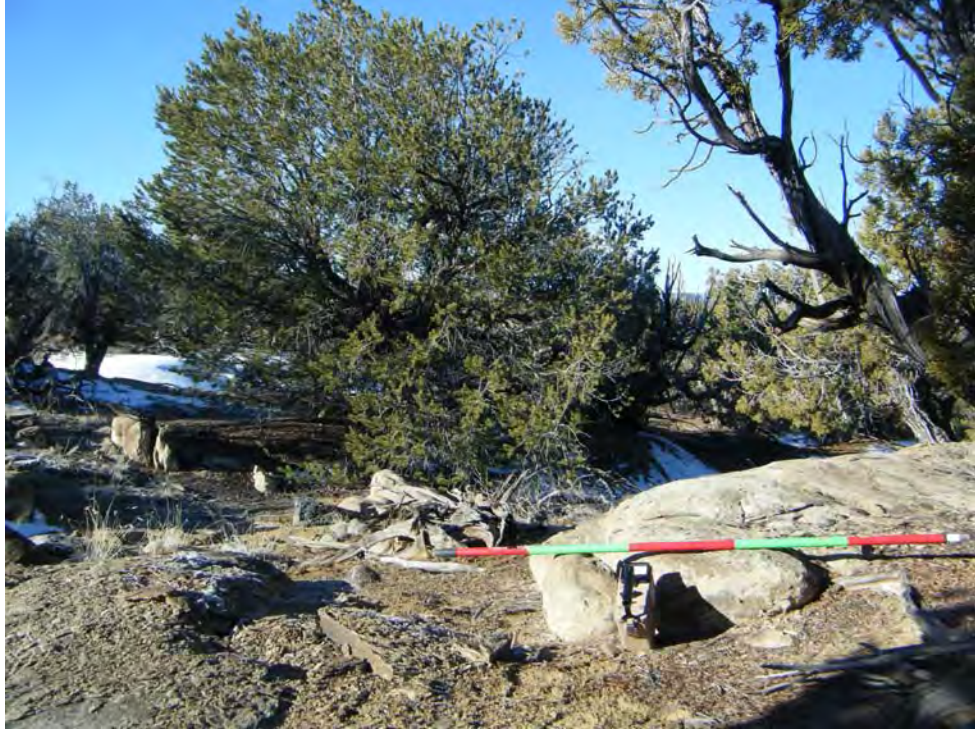
Photo 5-Looking southwest at point Rad-3.

Photo 5 - rad 3, looking SW

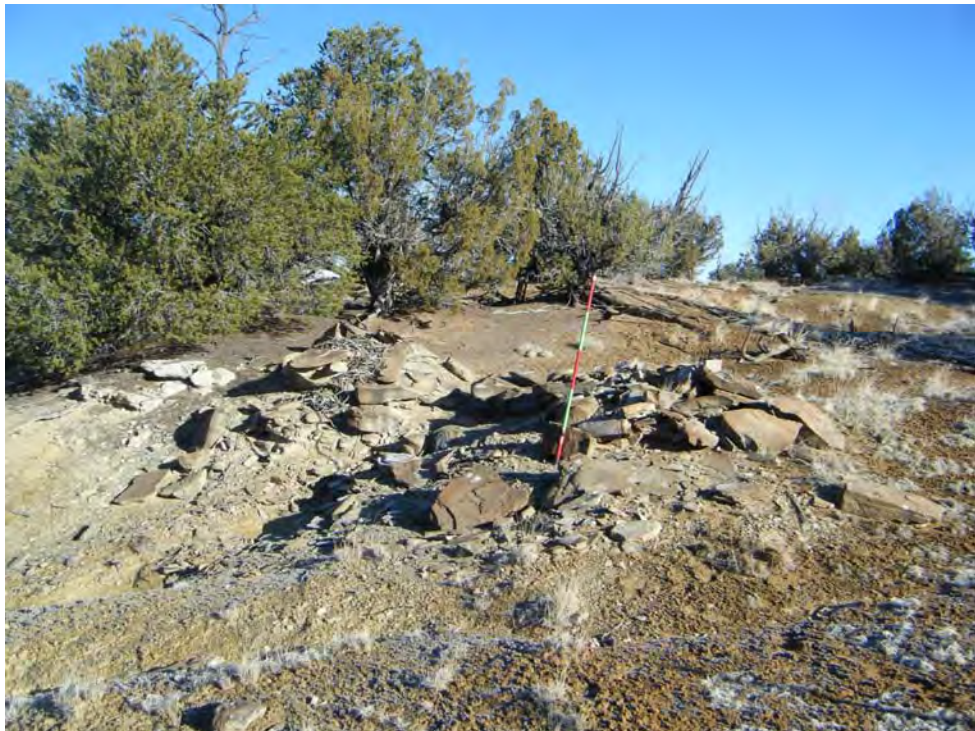
Photo 6-Looking north at PilePly-2.

Photo 6 - pile 2, looking N

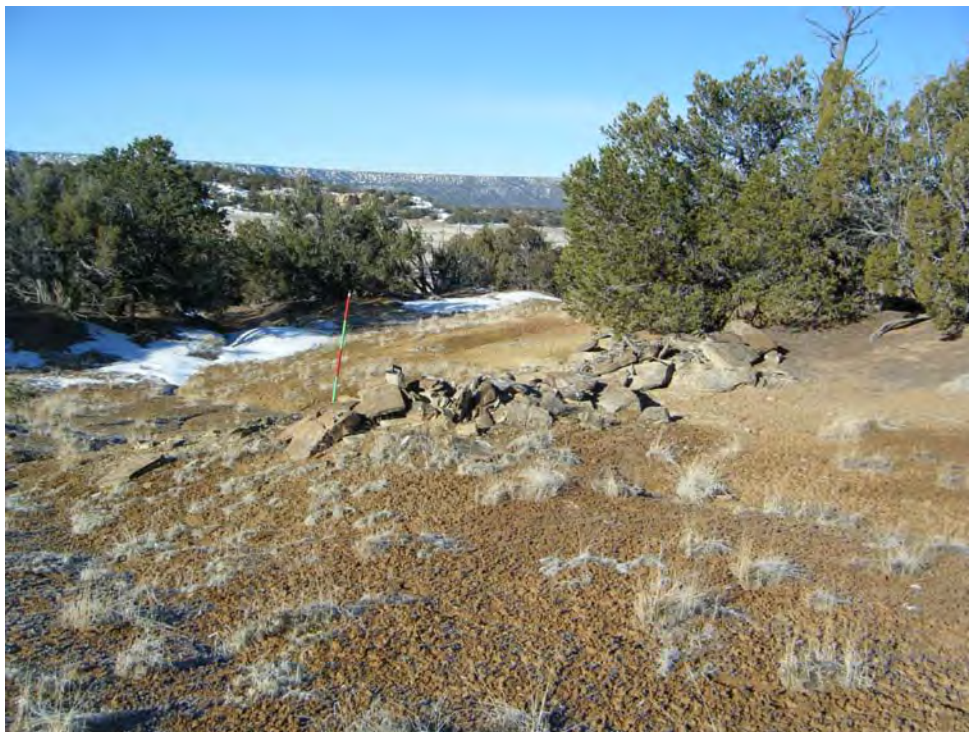
Photo 7-Looking west at PilePly-2.

Photo 7 - pile 2, looking W

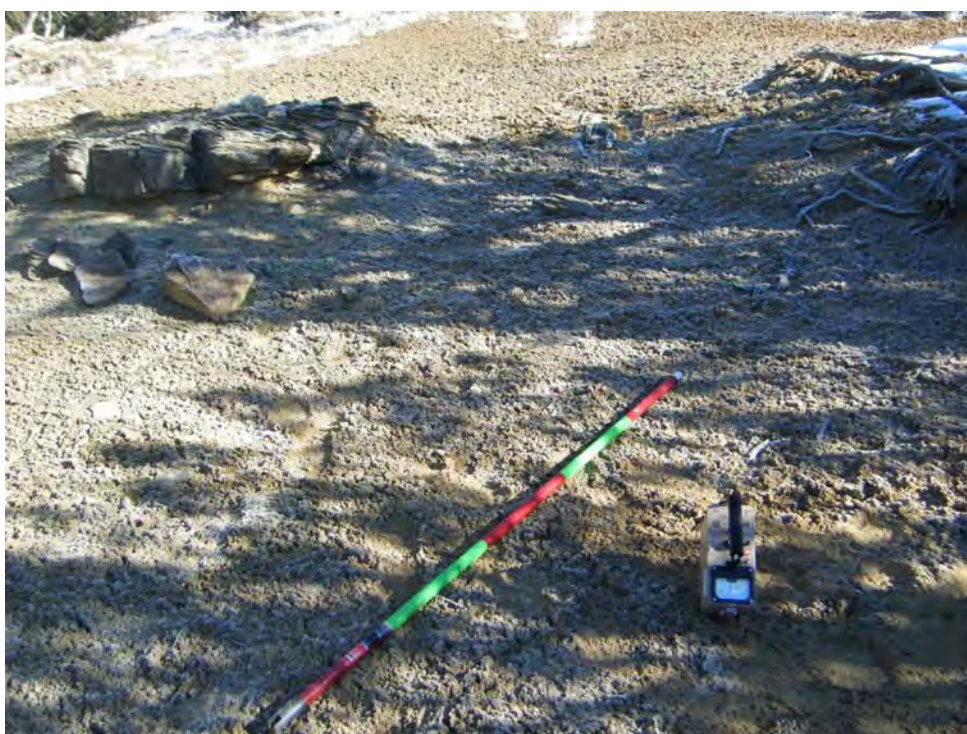
Photo 11-Photo of point Rad-5. Scintillometer marks the point of highest gamma readings.

Photo 11 - Rad 5, anomalous high reading, no
mine features nearby, rock in upper left
of photo is not rad source

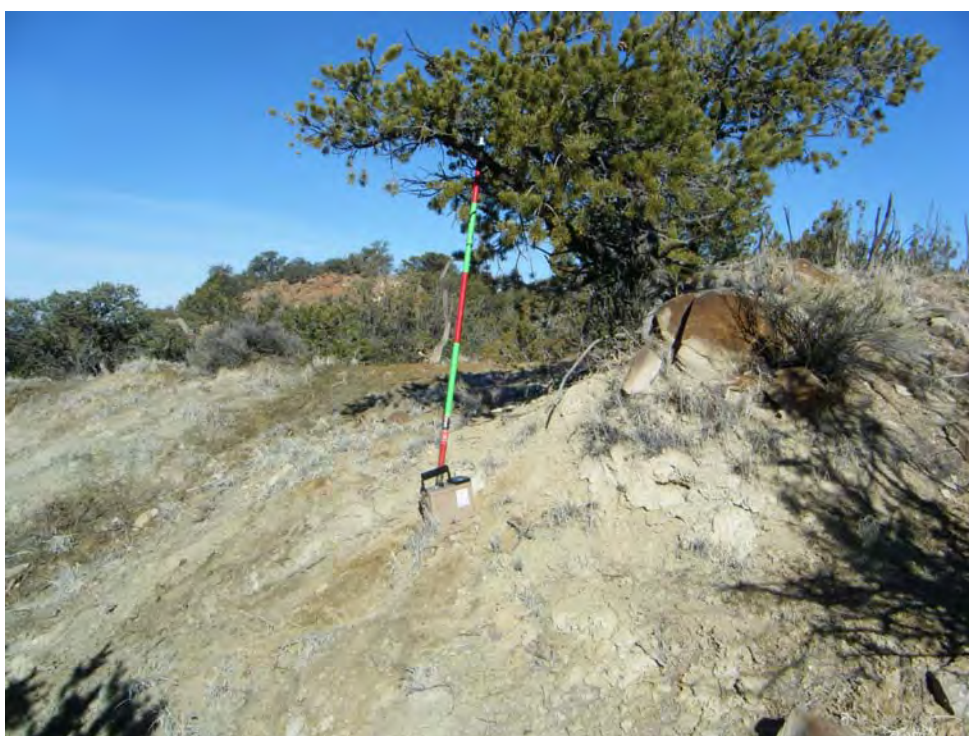
The maximum gamma radiation reading for the AUM Site was 100 $\mu\text{R/hr}$ at contact at point Rad-8. This reading was recorded on a soil-covered hillside (see Photo 13). Adjacent bedrock was not radioactive. One other location (point Rad-5) recorded 30 $\mu\text{R/hr}$ at contact, approximately 3 times background level. Like point Rad-8, this location was covered with soil; nearby rocks were not radioactive.

Photo 13-Looking west at point Rad-8. Scintillometer indicates area of highest gamma ray readings.

Photo 13 - rad 8, looking W

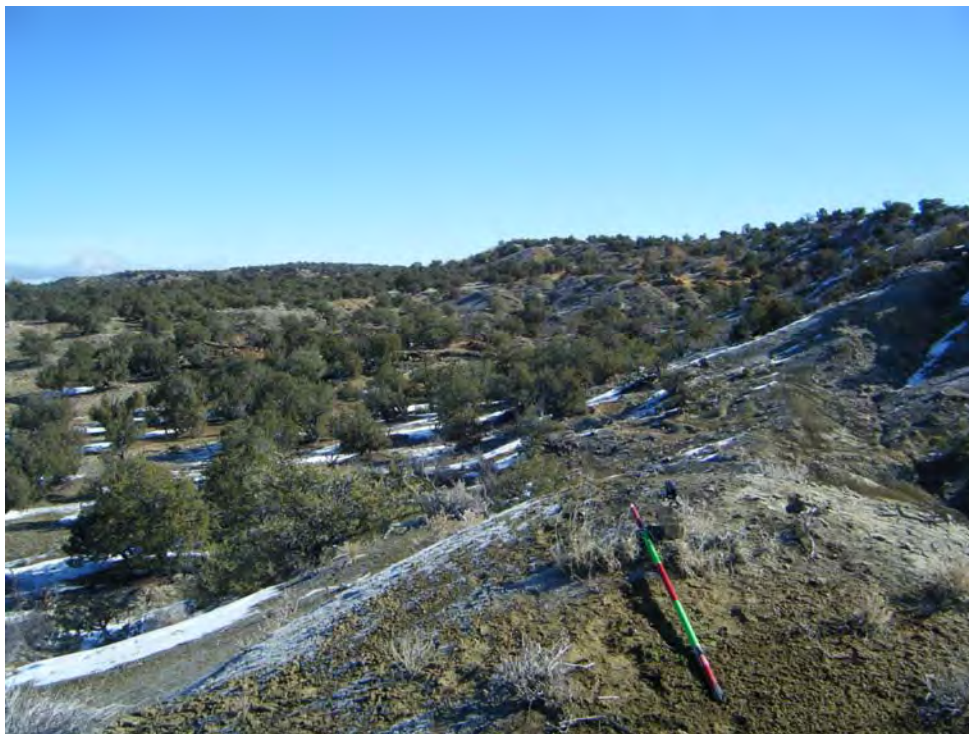
Photo 14-Point Rad-9, looking NE at the eastern edge of the AUM Site.

Photo 14 - rad 9, looking NE

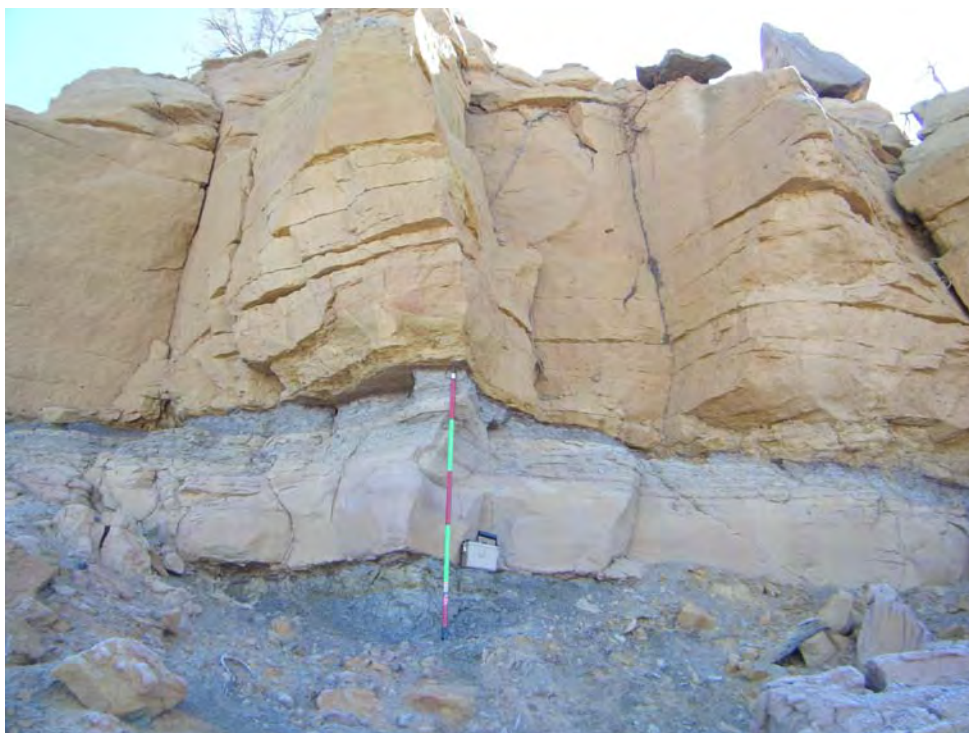
dip gently to the south (Chamberlin *et al*, 1994). At the AUM Site itself, sandstone forms the caprock of low mesas, separated by shallow valleys incising mudstones and shales. Photo NM0116_015 was taken alongside one such mesa and shows the resistant sandstone underlain by friable shale. Radioactive anomalies were found along hillsides in loose soil. No actual rock samples were found that had above-background radiation levels, suggesting that the source of the anomaly may be a shale or very loose sandstone.

Photo 15-Looking east at point Rad-10.

Photo 15 - rad 10, looking E
