Field Compliance Order

Facility Name: NMDOT D 2 Service Center	Facility Number: 29673
Facility Address: 4505 West Second Street, Roswell, NM 88201	
Owner Name: New Mexico (State of) NMDOT District 2	Owner Number: 14093
Operator Name: New Mexico (State of) NMDOT District 2	Operator Number: O1988

Aboveground Storage Tank Systems Inspection Report

Inspection Type: Compliance	Case Number: 22 20190715 0078	Inspection Start Time: 1:30:00 PM	Date: 15-Jul-19
------------------------------------	--------------------------------------	-----------------------------------	-----------------

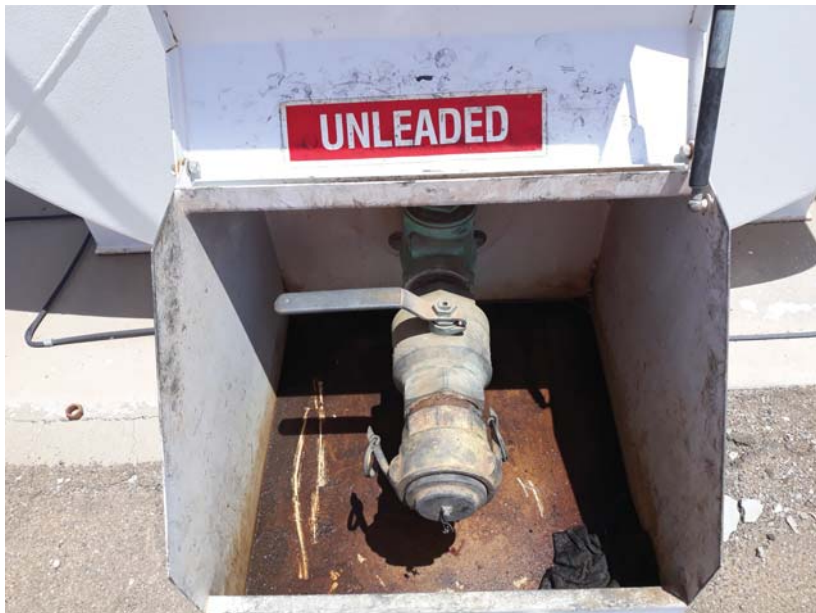
Picture Number: 1

Debris and fuel was noted in the remote fill boxes at the Facility. This was cleaned out at the time of inspection.

Unleaded Remote Fill Box

Note: Fuel/dirt and rag in fill box.

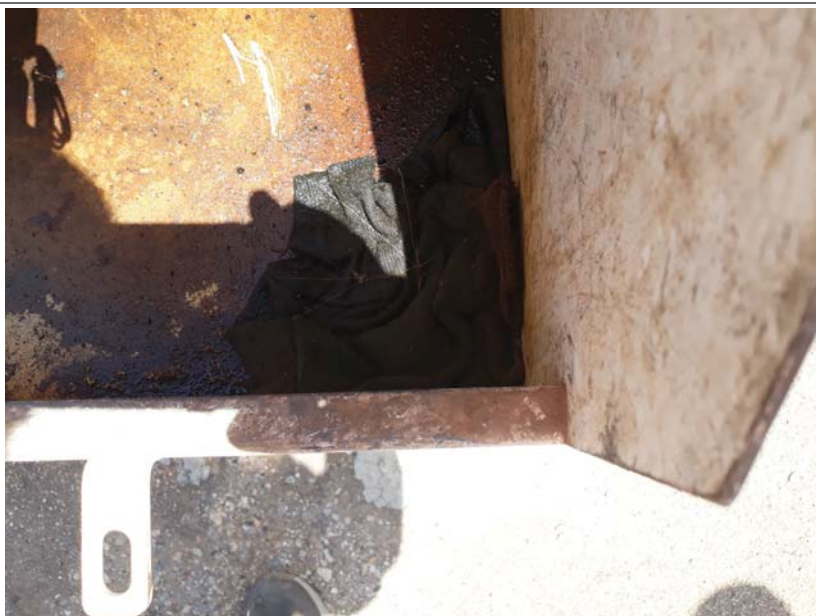
Picture Number: 2

Detail of Fuel Soaked Rag in Fill Box

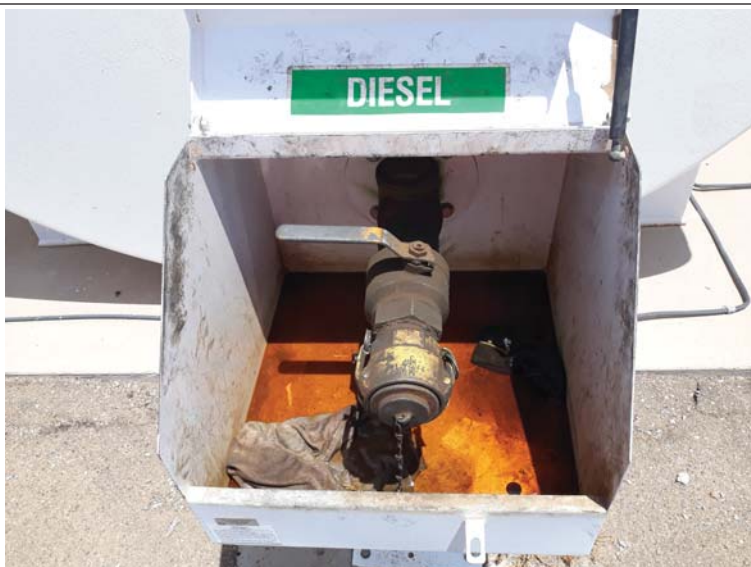
Picture Number: 3

Diesel Remote Fill Box

Note: Fuel/dirt and rag in fill box.

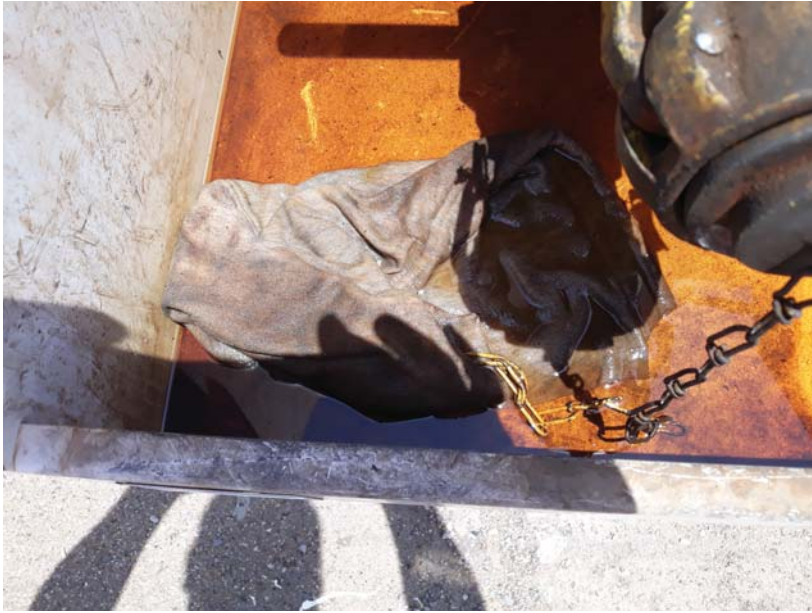
Picture Number: 4

Detail of Fuel Soaked Rag in Fill Box

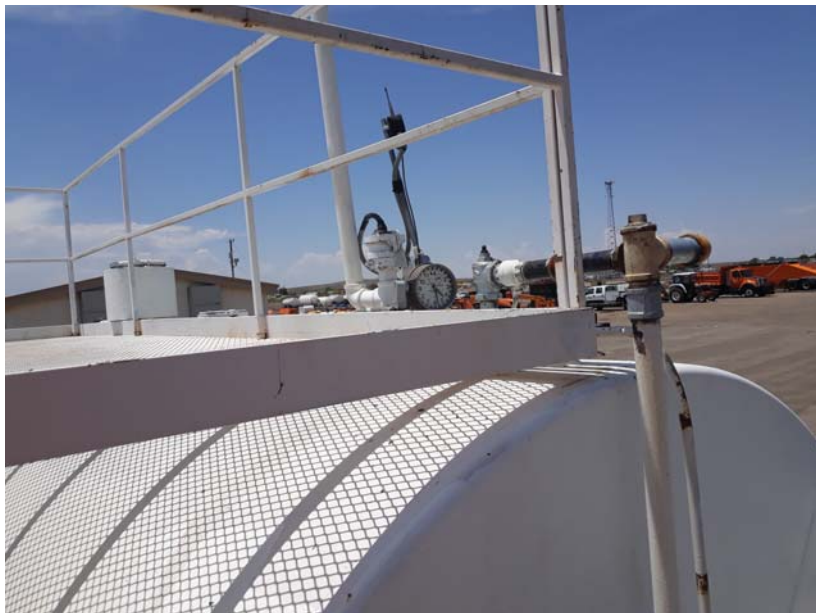
Picture Number: 7

Inspector noted that the clock gauges were not technically visible to the delivery driver. Ensure that during delivery, someone is checking the clock gauges and communicating the fuel level to the delivery driver in order to prevent an overfill in the case of an audible alarm failure.

Clock Gauge for Diesel Tank

Note: Facing away from delivery driver and on the far side of the tank from the fill box. Unleaded tank has a similar setup.

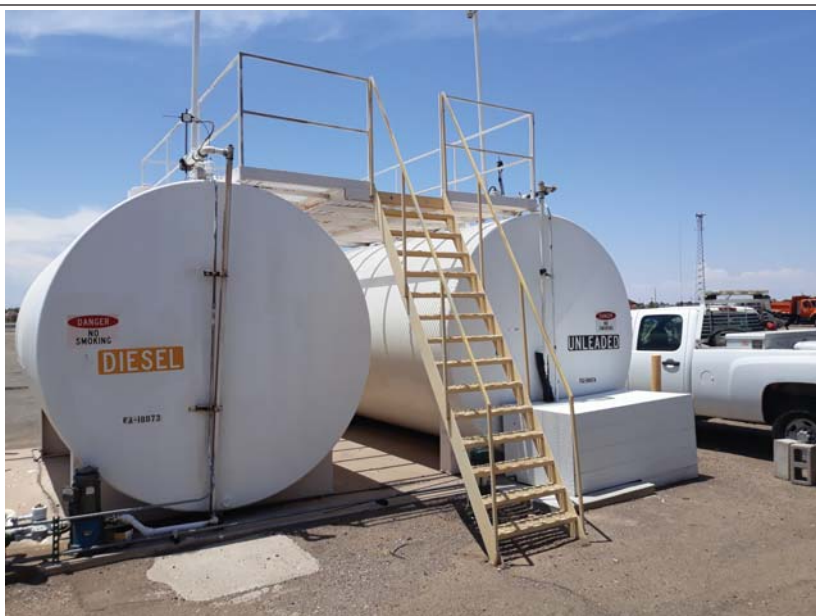
Picture Number: 8

Backside of Tanks

Note: Box built over piping and transition sump for unleaded.

Consider installing a hinge on the lid of the new box cover for the piping, to allow access to the piping and the 2nd transition sump, which is located inside the box, as required by the regulations for the visual inspection method of release detection for the piping.

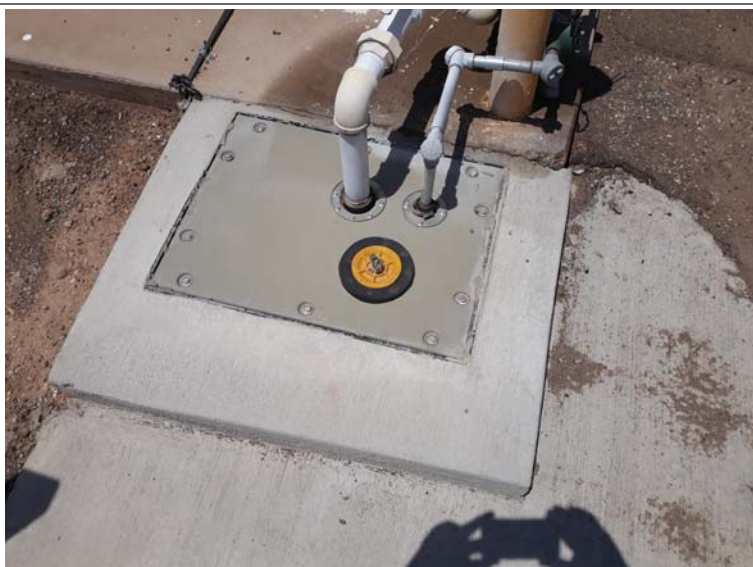
Picture Number: 9

The transition sumps only have a small inspection port. The A/B operator informed the PSTB Inspector that they only check the sensor to inspect the transition sumps during the walk-through inspection. Ensure that the transition sumps are also visually inspected during the walk-through inspections.

Diesel Transition Sump

Note: The rubber plug is the only easily accessible inspection port.

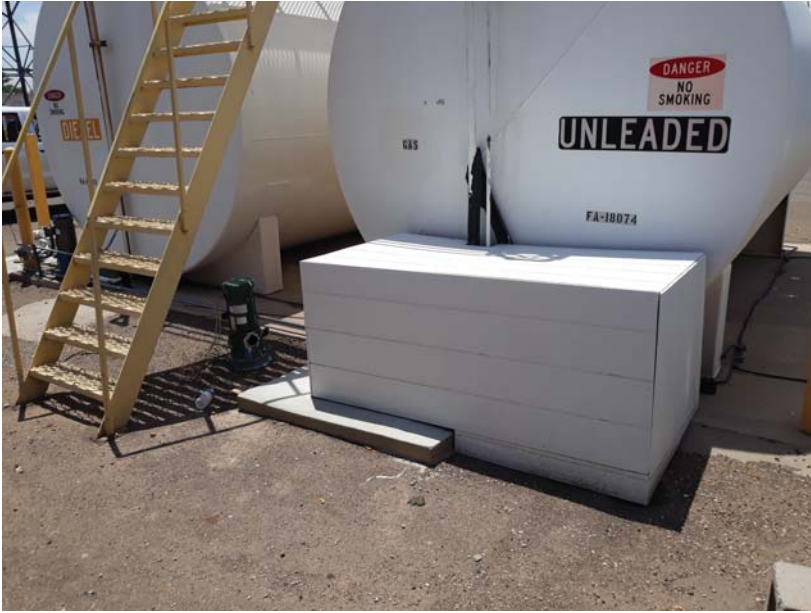
Picture Number: 10

Detail of Box Over Unleaded Piping & Transition Sump

Note: No hinge on lid & box is screwed together prohibiting easy access.

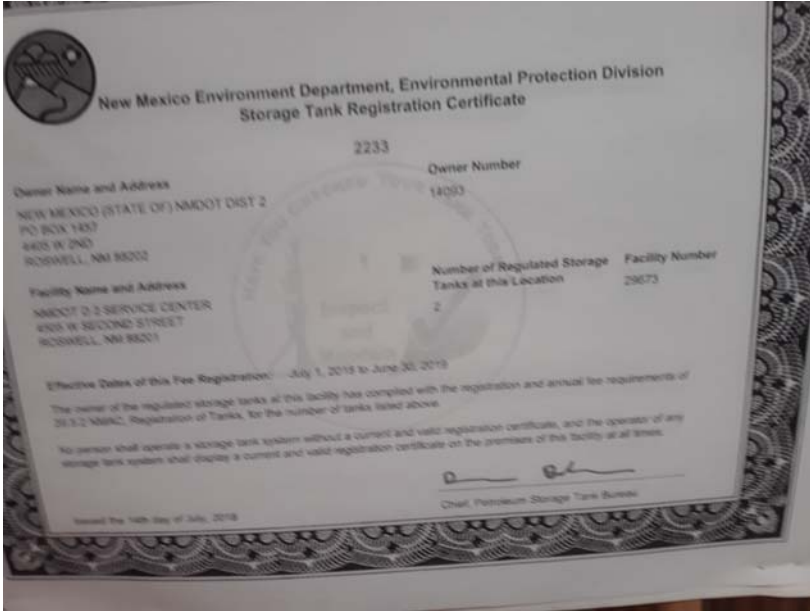
Picture Number: 13

20.5.102.207.A NMAC: Failure to display a current and valid registration certificate at the facility (Tanks 34815 & 34816) (2 Occurrences)- The current registration certificate was not at the facility at the time of the inspection. Display the current registration certificate at the Facility and submit photographic evidence to the assigned PSTB Inspector, Elmer Smith (Elmer.Smith@state.nm.us).

Tank Registration Certificate

Note: Certificate is out of date.

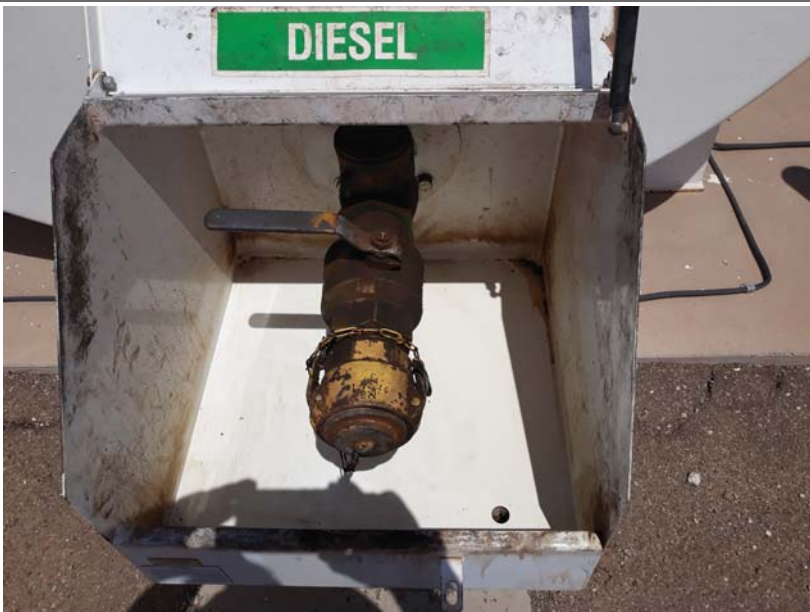
Picture Number: 14

Diesel Fill Box Cleaned Out

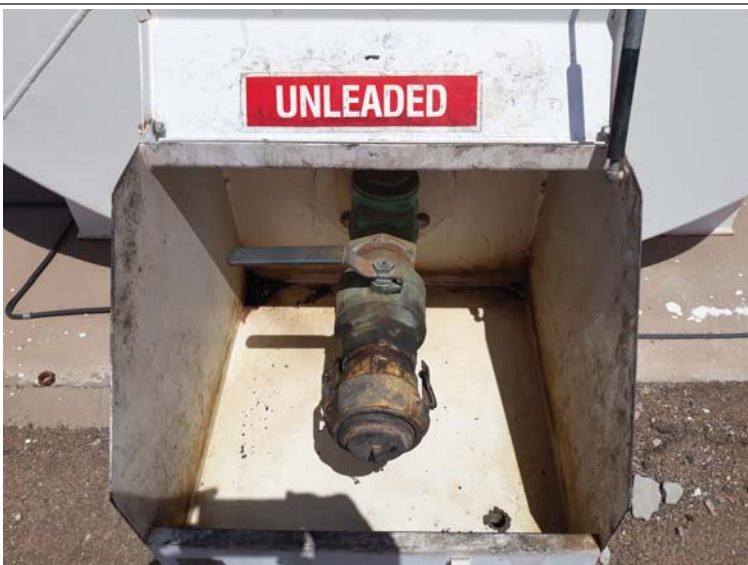
Picture Number: 15

Unleaded Fill Box Cleaned Out
