May 15, 2020

**RE: Fifth Monthly NAPL Recovery Report,  
Fairview Station Site, Española, New Mexico  
Facility #28779 RID #4657 WPID #4096-6**

Figure 1 – Non-Aqueous Phase Liquid Map – February 13, 2020

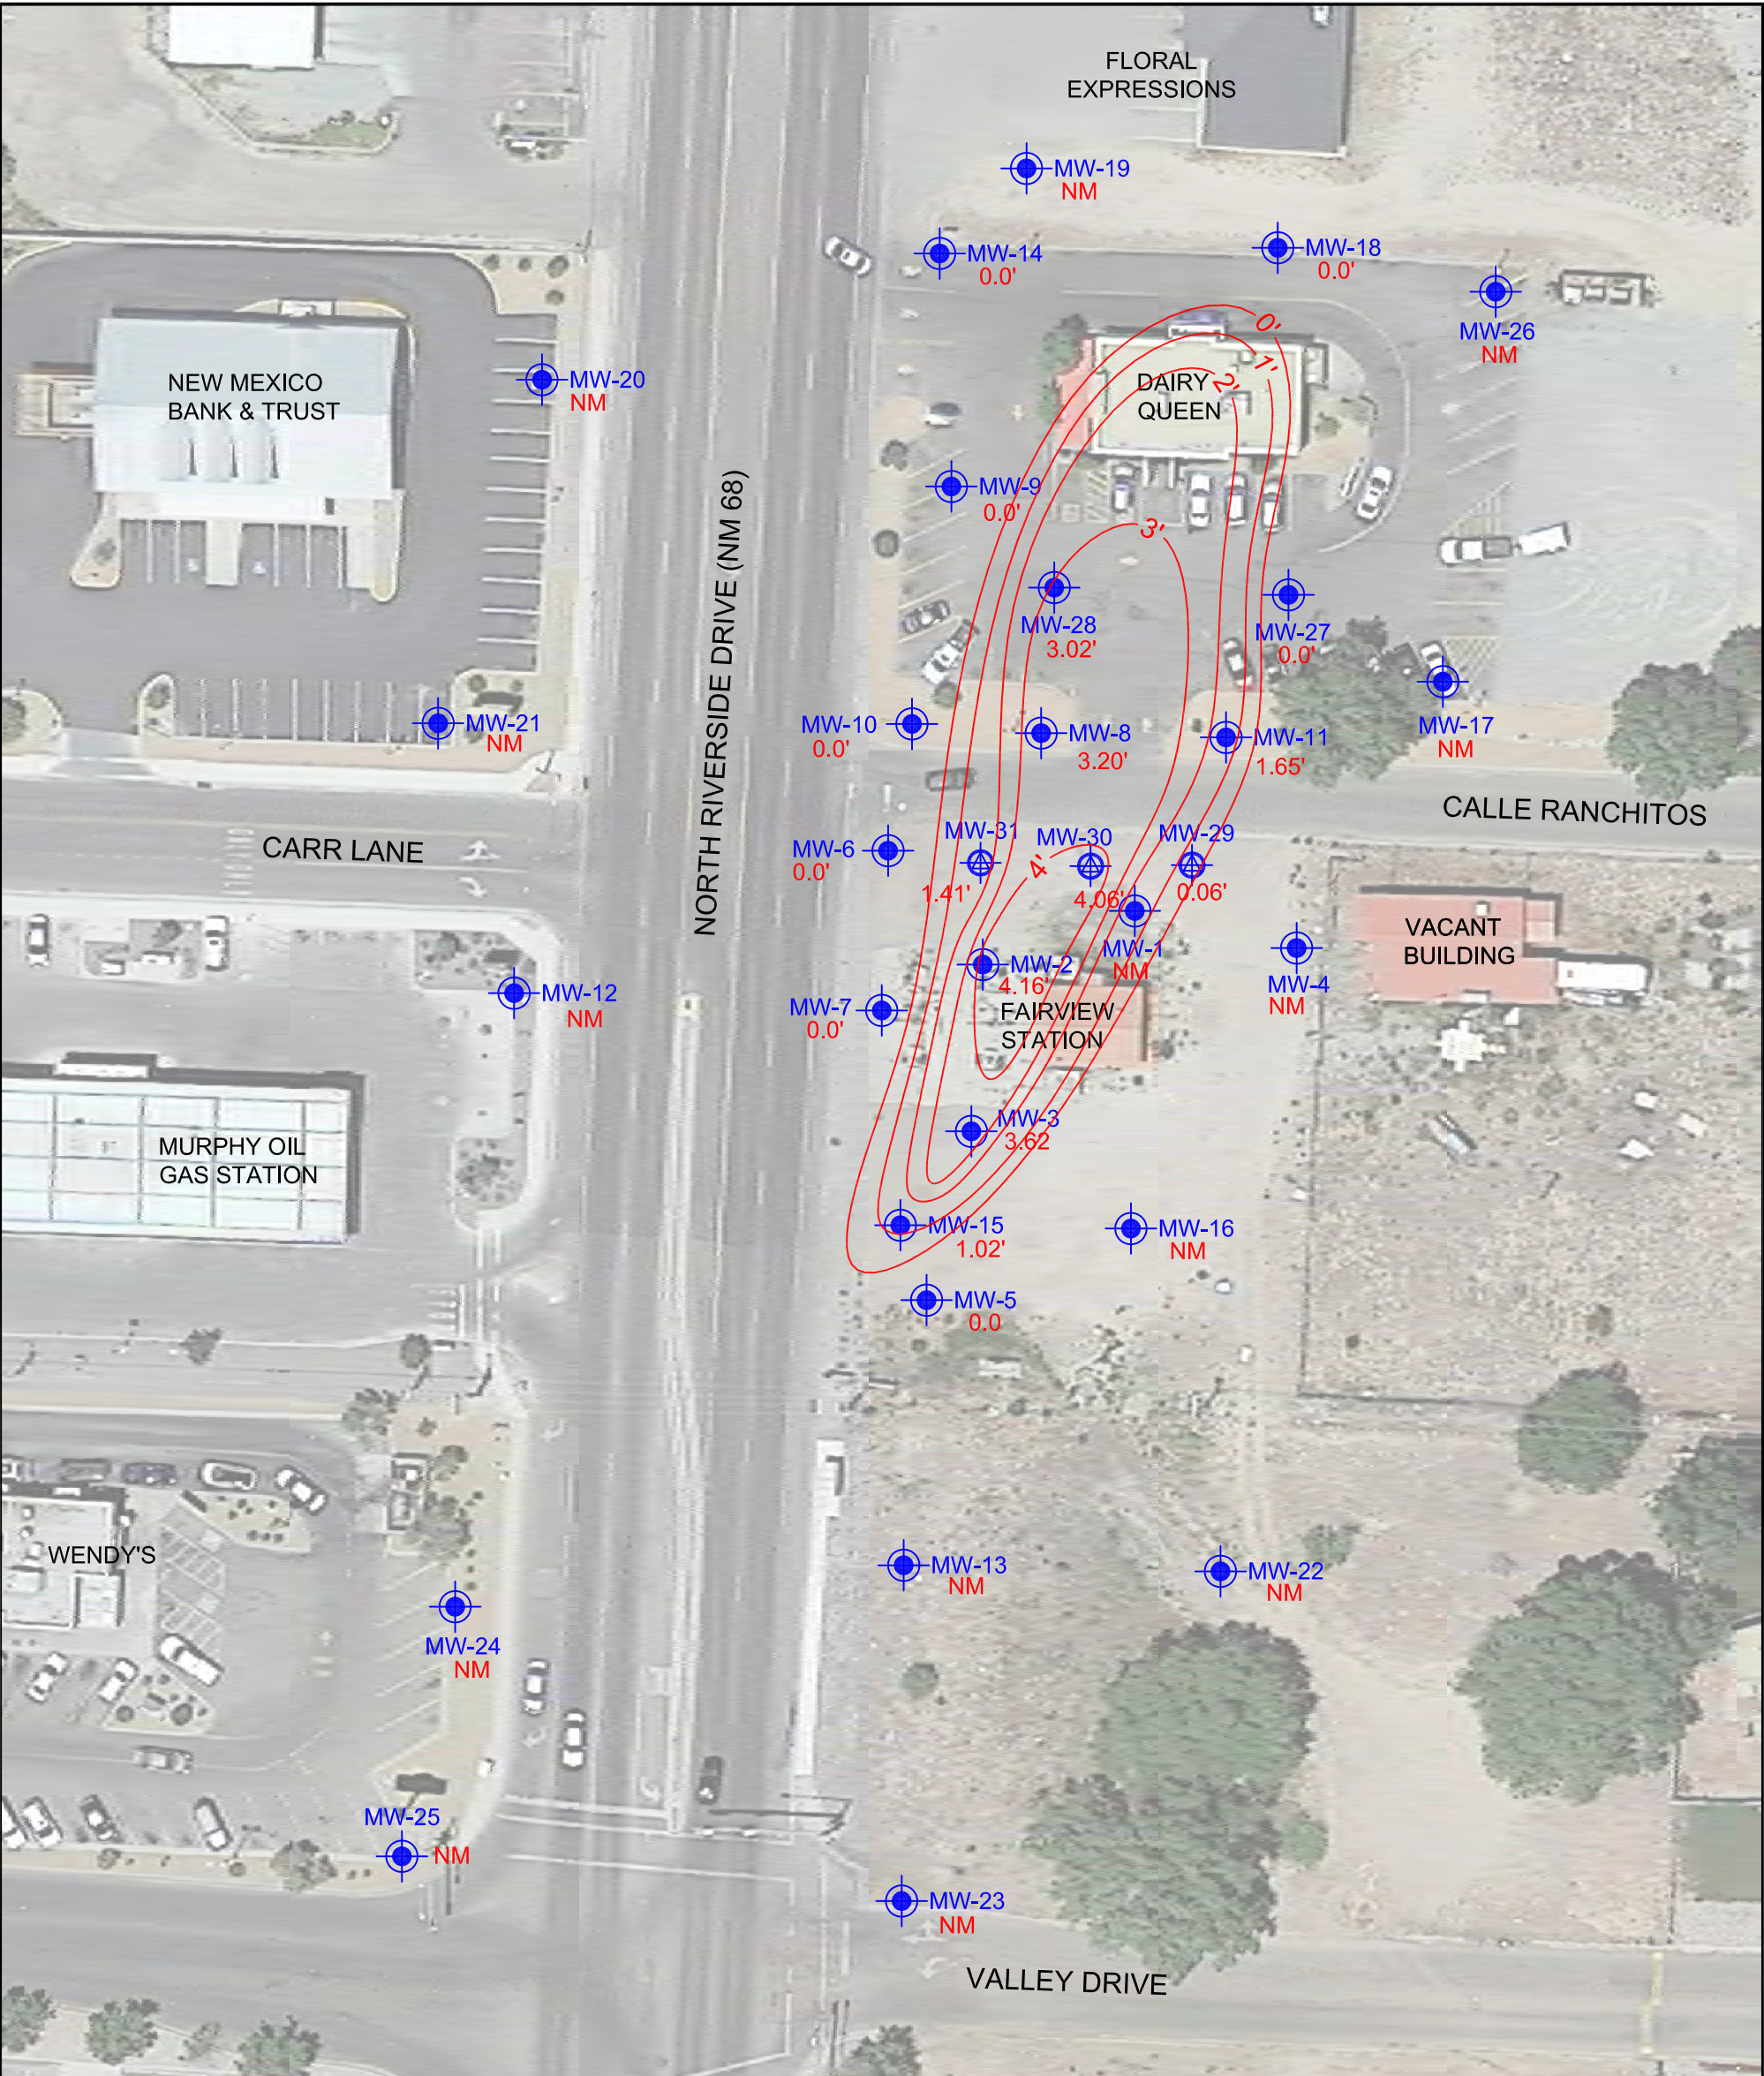
On March 20 and 25, 2020, SMA performed the fifth monthly NAPL recovery. Seventeen monitoring wells were gauged for depth to NAPL and depth to water. Of these seventeen wells, ten monitoring wells contained NAPL with apparent thicknesses ranging from 0.02 to 4.16 feet.

Overall, apparent NAPL thicknesses have increased in most wells compared to the previous NAPL recovery event. Only two monitoring wells exhibited a decrease in initial NAPL thickness (MW-2 & MW-3). The increase in NAPL thicknesses in March are likely due to the groundwater elevation decreasing by about one half of a foot.

Figure 1 depicts the apparent NAPL thicknesses and NAPL contours during the March 2020 event. Table 1 presents the initial depth to NAPL and water measurements. Table 2 depicts the NAPL thicknesses before and after recovery with the NAPL amounts recovered.
