# Abandoned Uranium Mine Assessment for the Agua Torres Site (NM0252)

**FINAL REPORT**

**June 1, 2010**

NM0252

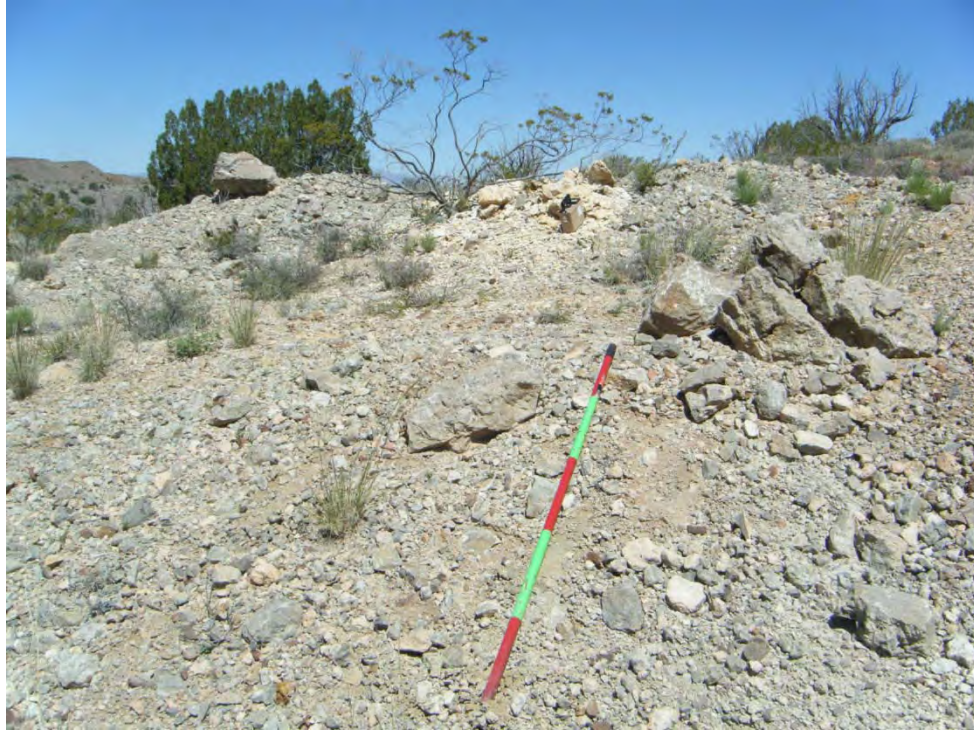
Two waste piles and one disturbed area were found onsite. PilePly-1 consisted of Madera Group waste rock (see Photo 3 in Appendix A). PilePly-2 was composed of soil and rocks (see Photo 4 in Appendix A). The disturbance (DistPly-1) consisted of a shallow scrape in Madera Group limestone (see Photo 21 in Appendix A). The maximum gamma radiation measurement on these features was 220  $\mu\text{R/hr}$  at 0 ft above ground at radiation survey point Rad-1 on PilePly-1.

Photo 3-Looking west at PilePly-1.

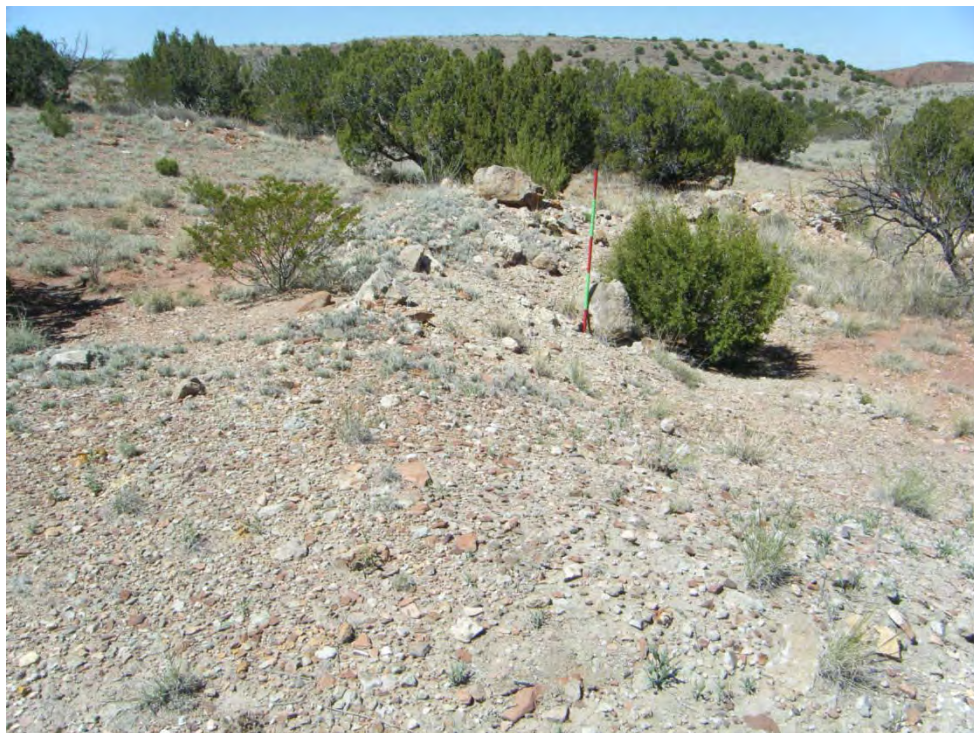
A drainage (ErosLn-1) runs through Pit-1 and cuts into PilePly-2 (see Photo 13 in Appendix A). A slot canyon with running water (ErosPt-1) is located about 0.2 miles to the northwest (see Photos 26 and 27 in Appendix A).

Photo 4-Looking southwest at PilePly-2.

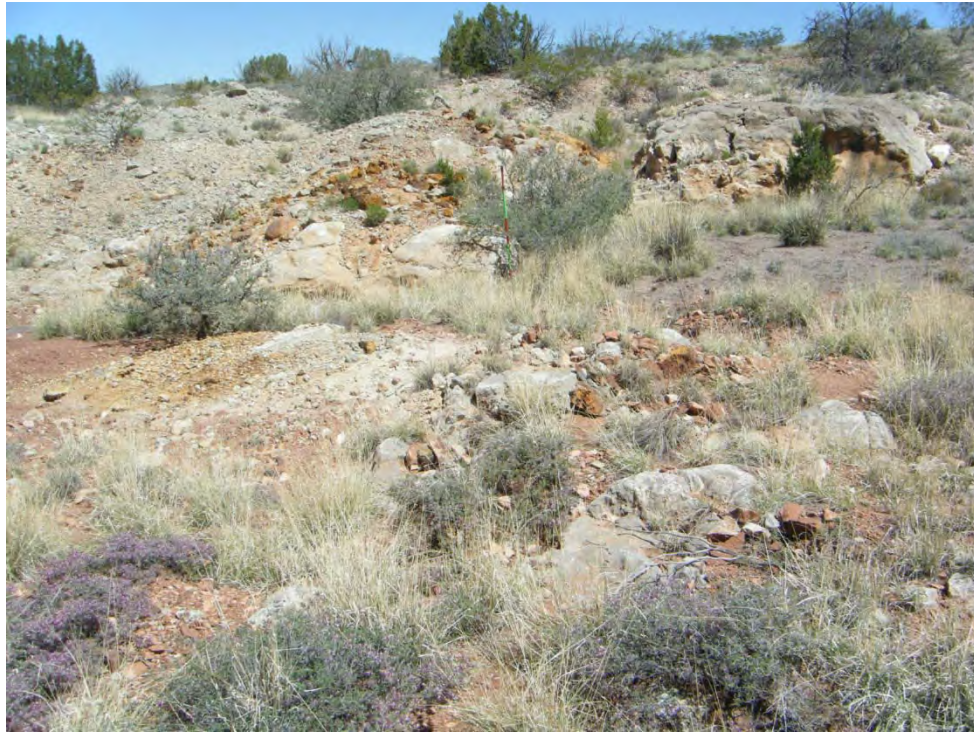
One open cut (CutPly-1), one trench (Trench-1), and one pit (Pit-1) were found at the AUM Site. CutPly-1 is a shallow cut located near the Abo-Madera contact (see Photo 20 in Appendix A). No mineralization was apparent in this cut. Pit-1 is a shallow excavation into Madera Formation limestone (see Photo 8 in Appendix A). Mineralization was evident in the north wall of the pit at radiation survey point Rad-4 (470  $\mu$ R/hr at 0 ft above ground; see Photo 9 in Appendix A). A trench (Trench-1) cuts into Madera Group limestone on the northern face of Pit-1 (see Photo 11 in Appendix A). The maximum gamma radiation measurement on these features was 900  $\mu$ R/hr at 0 ft above ground at radiation survey point Rad-9 in Pit-1.

Photo 8-Looking north at Pit-1.

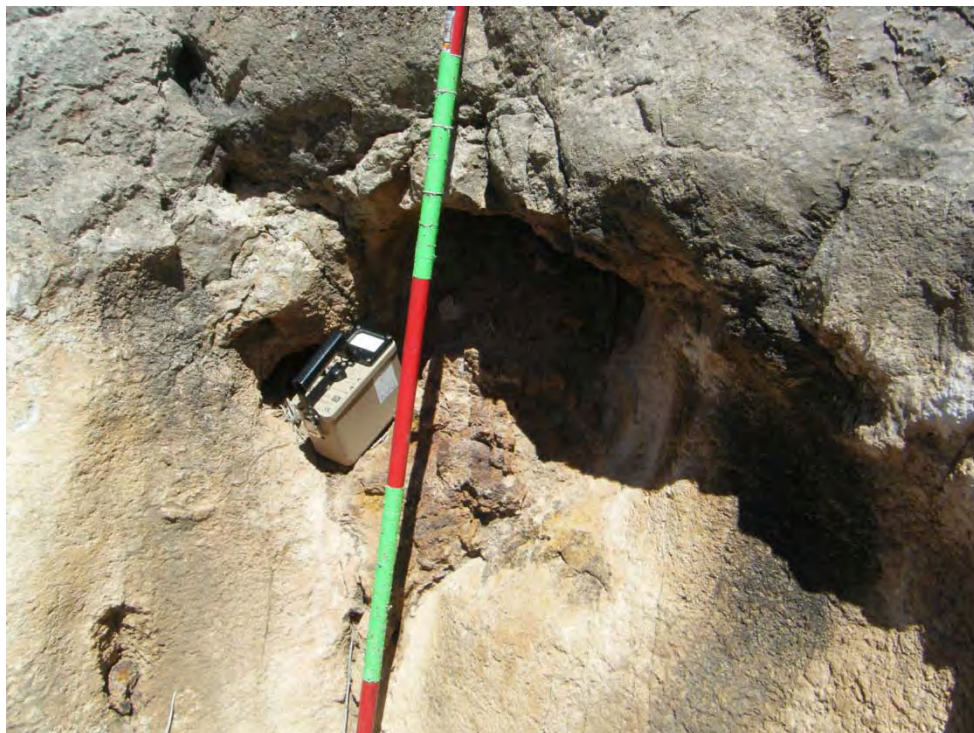
Mineralization occurs in irregular masses within the Madera Group limestone near the Madera-Abo contact (see Photo 9 in Appendix A). This mineralization is friable and ranges from rust red to brown in color.

The maximum gamma radiation measured onsite was 900  $\mu\text{R/hr}$  at 0 ft above ground at radiation survey point Rad-9 in Pit-1 (see Photo 14 in Appendix A). A gamma radiation measurement taken on mineralization in Pit-1 (radiation survey point Rad-4, see Photo 9 in Appendix A) recorded 470  $\mu\text{R/hr}$  at 0 ft above ground.

Photo 9-Looking north at radiation survey point Rad-4 (470  $\mu$ R/hr at 0 ft above ground).

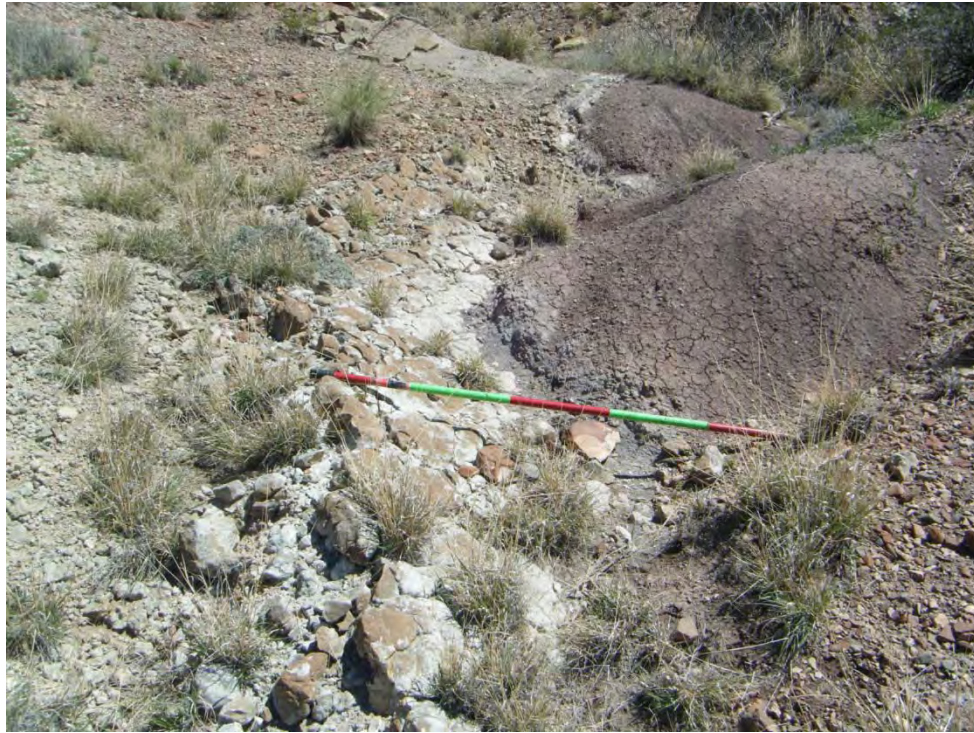
Photo 10-Looking north at the contact between the Abo Formation (right) and the Madera Formation (left).

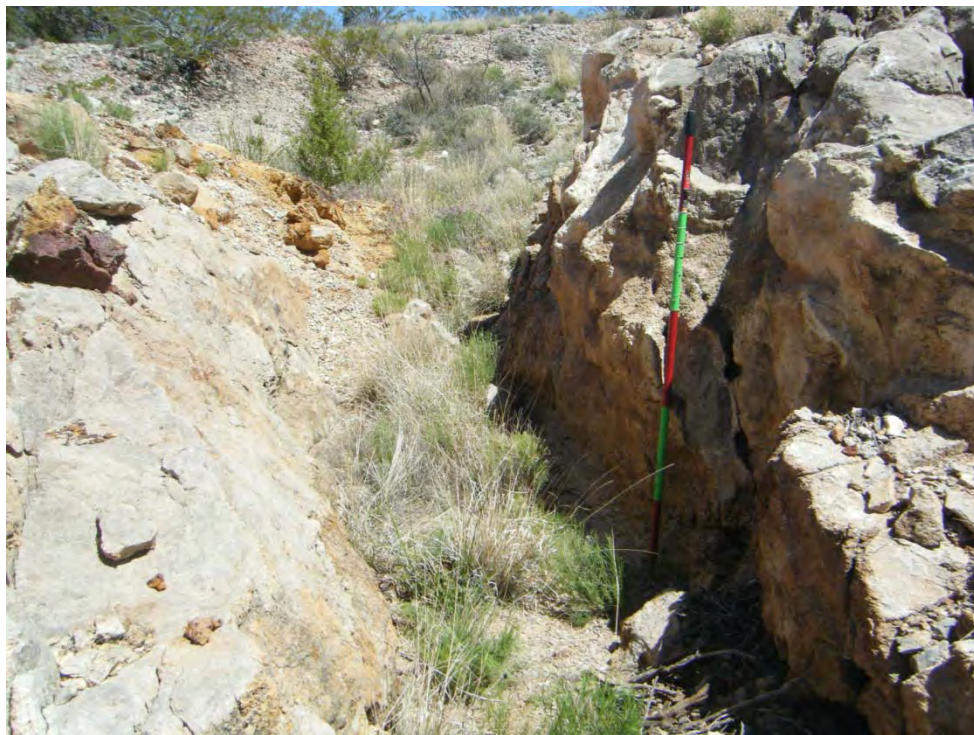
Photo 11-Looking north at Trench-1.

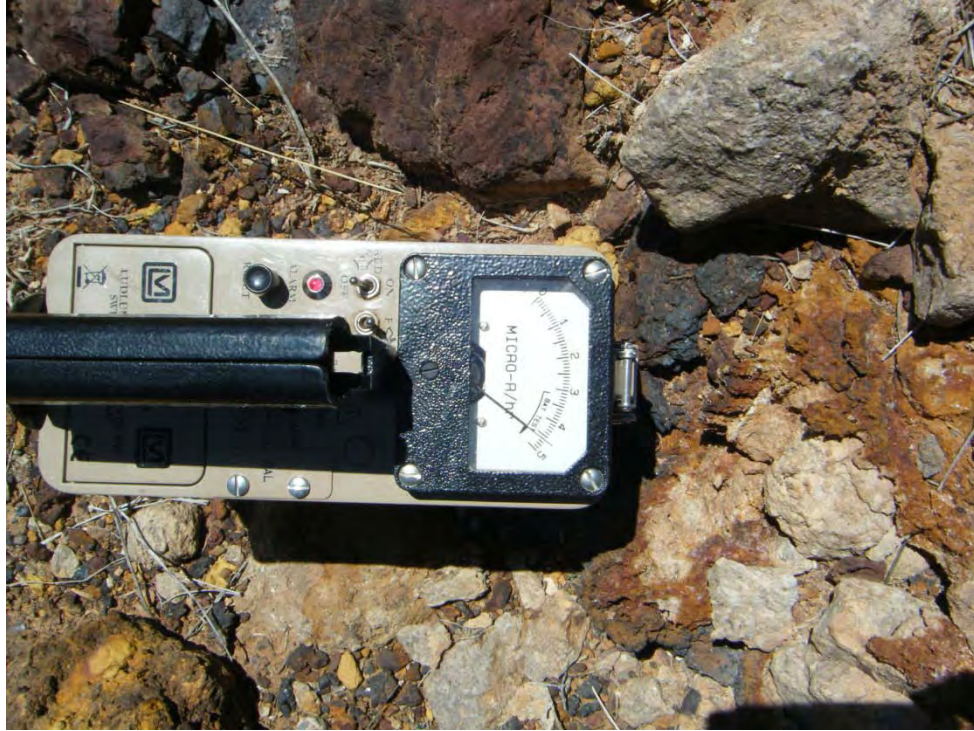
Photo 12-Mineralization at radiation survey point Rad-7 (470  $\mu$ R/hr at 0 ft above ground).

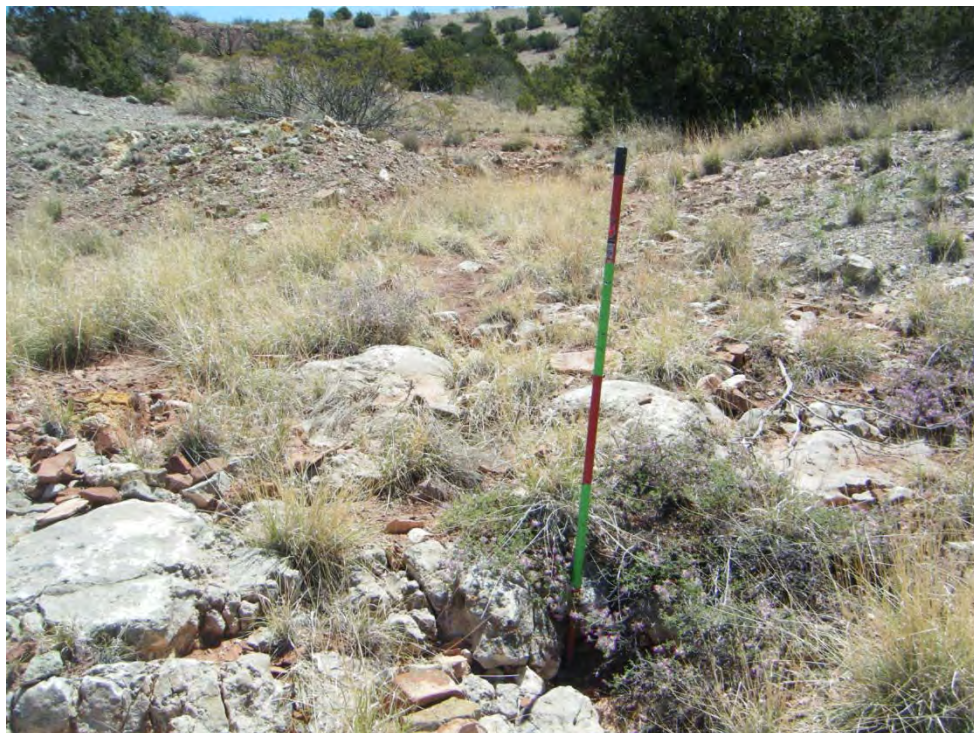
A drainage runs through Pit-1 and cuts through PilePly-2.

Photo 13-Looking east at ErosLn-1.

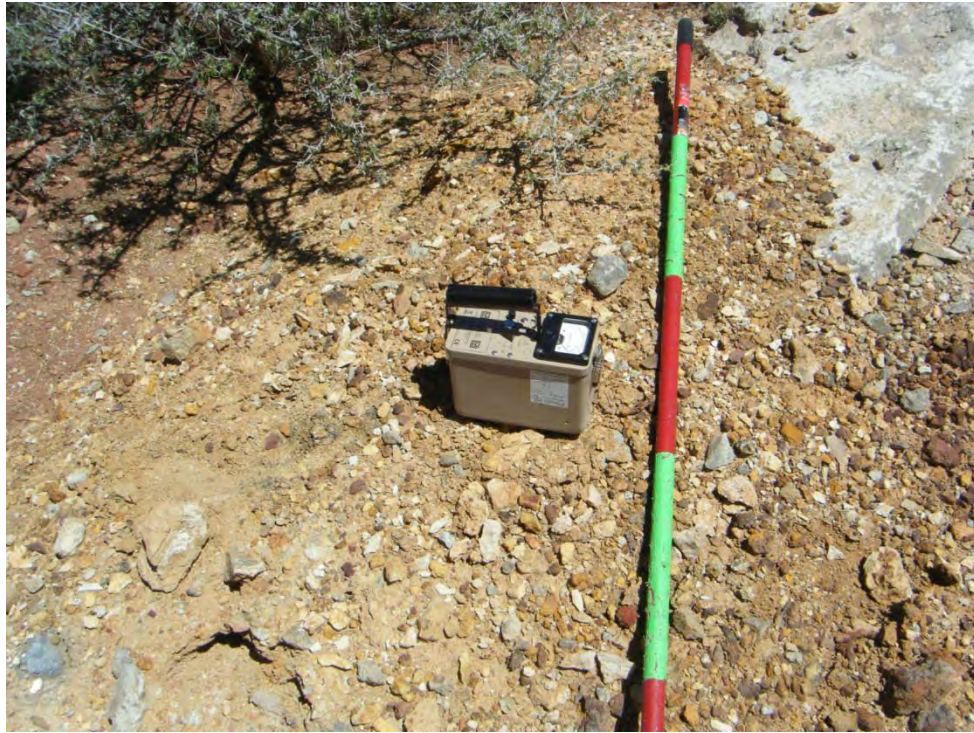
Photo 14-Looking north at radiation survey point Rad-9 (900  $\mu$ R/hr at 0 ft above ground).

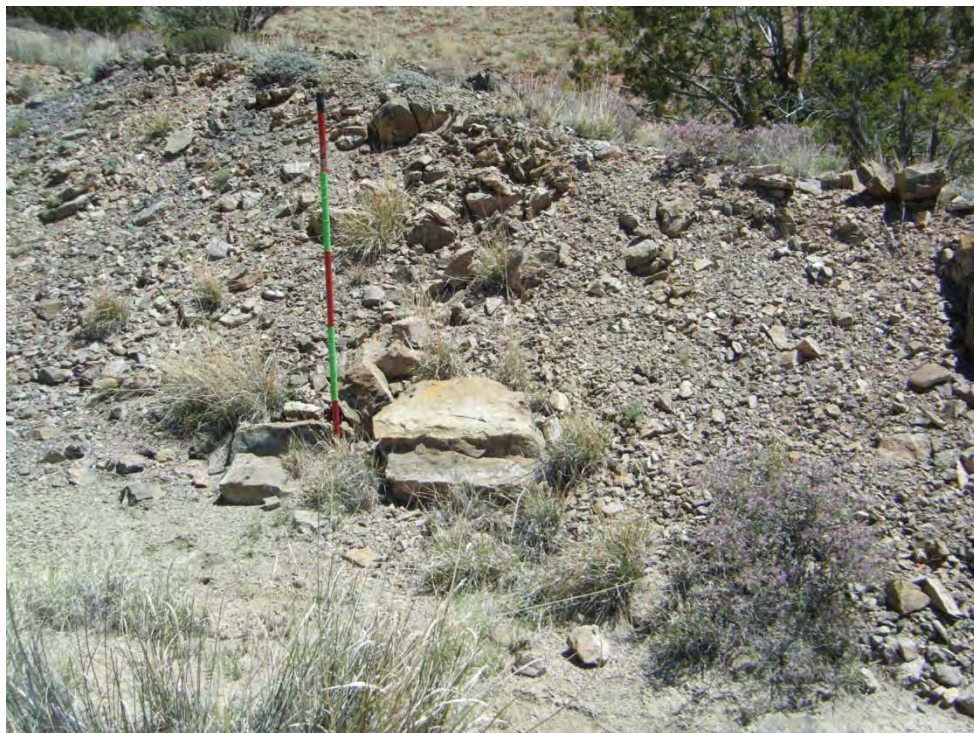
Photo 20-Looking north at CutPly-1.

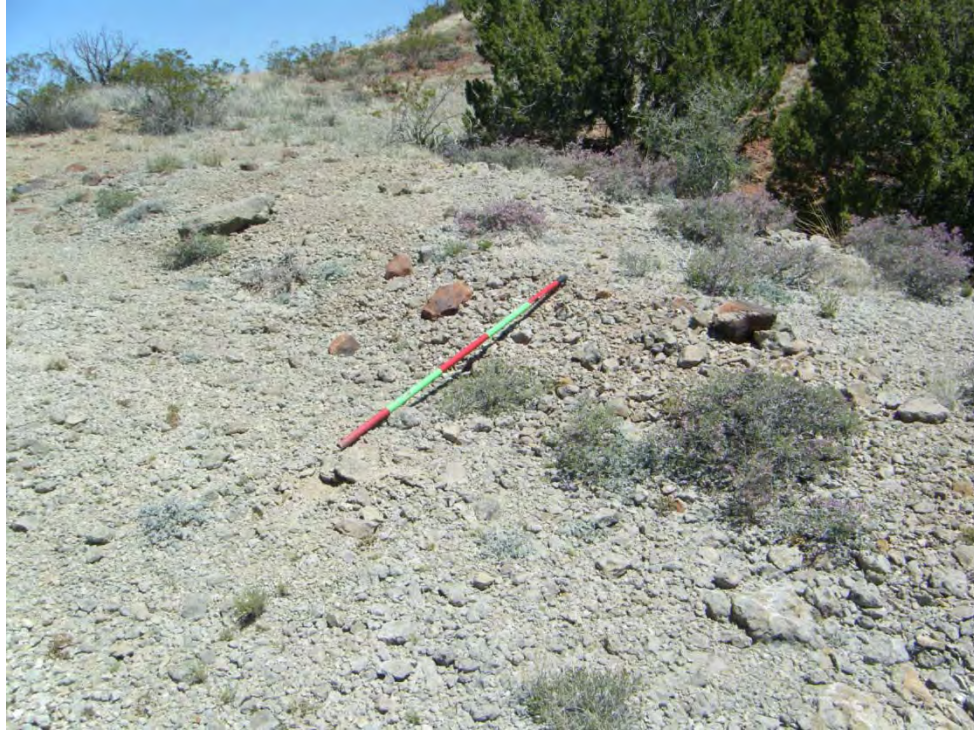
Photo 21-Looking north at DistPly-1.

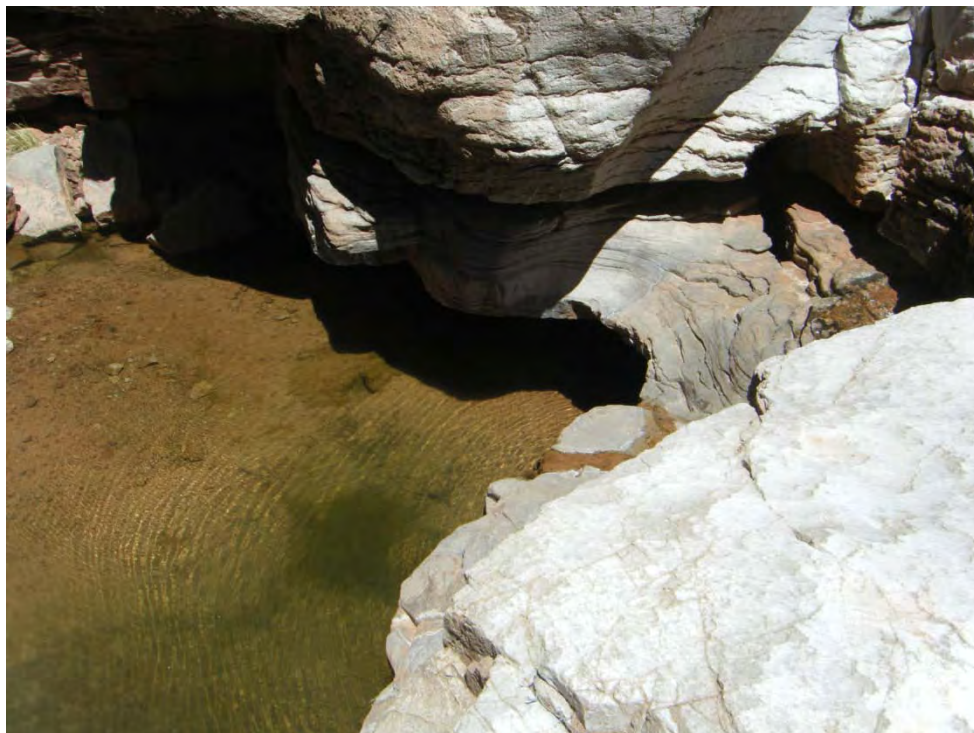
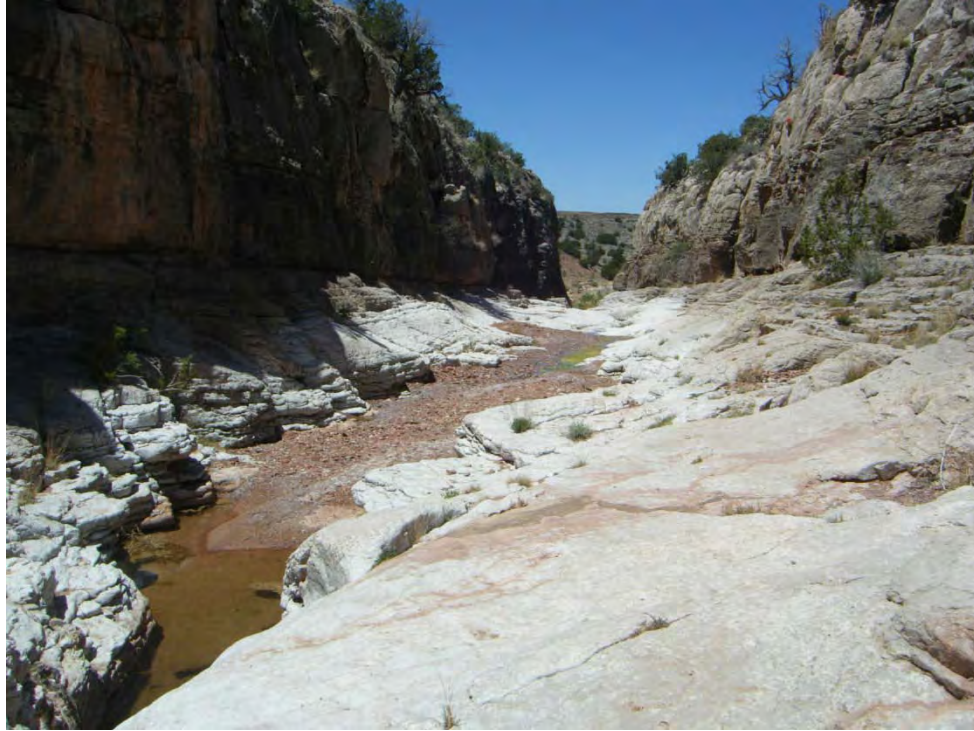
The surface runoff at the AUM Site discharges west to Cibola Canyon, which joins the Rio Grande 10 miles to the west. Running water and pools were observed at Cibola Spring 0.2 miles northwest of the Site (see Photos 26 and 27 in Appendix A).

Photo 26-A pool in a canyon about 0.2 miles northwest of the AUM Site (ErosPt-1). This is Cibola Spring.

Photo 27-Another view of Cibola Spring (ErosPt-1).
