# Abandoned Uranium Mine Site Assessment for the Good Luck Site (NM0175)

**FINAL REPORT**

**April 20, 2010**

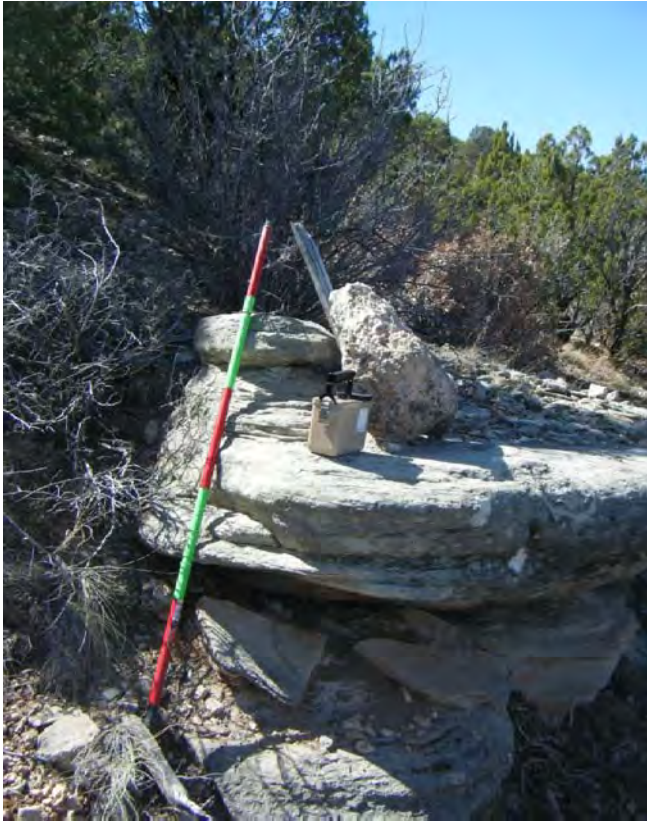
Two mine roads (Rd-1 and Rd-2) exist at the AUM Site. Both of these roads are no longer passable. A possible claim marker was discovered (Claim-1, see Photo 4 in Appendix A).

Photo 4-A possible claim marker (Claim-1).

Claim 1 - wooden plank supported by  
a rock

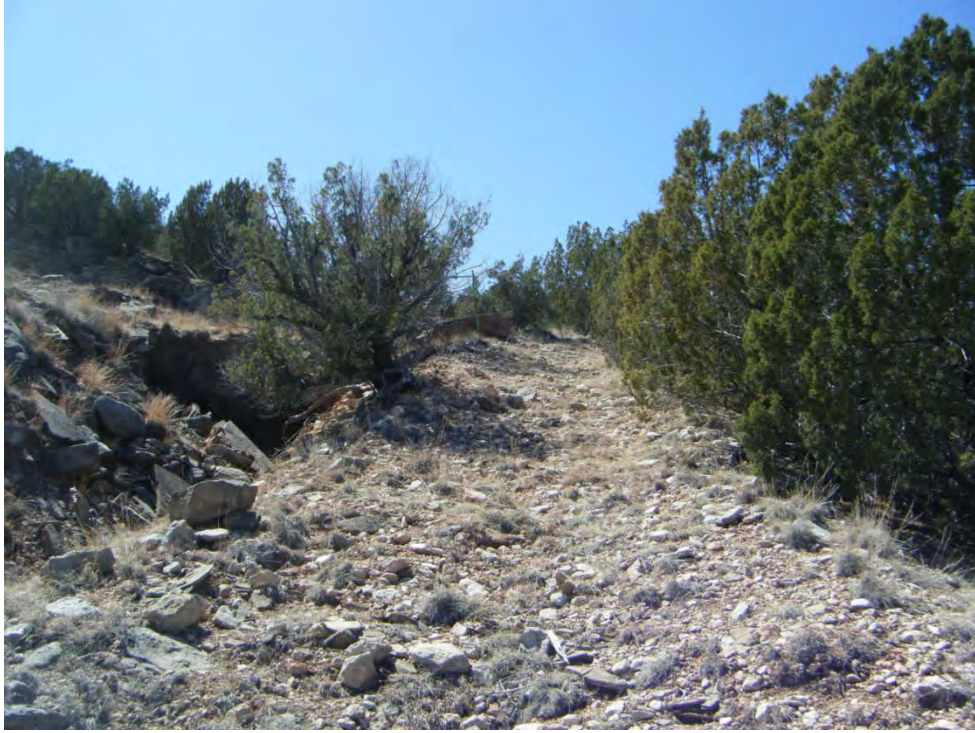
Photo 5-Looking southwest up the slope at Rd-1.

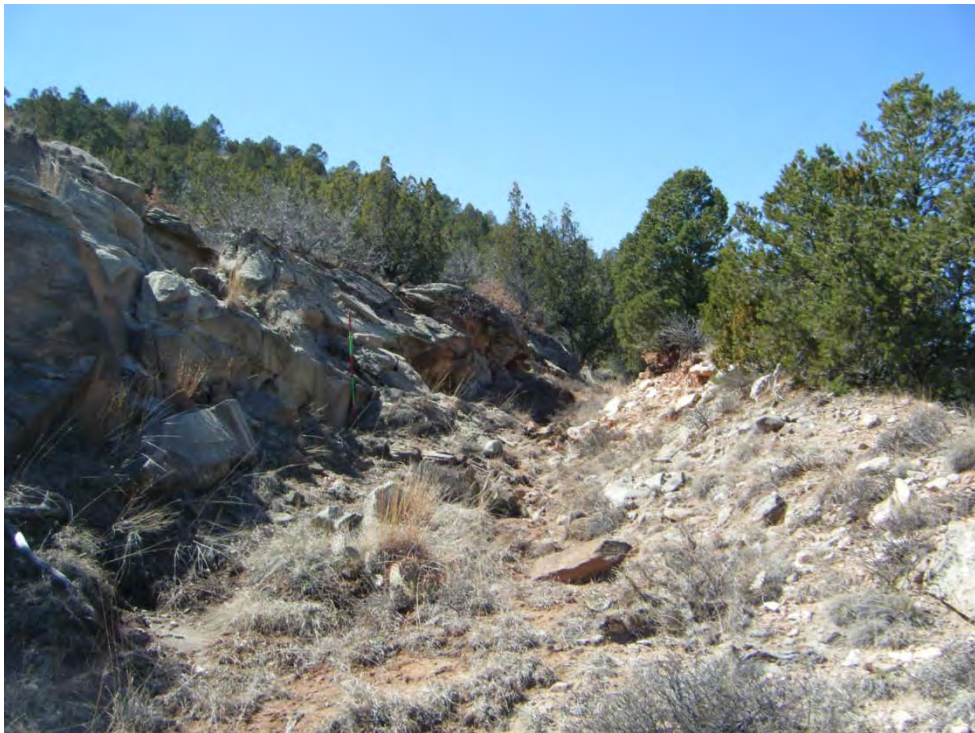
Photo 6-CutLn-1, looking west.

Cut in - rd 1 lead to open cut 20ft wide, 6ft deep

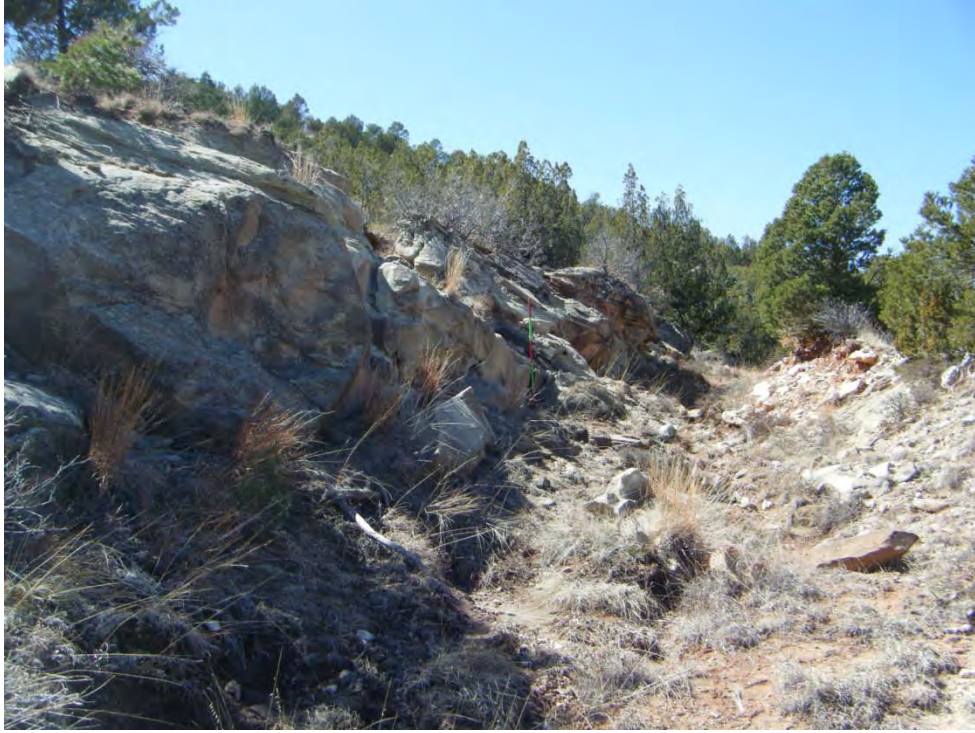
Two open cuts were discovered at the AUM Site. CutLn-1 is the trench cut mentioned by Anderson, 1980. Photo 7 (see Appendix A) is a view of CutLn-1 that replicates photo “a” in the Anderson Report. The highest gamma ray reading in CutLn-1 was 9  $\mu\text{R/h}$  at contact. CutPly-1 is the other open cut found onsite. This open cut was next to a mining road (Rd-2). The highest gamma ray reading recorded in CutPly-1 was 17  $\mu\text{R/h}$  at contact.

Photo 7-CutLn-1, looking southwest, replicating Anderson photo "a".

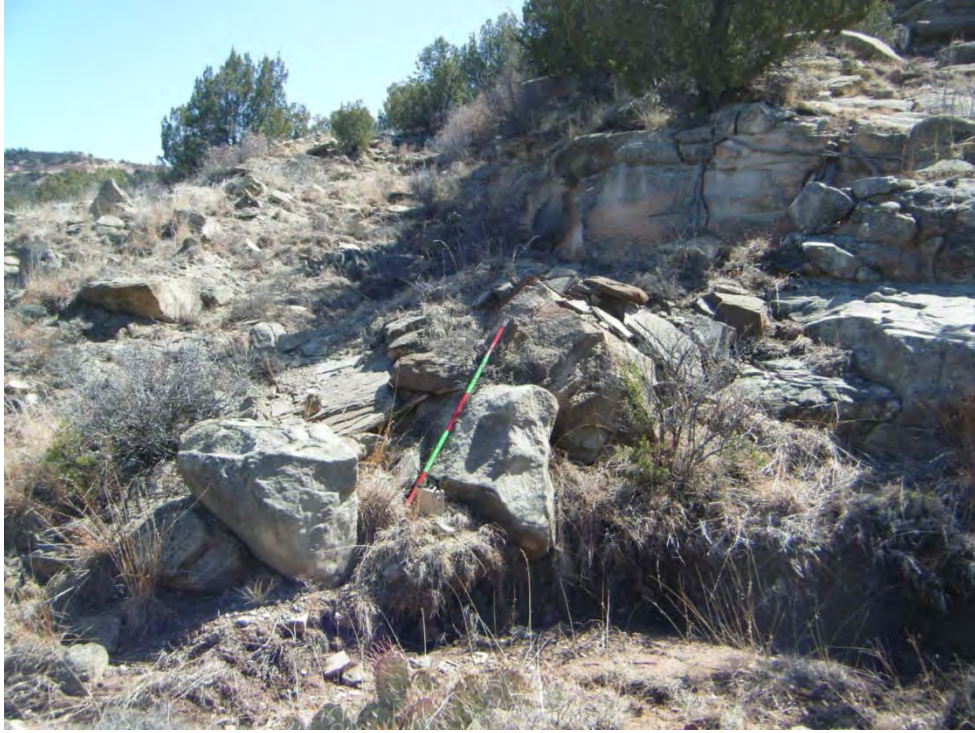
Two piles were found at the AUM Site. PilePly-1 is a small boulder pile at the northwest end of CutPly-1. Photo 9 (see Appendix A) shows PilePly-1 with CutPly-1 in the background, replicating photo b in the Anderson Report. The maximum gamma ray reading at PilePly-1 was 30  $\mu\text{R/hr}$  at contact. PilePly-2 is a larger, flat topped pile to the east of CutPly-1. Rocks in this pile contained fragments of petrified wood and zones of conglomerate. The highest gamma ray reading at PilePly-2 was 39  $\mu\text{R/hr}$  at contact.

Photo 9-Looking southeast at PilePly-1.

Pilepoly 1 - 5ft high, 10ft x 20ft

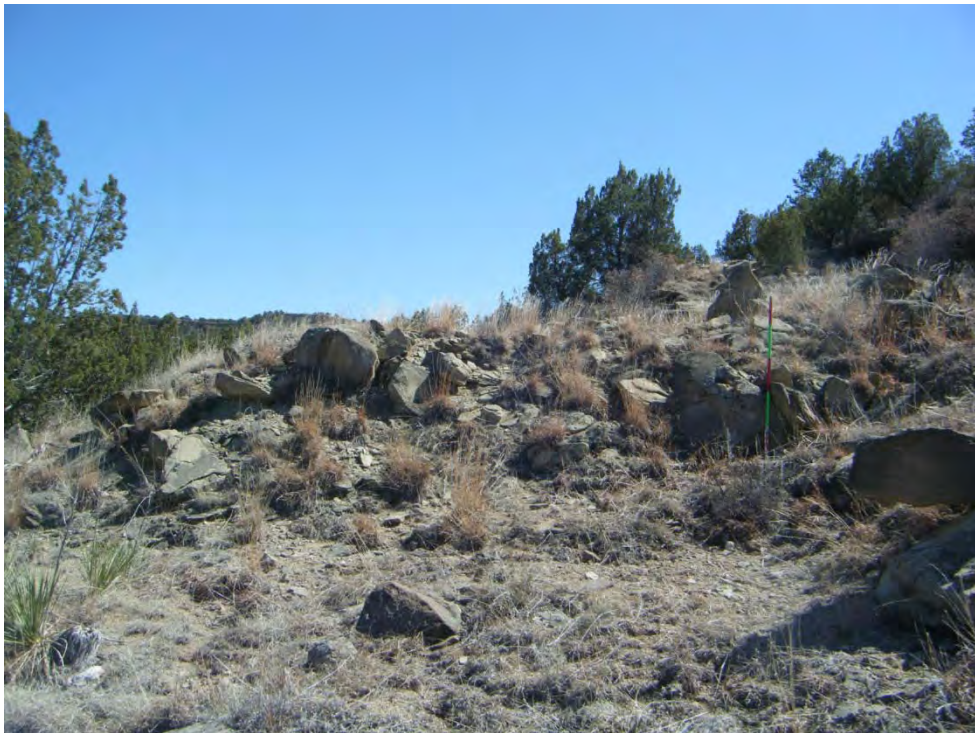
The maximum gamma radiation reading for the AUM Site was 39  $\mu\text{R/hr}$  at contact at radiation survey point Rad-8. This reading was taken on a pile (PilePly-2).

Photo 10-Looking southeast at PilePly-2.

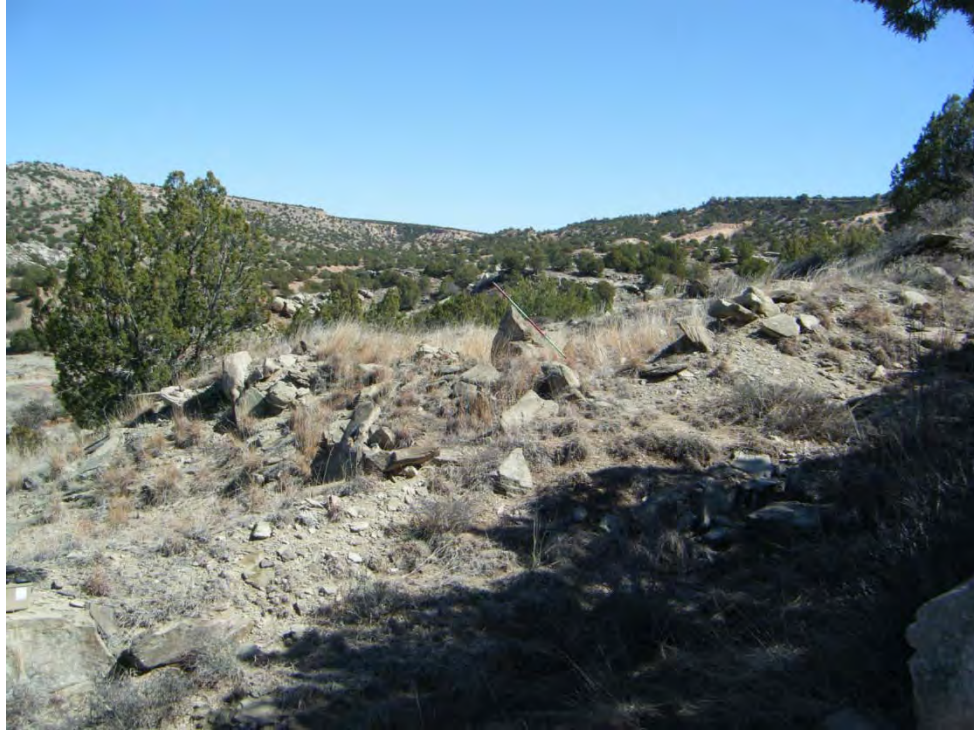
Photo 11-Looking east at PilePly-2.

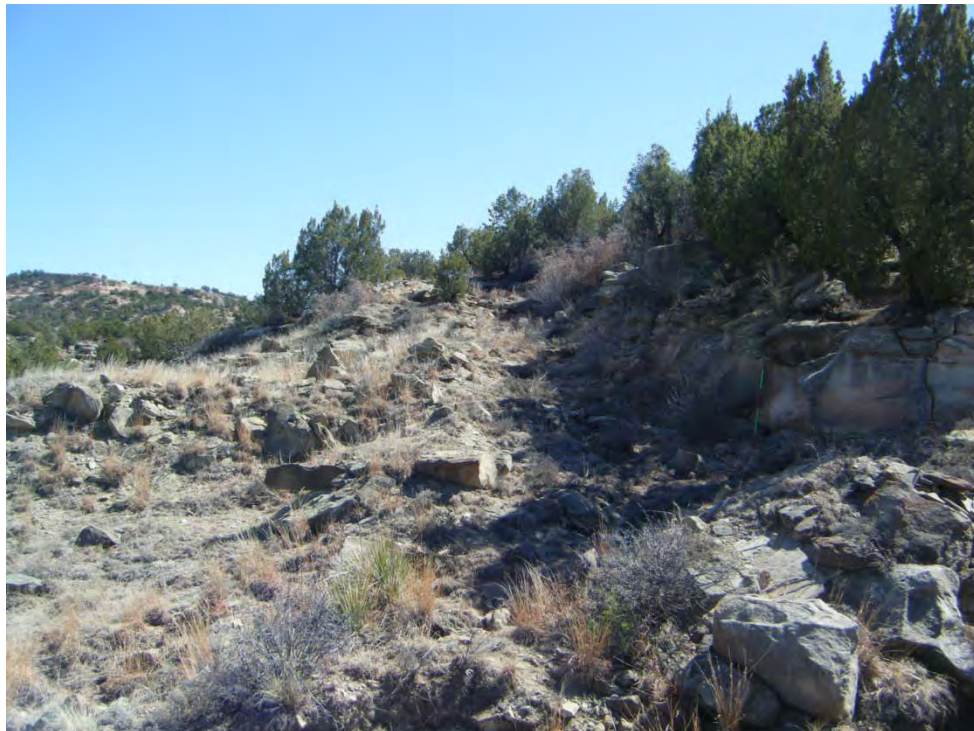
Photo 12-Looking east at PilePly-1 (foreground), PilePly-2 (left background), Rd-2 (center background), and CutPly-1 (right background).

Cutply 1 - 10ft wide, 5ft deep  
 Photo 12 - shows pileply 1, pileply 2, cutply 1, and rd 2.  
 Rd 2 - 10ft wide, runs SE - NW

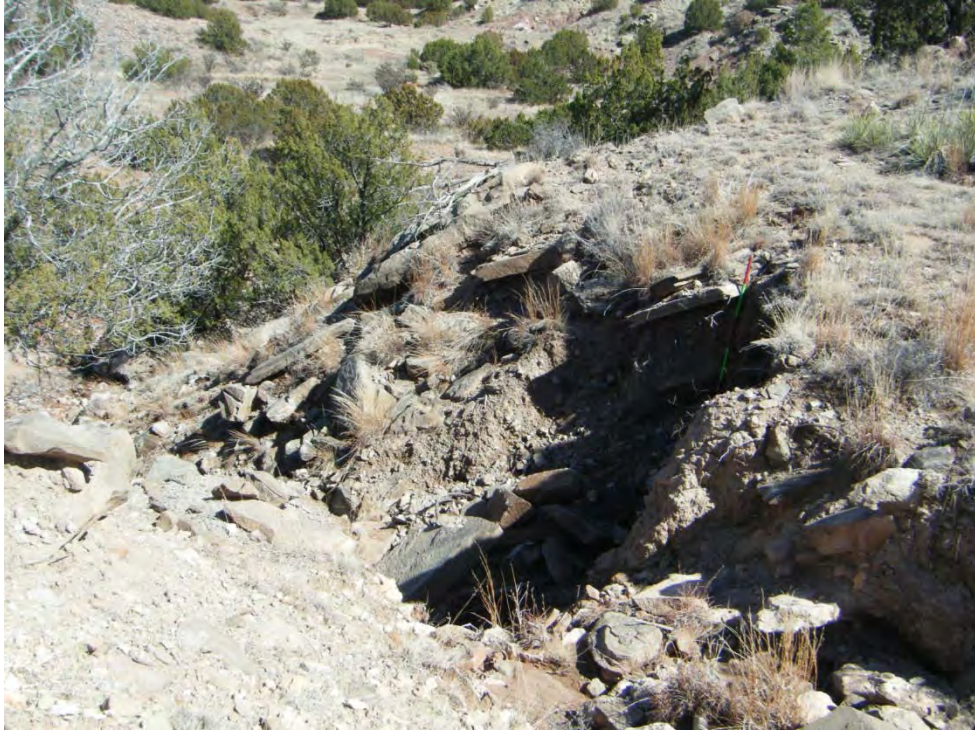
A large gully (ErosPly-1) is developing from runoff channeled by CutLn-1. This gully is also cutting into Rd-1. See Photos 13 and 14 in Appendix A for a view of this feature.

Photo 13-Looking east at ErosPly-1.

Erosply 1 - erosion from water running through cutln 1 + down the hill  
 Photo 13 - erosply 1, looking E  
 Photo 14 - erosply 1, looking NW

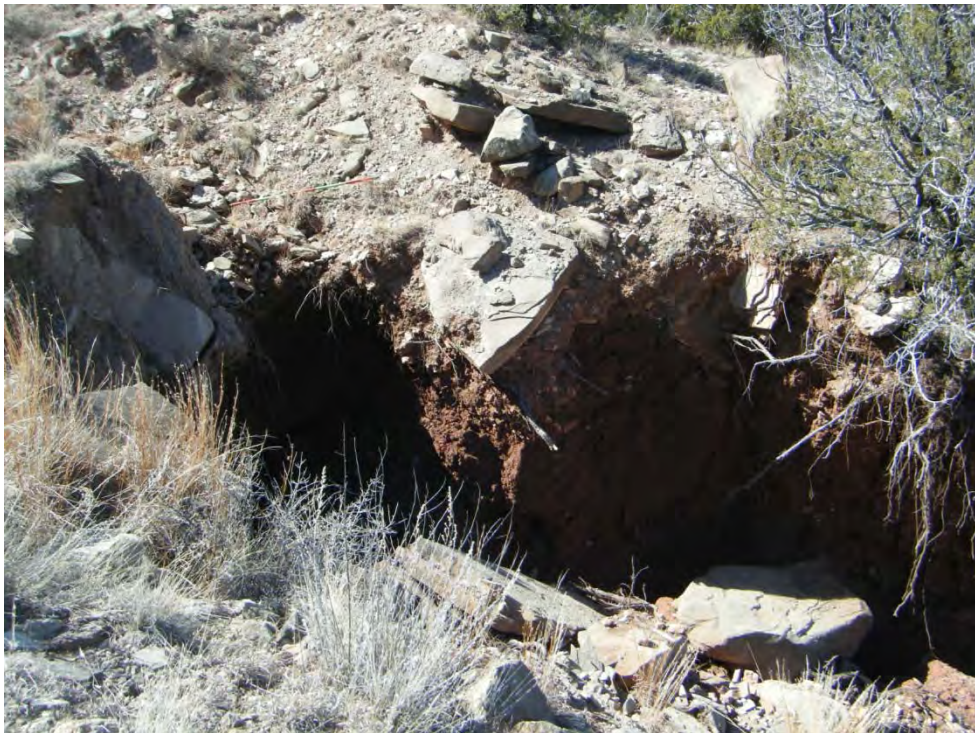
Photo 14-Looking northwest into ErosPly-1.
