Abandoned Uranium Mine Site Assessment for the Red Tiger Site (NM0247)

FINAL REPORT

March 24, 2010

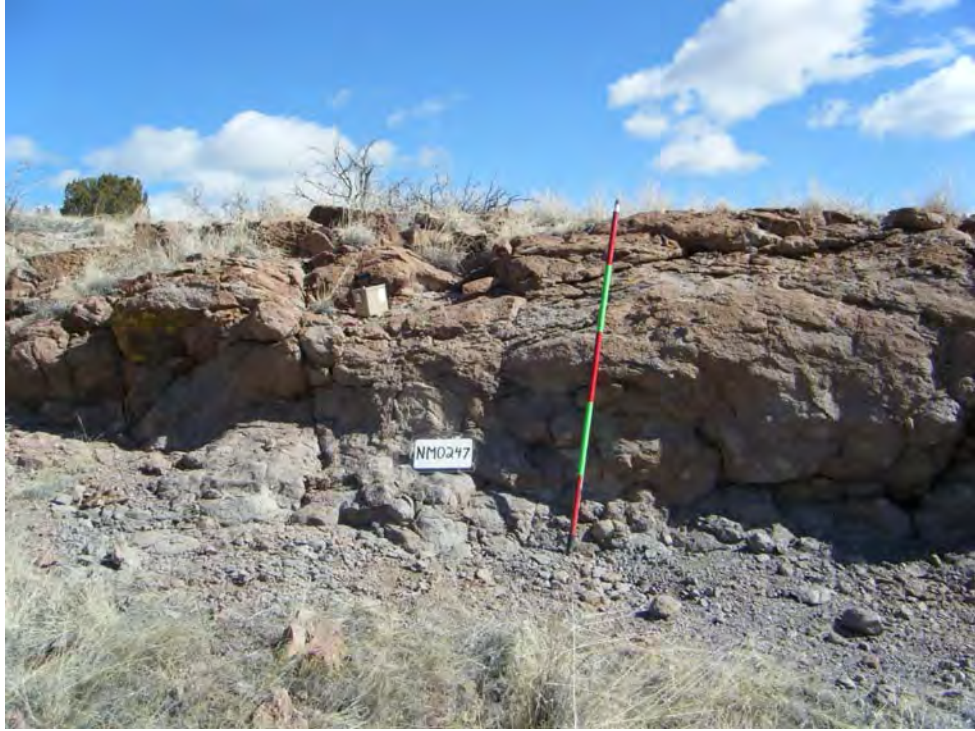
Photo 1-Site photo and point RadBack-1.

Radback 1 - contact = 7uR/hr; 1m = 8uR/hr
Photo 1 - radback 1

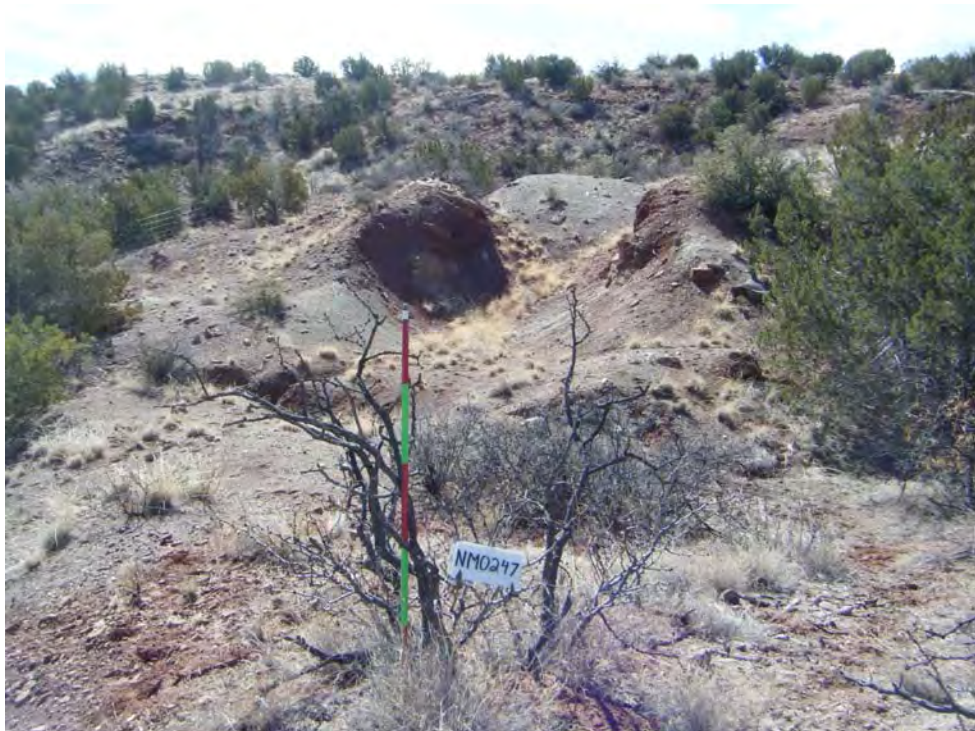
Photo 2-View of CutLn-1 and PilePly-1, looking southeast (point Photo-2).

Photo 2 - first view of AUM site, cut 1 and pile 1 in background, looking SE

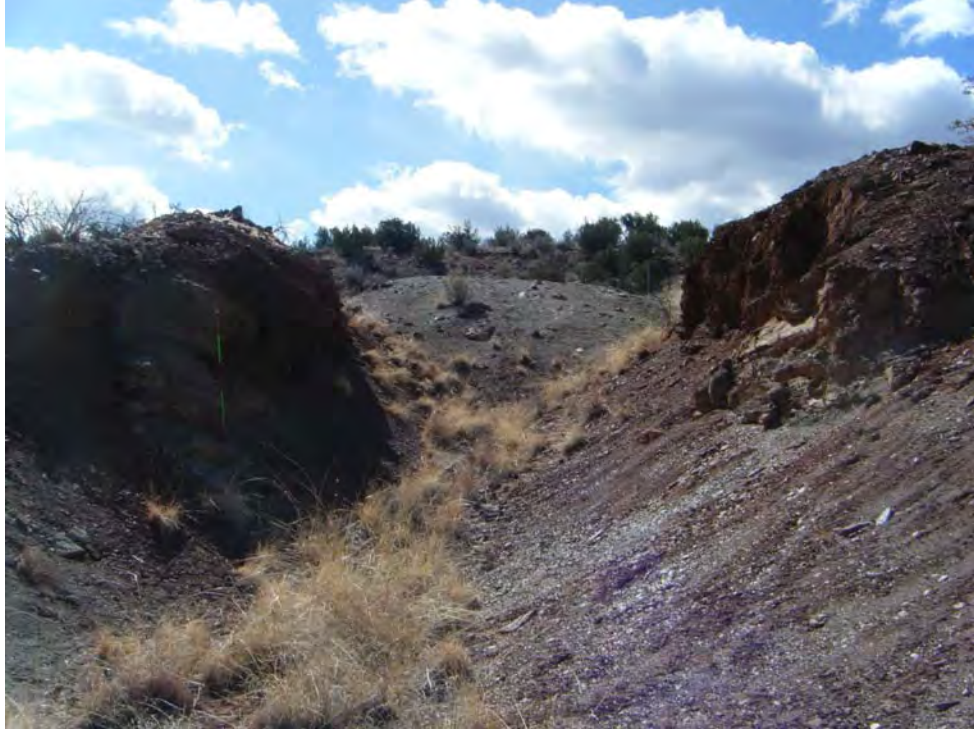
Photo 3-Closer view of CutLn-1 in the foreground and PilePly-1 in the background, looking southeast.

Photo 3 - cut 1 with pile 1 in background, scale pole is next to Rad 1, looking SE

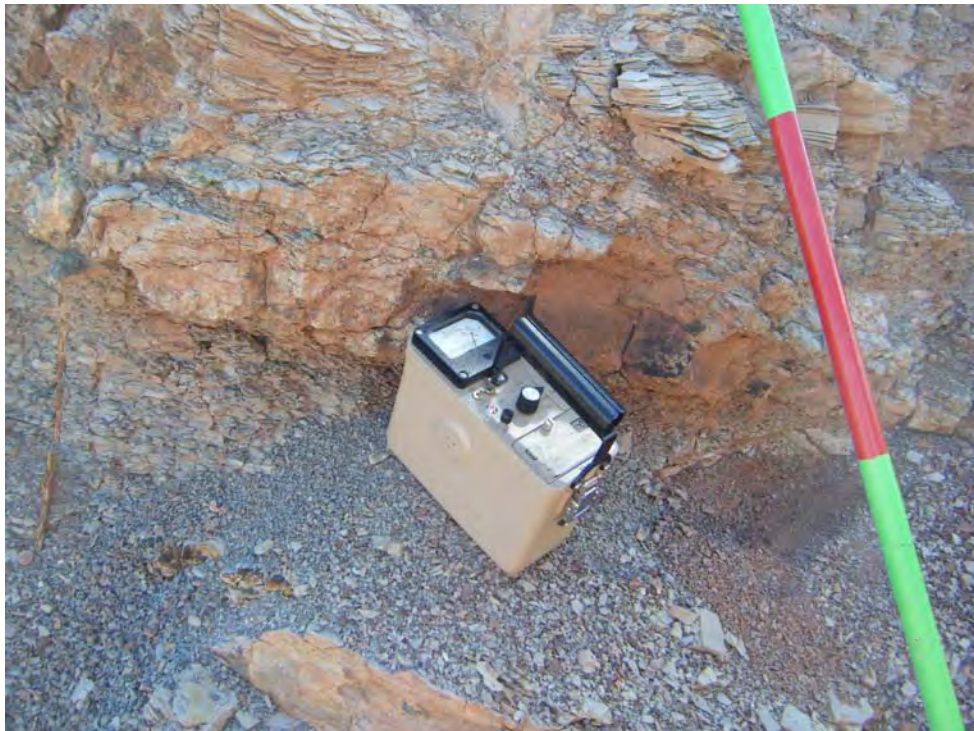
Photo 4-Photo of point Rad-1 inside CutLn-1.

Rad 1 - contact = ~~35~~^{AEA} $\mu\text{R/hr}$; 1m = 20 $\mu\text{R/hr}$

Photo 4 - black staining has rad readings of 3x background, inside cut 1

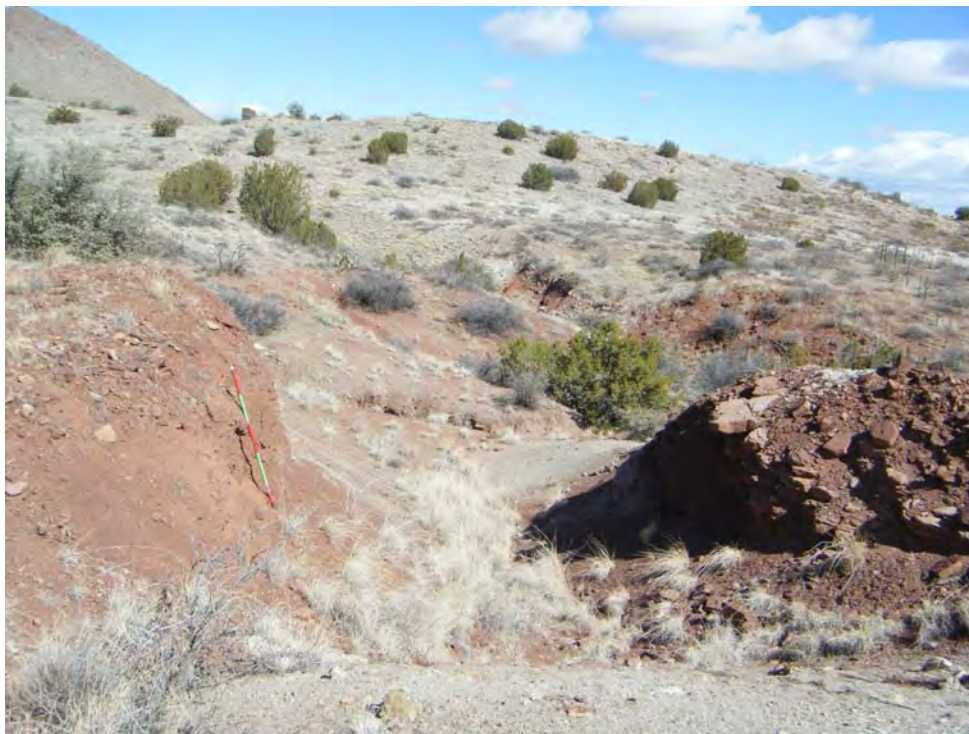
Photo 5-Looking north at CutLn-1.

Photo 5 - cut 1, looking N from pile 1

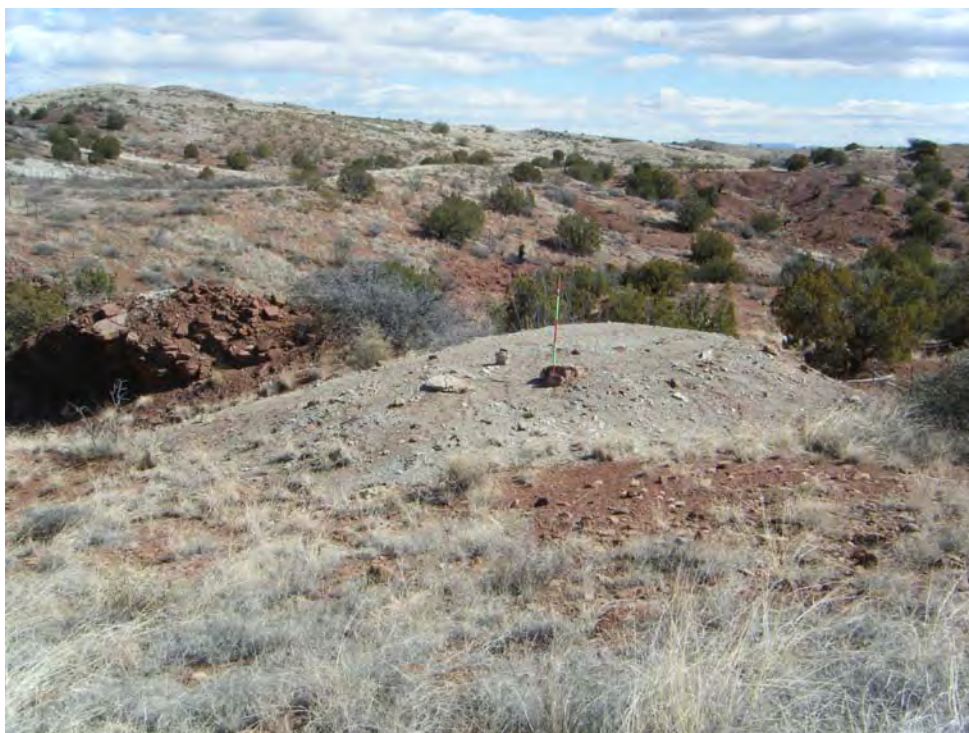
Photo 6-Looking southwest at PilePly-1.

Photo 6 - pile 1, looking NE, cut 1 is to the left

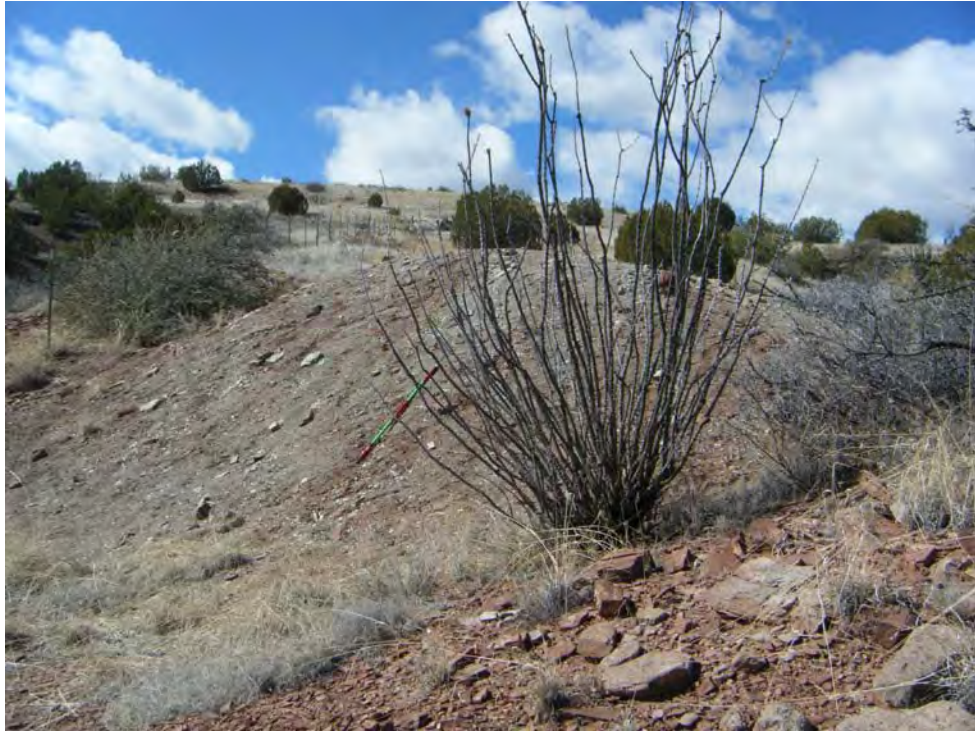
Photo 7-Looking southwest at PilePly-1.

Photo 7 - pile 1, looking SW

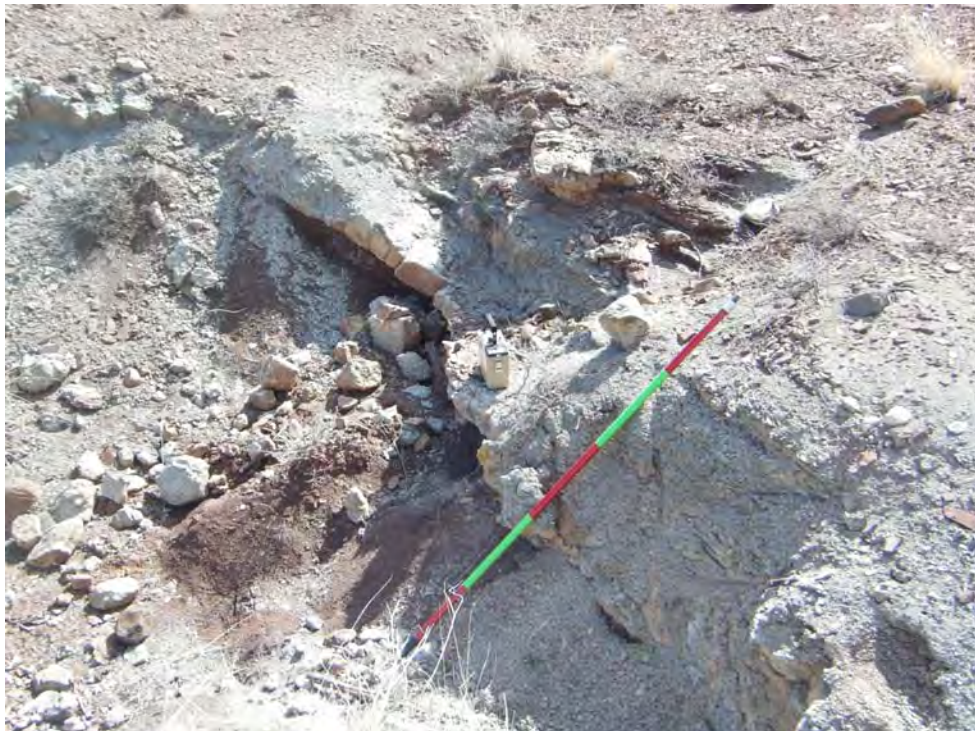
Photo 8-Outcrop near CutLn-1. A radiation survey point was taken here (point Rad-3).

Rad 3 - contact = 30 $\mu\text{R/hr}$; 1m = 21 $\mu\text{R/hr}$

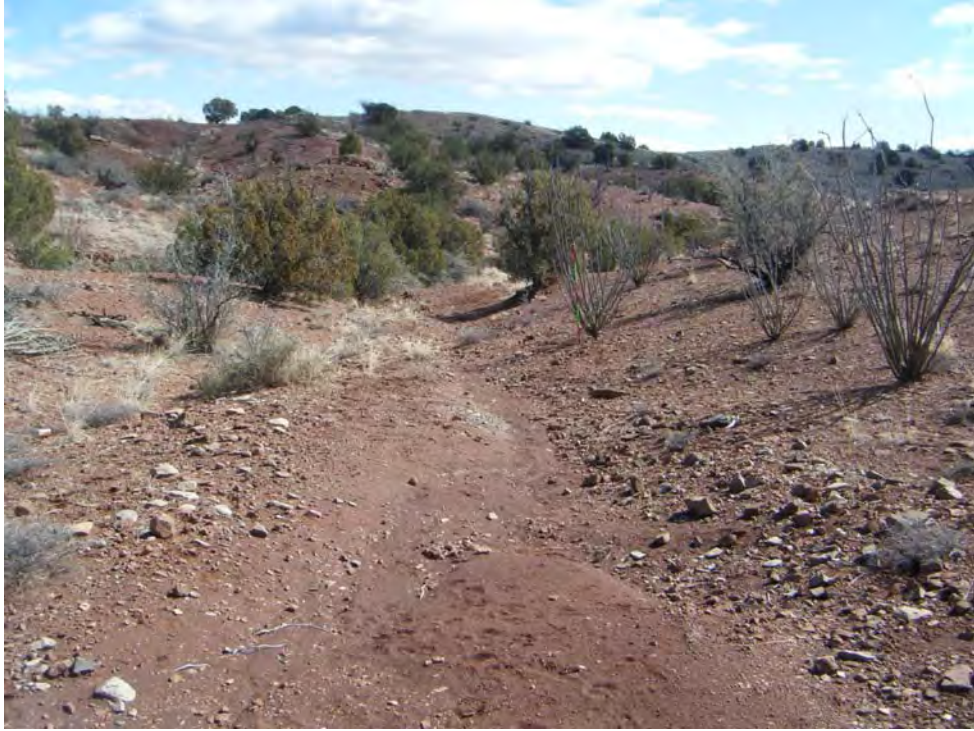
Photo 9-Looking east along Rd-1.

Photo 9 - Rd 1, looking E

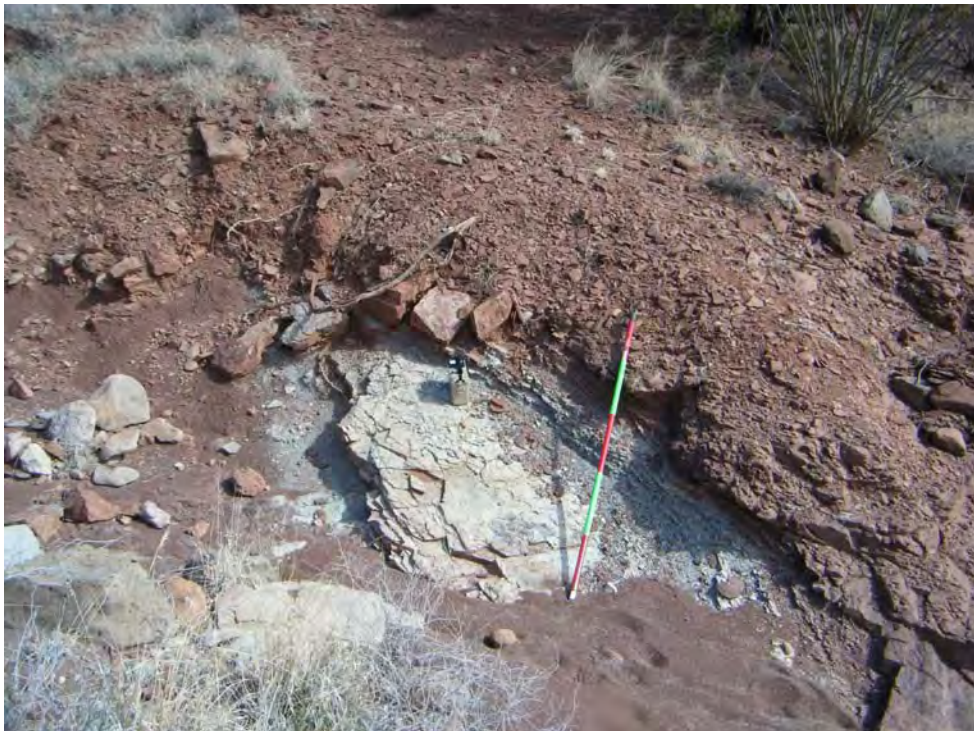
Photo 10-Outcrop in arroyo downstream of site, looking east (point Rad-4).

Rad 4 - contact = 13 $\mu\text{R/hr}$; 1m = 12 $\mu\text{R/hr}$

Photo 10 - Rad 4, in arroyo downstream of site, looking E

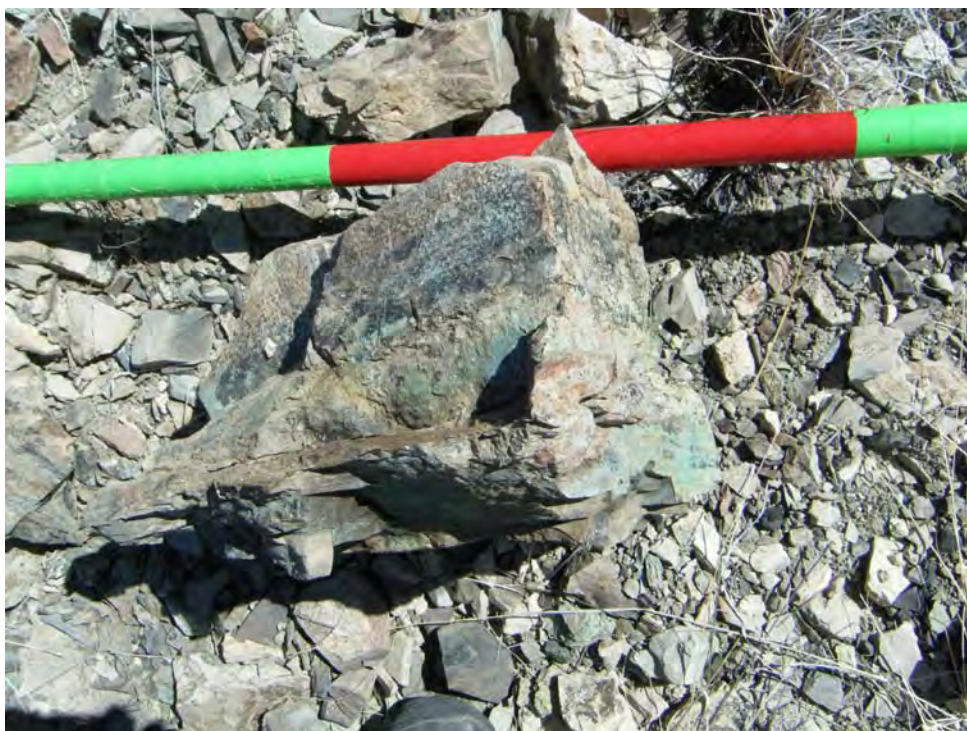
Photo 12-Cherty boulder with copper bearing minerals (point Rad-6, 160 μ R/hr at contact).

Rad 6 - contact = $160 \mu\text{R}/\text{hr}$; $1\text{m} = 21 \mu\text{R}/\text{hr}$

Photo 12 - rad 6, friable siltstone w/ copper bearing mineral

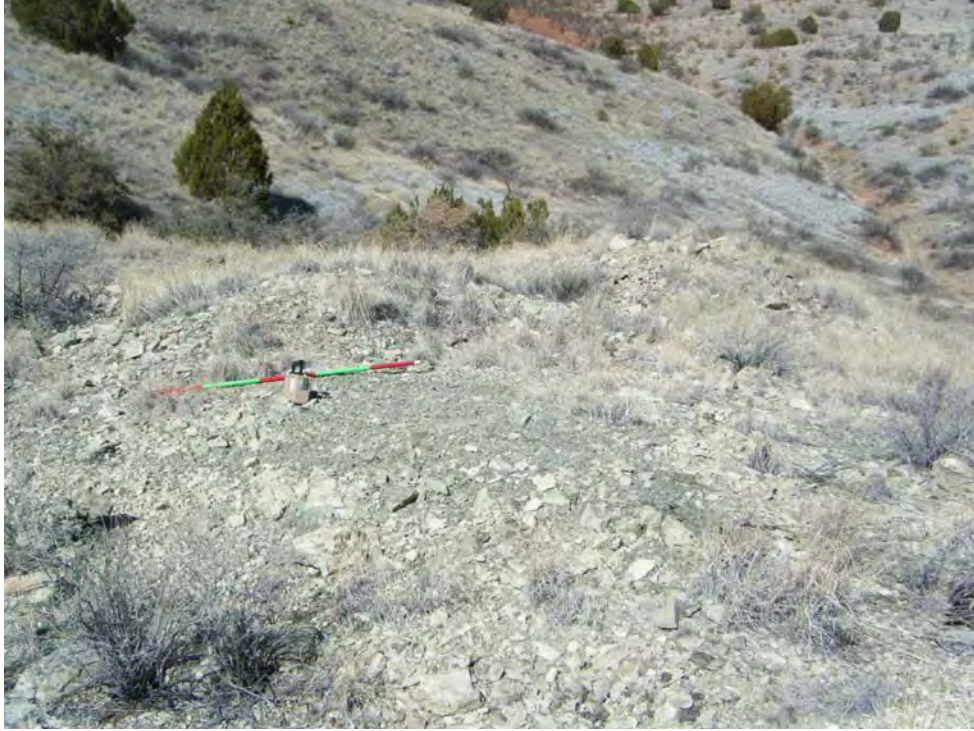
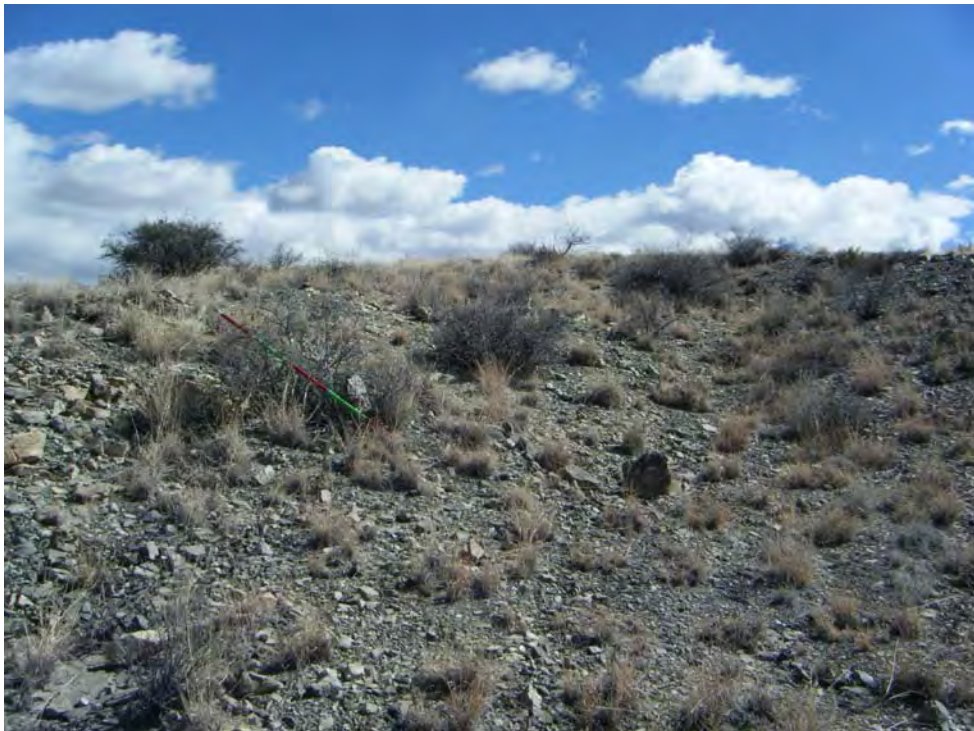
Photo 13-Looking west at DistPly-1.

Photo 14-Looking east at DistPly-1.

Dist 1 - large area of broken rock with radiation readings above background area has revegetated itself

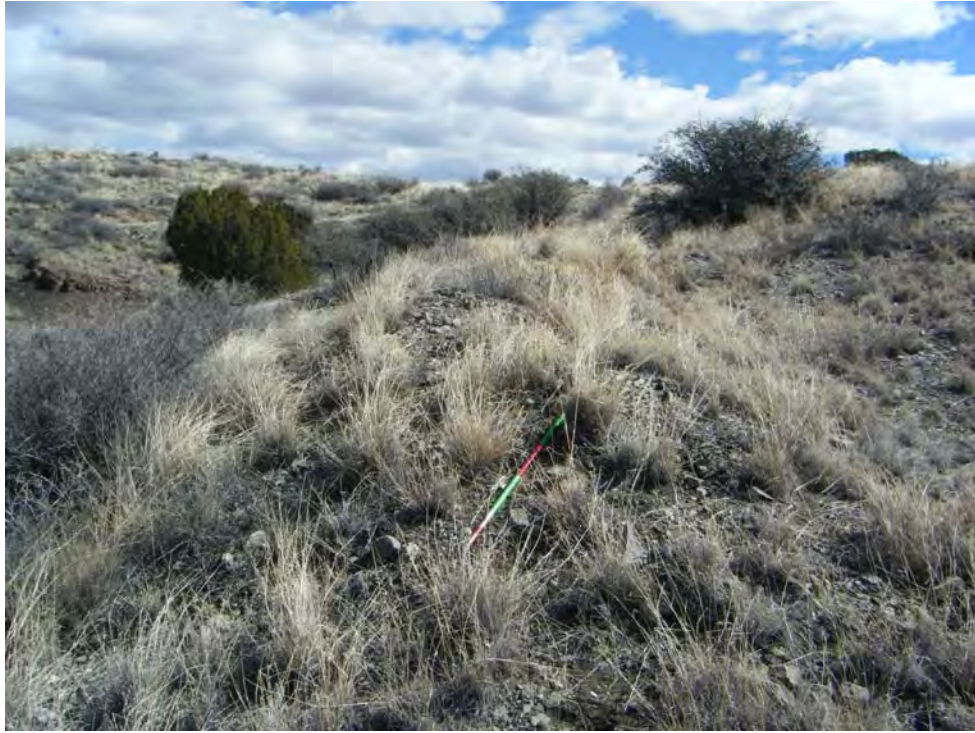
Photo 15-View of Berm-1. Note how the berm is revegetated.

Berm 1 - 50ft long, 5ft wide, 1ft high

Berm 1 has naturally revegetated itself.

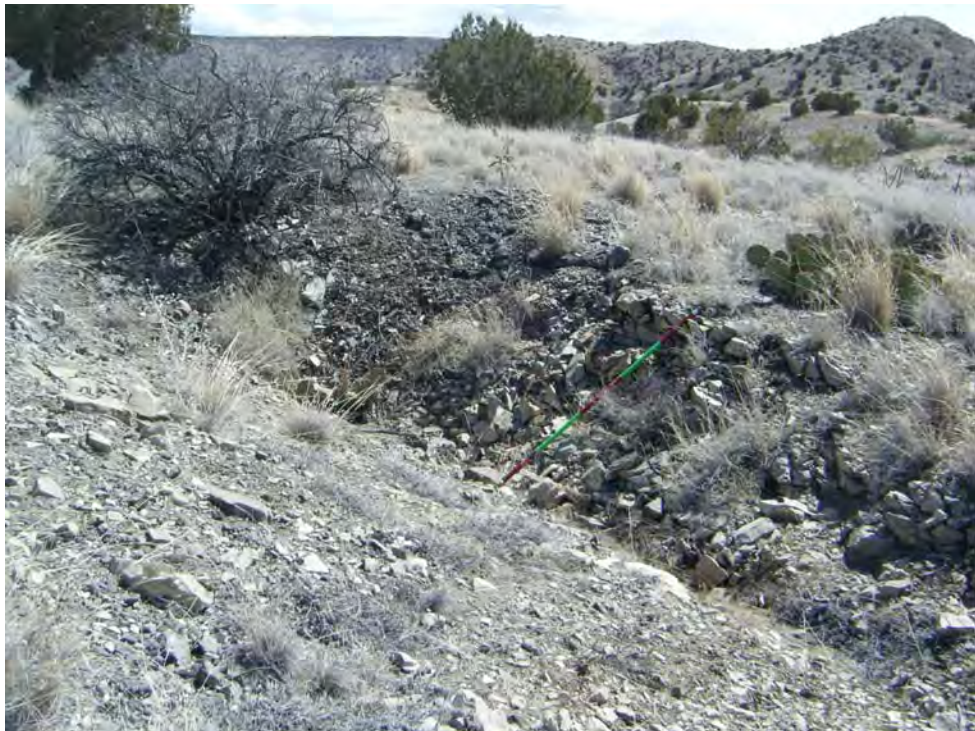
Photo 16-Looking southeast at CutPly-2.

Cut 2 - 30ft long, 4ft deep, 6ft wide

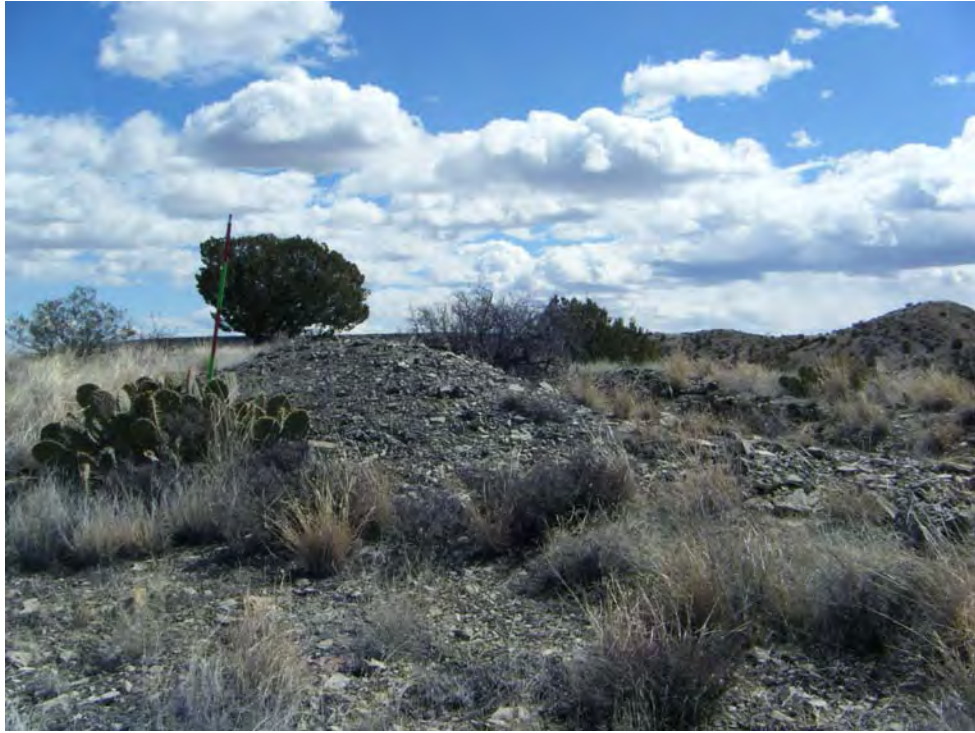
Photo 17-Looking east at PilePly-2.

Pile 2 - 4ft high, 10ft wide, 20ft long

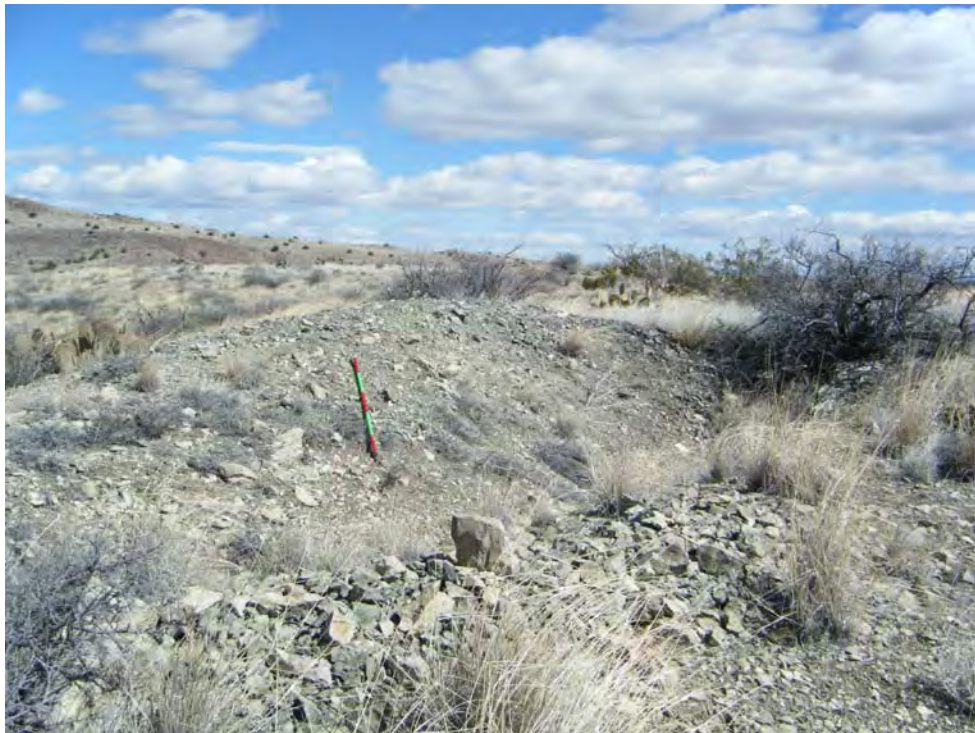
Photo 18-Looking north at PilePly-2 and CutLn-2 (point Photo-18).

Pile 2 was created from cut 2

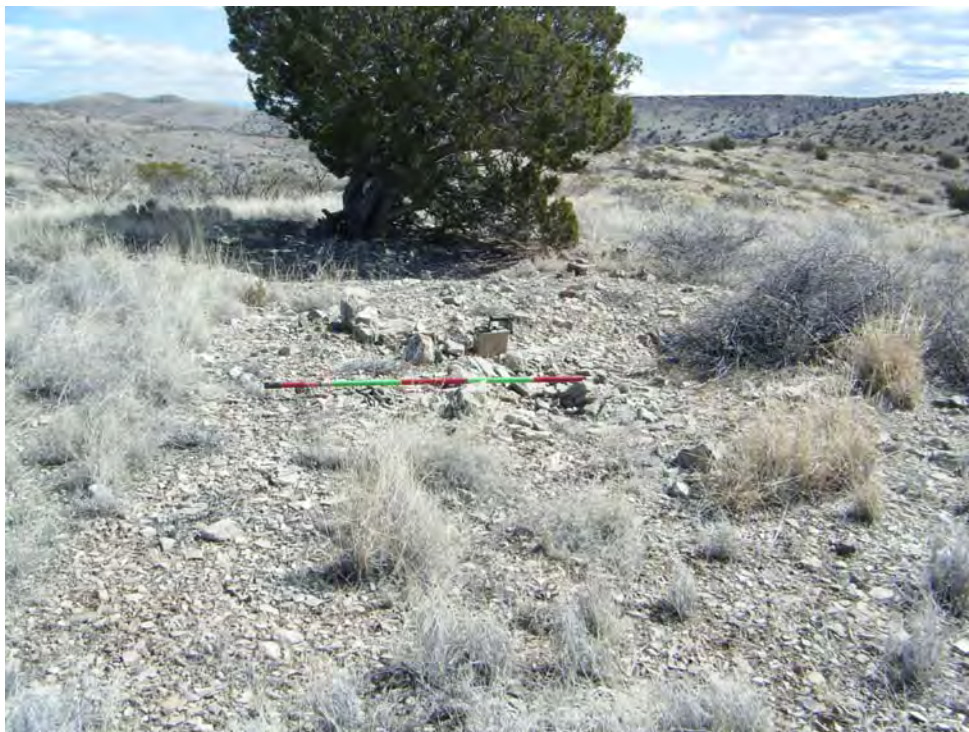
Photo 19-Looking east at DistPly-2.

Dist 2 - 20ft x 30ft, broken rocks

spread across the ground

Rad 11 - contact = 60 $\mu\text{R/hr}$; 1m = 40 $\mu\text{R/hr}$

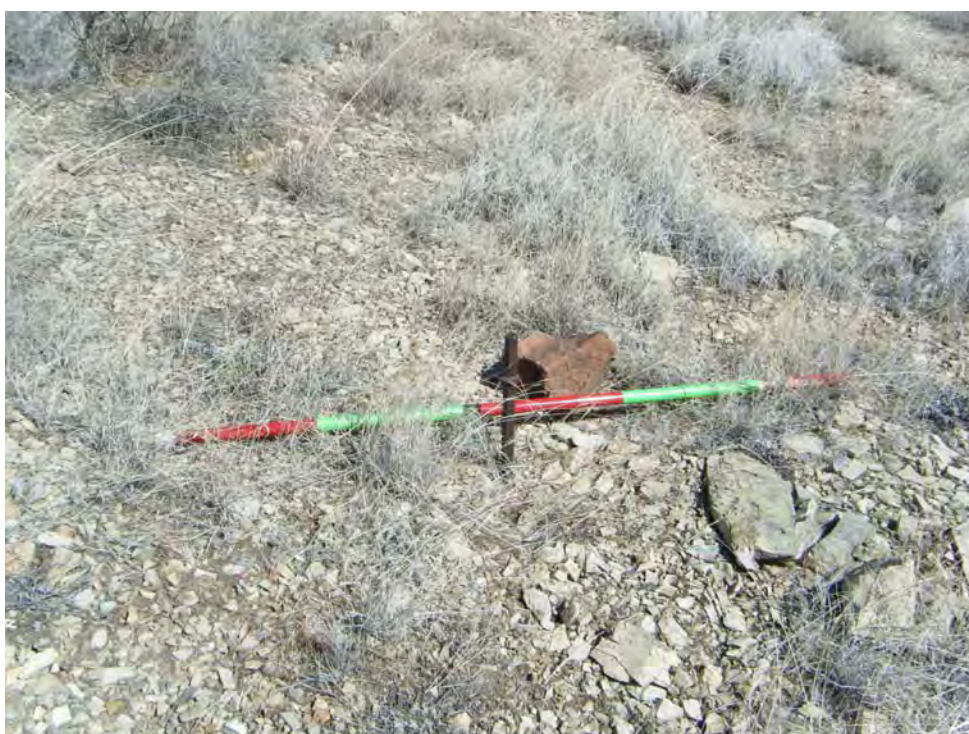
Photo 20-A stake found onsite (Claim-1).

Claim 1 - Iron stake sticking 1ft
out of the ground

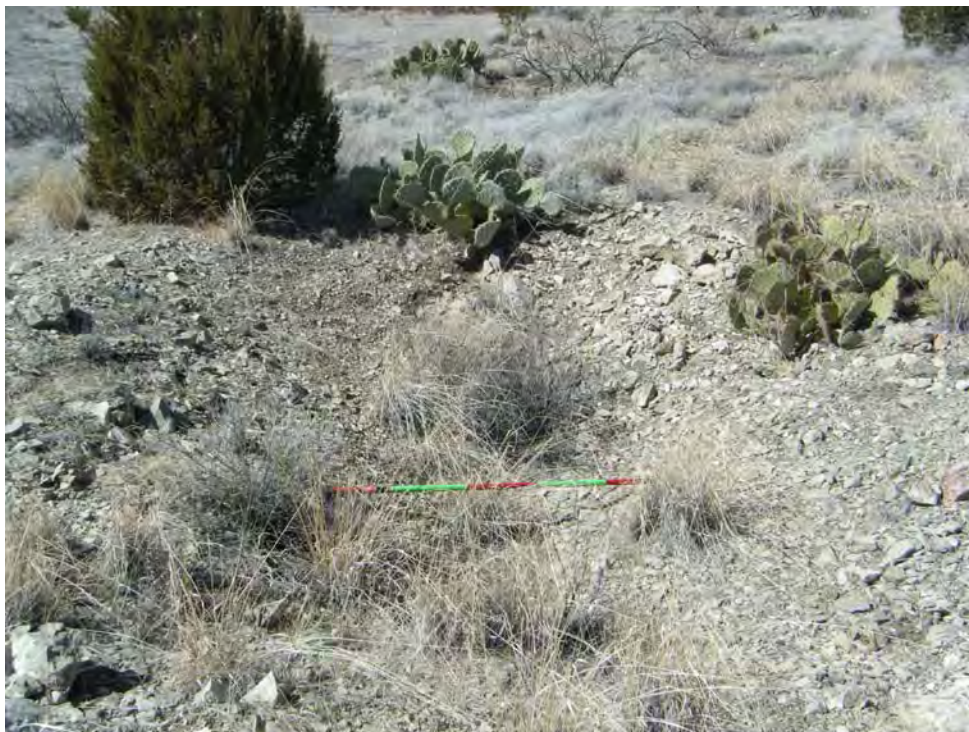
Photo 21-Looking east at Pit-1.

Pit 1 - 15ft wide, 20ft long, 4ft deep

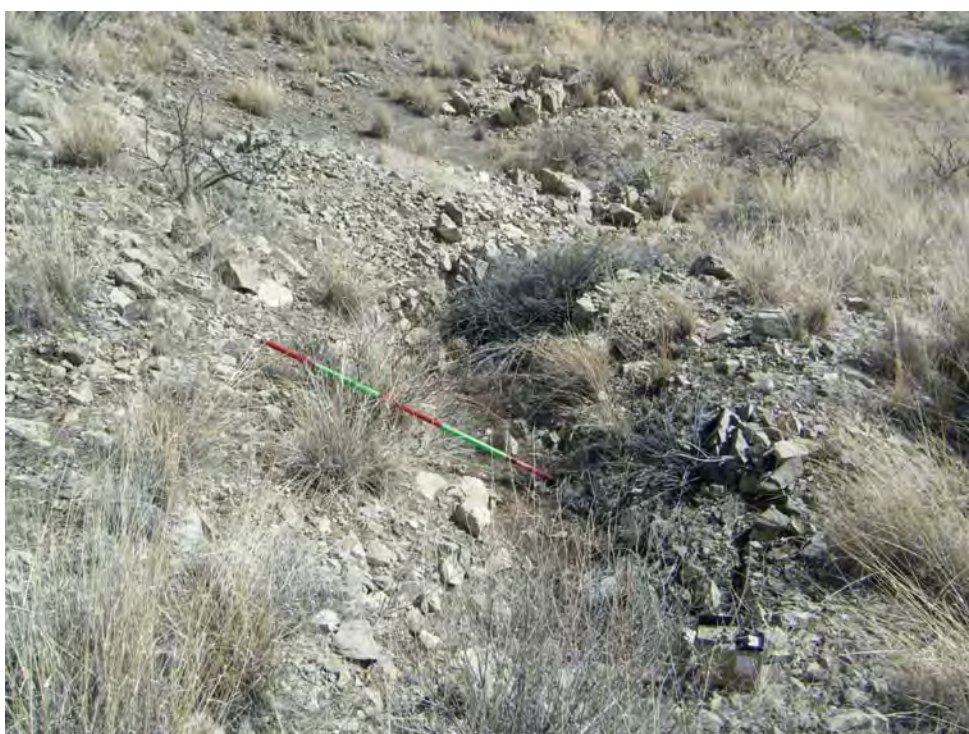
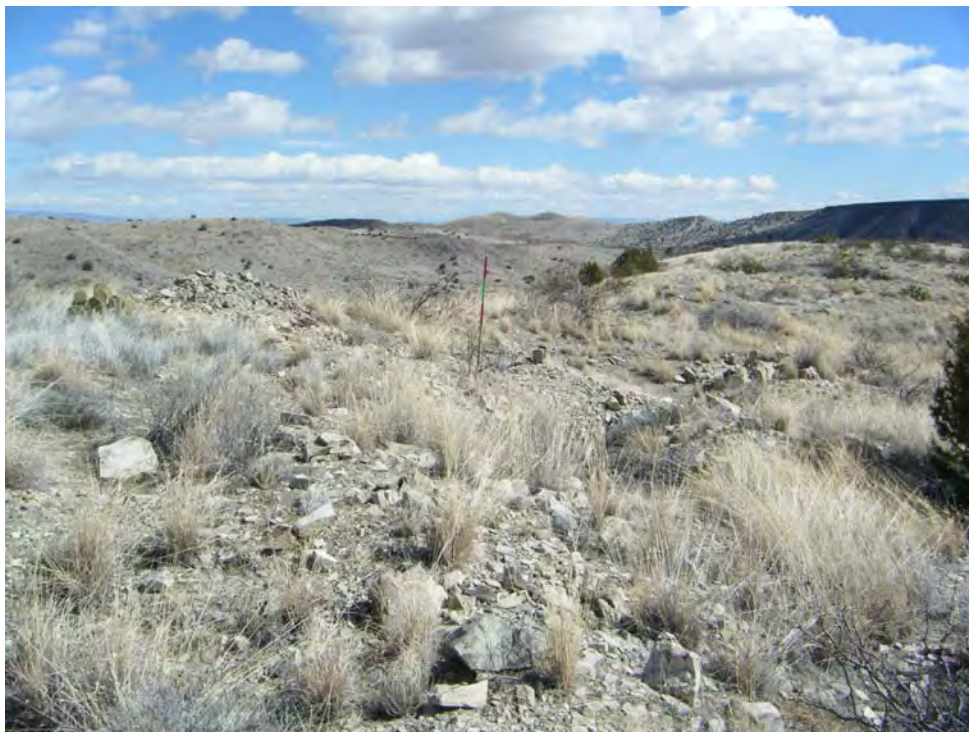
The maximum gamma radiation reading for the AUM Site was 270 $\mu\text{R/hr}$ at bedrock contact at point Rad-14. This reading was taken in a prospect pit (Pit-2). A reading of 100 $\mu\text{R/hr}$ at contact was recorded on a pile ridge (Pileridge-2) at point Rad-19. Another measurement of 160 $\mu\text{R/hr}$ was recorded on a mineralized boulder inside of a shallow disturbed region (DistPly-1).

Photo 22-Looking east at Pit-2.

Photo 23-Looking northeast over Pit-2 (point Photo-23).

Pit 2 - 15ft x 5ft x 2ft deep

Rad 14 - contact = 270 $\mu\text{R/hr}$; 1m = 40 $\mu\text{R/hr}$

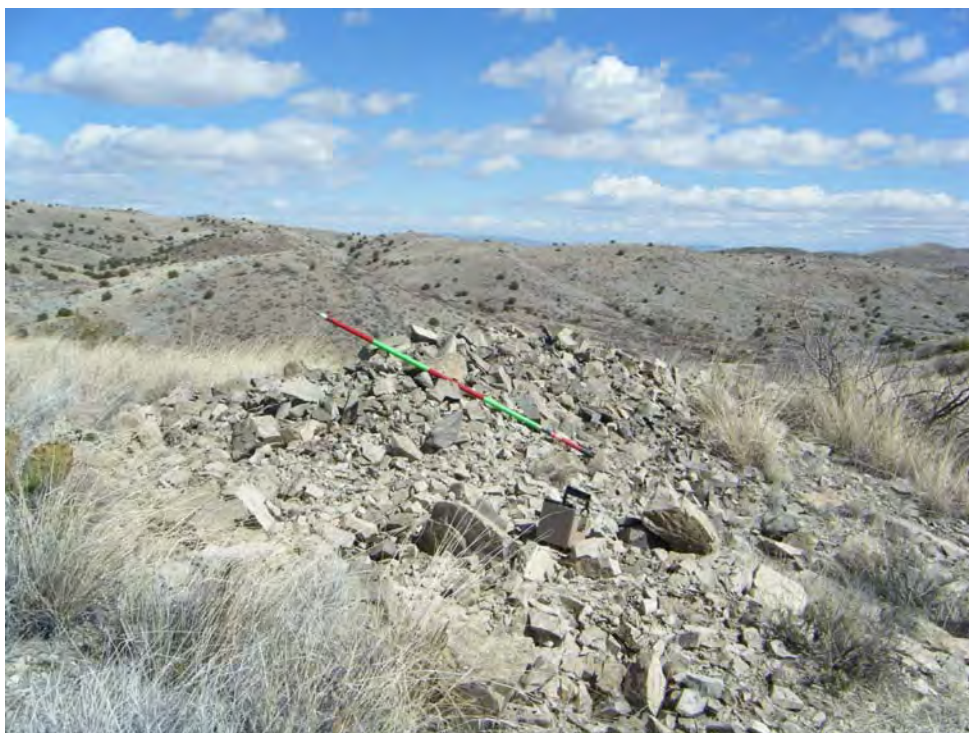
Photo 24-Looking northeast at PilePly-3.

Pile 3 - 4ft high, 10ft x 30ft

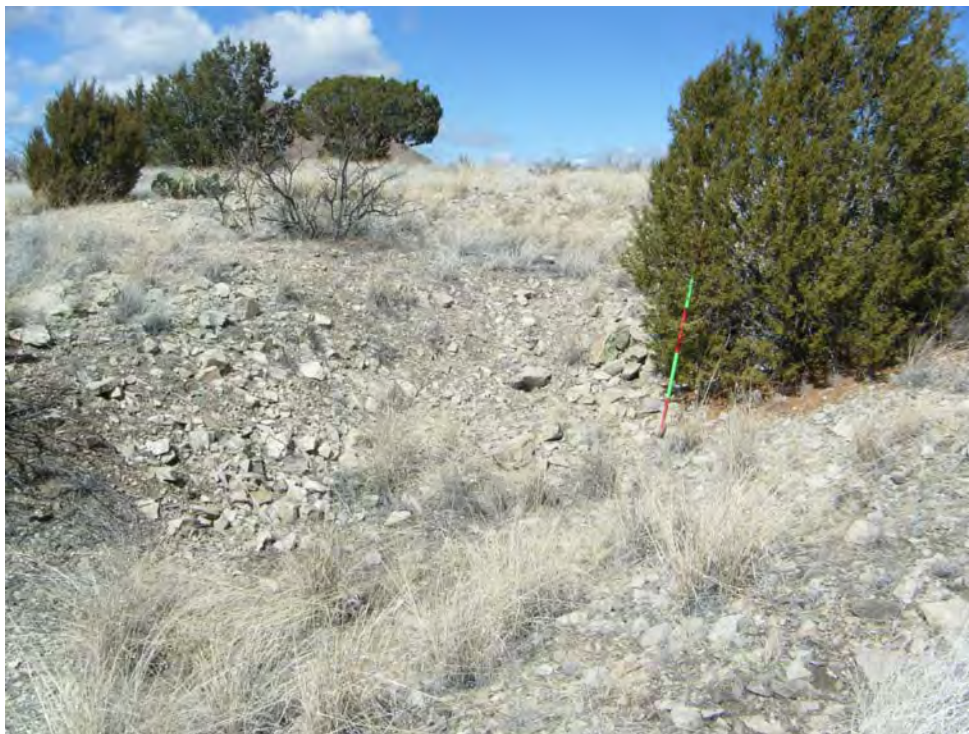
Photo 25-Looking north at CutPly-1.

Cut 3 - 3ft deep, 30ft x 15ft

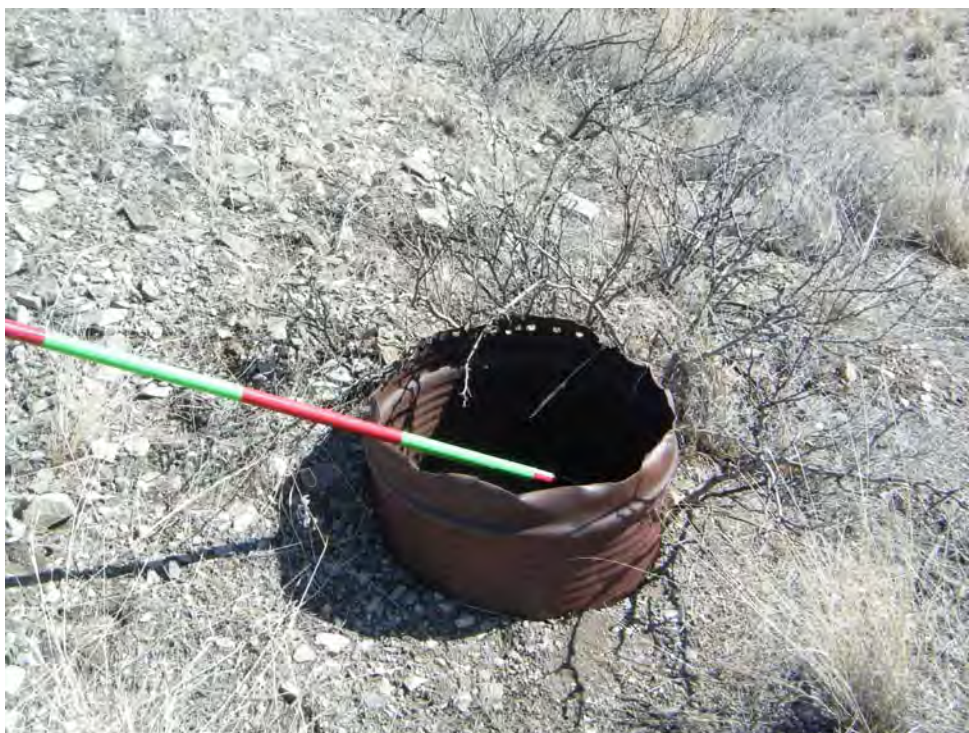
Photo 26-Looking east at half of a 55 gallon drum found onsite (Equip-1).

Equip 1 - half of a 55 gal steel drum,
partially buried, empty, next to pile 4

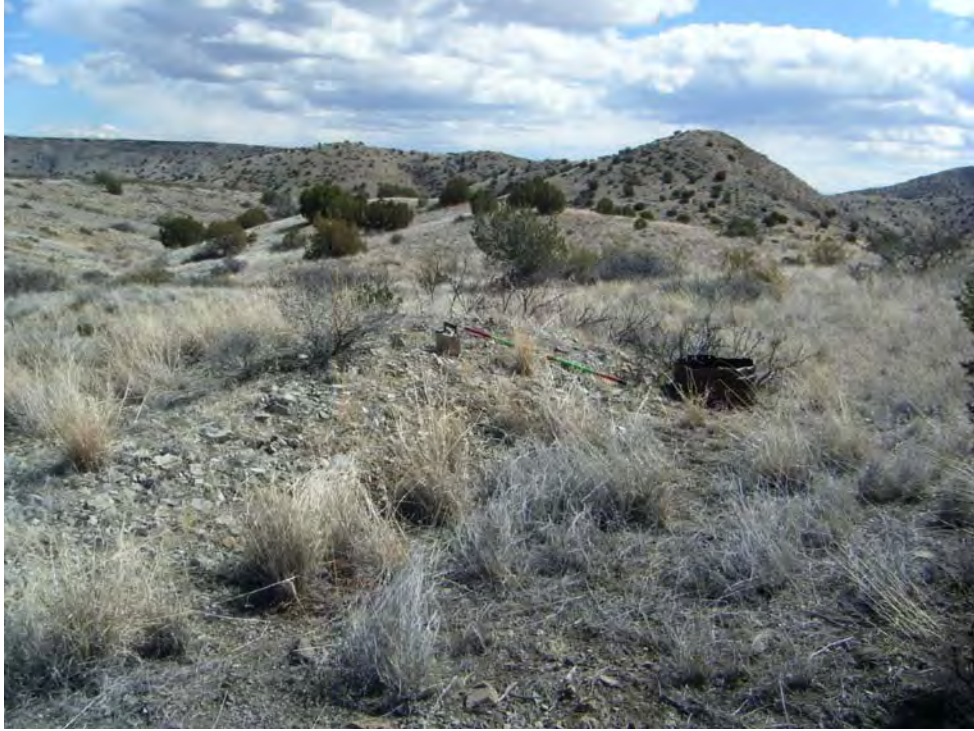
Photo 27-Looking east at PilePly-4.

Pile 4 - 20ft x 30ft, 3ft high

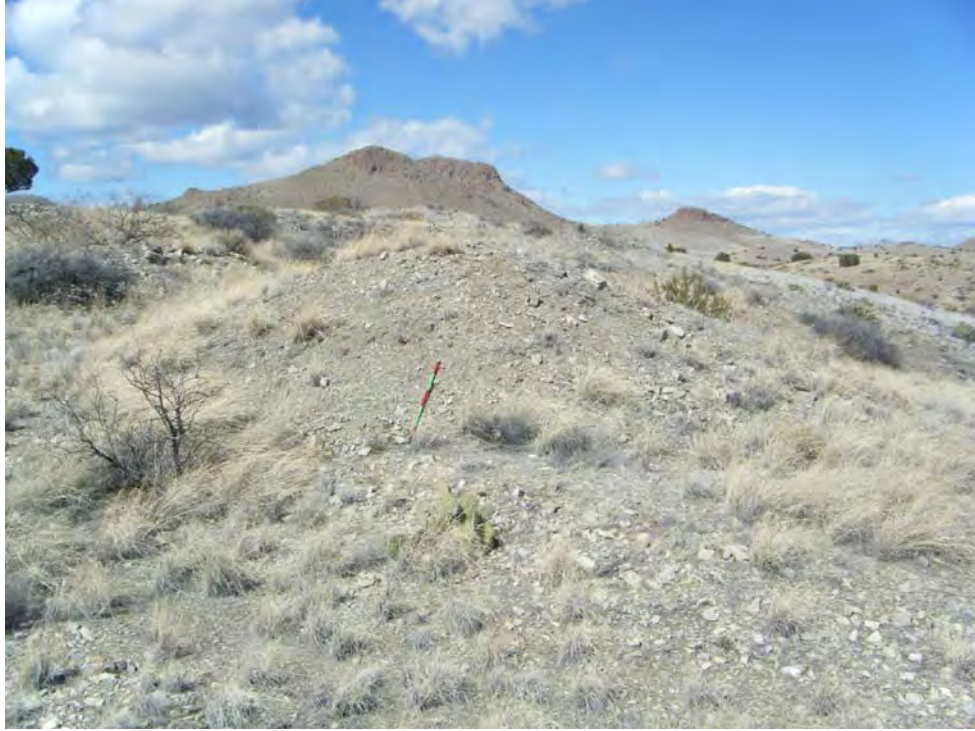
Photo 29-Looking north at PilePly-5.

Pile 5 - 10ft high, 20ft x 30ft

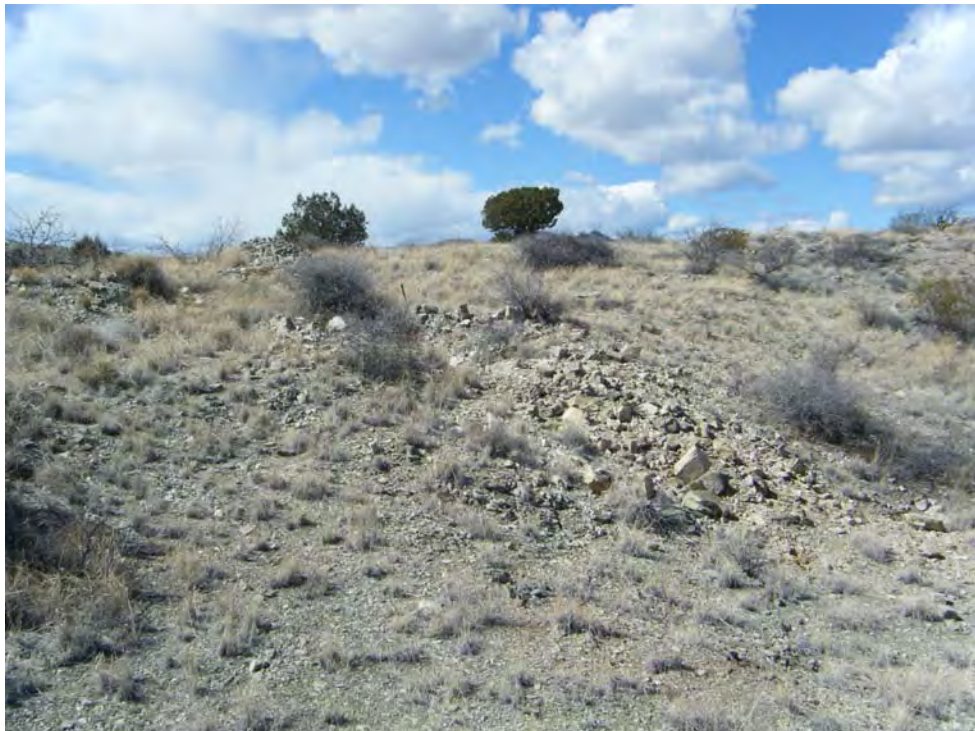
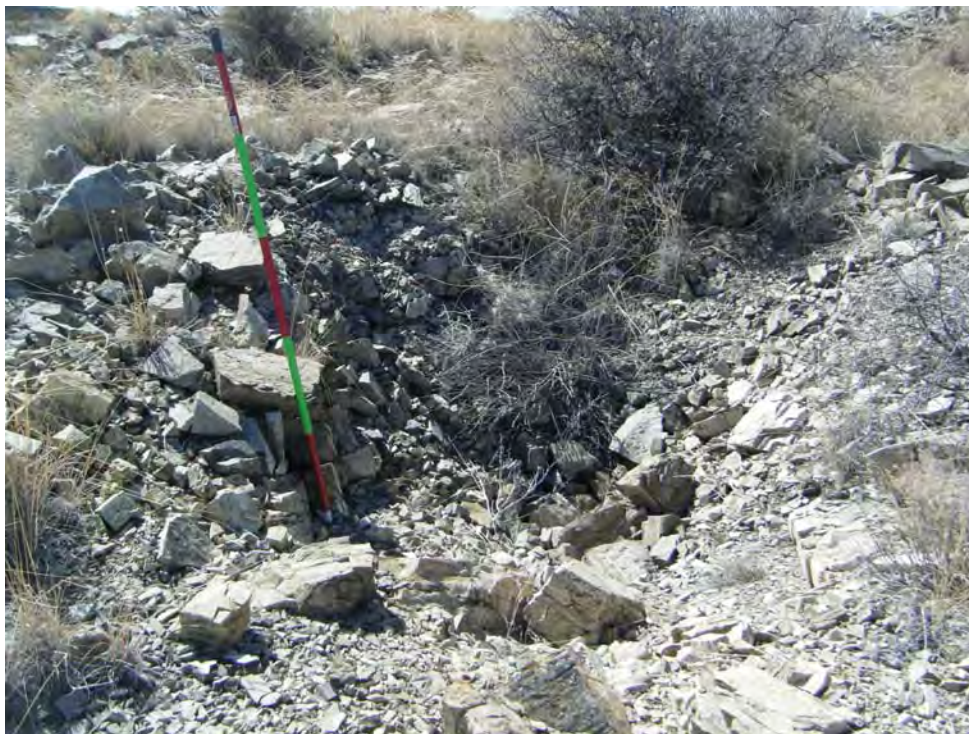
Photo 30-Looking west at Pit-3.

Photo 31-Closeup of Pit-3, looking southwest.

Pit 3 - 5ft deep, 10ft x 15ft

Rad 19 - contact = $100 \mu\text{R/hr}$; $1\text{m} = 24 \mu\text{R/hr}$

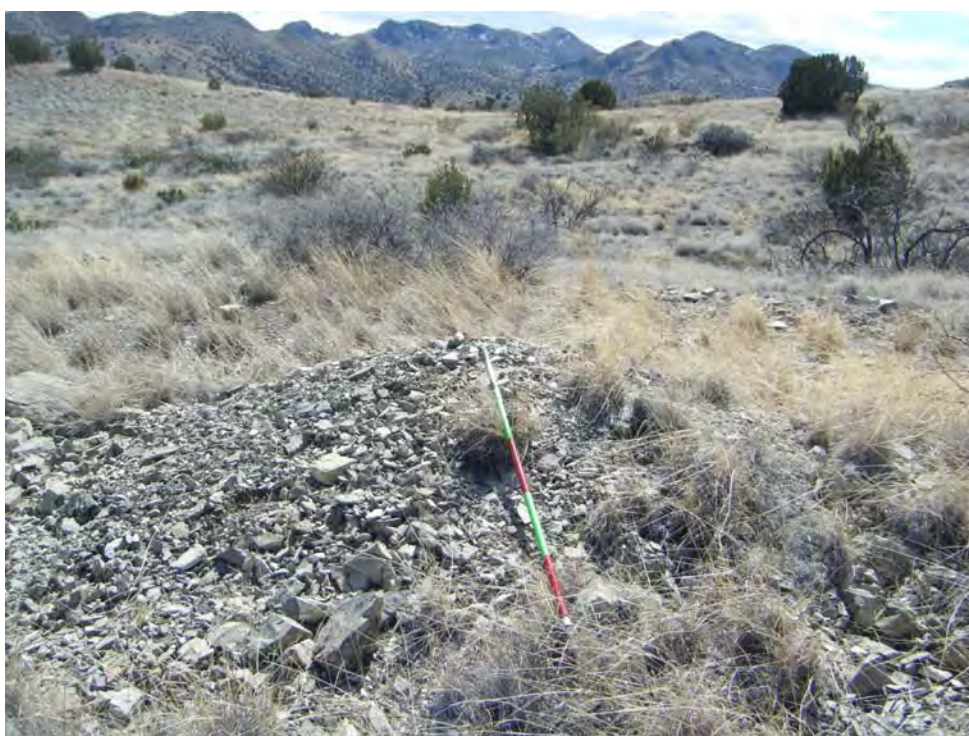
Photo 32-Looking southeast at PilePly-6.

Pile 6 - 3ft high, 10ft x 8ft

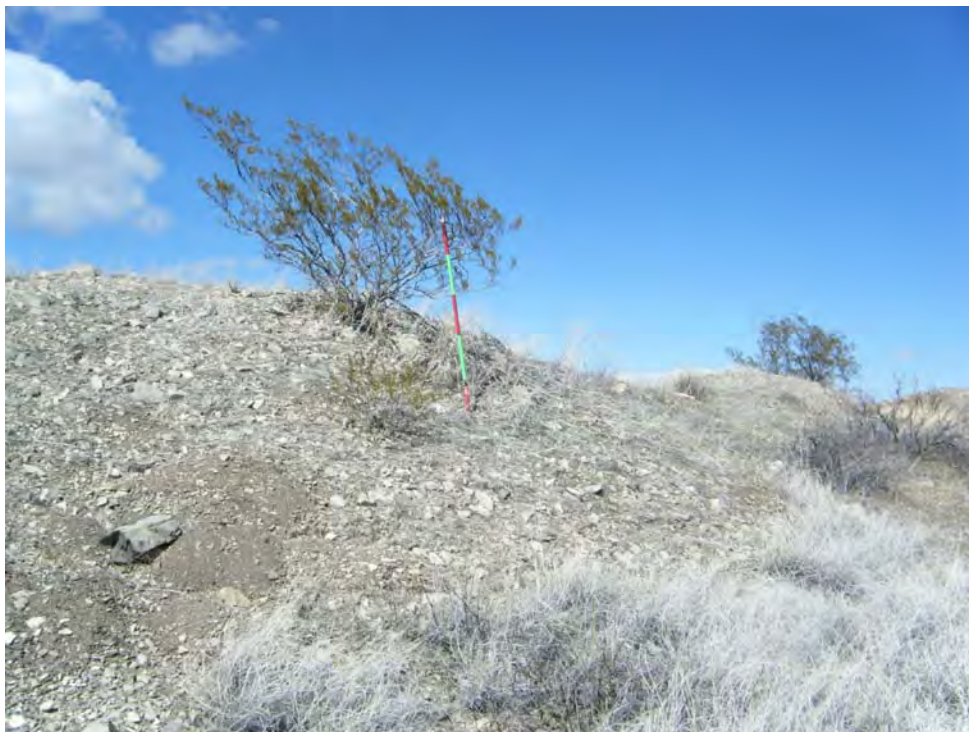
Photo 33-Looking north at Pileridge-1.

Pile Ridge 1 - 6ft high, 10ft high
