Abandoned Uranium Mine Site Assessment for the Red Tiger Site (NM0247)

FINAL REPORT

March 24, 2010

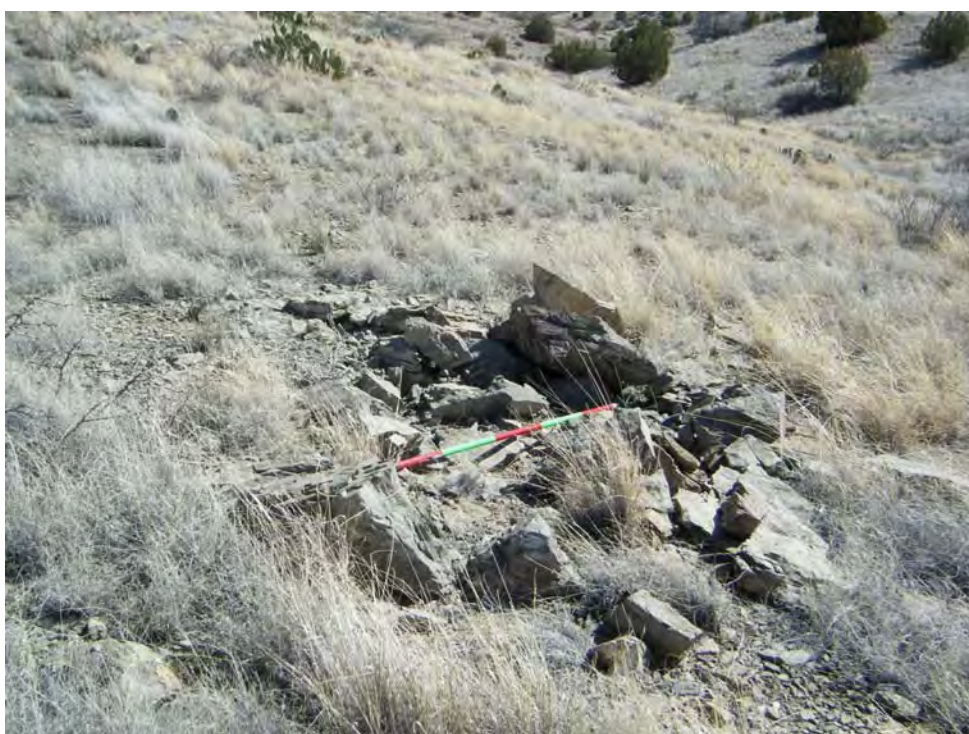
Photo 34-Looking southeast at DistPt-1.

Dist 3 - 5ft x 7ft, looks like it might have been a pit that was filled with rocks

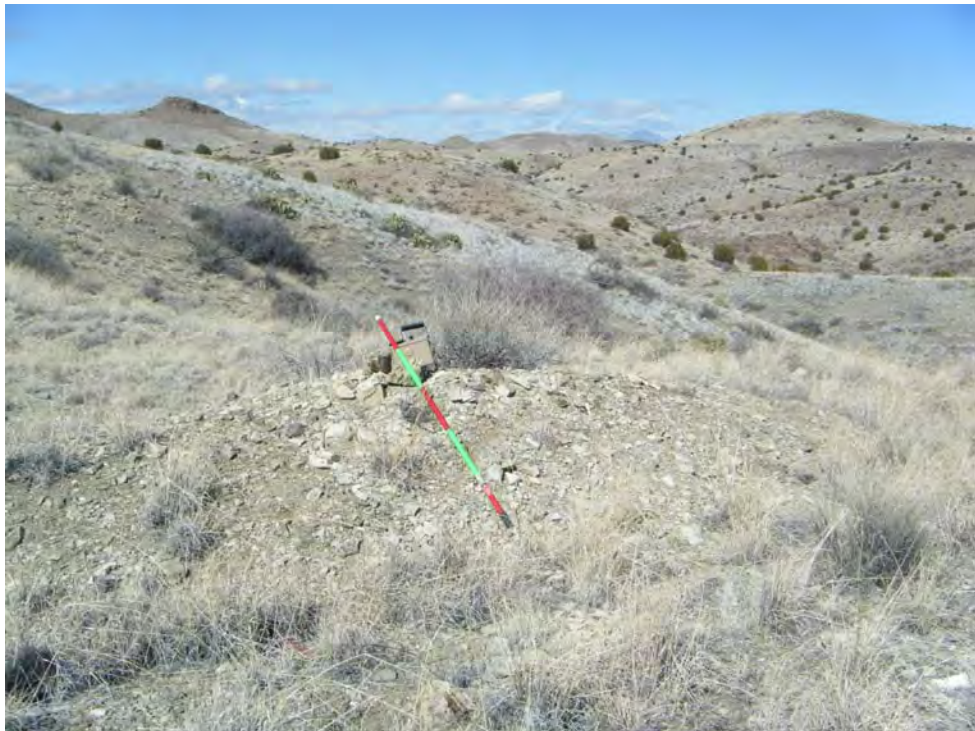
Photo 42-Looking north at PilePly-7.

Pile 7 - 2ft high, 10ft x 5ft

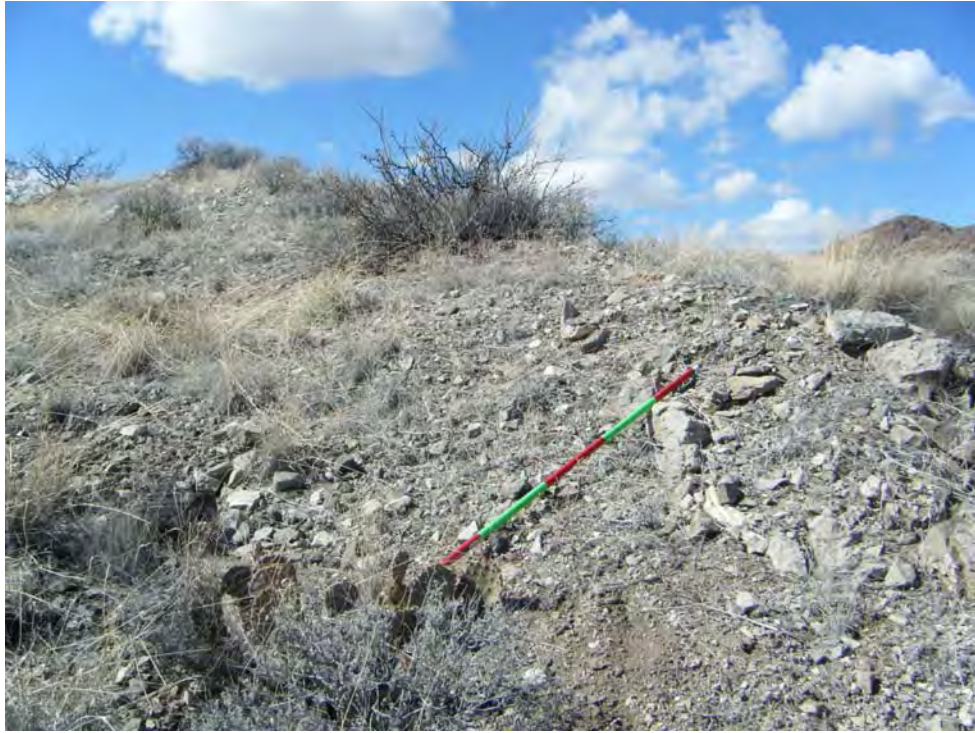
Photo 45-Looking west at Pileridge-2.

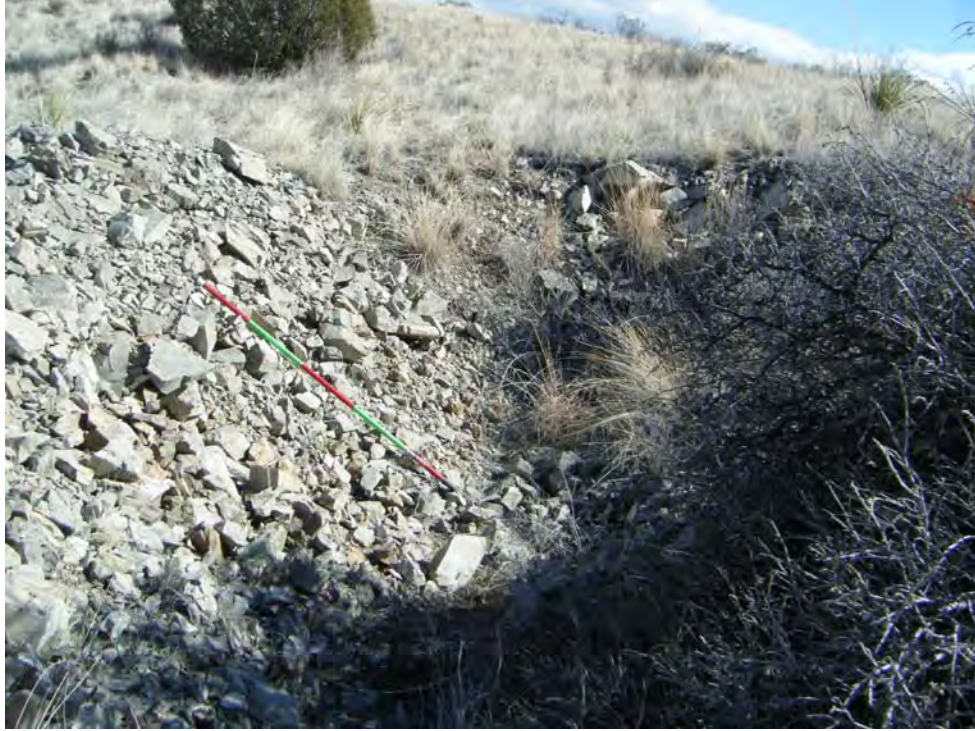
Photo 47-Looking east at CutPly-2.

Cut 4 - 15 ft x 25 ft, 8 ft deep

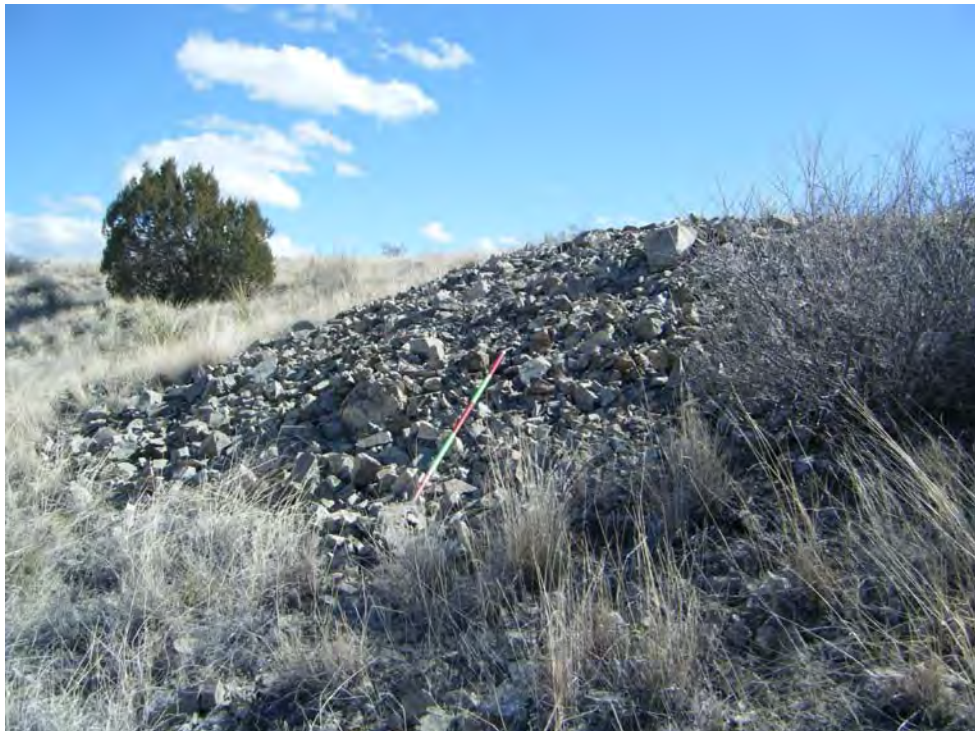
Photo 48-Looking east at PilePly-9.

Pile 9 - 15 ft high, 25 ft x 25 ft

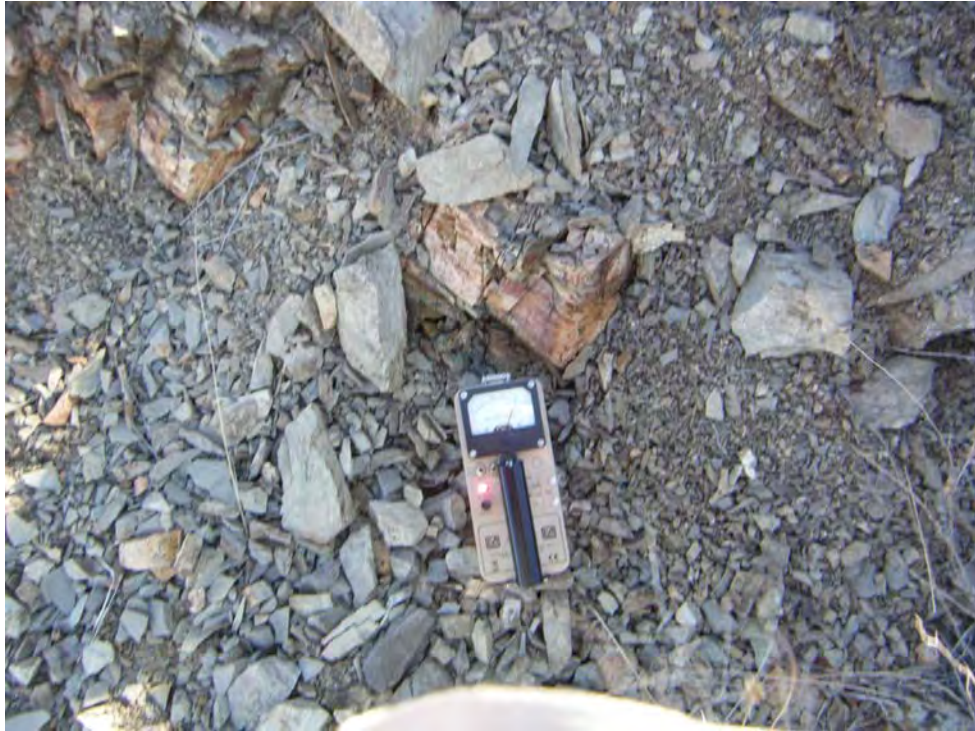
Photo 49-Bedrock inside CutPly-3 (point Rad-28).

Rad 28 - contact = 48 μ R/hr; 1 m = 20 μ R/hr

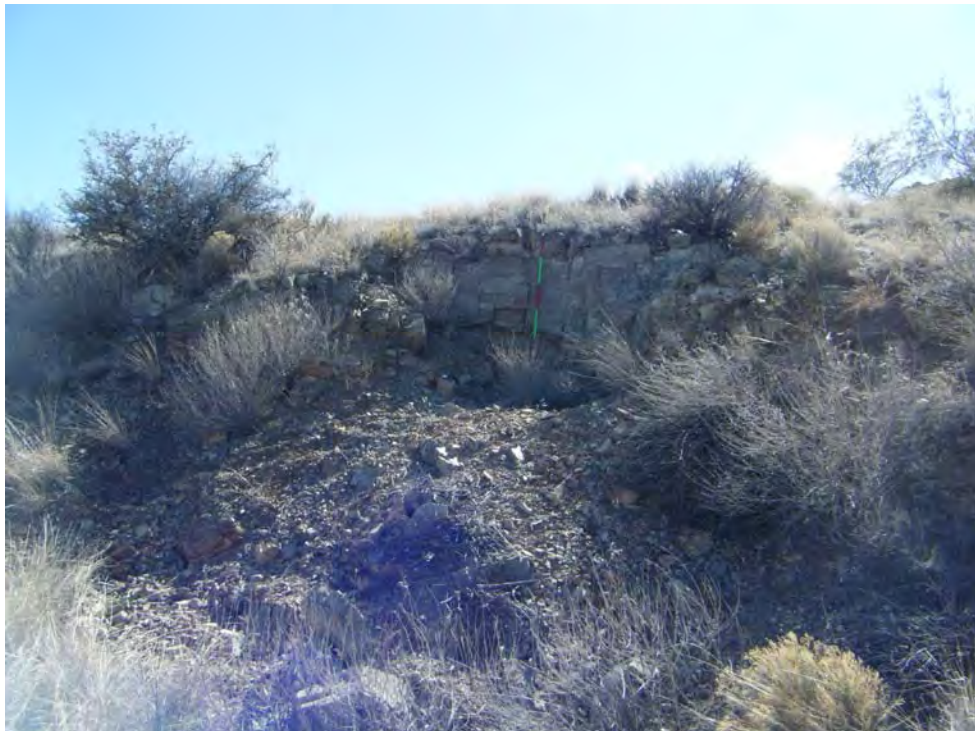
Photo 50-Looking south at CutPly-3.

Cut 5 - 7 ft deep, 10 ft x 15 ft
