Navajo Abandoned Uranium Mine Site Screen Report

Kermac No. 22

Navajo AUM Eastern Region

March 2009

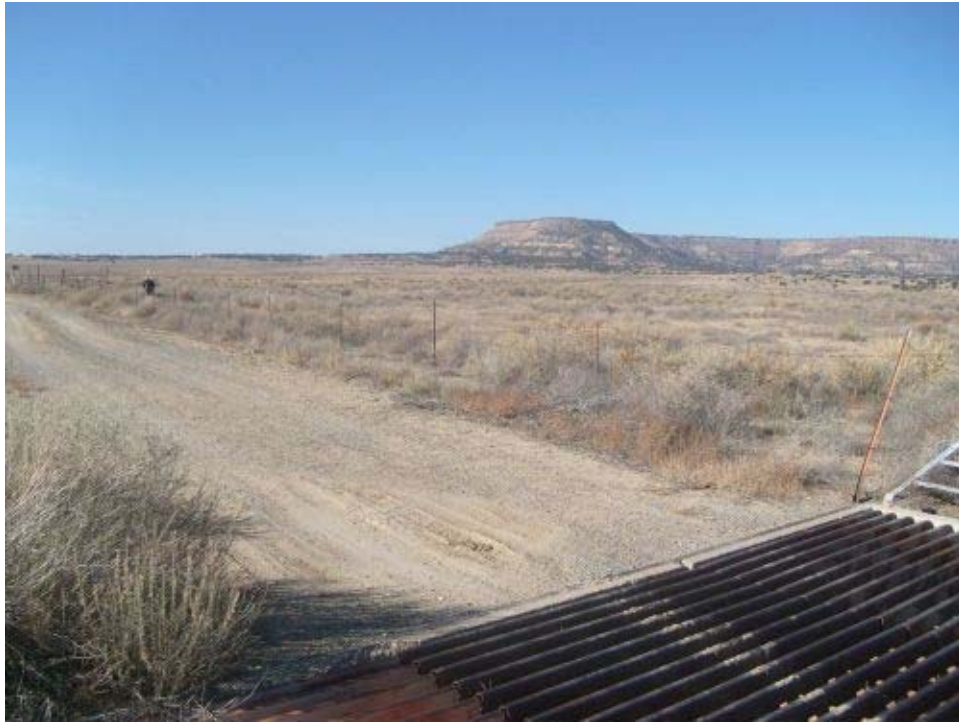
Photo 1. Kermac 22 mine site, towards west/southwest from road at northeast corner of site

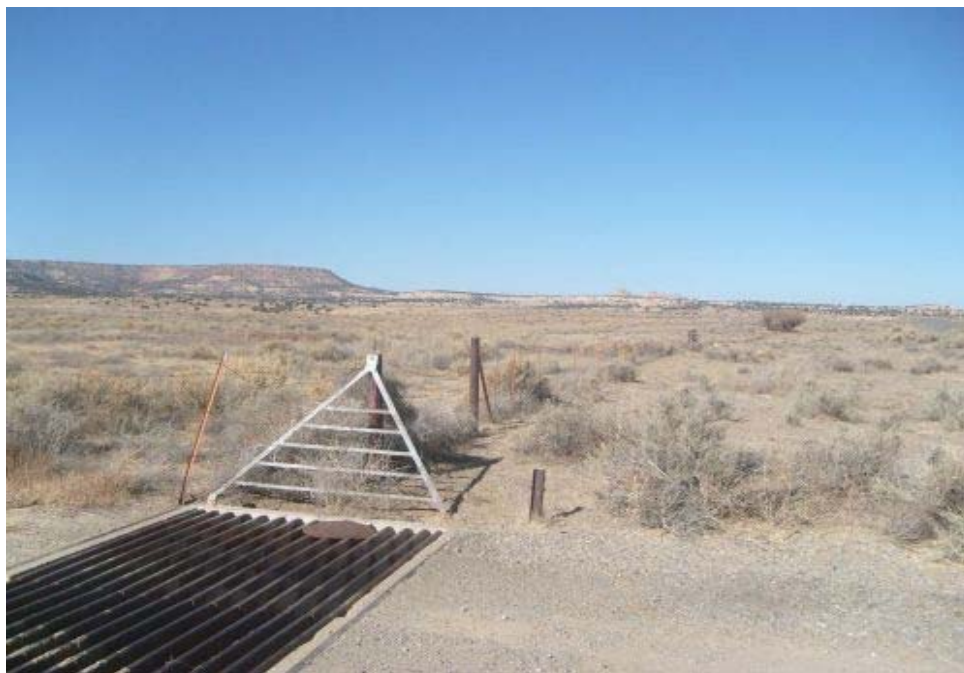
Photo 2. Kermac 22 mine site, towards west/southwest from road at northeast corner of site

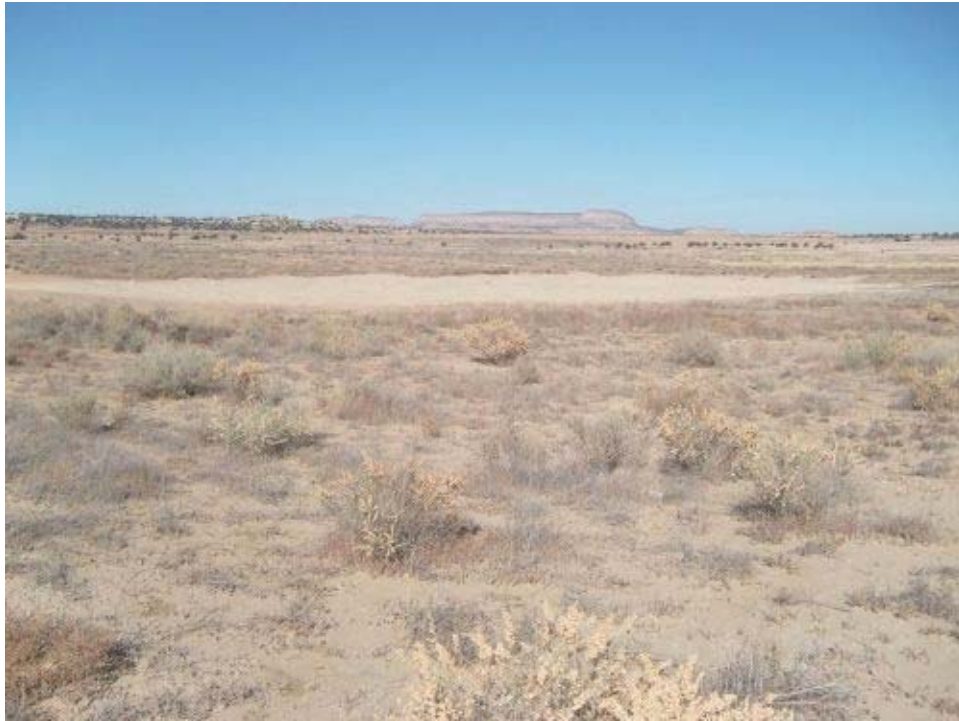
Reclamation status of the mine site is currently unknown. A covered area was observed in the center of the site (Photo 3). According to the New Mexico Mining and Mineral division the mine was reclaimed in 1994.

Is there a reclamation cap or sealed adit in place at the site? Yes, covered area in center of site

Is the cap/seal functionally intact? Yes

Photo 3. Covered area at the center of the site

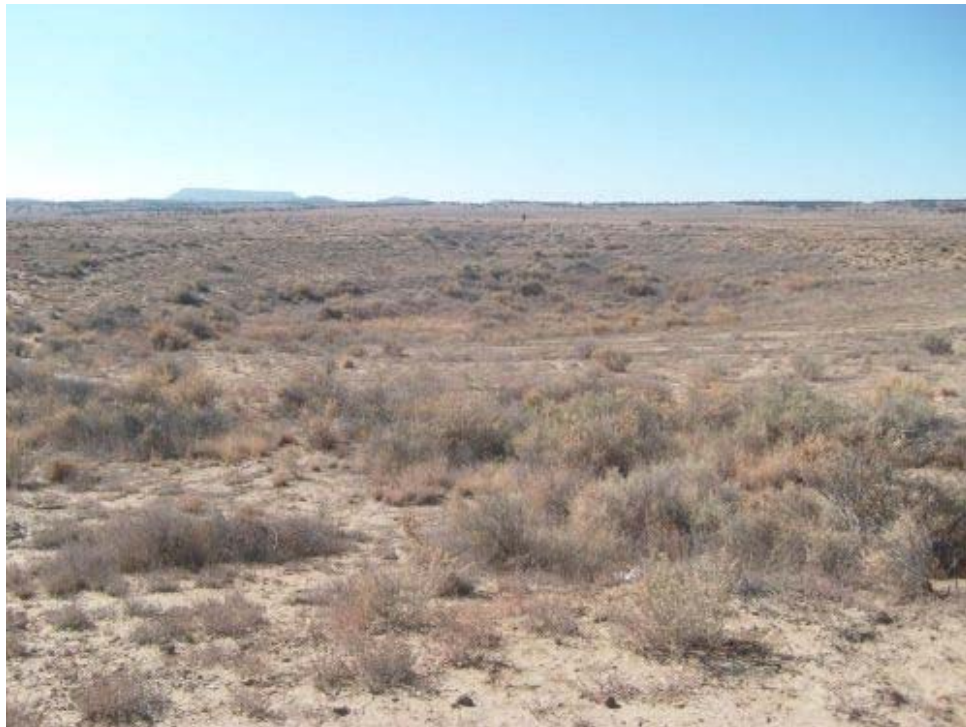
A total of 4,842 gamma radiation measurements were collected from the mine site, ranging from 11,268 cpm to 227,145 cpm. An area of depression within the site was measured at approximately 20,000 cpm. The measurements are represented in Figures 1 and 2.

Photo 4. Large depression south of road

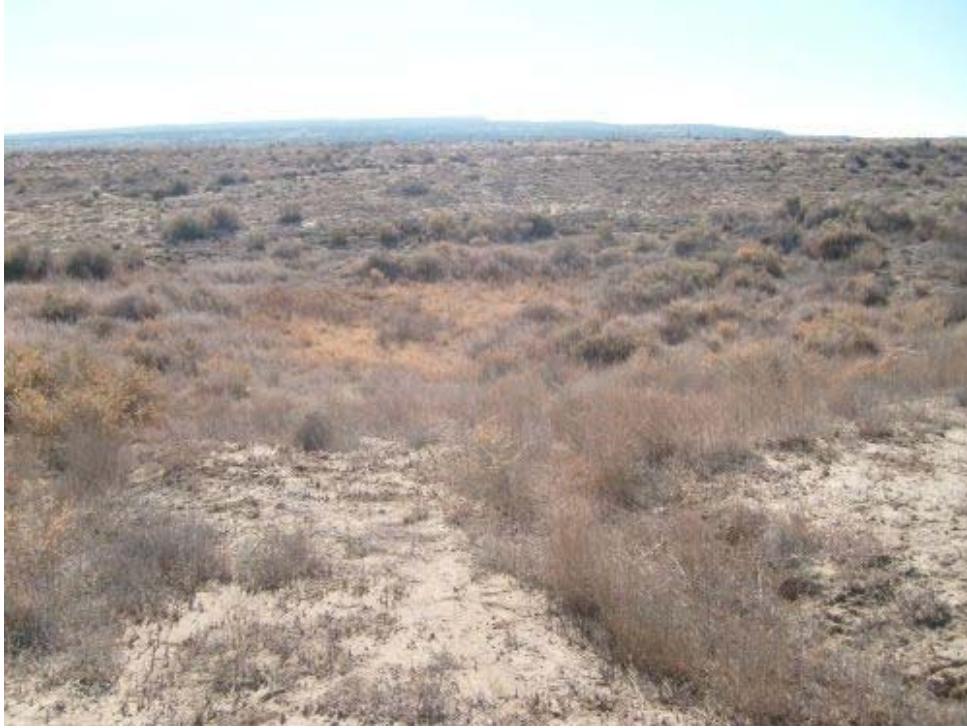
Photo 5. Large depression south of road

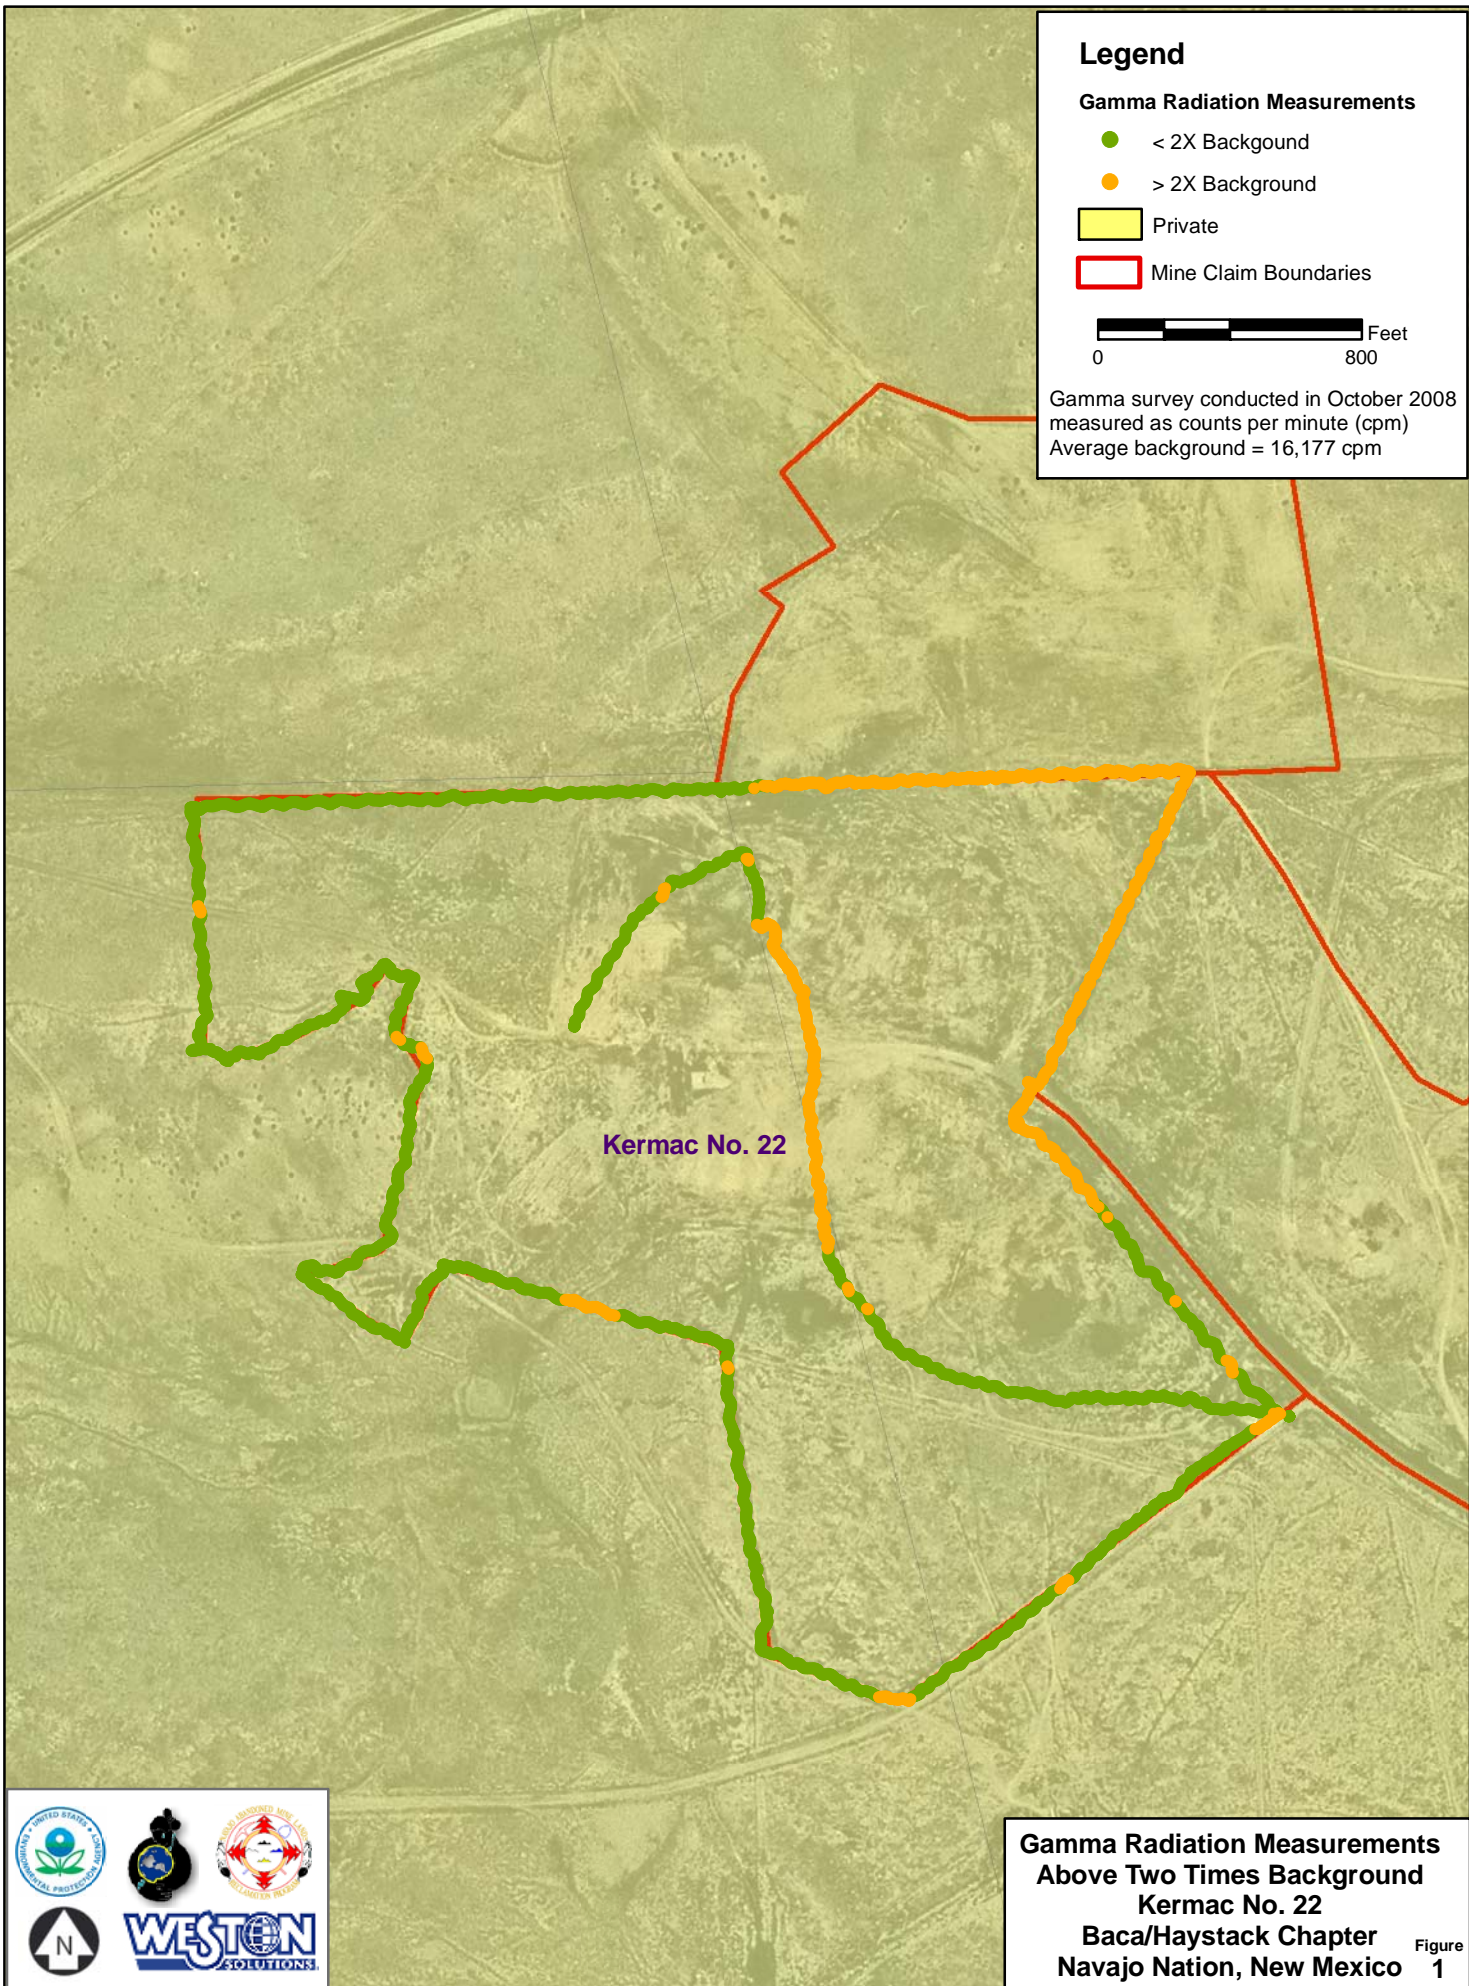
**Gamma Radiation Measurements
 Above Two Times Background
 Kermac No. 22
 Baca/Haystack Chapter
 Navajo Nation, New Mexico** Figure 1

Gamma survey conducted in October 2008
 measured as counts per minute (cpm)
 Average background = 16,177 cpm
