# Abandoned Uranium Mine Field Survey Project

prepared for  
New Mexico Energy, Minerals and Natural Resources Department  
Mining and Minerals Division

July 18, 2008

## Zia Mine

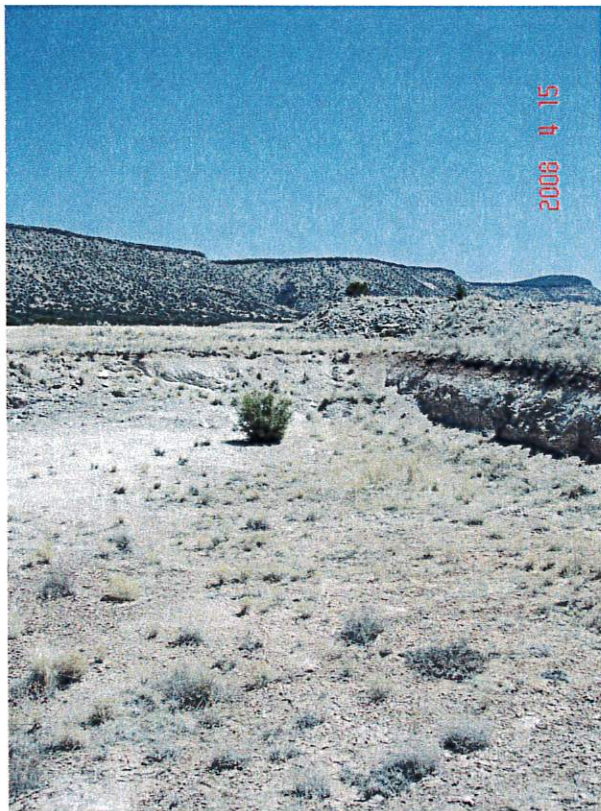
View east

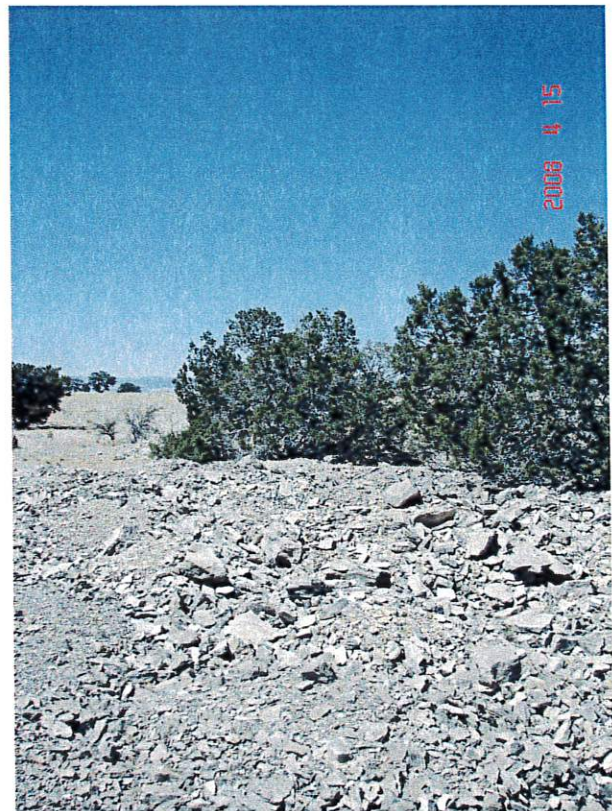
View west

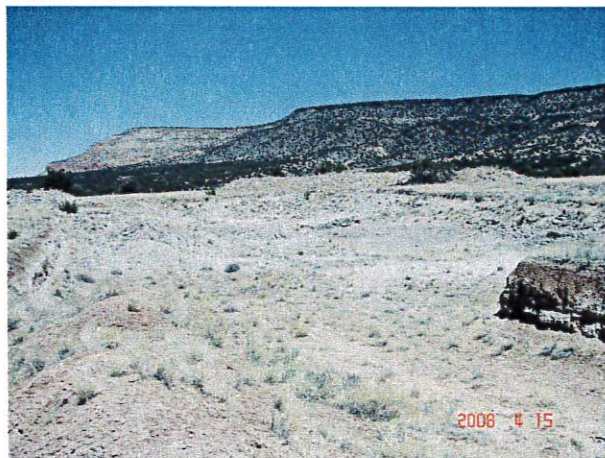
View north into shallow pit

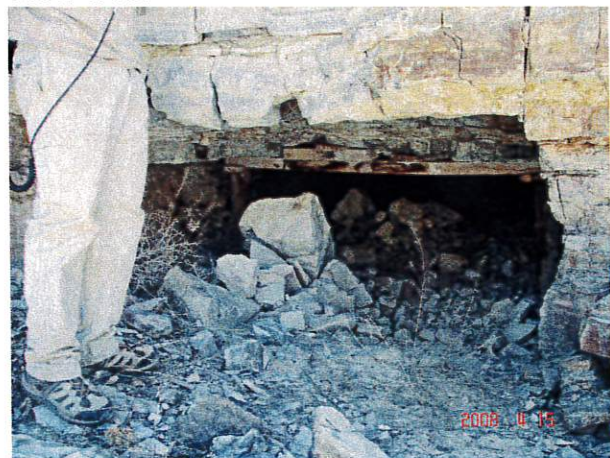
Adit

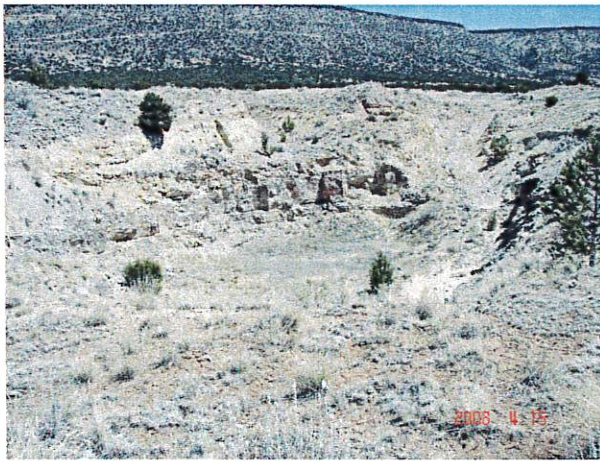
Main pit, view north

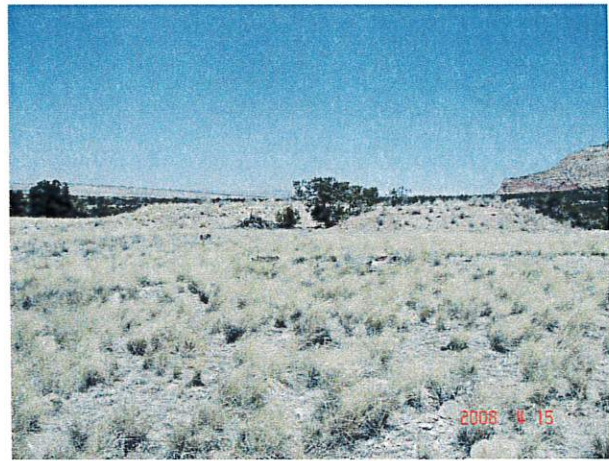
View northwest
