**RE: Sixth Monthly NAPL Recovery Report,  
Fairview Station Site, Española, New Mexico  
Facility #28779                      RID #4657                      WPID #4096-7**

Souder, Miller & Associates (SMA) is pleased to submit the sixth monthly NAPL recovery report. This report is submitted in accordance with the workplan dated August 16, 2019 and approved by NMED PSTB on September 30, 2019.

**NON-AQUEOUS PHASE LIQUID MAP - APRIL 10, 2020**  
**FAIRVIEW STATION**  
**ESPAÑOLA, NEW MEXICO**

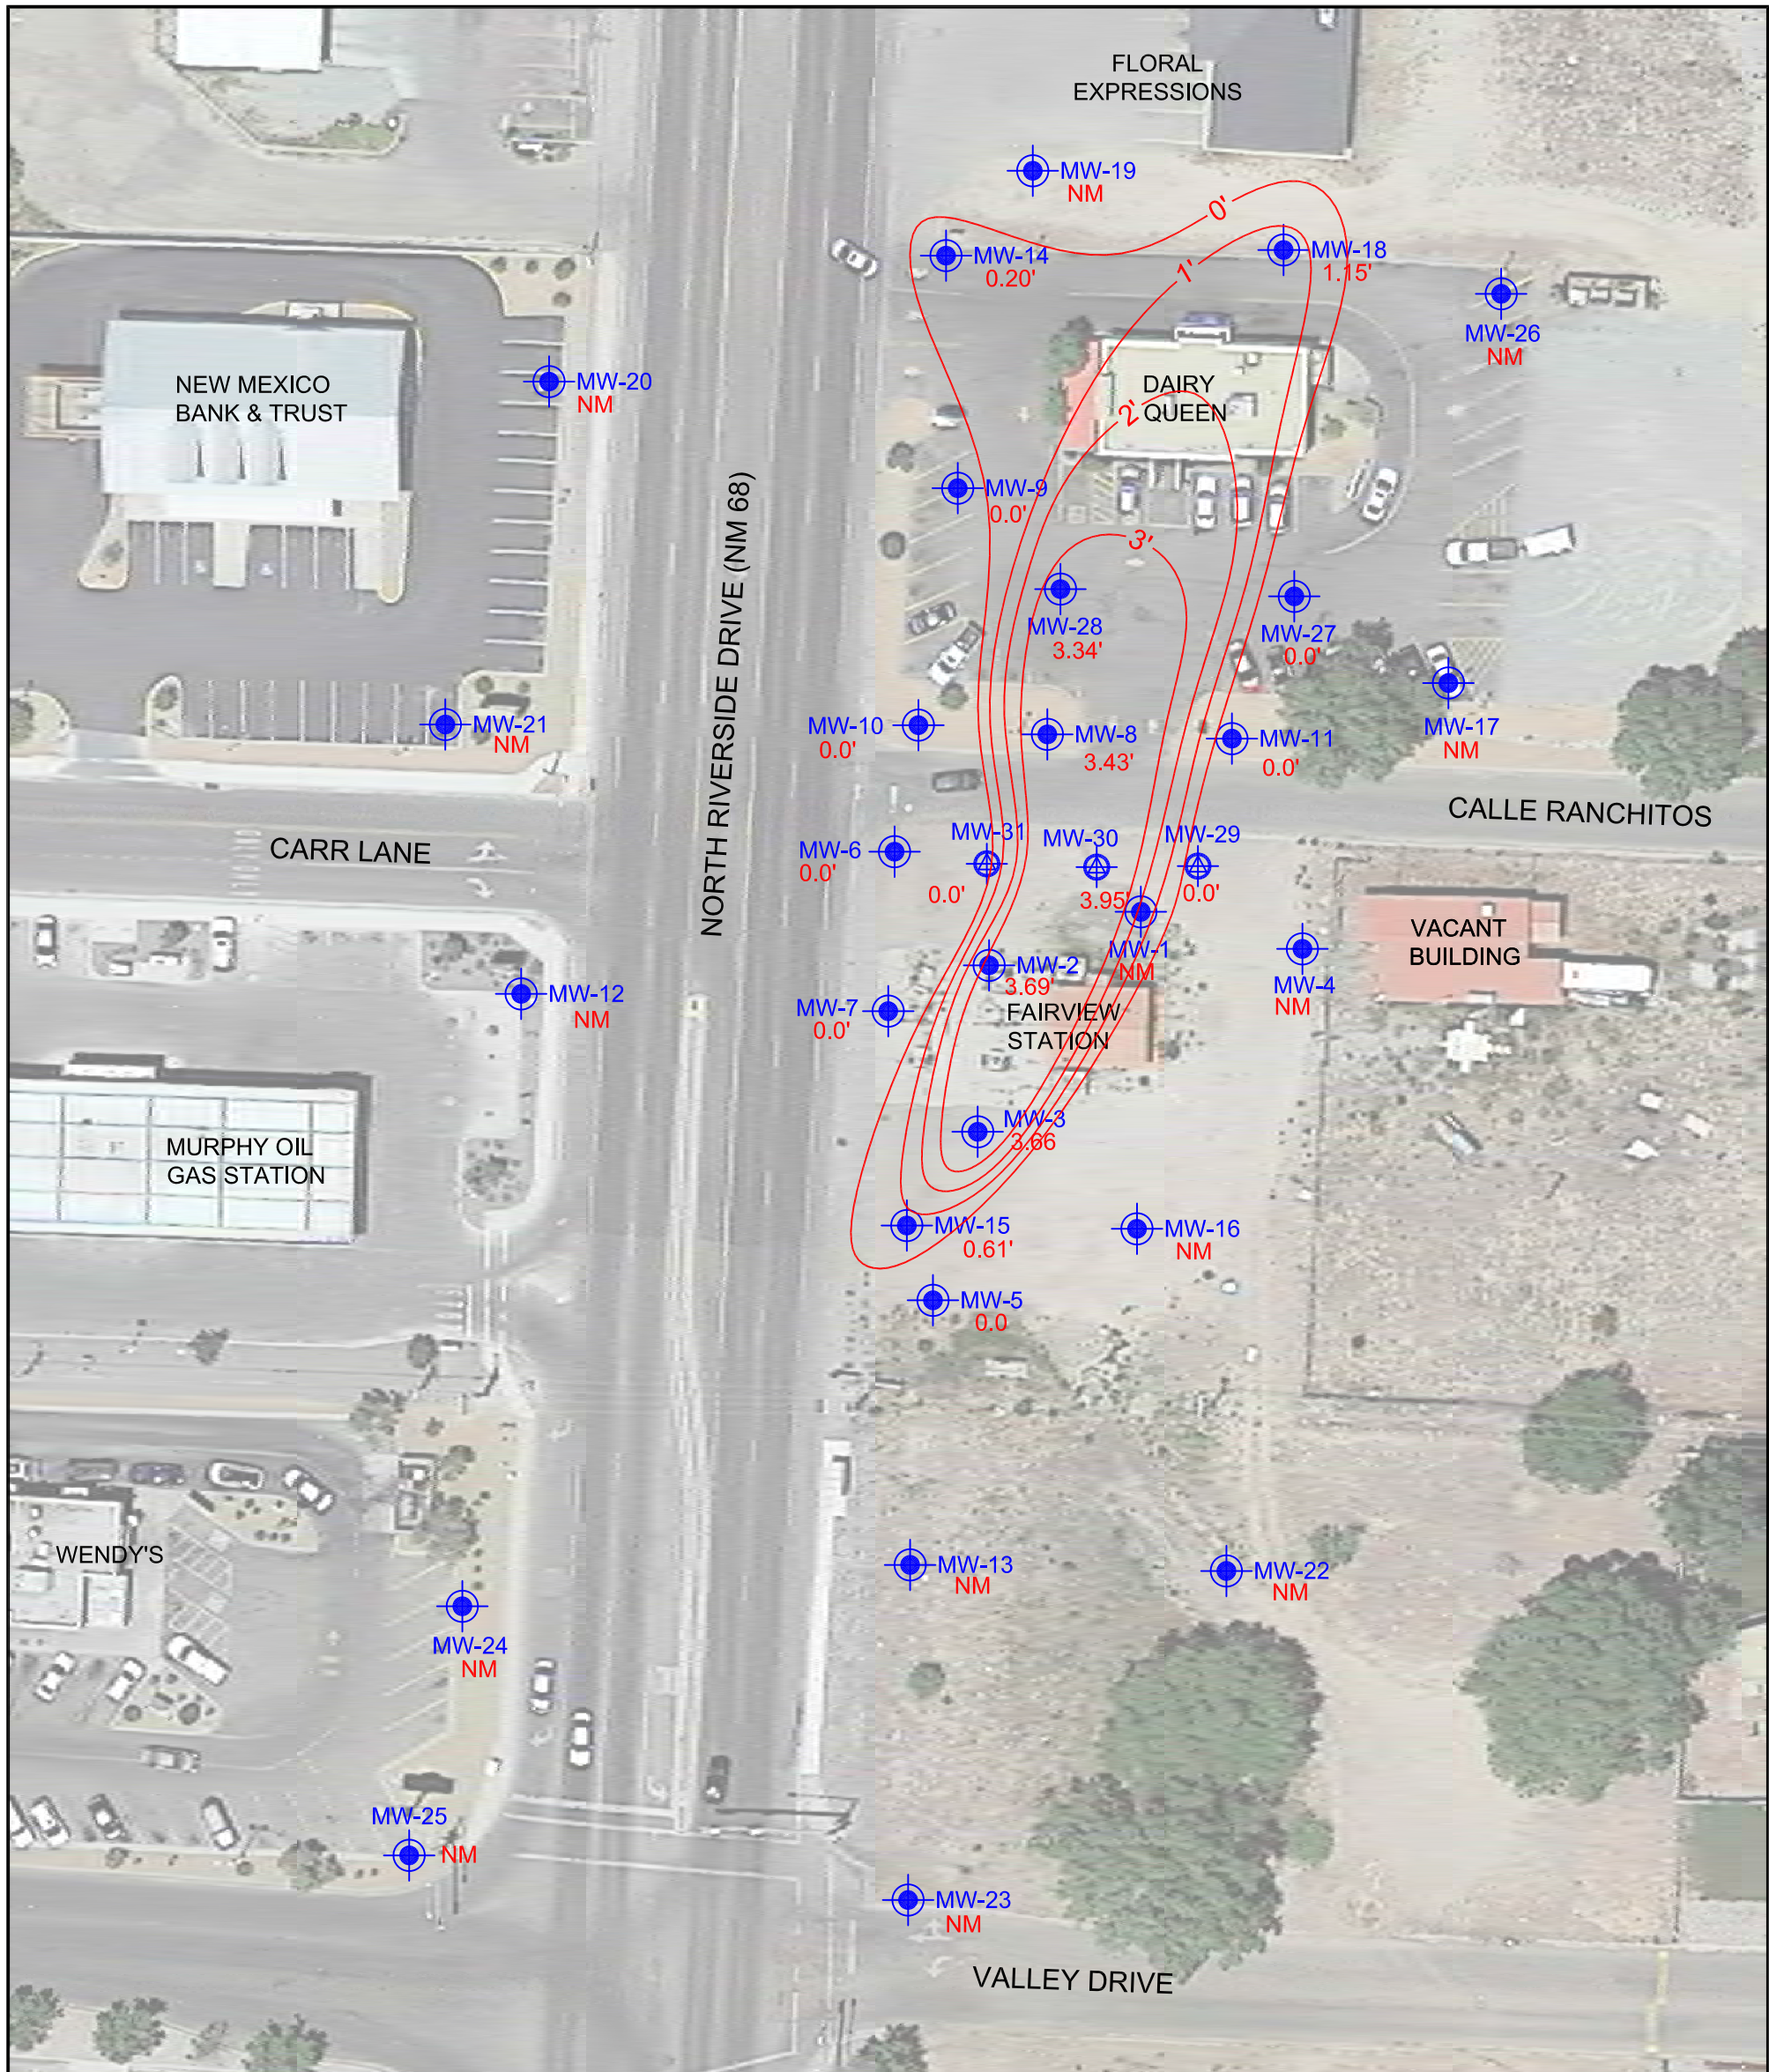
Designed AJE	Drawn AJE	Checked SAM
Date: MAY 2020		
Scale: Horiz: 1" = 50'		
Vert: N/A		
Project No:		
Sheet: <b>Figure 1</b>

On April 10, 2020, SMA performed the sixth monthly NAPL recovery. Seventeen monitoring wells were gauged for depth to NAPL and depth to water. Of these seventeen wells, eight monitoring wells contained NAPL with apparent thicknesses ranging from 0.20 to 3.95 feet.

Overall, apparent NAPL thicknesses had variable trends compared to the previous NAPL recovery event. Five monitoring wells (MW-3, MW-8, MW-14, MW-18, and MW-28) exhibited increases in initial NAPL thickness. Three monitoring wells containing NAPL (MW-2, MW-15, and MW-30) contained less NAPL compared to the previous month. Three wells (MW-11, MW-29, and MW-31) that contained NAPL in March did not contain NAPL in April. Drastic fluctuations in NAPL thicknesses has occurred in multiple wells on several occasions at the site. These fluctuations do not appear to be solely related to groundwater elevation changes as they occur both during periods of rising and falling groundwater elevation.

Figure 1 depicts the apparent NAPL thicknesses and NAPL contours during the April 2020 event. Table 1 presents the initial depth to NAPL and water measurements. Table 2 depicts the NAPL thicknesses before and after recovery with the NAPL amounts recovered.
