February 9, 2026

Re: Letter Report for Oxidizer Annual Maintenance and Conversion to Catalytic Mode
Former Y Station, 721 Commerce Way, Clovis, New Mexico
Facility #53742, Release ID #4746, WPID #4418

PROJECT/SERVICE INSPECTION REPORT

CLIENT: DBS&A
PROJECT: CLOVIS NEW MEXICO

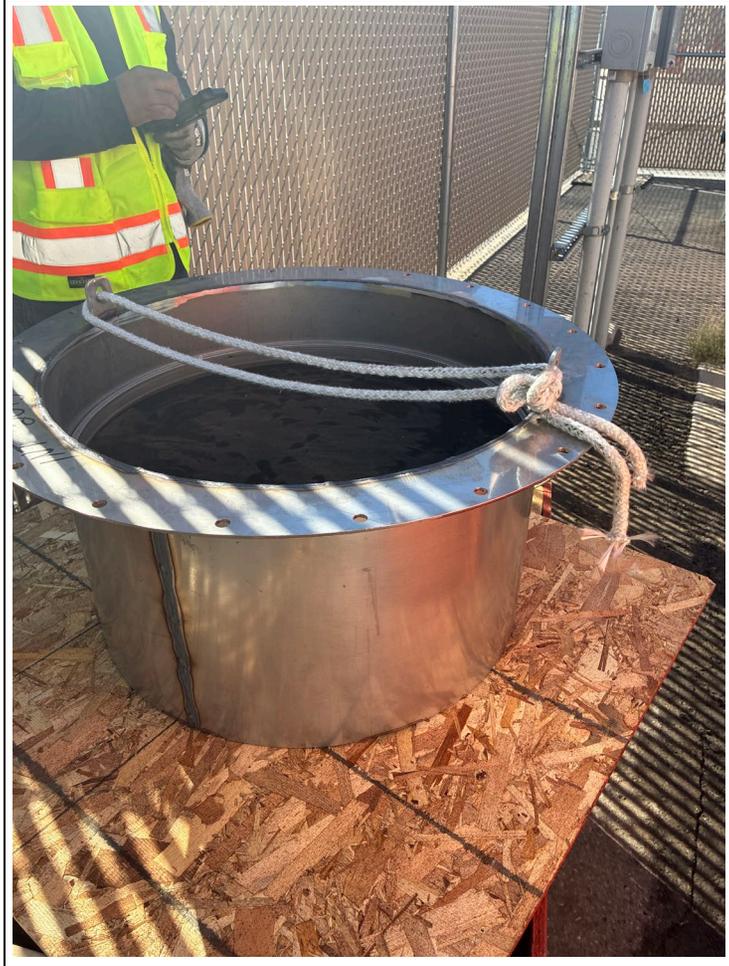
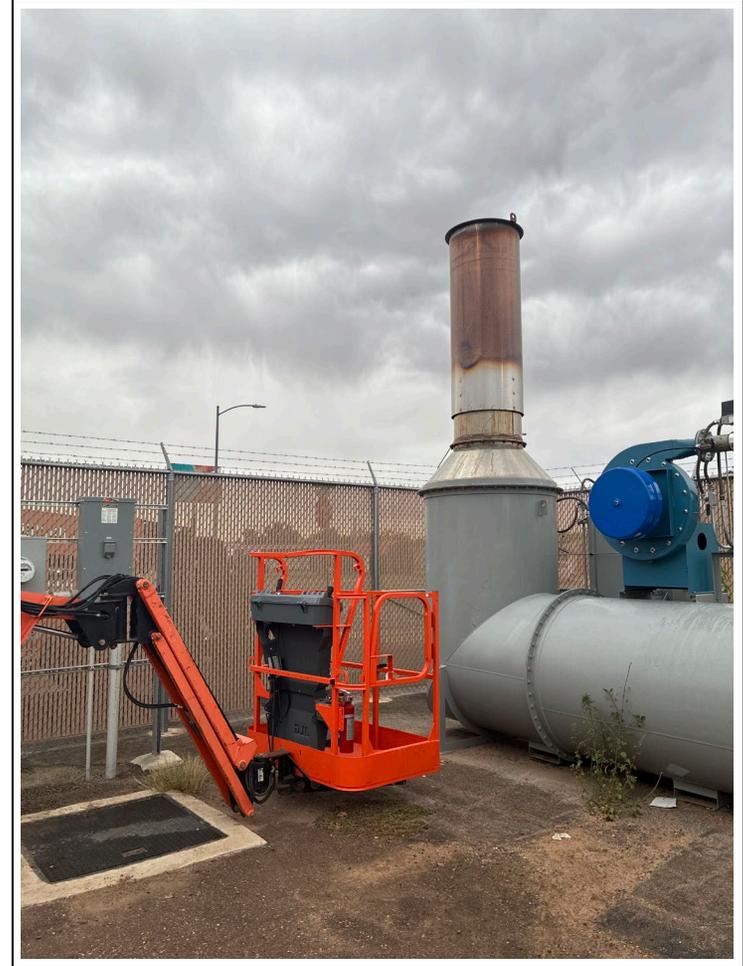
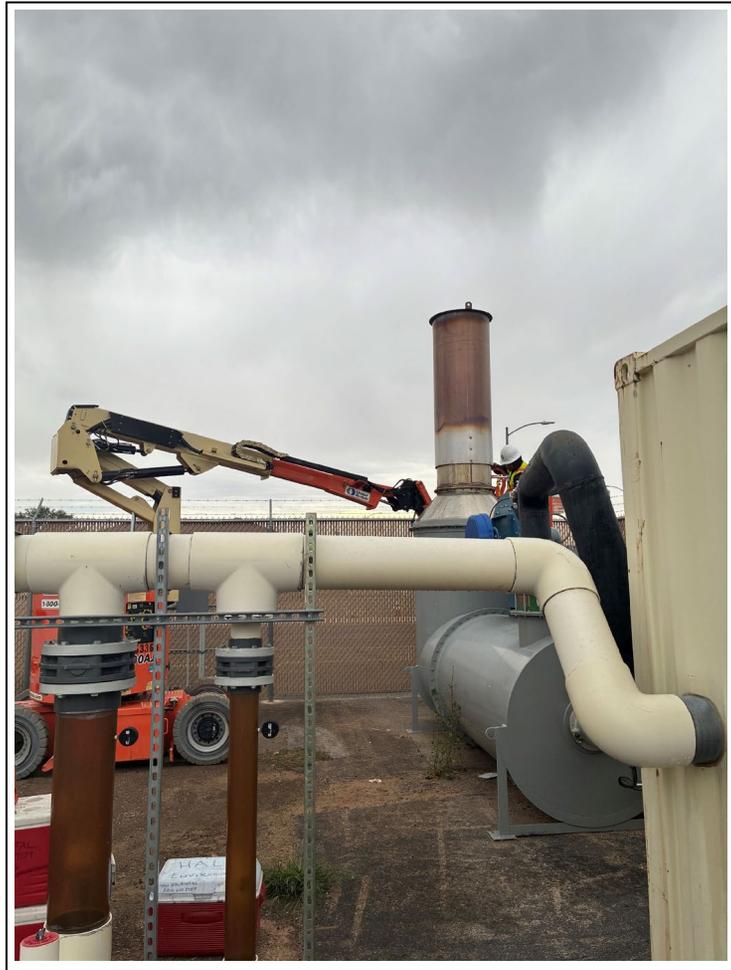
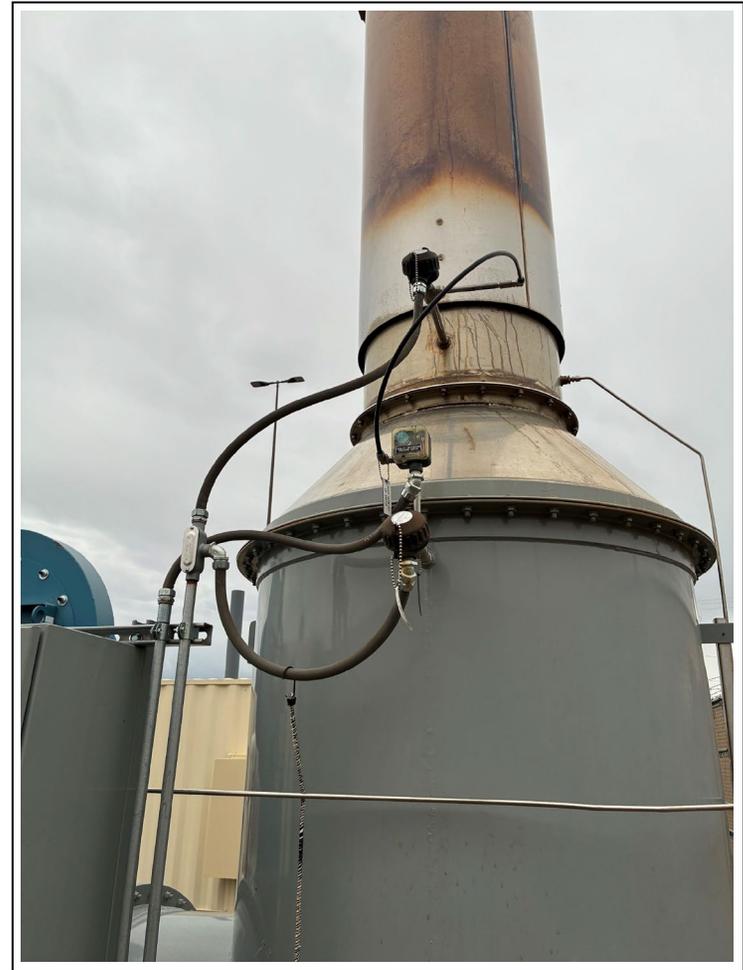
DBS&A coordinated with the New Mexico Environment Department (NMED) Petroleum Storage Tank Bureau (PSTB) and EnviroWorks, LLC (EnviroWorks) of Edgewood, New Mexico to retrieve the catalyst module from the PSTB storage unit in Santa Fe, New Mexico. EnviroWorks delivered the catalyst on October 21, 2025. On October 22, 2025, EnviroWorks removed the stack using an articulating boom manlift and reach fork and installed the catalyst. The stack and thermocouple were then reinstalled. Adjustments were made to the system programming and control settings under the supervision of Intellishare Environmental (Intellishare) of Menomonie, Wisconsin on November 4, 2025. Photographs of the catalyst installation are provided in Attachment 1.
