**NEW MEXICO  
ENVIRONMENT DEPARTMENT**

RE: Tanker Spill into the Cimarron River and Associated Clean-Up near Cimarron, New Mexico

### **Inspection Findings**

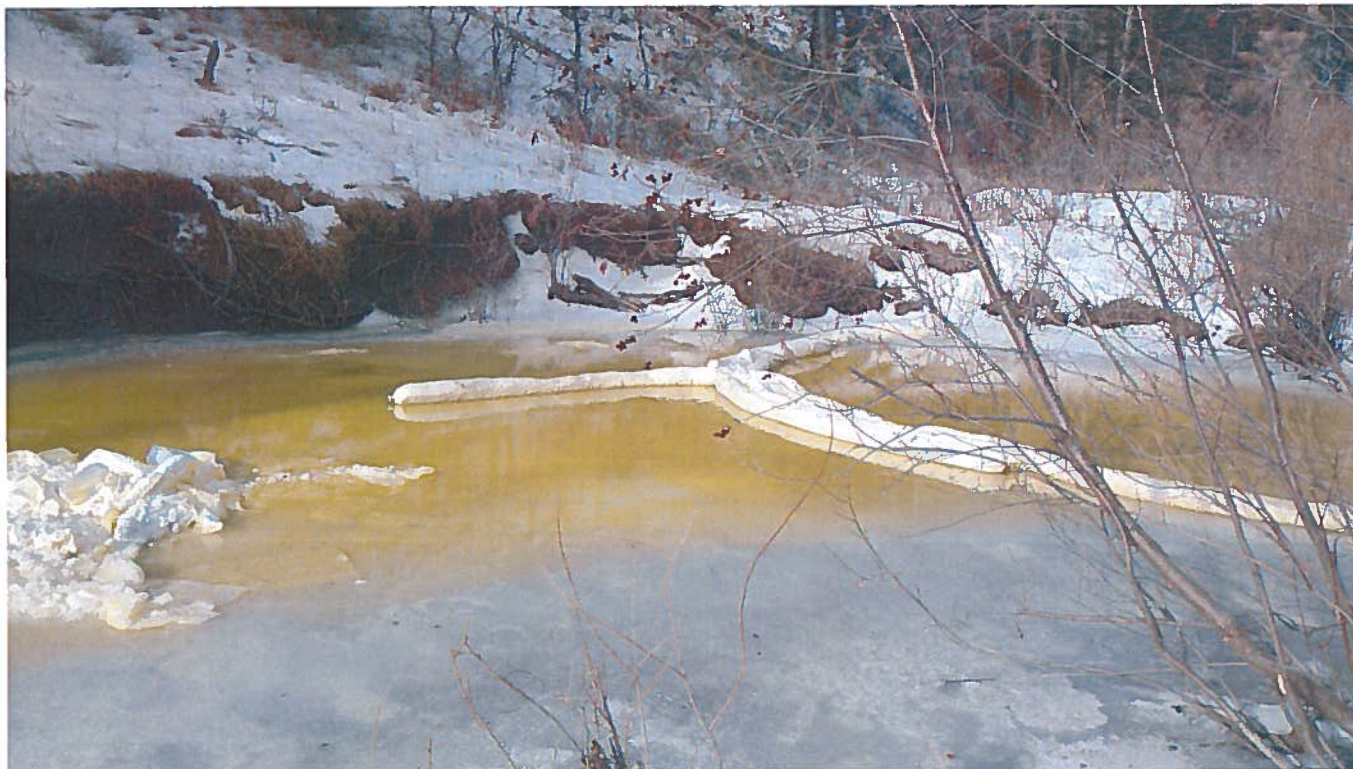
*NMED/SWQB*  
**Official Photograph Log**  
Photo # 1

Photographer: Chuck Dentino	Date: 12-29-16	Time: Unknown
City/County: Cimarron/Colfax County		
Location: In Cimarron River below culverts and above 500' downstream of spill sampling location.		
Subject: Fuel spilled onto existing ice the day after the initial accident.

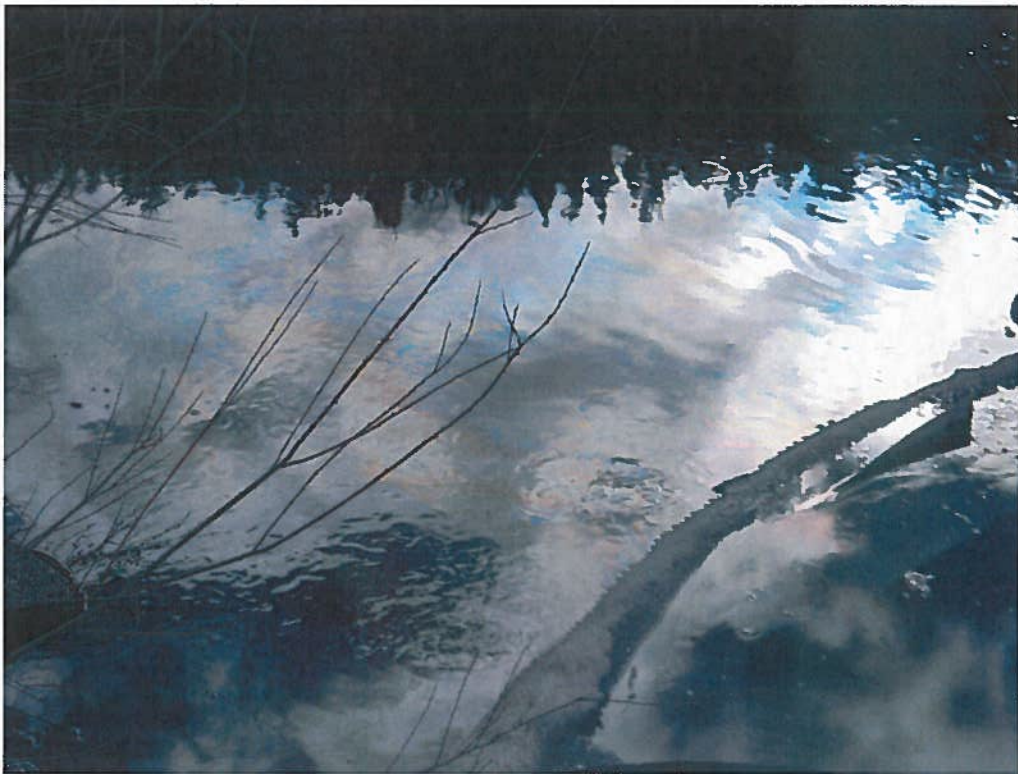
**NMED/SWQB**  
**Official Photograph Log**  
Photo # 2

SWQB staff visited the crash site again with the contractor on January 17, 2017. The contractor had replaced the absorbent booms in the river, but SWQB staff still observed a strong sheen and strong petroleum odors. There was a very heavy odor of petroleum approximately 100 to 500 feet downstream of the crash site (downstream of the Highway 64 bridge), the water below the ice had a thick petroleum slippery feel and even more odor, and a petroleum sheen could be seen in several places. Due to these observations, NMED indicated to the contractor that additional measures needed to be taken immediately by Fronk Oil to continue addressing the spill including placing double booms to provide more opportunity to catch any remaining fuel, placing socks in between booms for added protection, and collecting additional soil and water samples at locations that are consistent with the “problem” area near the beaver dam/pond. Removal of contaminated ice was also discussed.

Photographer: Barbara Cooney	Date: 1-17-17	Time: Unknown
City/County: Cimarron/Colfax County		
Location: Downstream of 500' below spill location.		
Subject: Petroleum sheen on the river surface.

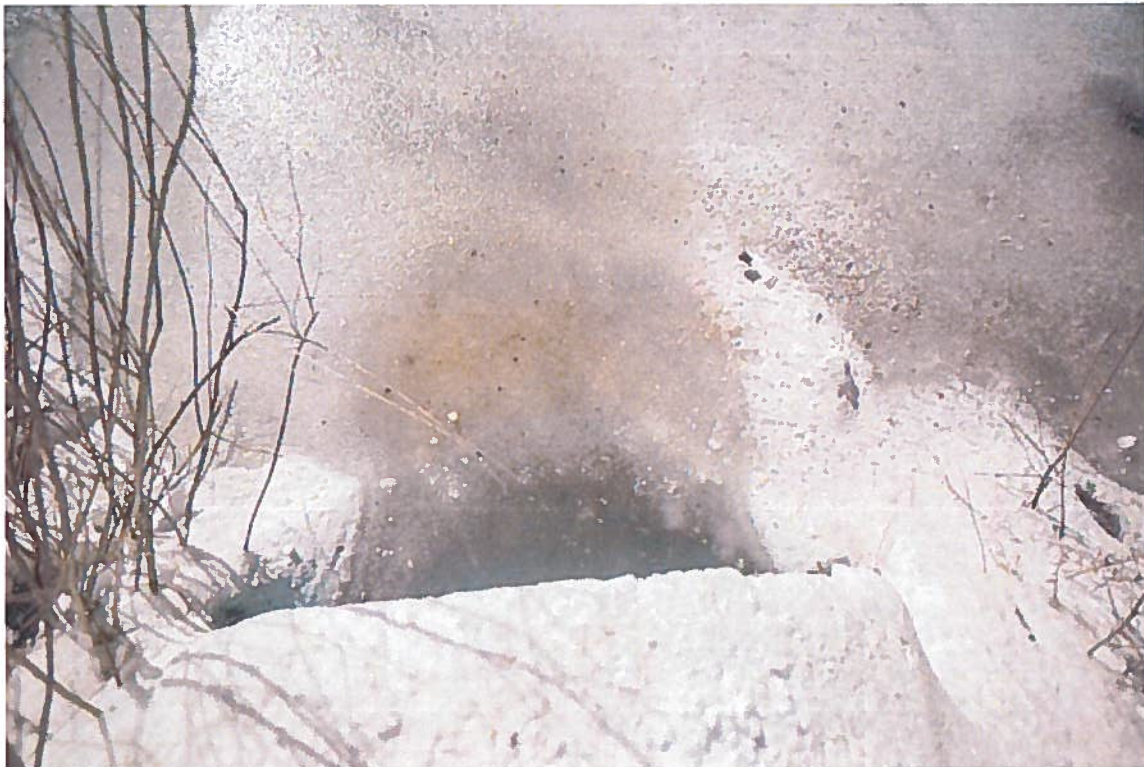
***NMED/SWQB***  
**Official Photograph Log**  
Photo # 3

Photographer: Sarah Holcomb	Date: 1-25-17	Time: Unknown
City/County: Cimarron/Colfax County		
Location: Below the culverts along Hwy 64 in Cimarron Canyon.		
Subject: Fuel is entrained in the ice present below the culverts running underneath the highway.

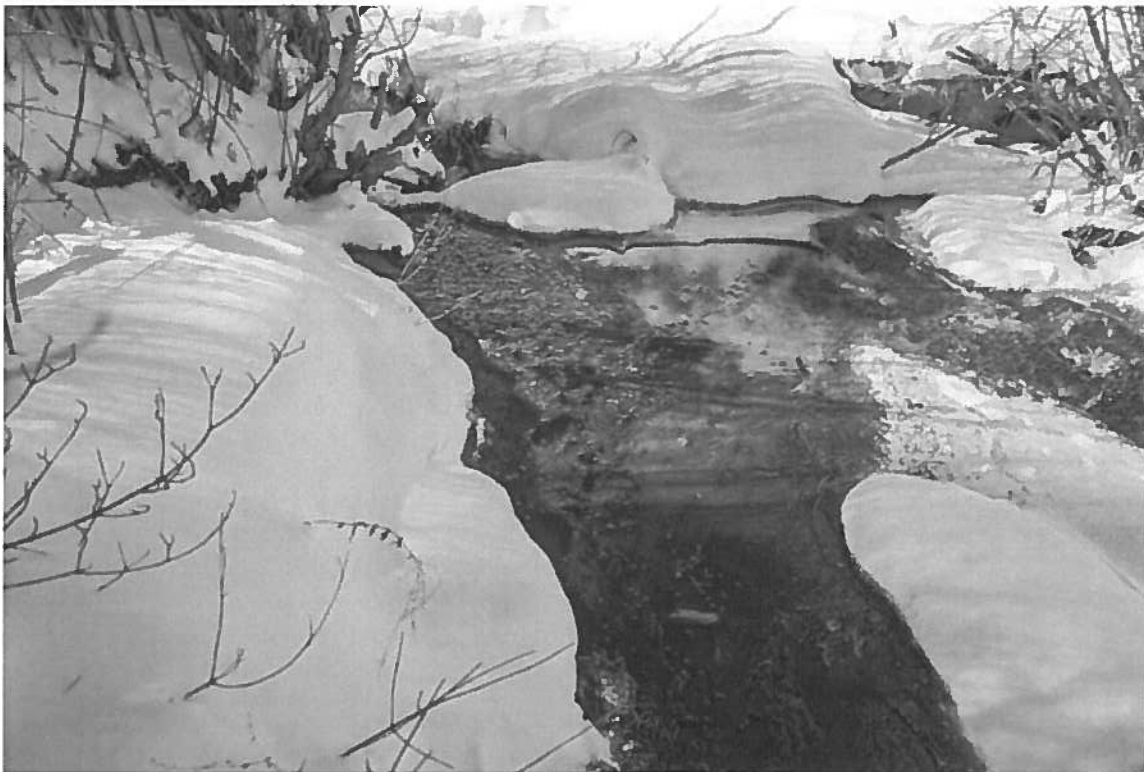
*NMED/SWQB*  
**Official Photograph Log**  
Photo # 4

The contractor and SWQB staff returned to the site on Wednesday, January 25, 2017 to check on booms, take pictures, and evaluate the situation. There was a fresh 6 inches or more of snow on the ground making observations difficult. The booms appeared to be capturing any remaining fuel and bacterial activity (breaking down fuel) was evident in visible portions of the river.

Photographer: Sarah Holcomb	Date: 1-25-17	Time: Unknown
City/County: Cimarron/Colfax County		
Location: In the Cimarron River at the crash site.		
Subject: Evidence of bacterial activity breaking down the available hydrocarbons in the water column.

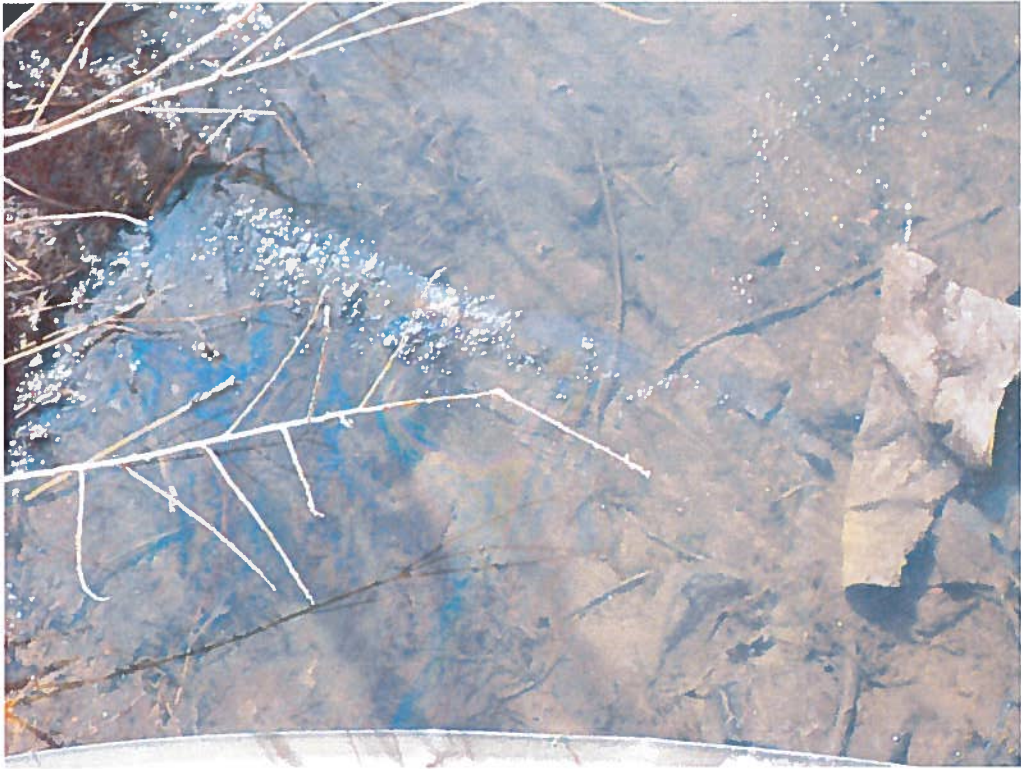
*NMED/SWQB*  
**Official Photograph Log**  
Photo # 5

Photographer: Daniel Valenta	Date: 2-9-17	Time: Unknown
City/County: Cimarron/Colfax County		
Location: In the Cimarron River below the highway culverts.		
Subject: A sheen on the water is still evident as fuel entrained in the ice is being released during melting events.

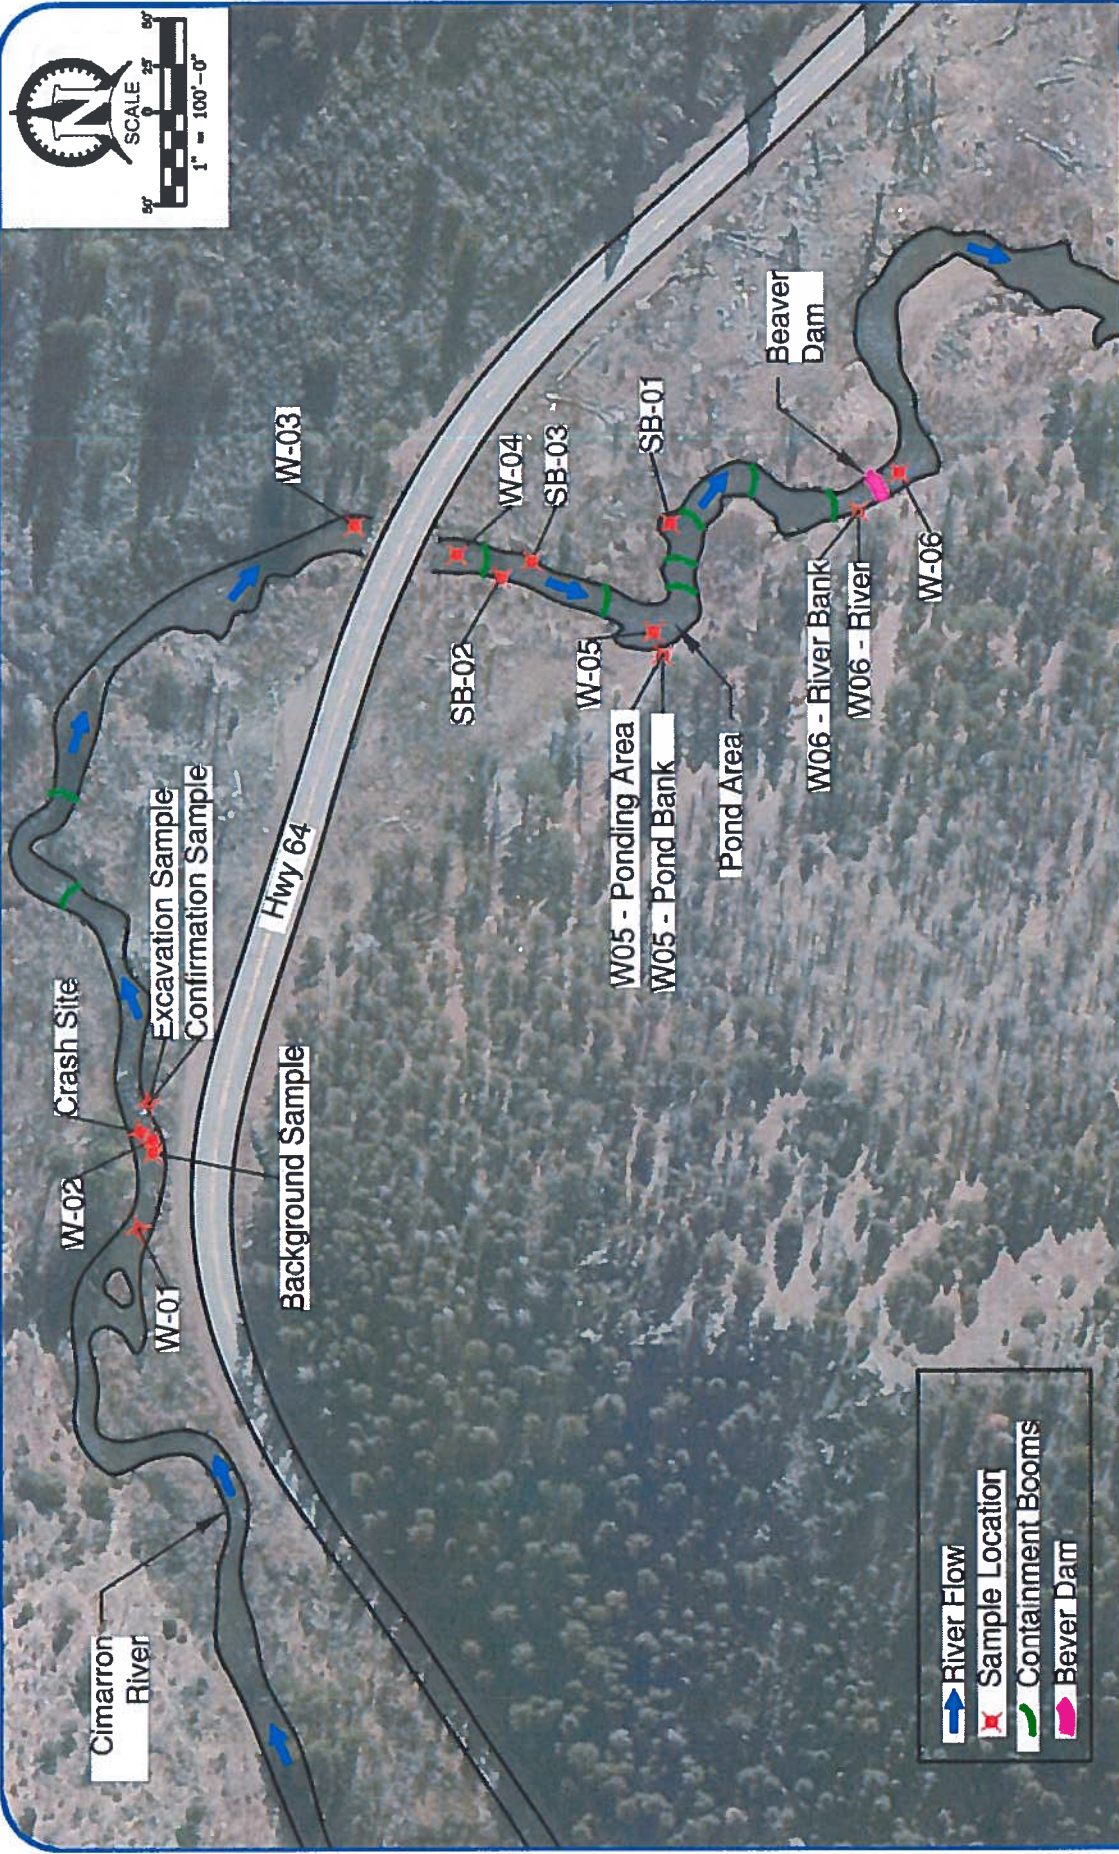
**Site and Samples Location**  
 Scale is approximate

Analytical results from soil samples taken on January 20 indicated high levels of hydrocarbons (DRO) present at sites SB2 (6000 mg/kg) and SB3 (25,000 mg/kg) demonstrating the need to further excavate and remove contaminated soil (and ice) at the crash site and along the Cimarron River. D&H did not collect water quality samples on January 20 as we had requested.

- Collect the following samples on a biweekly basis for analysis of DRO, GRO, and BTEX:
  - (1) **Soil samples** – “SB2” and “SB3”; right and left stream bank along pond area (500 feet downstream of crash site and downstream of bridge).
