# Abandoned Uranium Mine Site Assessment for the Napane Site (NM0137)

**FINAL REPORT**

**February 23, 2010**

NM0137

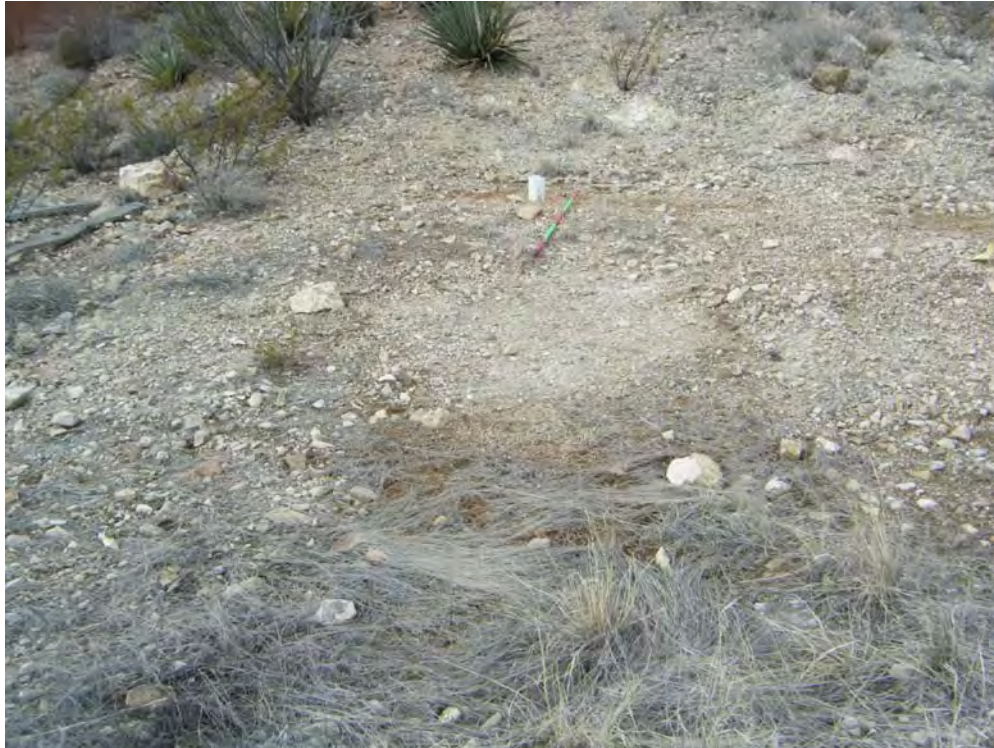
Photo 8 – View of DistPly-2. Note possible vent pipe (LU-1) in the upper center of the picture.

DistPly 2 - pad area, looks like reclamation work  
started, or pad to drill hole for vent shaft,  
PVC pipe 21' wide, 23' long

Photo 8 - DistPly 2 - drill pad  
Note: vent hole (PVC pipe) ~ 3' deep

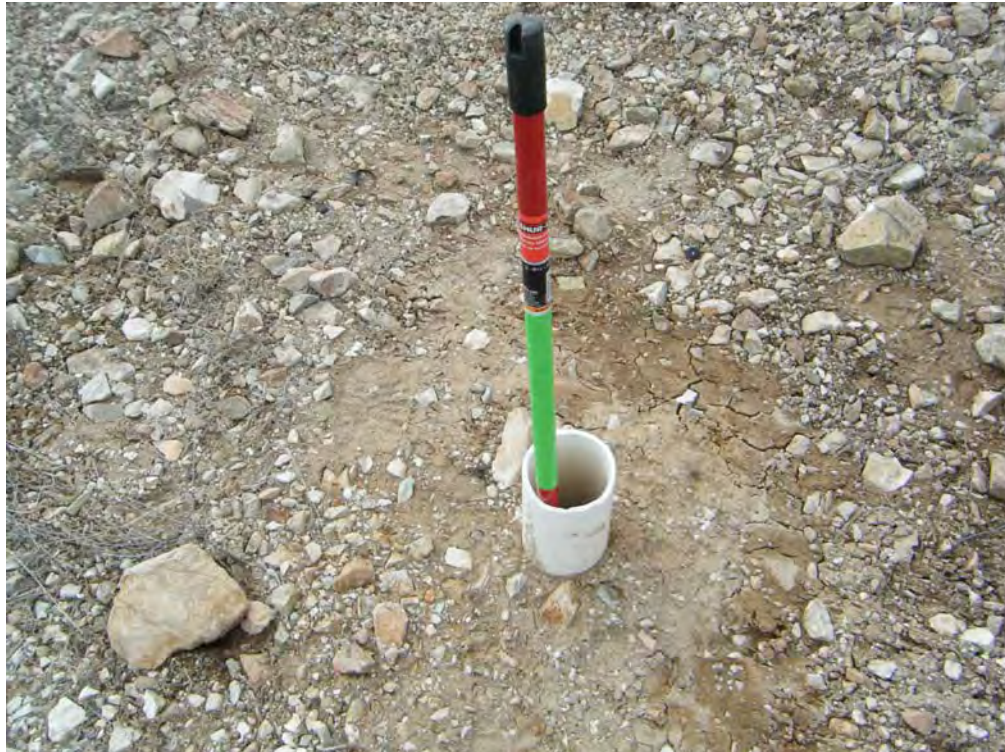
A PVC pipe sticking up in the middle of a disturbed area may have been a vent hole, but the borehole is only 3 ft deep (LU-1).

Photo 9 – Closeup of vent pipe in Photo 8 (LU-1).

Photo 9 - Vent hole  
3' deep

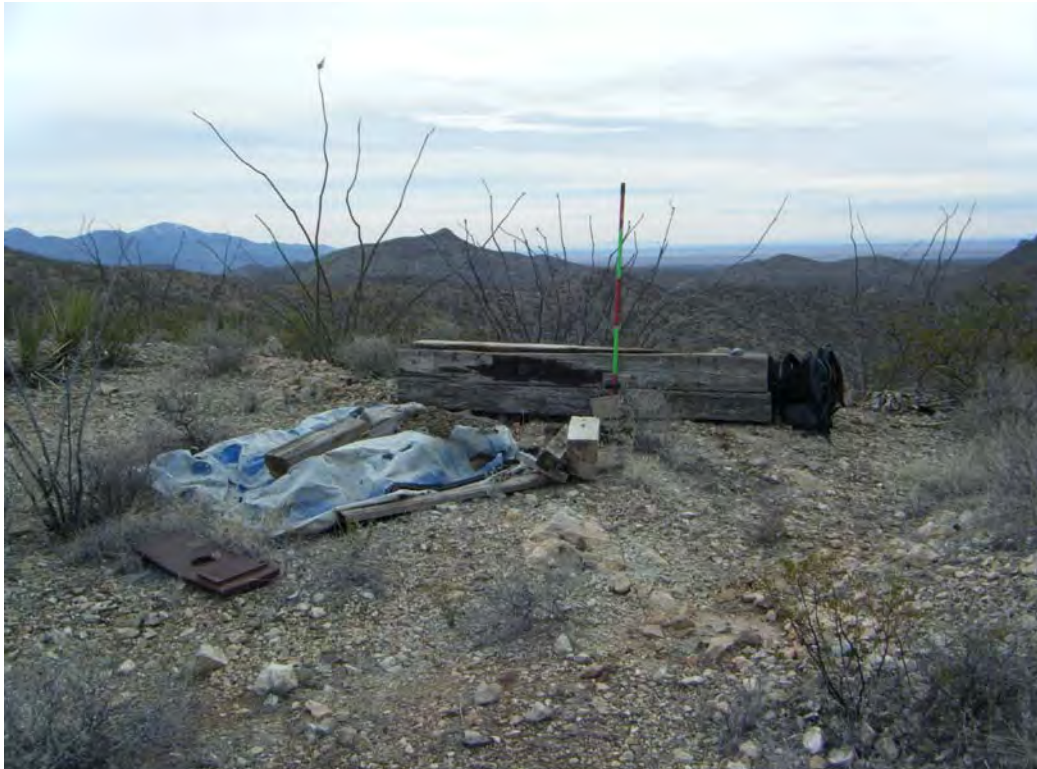
Photo 10 – Trash and railroad ties (Equip-1).

Photo 10 - Looking south at miscellaneous trash/  
railroad ties

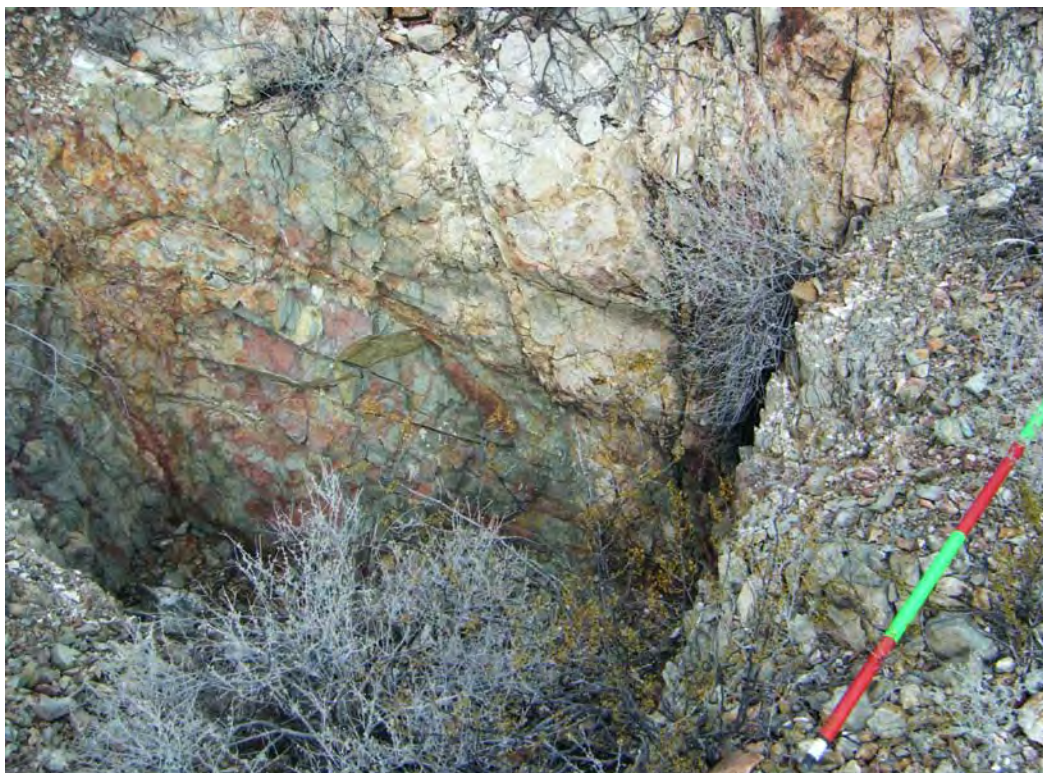
Photo 16 – Shaft-1, looking northwest.

Shaft 1 - 6' wide, 8' long, 6' deep

Photo 16 - Shaft 1, looking north into shaft

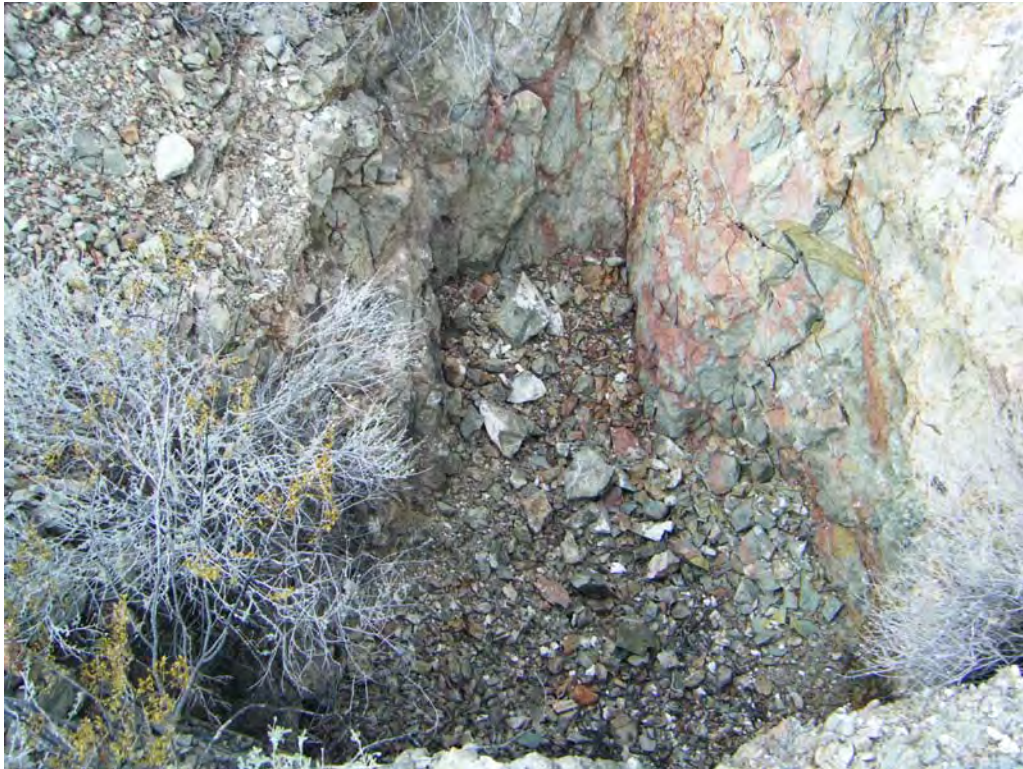
Photo 17 – Shaft-1, looking west.

Photo 17 - Shaft 1, looking west into shaft

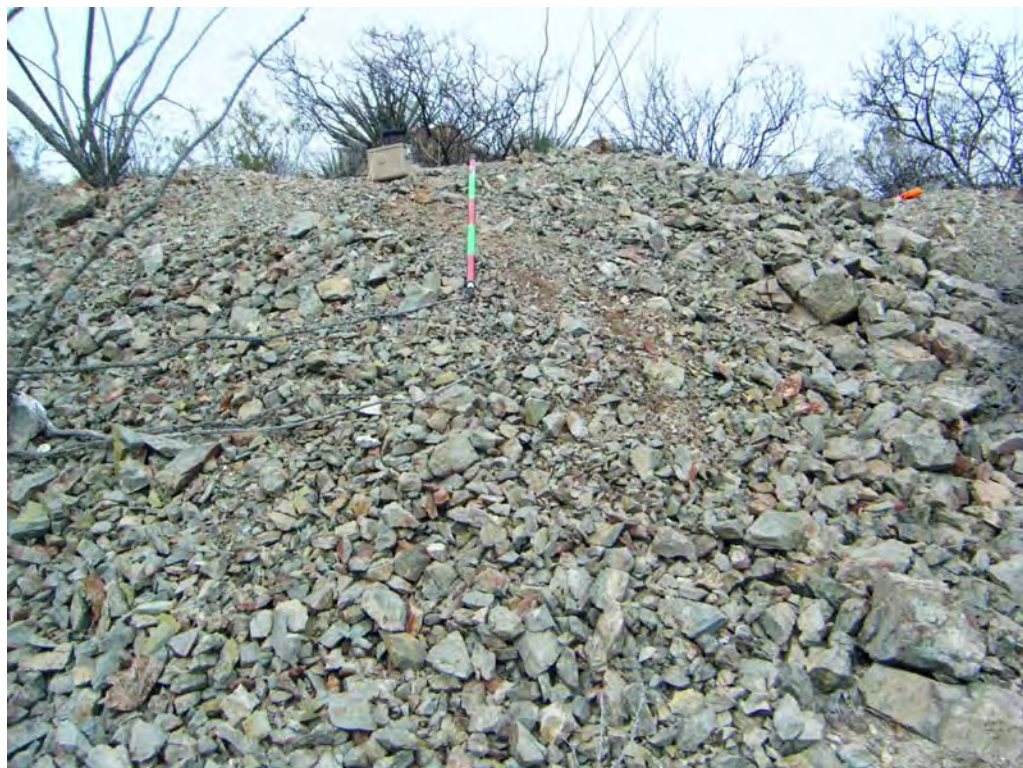
Photo 18 – PilePly1.

Pile <sup>Poly ALT</sup> 1 - 16' long x 10' wide, waste from Shaft 1

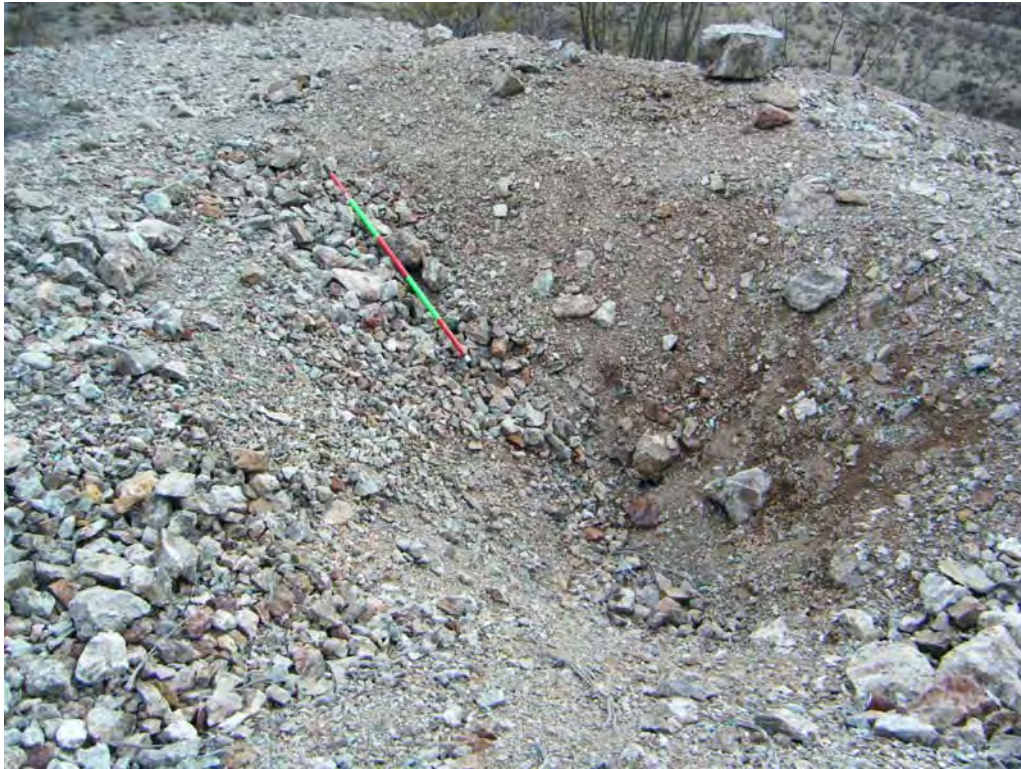
No open cuts or mining pits were identified at the AUM Site. However, a possible subsidence pit (Subsidply-1) was discovered immediately to the southeast of Shaft-2.

Photo 19 – A possible subsidence pit (Subsidply-1).

SubsidPly 1 - southeast of Shaft 2; 16' x 10' ~ 6ft deep

Photo 19 - SubsidPly 1, looking southwest

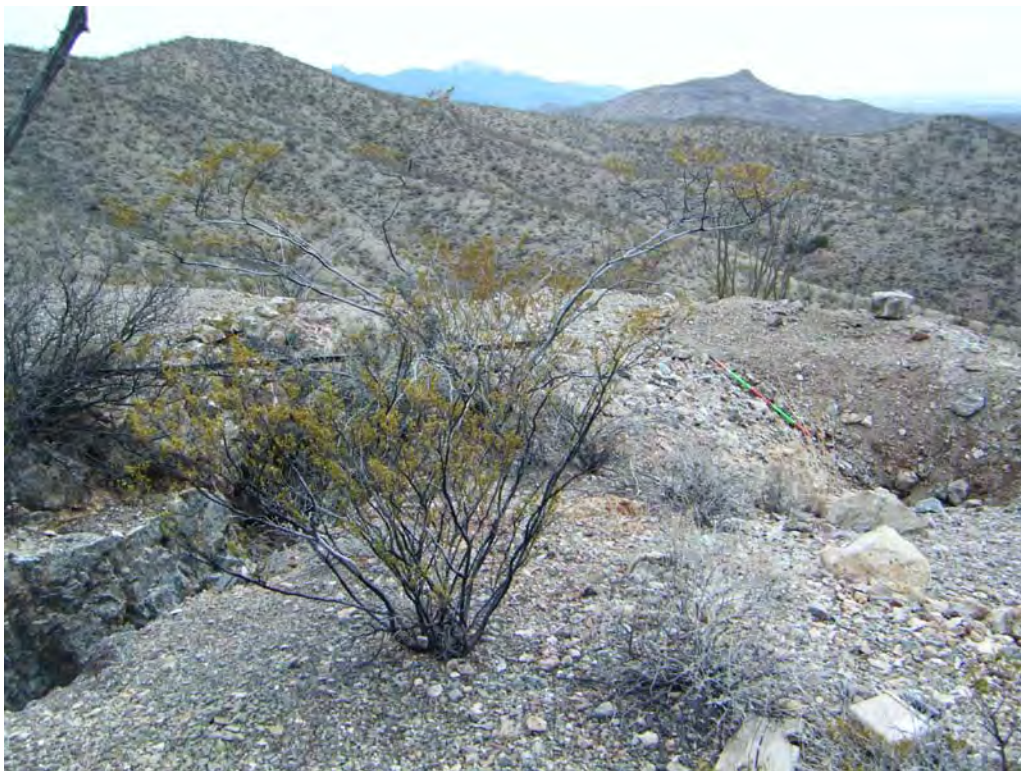
Photo 20 – Looking east-southeast at ShaftPly-2 (lower left) and Subsidply-1 (middle right).

Photo 20 - Looking east, southeast at shaft Ply 2 and  
subsidPly 1

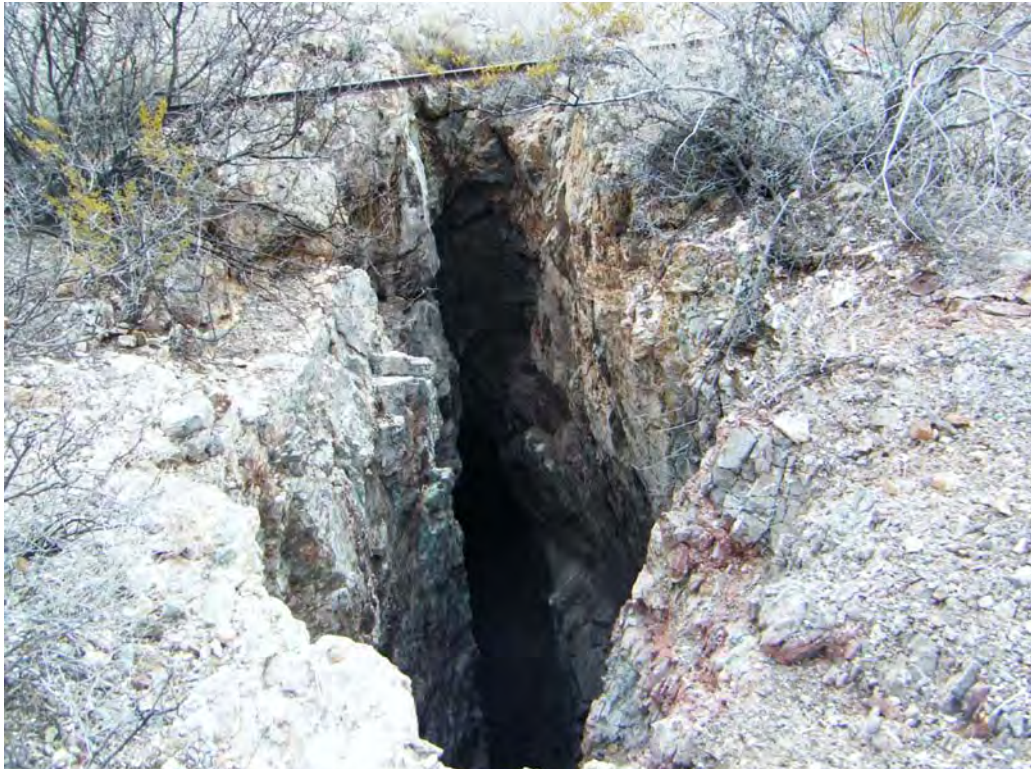
Photo 21 – Shaftply-2, looking west. The shaft is an estimated 40 ft deep.

Shaft Ply 2 - 40' deep, 40' long, 10' wide

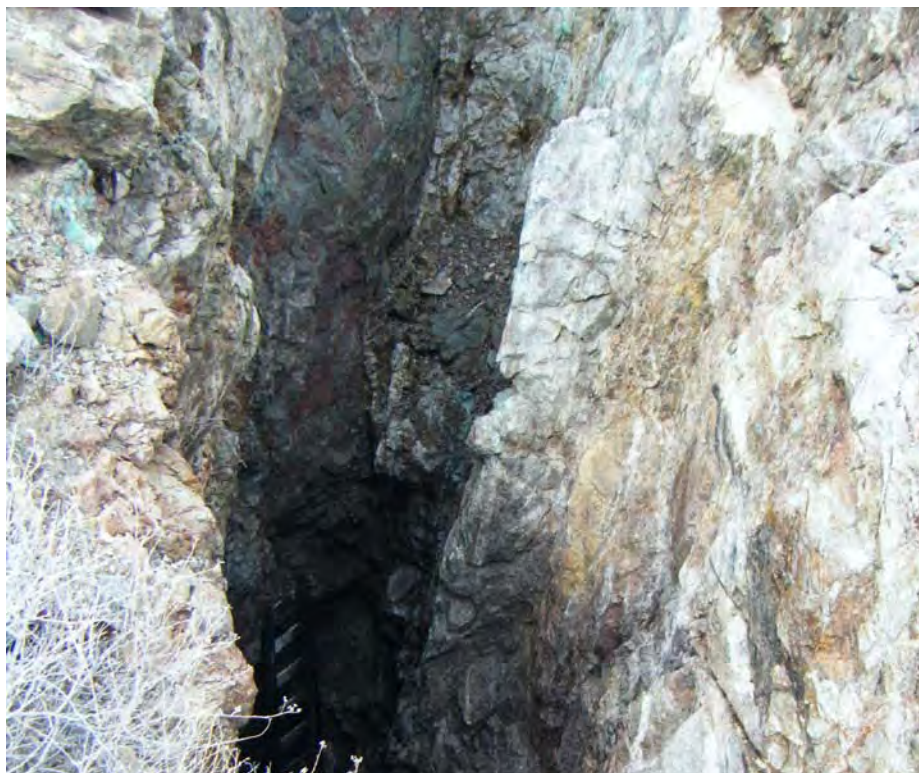
Photo 23 – Shaftply-2. Note ladder in the shaft.

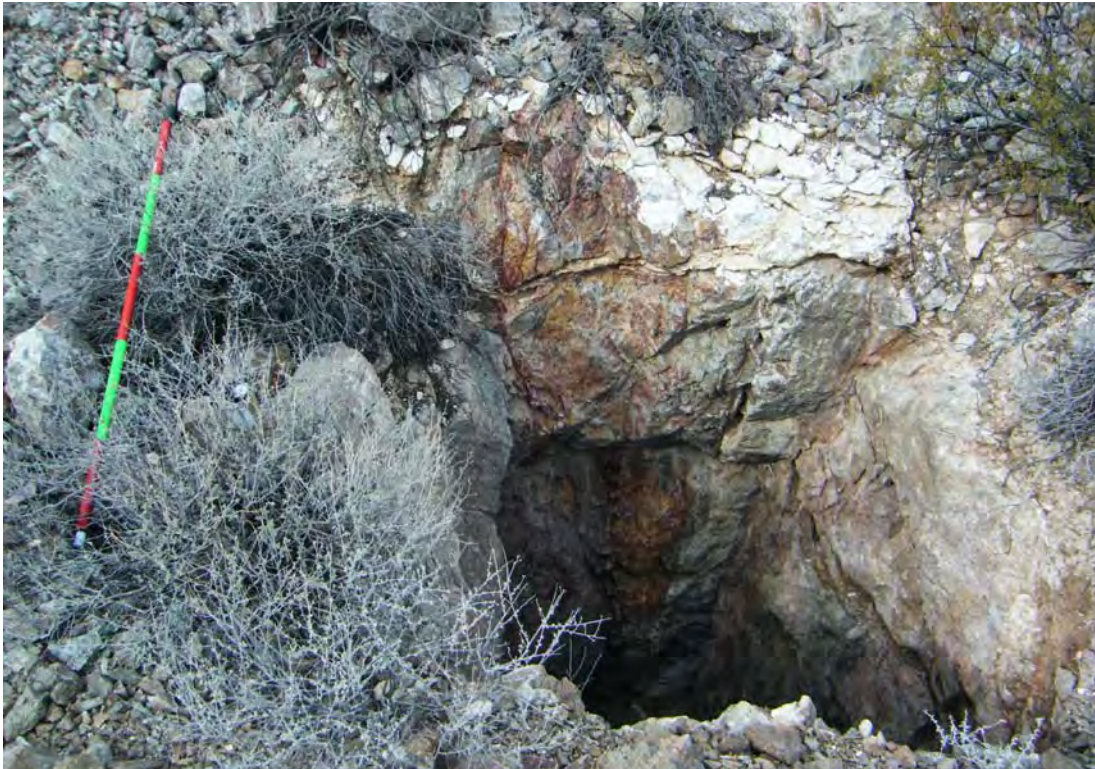
Photo 24 – Shaft-3. The shaft is about 15 ft deep.

<sup>ALT</sup>  
Shaft ~~Ply 2~~ 3 - 15' deep, 5' x 5'

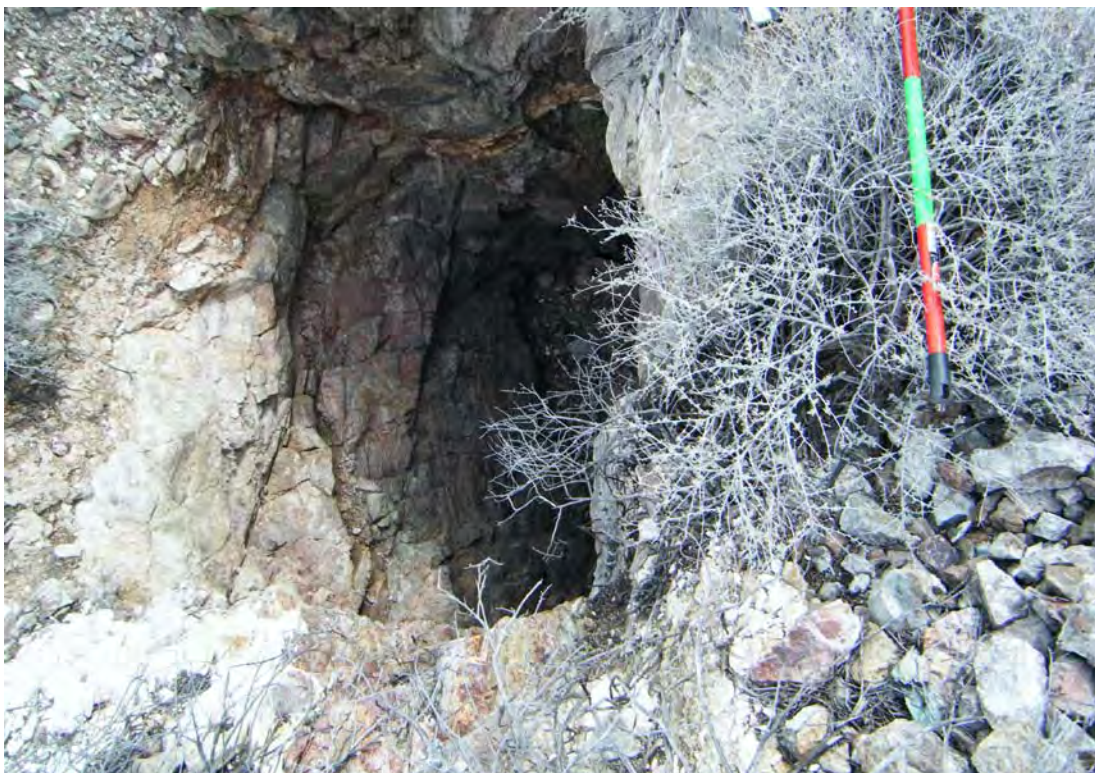
Photo 25 – Another view of Shaft-3.

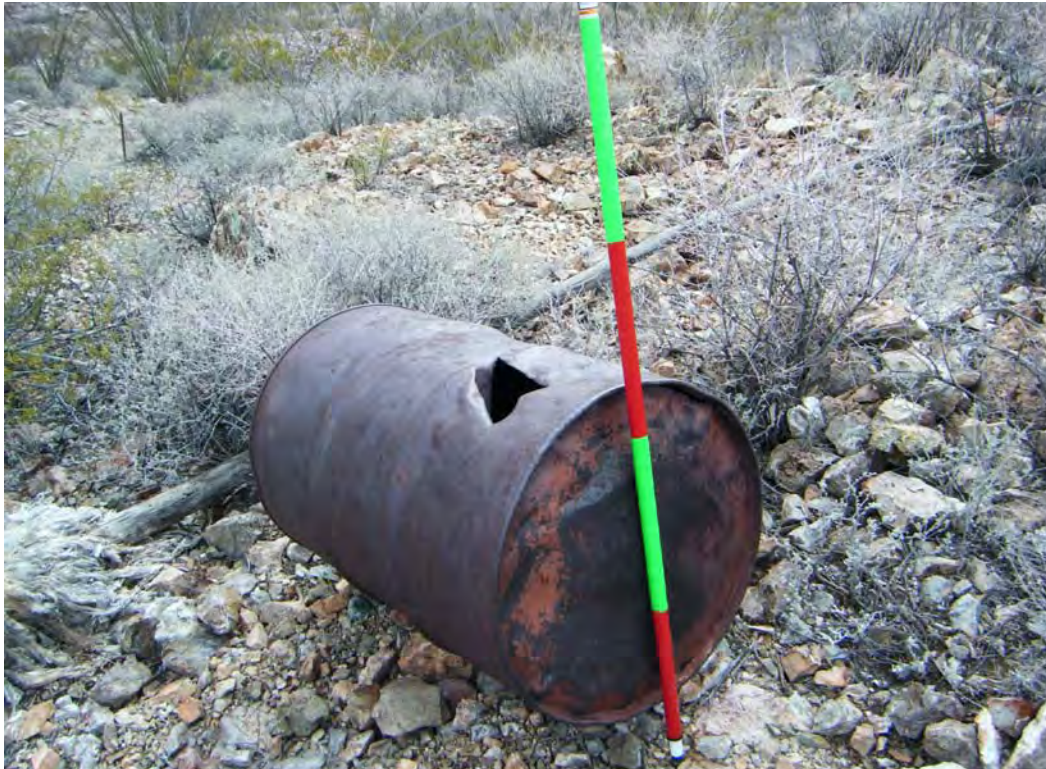
Photo 26 – A 55 gallon drum (Equip-2).

Equip 2 - 55 gallon metal drum, holes, empty

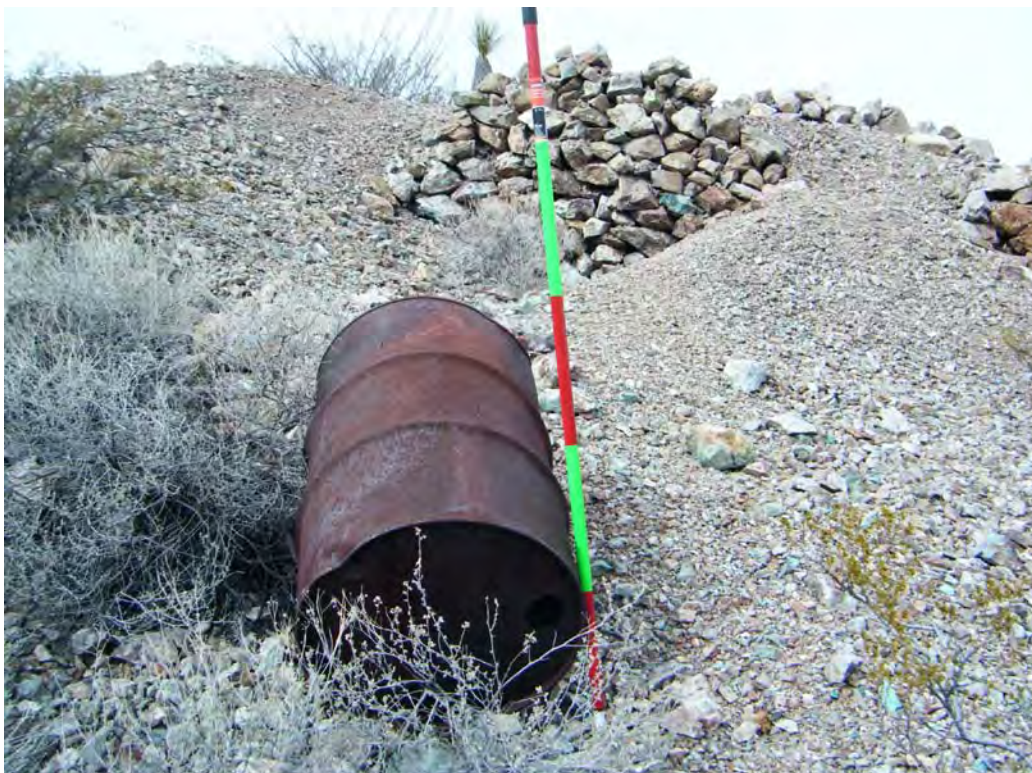
Photo 27 – Another 55 gallon drum (Equip-3) with a load out ramp in the background (Loadply-1).

Photo 27 - 55 gall drum, Equip 3 with loadout ramp in the background

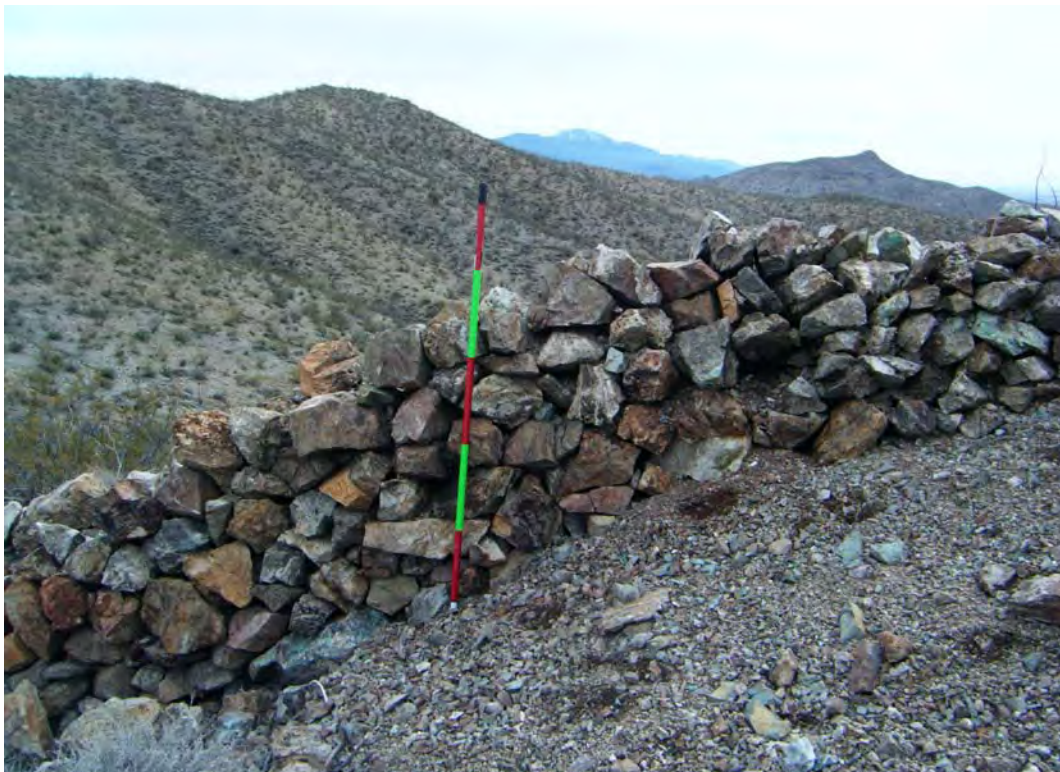
Photo 29 – Side view of load out ramp, looking southeast (Loadply-1).

Load Ply 1 - 5ft wide x 25' long, 0-5ft tall

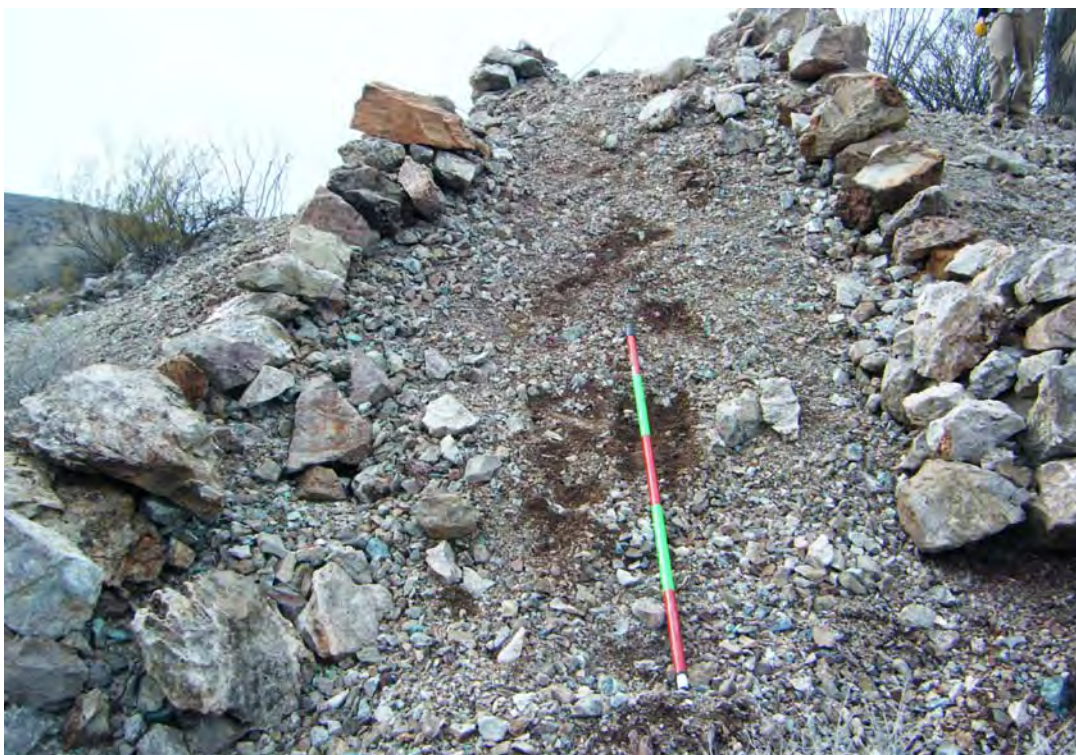
Photo 30 – Looking up load out ramp to the south (Loadply-1).

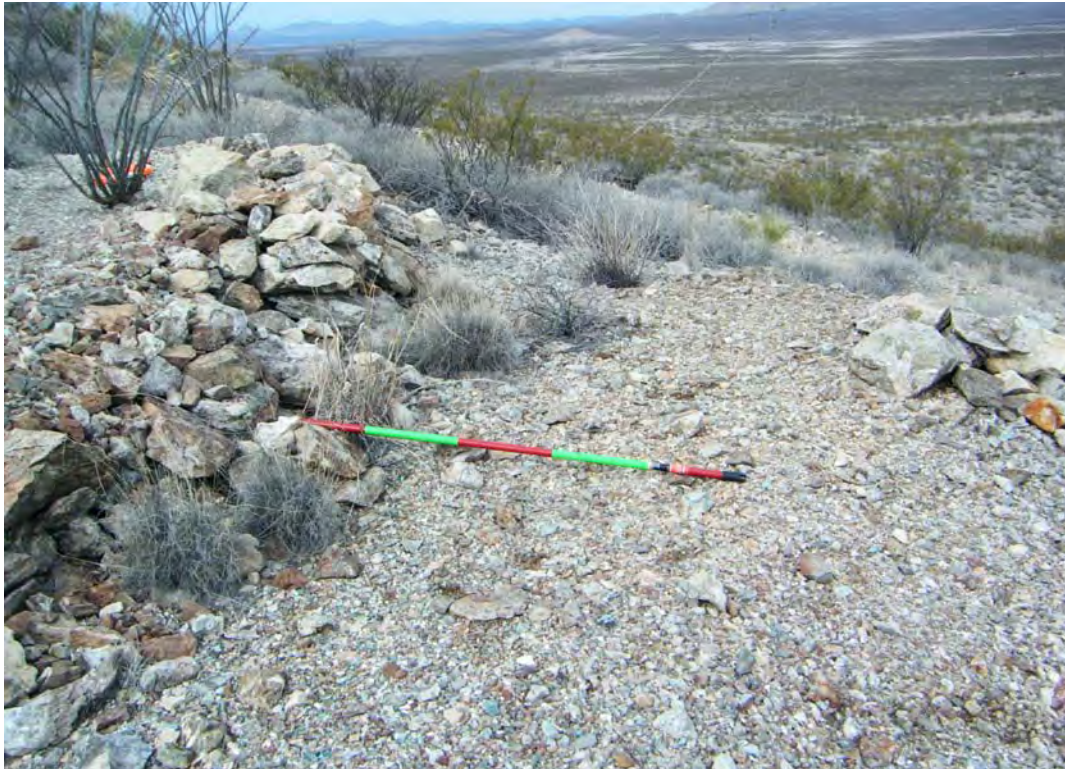
Photo 32 – Load out terraces, side view to the northwest (Loadply-2).

Load Ply 2 - 2 terraced levels

10ft high total, 28' long, 17' wide (both terraces)

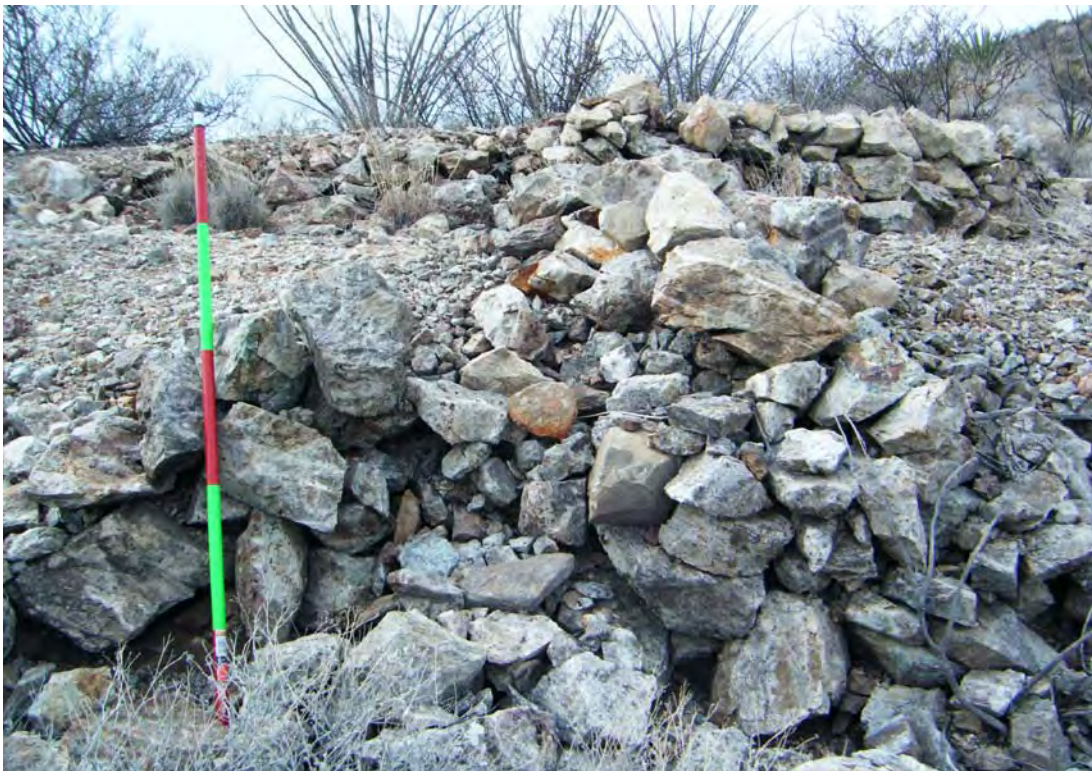
Photo 33– Looking up at terraces to the south (Loadply-2).

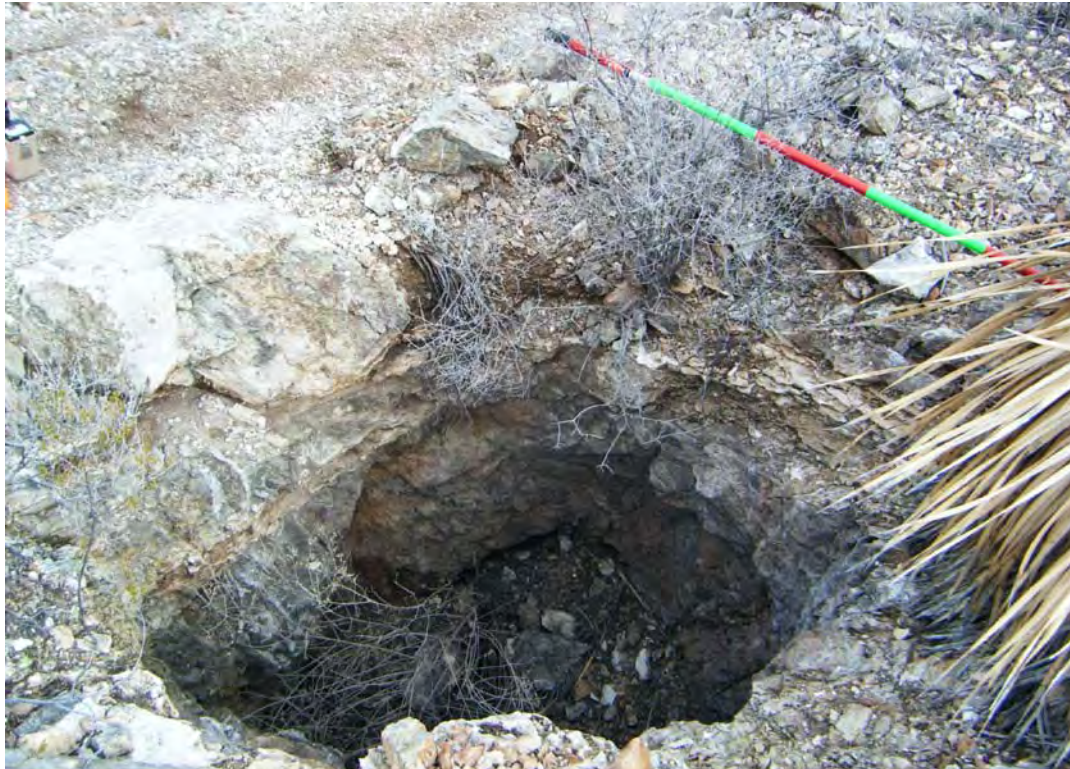
Photo 34 –Looking north at Shaft-4.

Shaft 4 - 4' x 6' x 6' deep

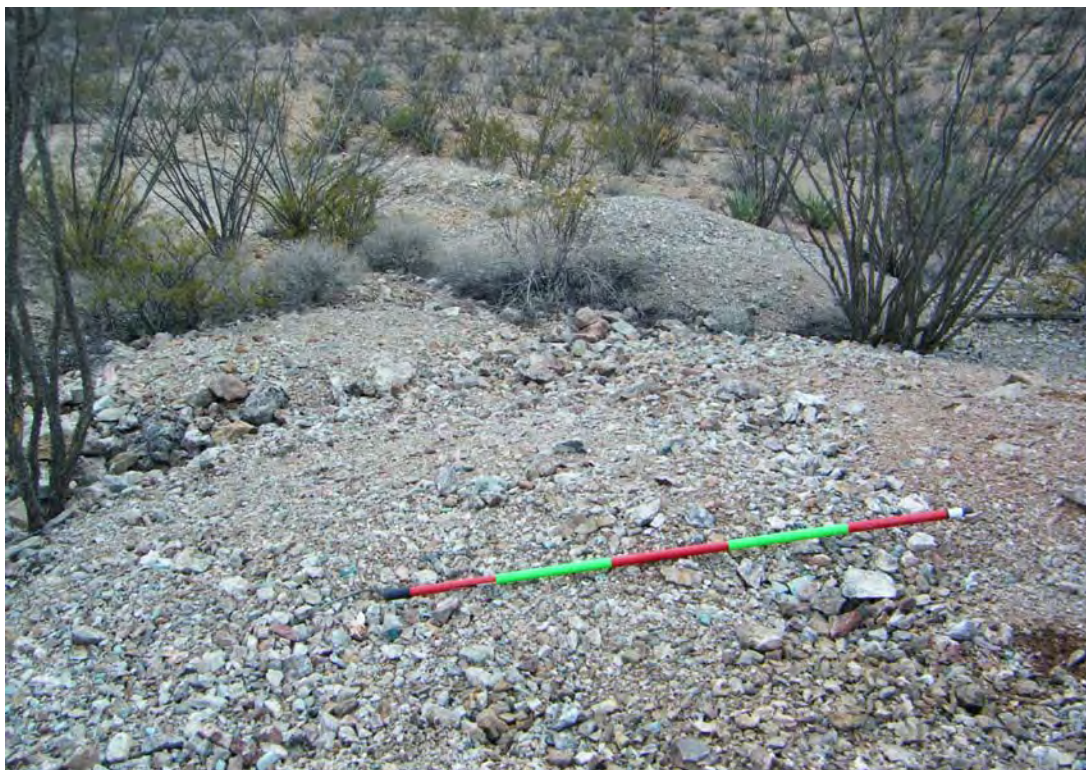
Some gullying and downward movement of waste rock was observed on the southeastern portion of the site.

Photo 36 – Looking south down at PilePly-2.

Pile Ply 2 - 70ft wide, 40ft tall, 60ft long 30° angle associated with shaft Ply 2 and shaft 3

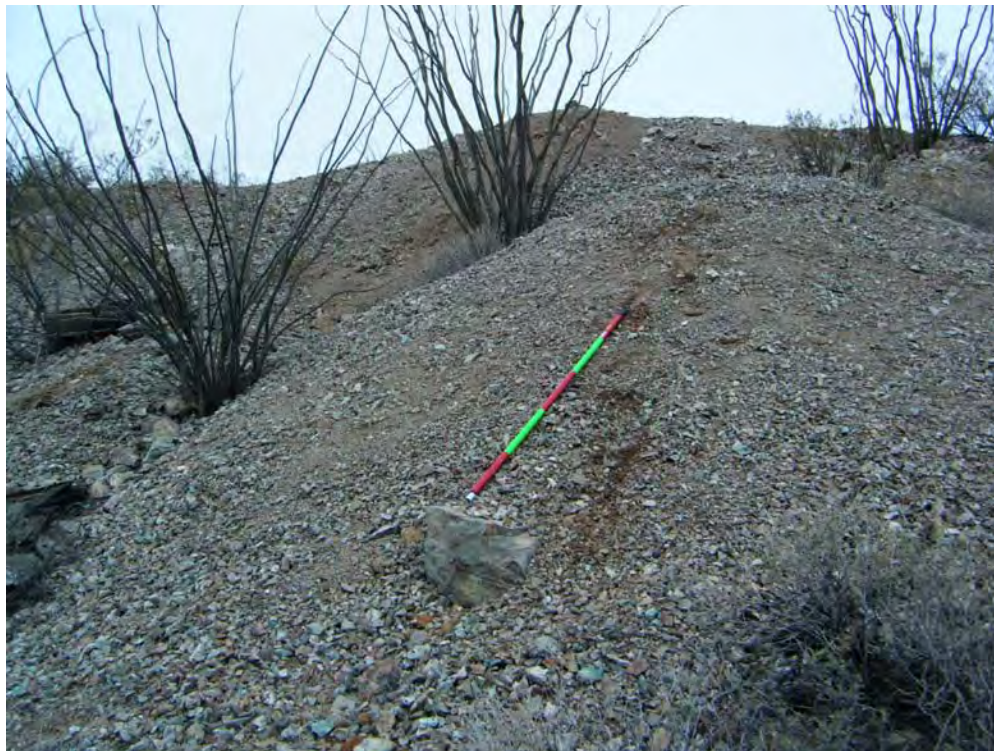
Photo 37 –Looking north up at PilePly-2.

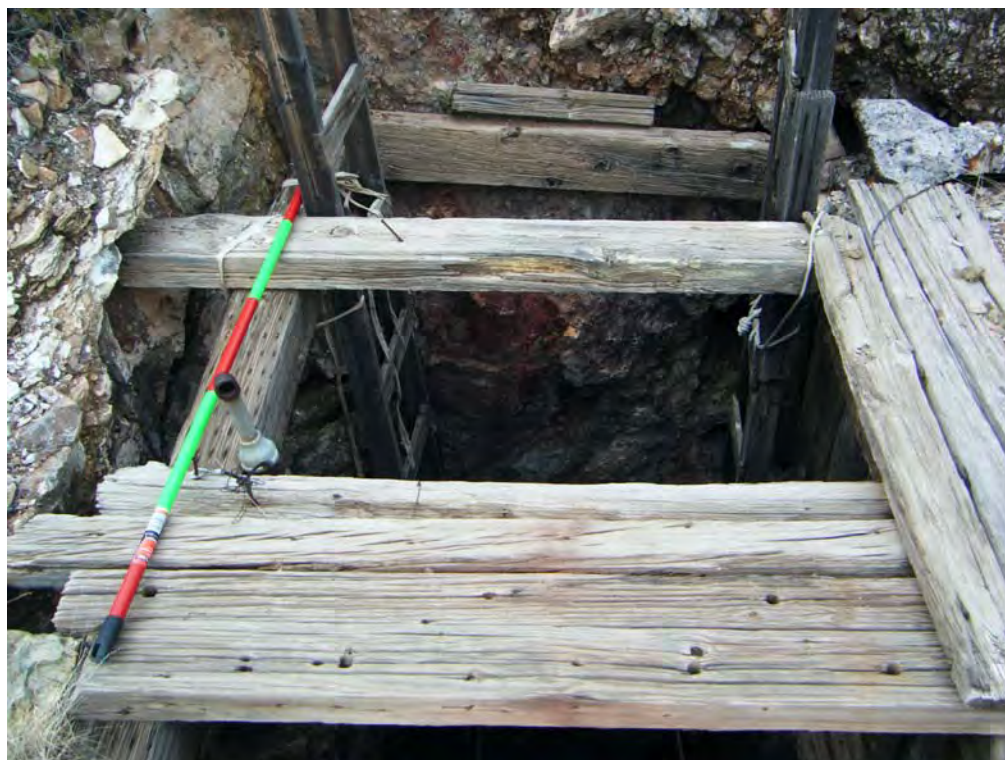
Photo 38– Looking northwest at Shaft-5. Photo (h) in the Anderson report was taken from the opposite side of the shaft.

Shaft 5 - 6ft x 6ft, estimated 50ft deep, could be deeper

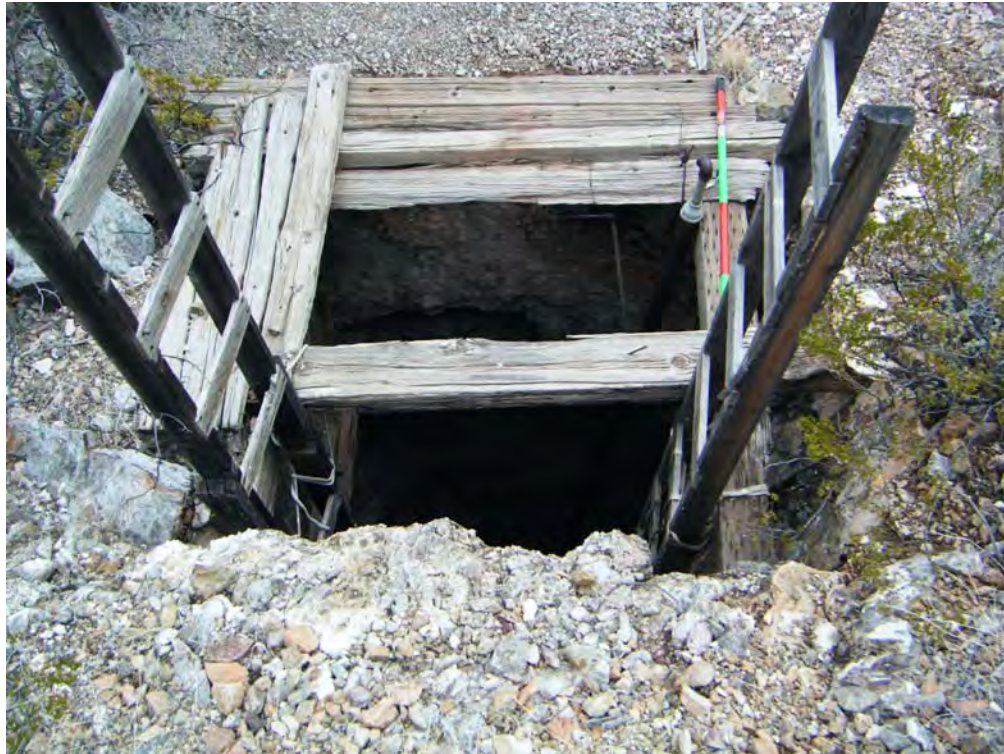
Photo 39 –Looking southeast at Shaft-5, replicating photo (h) in the Anderson report.

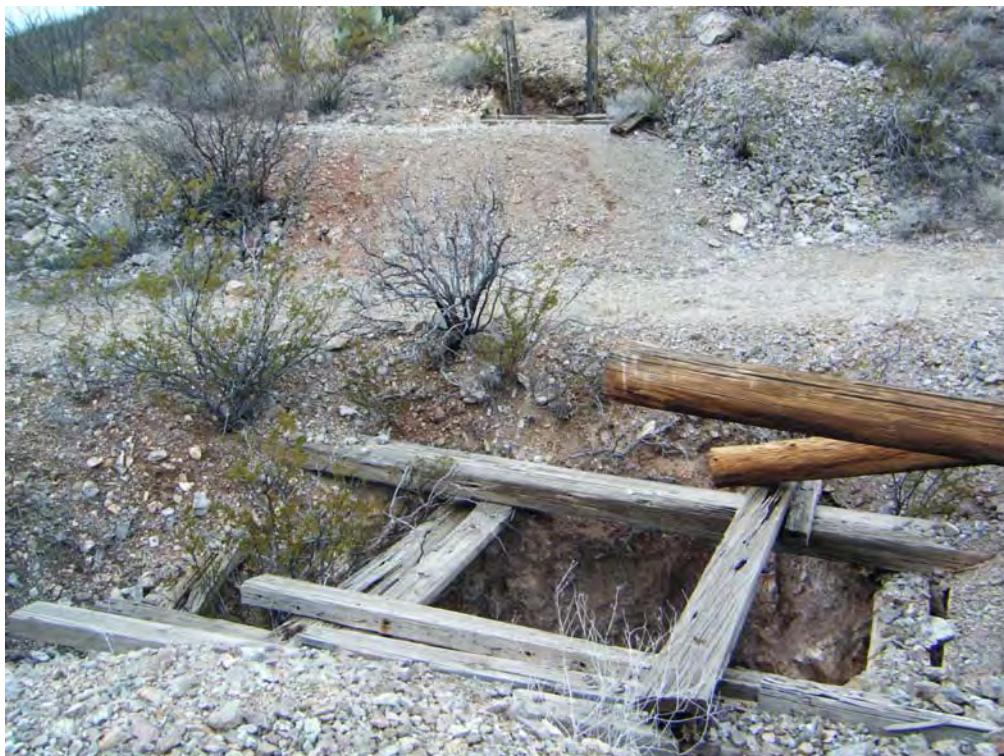
Photo 40 – ShaftPly-1 in the foreground, Shaft-5 in the background, looking west.

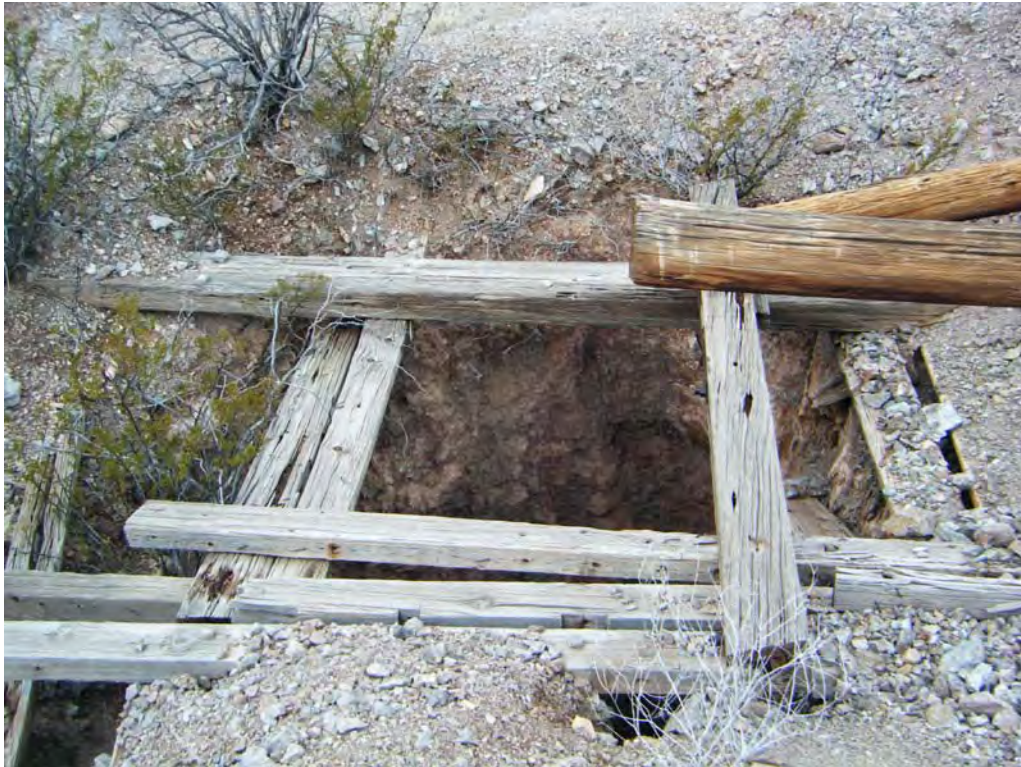
Photo 41 –Looking west into ShaftPly-1.

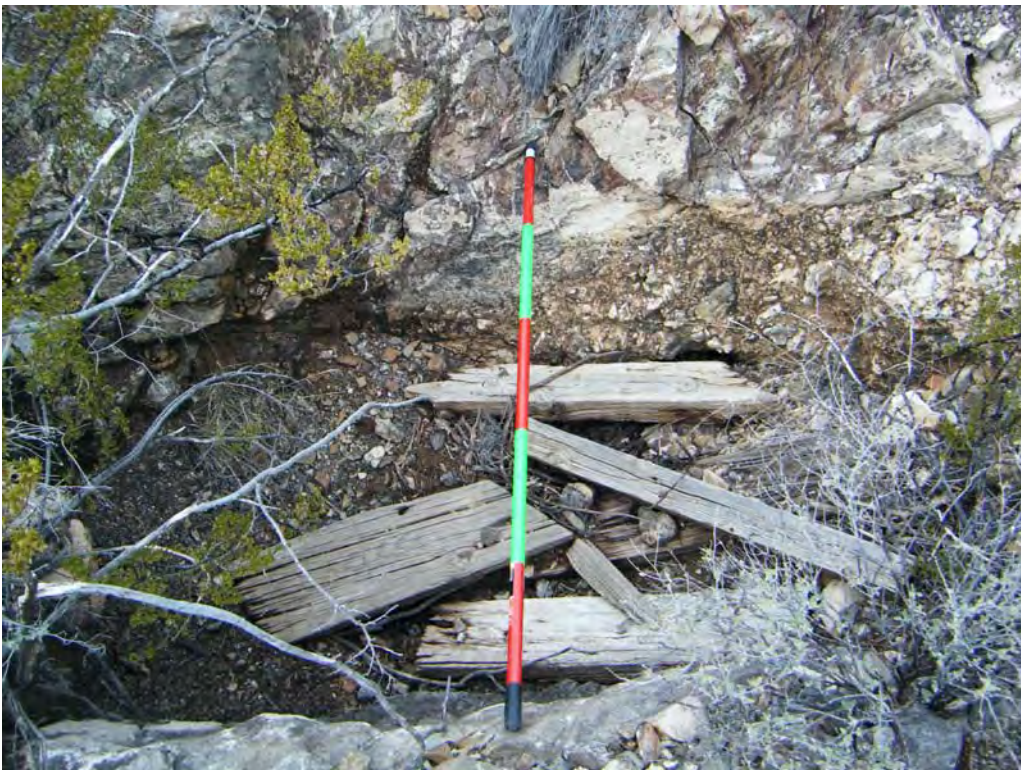
Photo 44 – Shaft-6.

Shaft 6 - 5ft x 7ft, 3ft deep; lumber at bottom

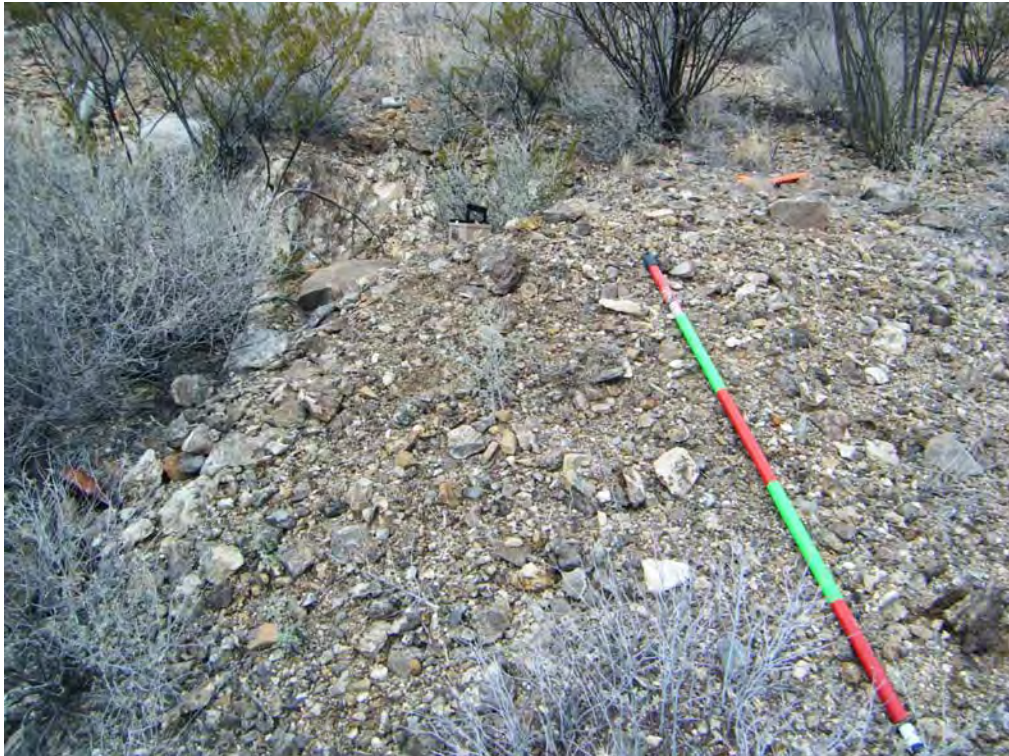
Photo 45 –PilePly-4, associated with Shaft-6.

Pile Ply 4 - associated with shaft 6; 7ft x 9ft,  
2 - 4ft deep/tall

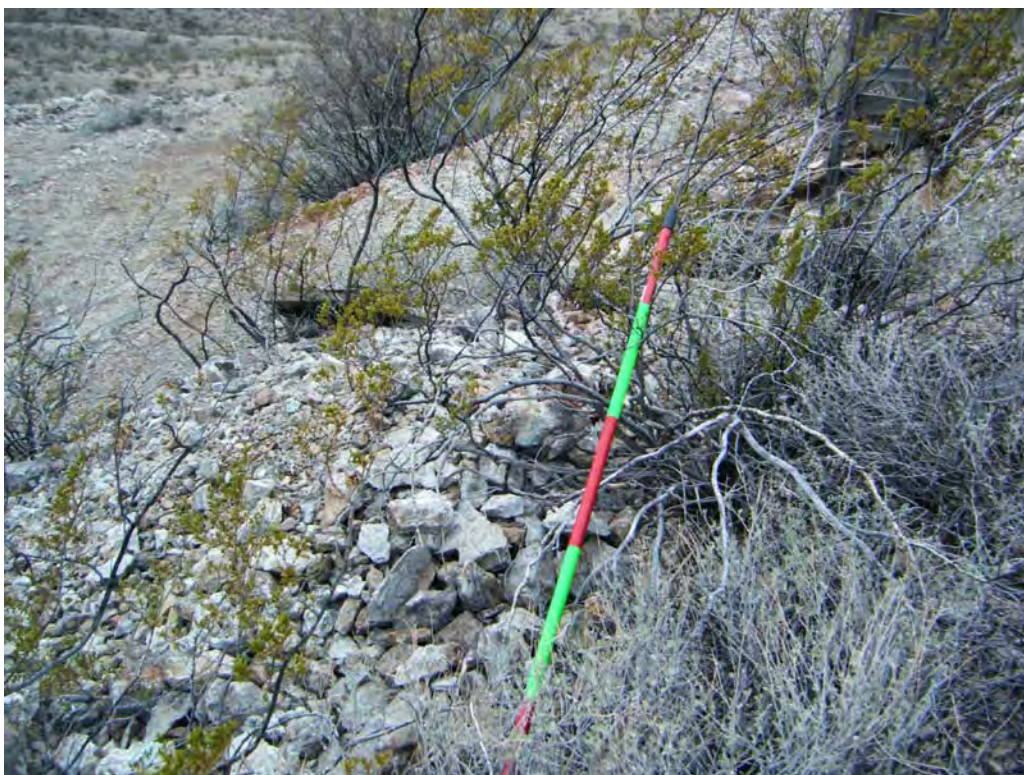
Photo 46 – PilePt-1.

Pile Pt 1 - 4ft x 5ft; ~4ft - 1ft high
