# Abandoned Uranium Mine Site Assessment for the Napane Site (NM0137)

**FINAL REPORT**

**February 23, 2010**

NM0137

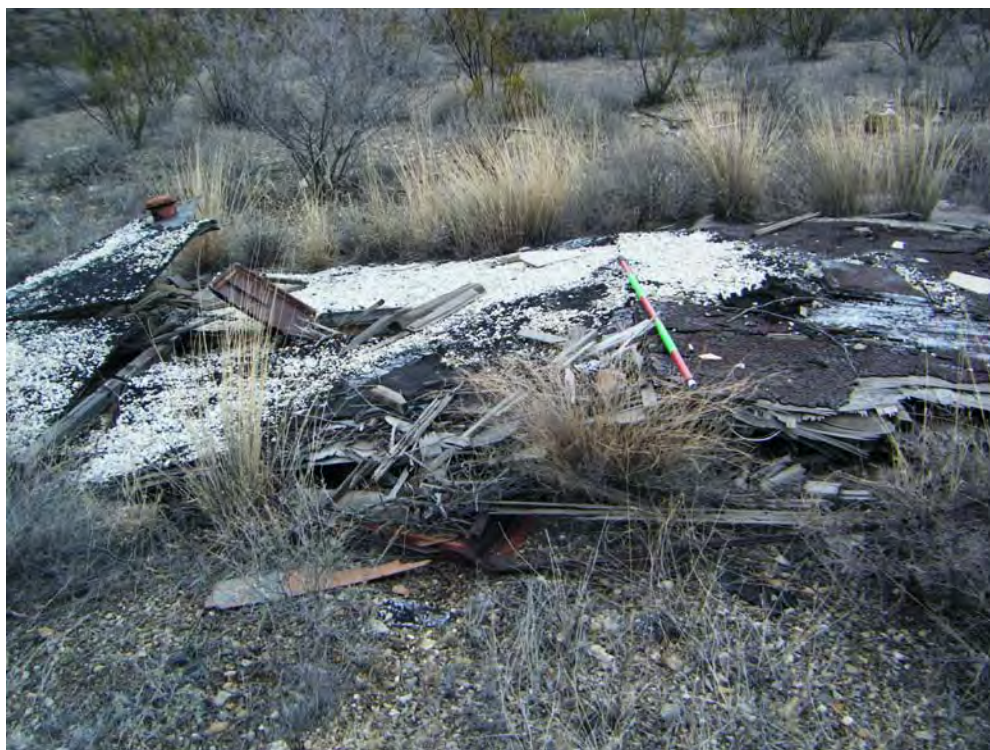
No mining related buildings and foundations were evident at the AUM Site. A collapsed structure found offsite (StrucPly-1) may be the trailer house referred to in Photo (a) of the Anderson report.

Photo 48 – This collapsed structure (StrucPly-1) may be the trailer house mentioned in the Anderson Report.
