Golder Associates Inc.

December 11, 2006

**RE: WELL PLUGGING AND ABANDONMENT REPORT,
RENTAL PROPERTY SITE, MURRAY ROAD,
ALBUQUERQUE, NEW MEXICO**

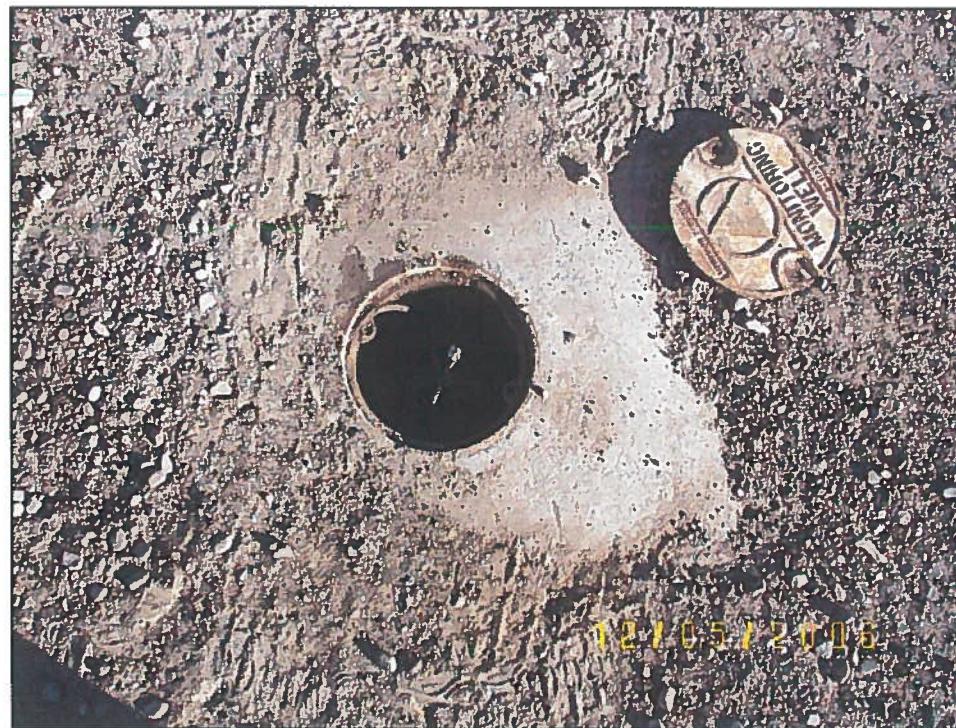
MW-1 - BEFORE ABANDONMENT

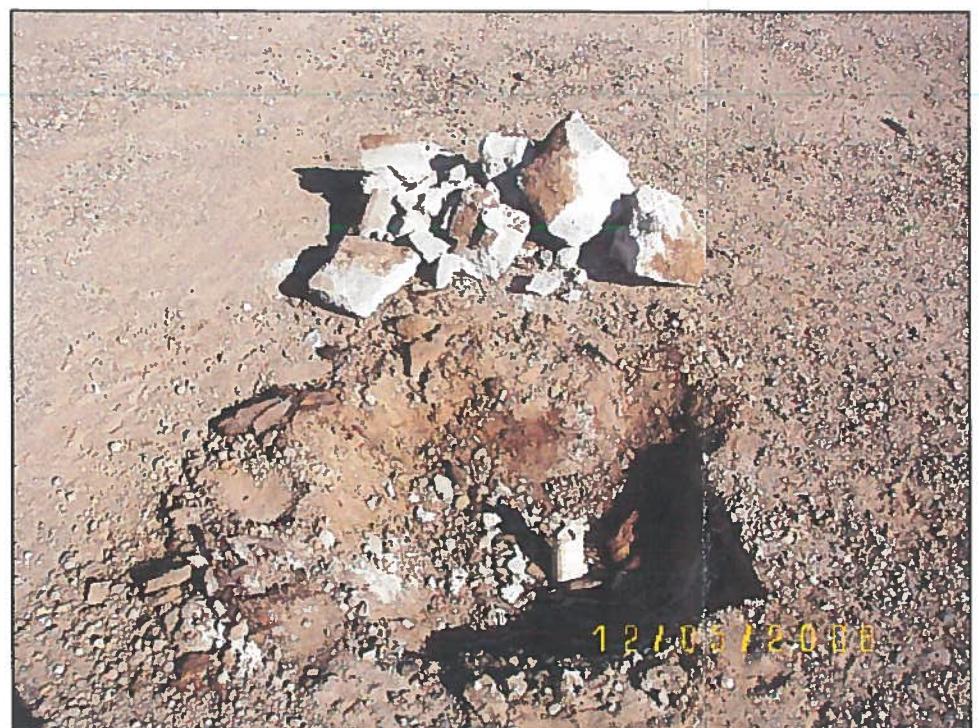
MW-1 - AFTER CONCRETE REMOVED

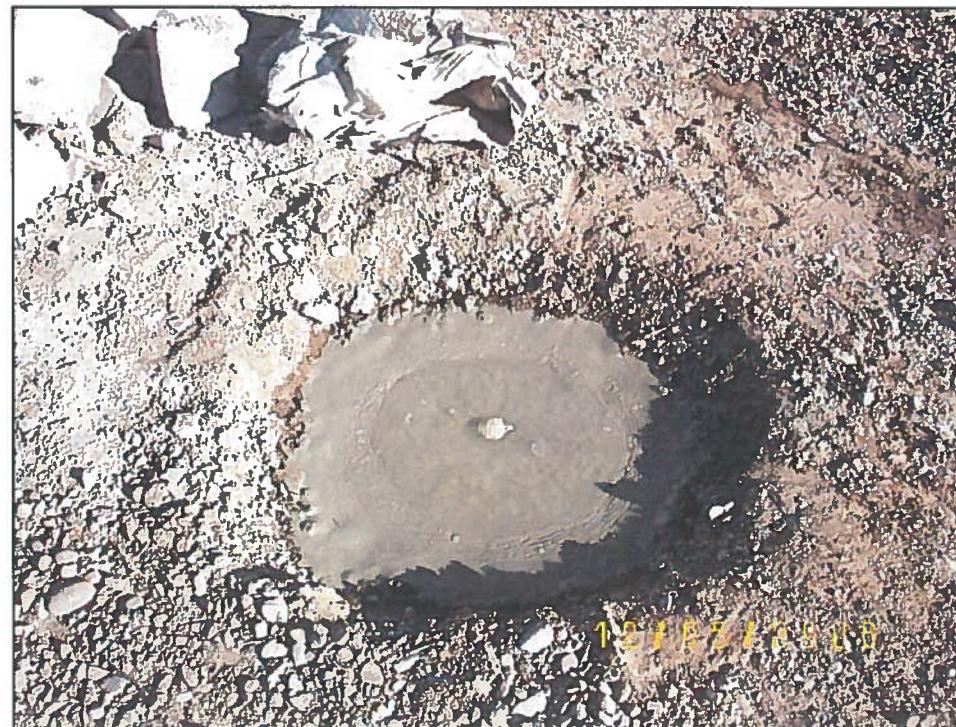
MW-1 - FILLED WITH BENTONITE / CEMENT GROUT BY TREMIE PIPE

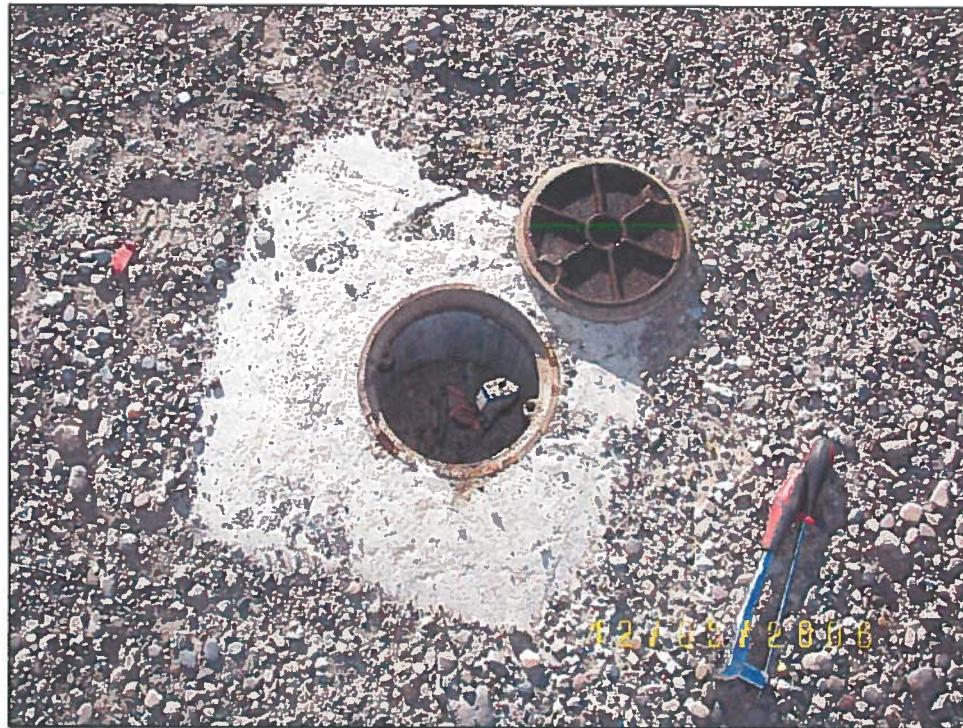
MW-2 - BEFORE ABANDONMENT

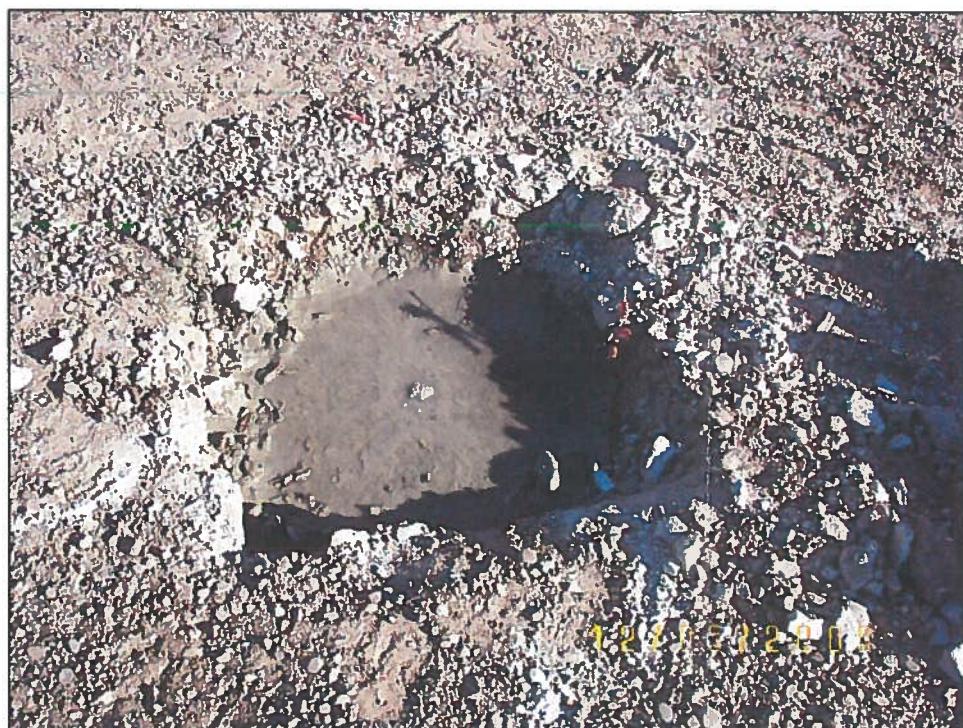
MW-2 - FILLED WITH BENTONITE / CEMENT GROUT BY TREMIE PIPE

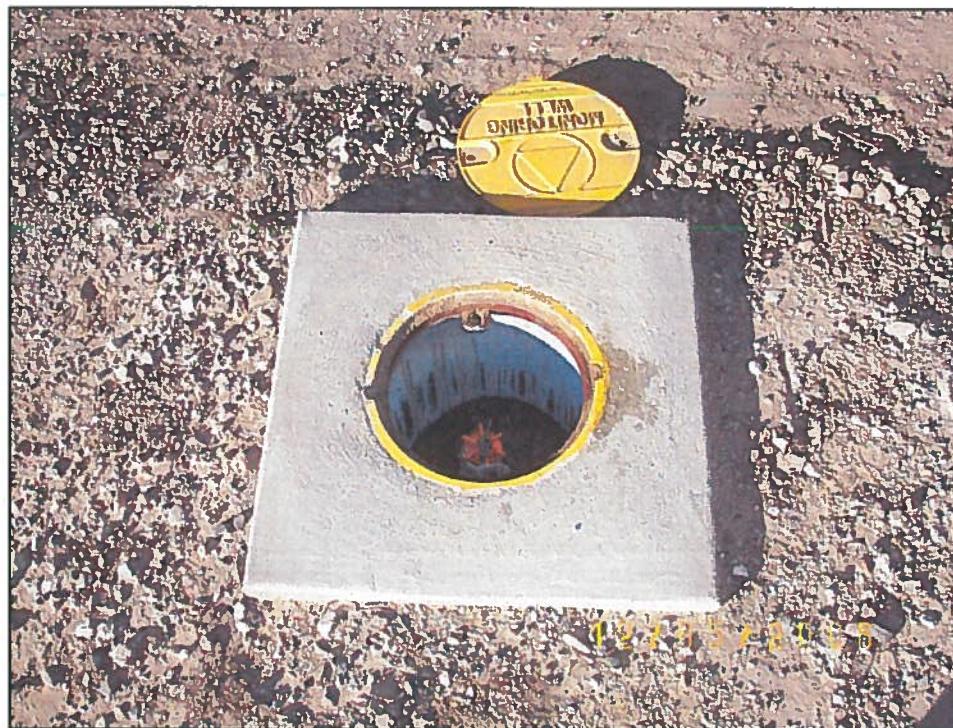
MW-4 - BEFORE ABANDONMENT

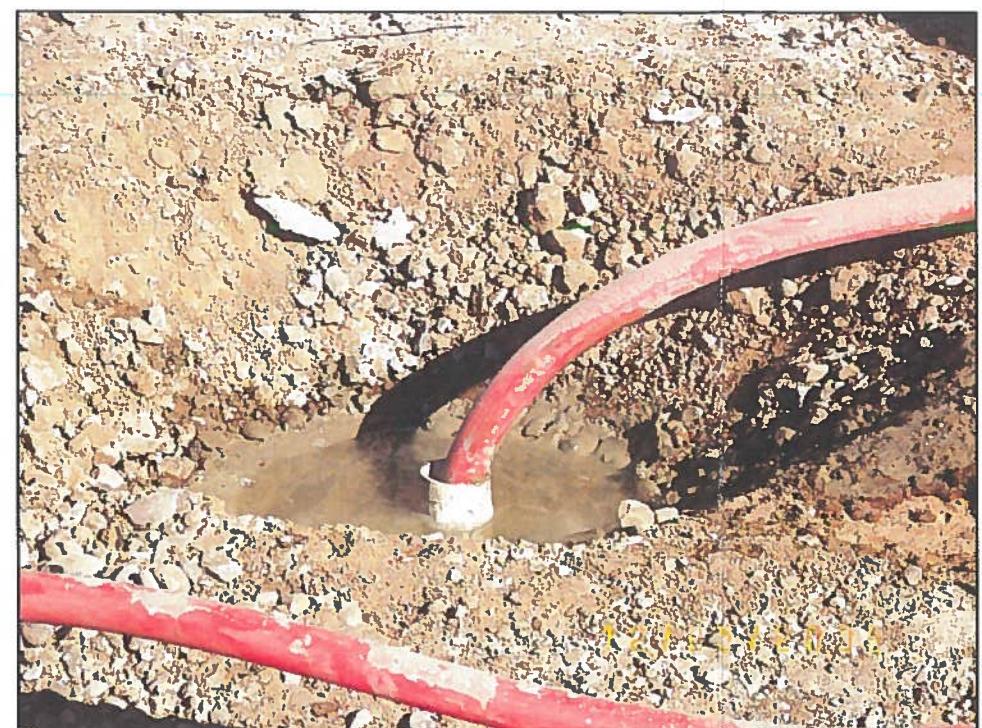
MW-4 - FILLING WITH BENTONITE / CEMENT GROUT BY TREMIE PIPE

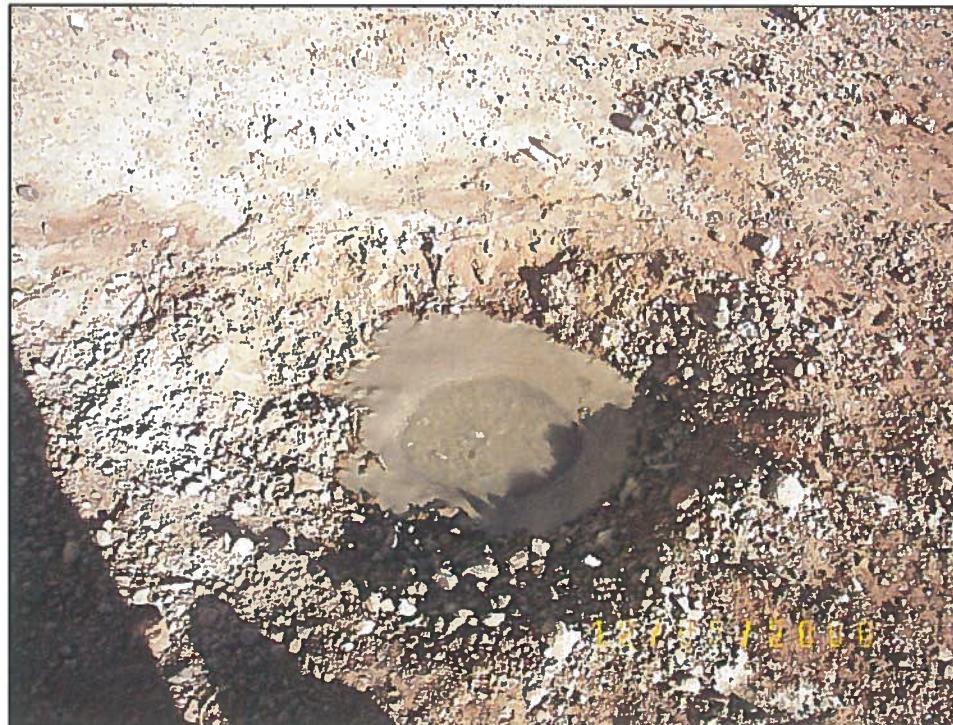
MW-4 - FILLED WITH BENTONITE / CEMENT GROUT BY TREMIE PIPE

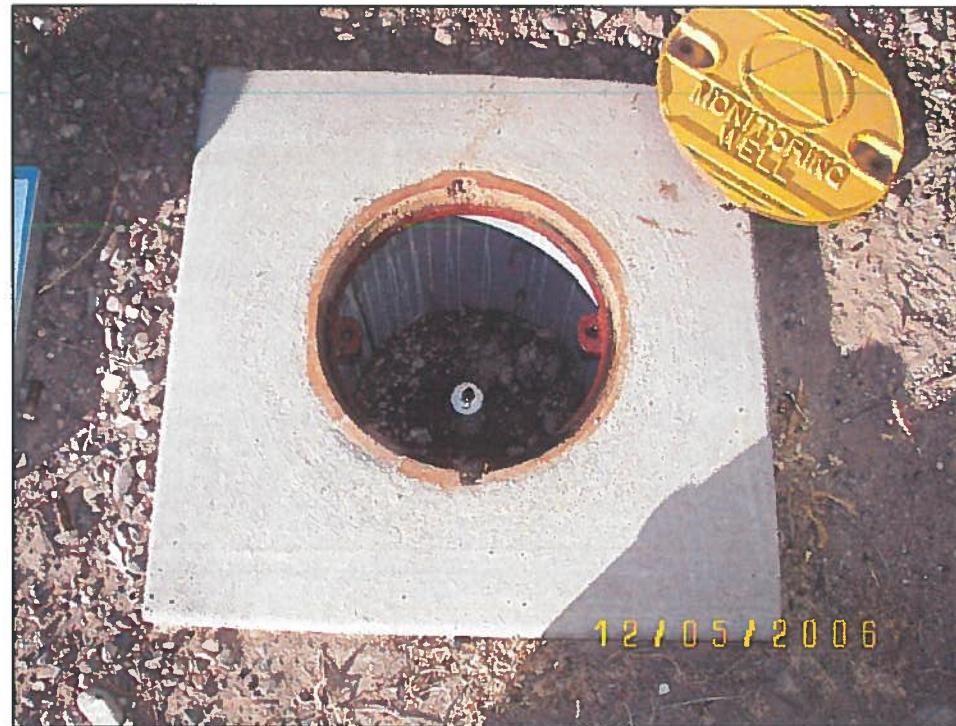
VM-1 - BEFORE ABANDONMENT

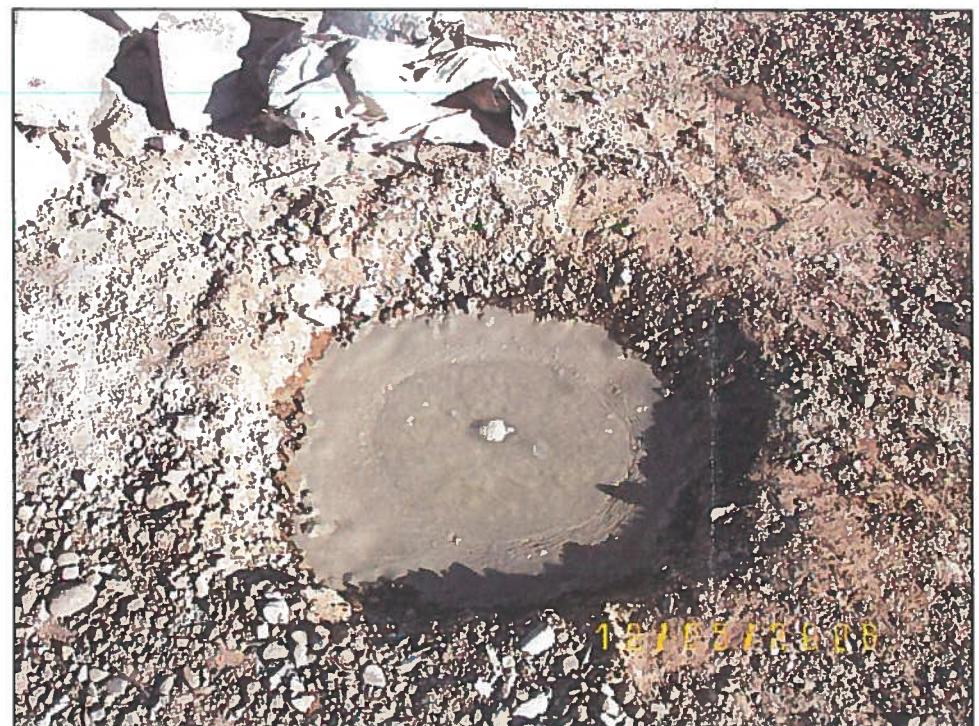
VM-1 - FILLED WITH BENTONITE / CEMENT GROUT BY TREMIE PIPE

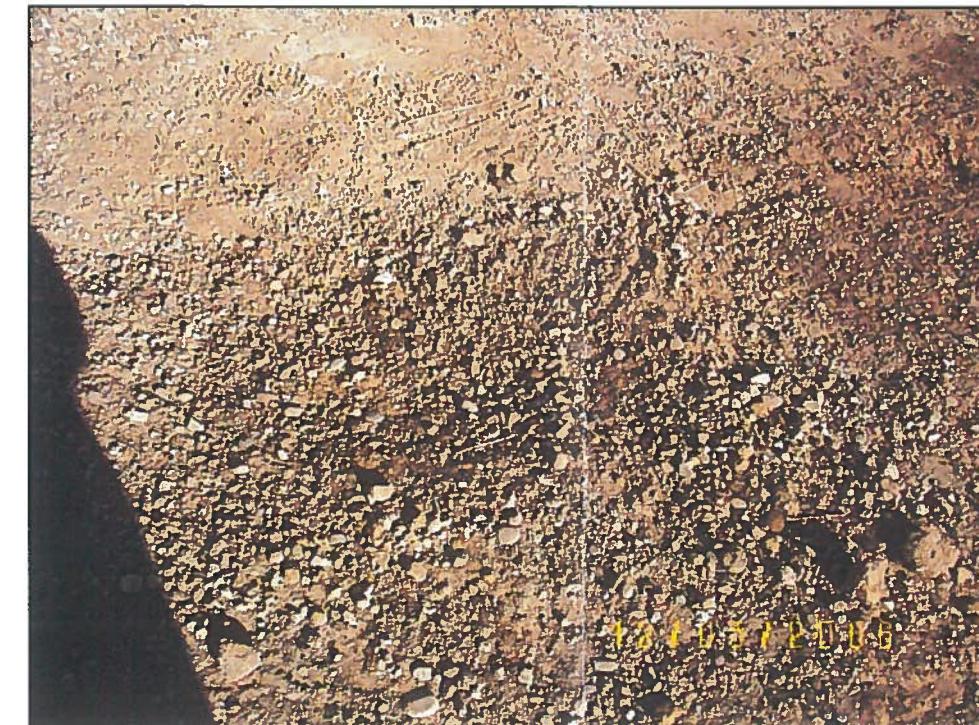
VM-1 - FINISHED COVER
