**RE: Second Monthly NAPL Recovery Report,  
Fairview Station Site, Española, New Mexico  
Facility #28779                      RID #4657                      WPID #4096-2**

Souder, Miller & Associates (SMA) is pleased to submit the second monthly NAPL recovery report. This report is submitted in accordance with the workplan dated August 16, 2019 and approved by NMED PSTB on September 30, 2019.

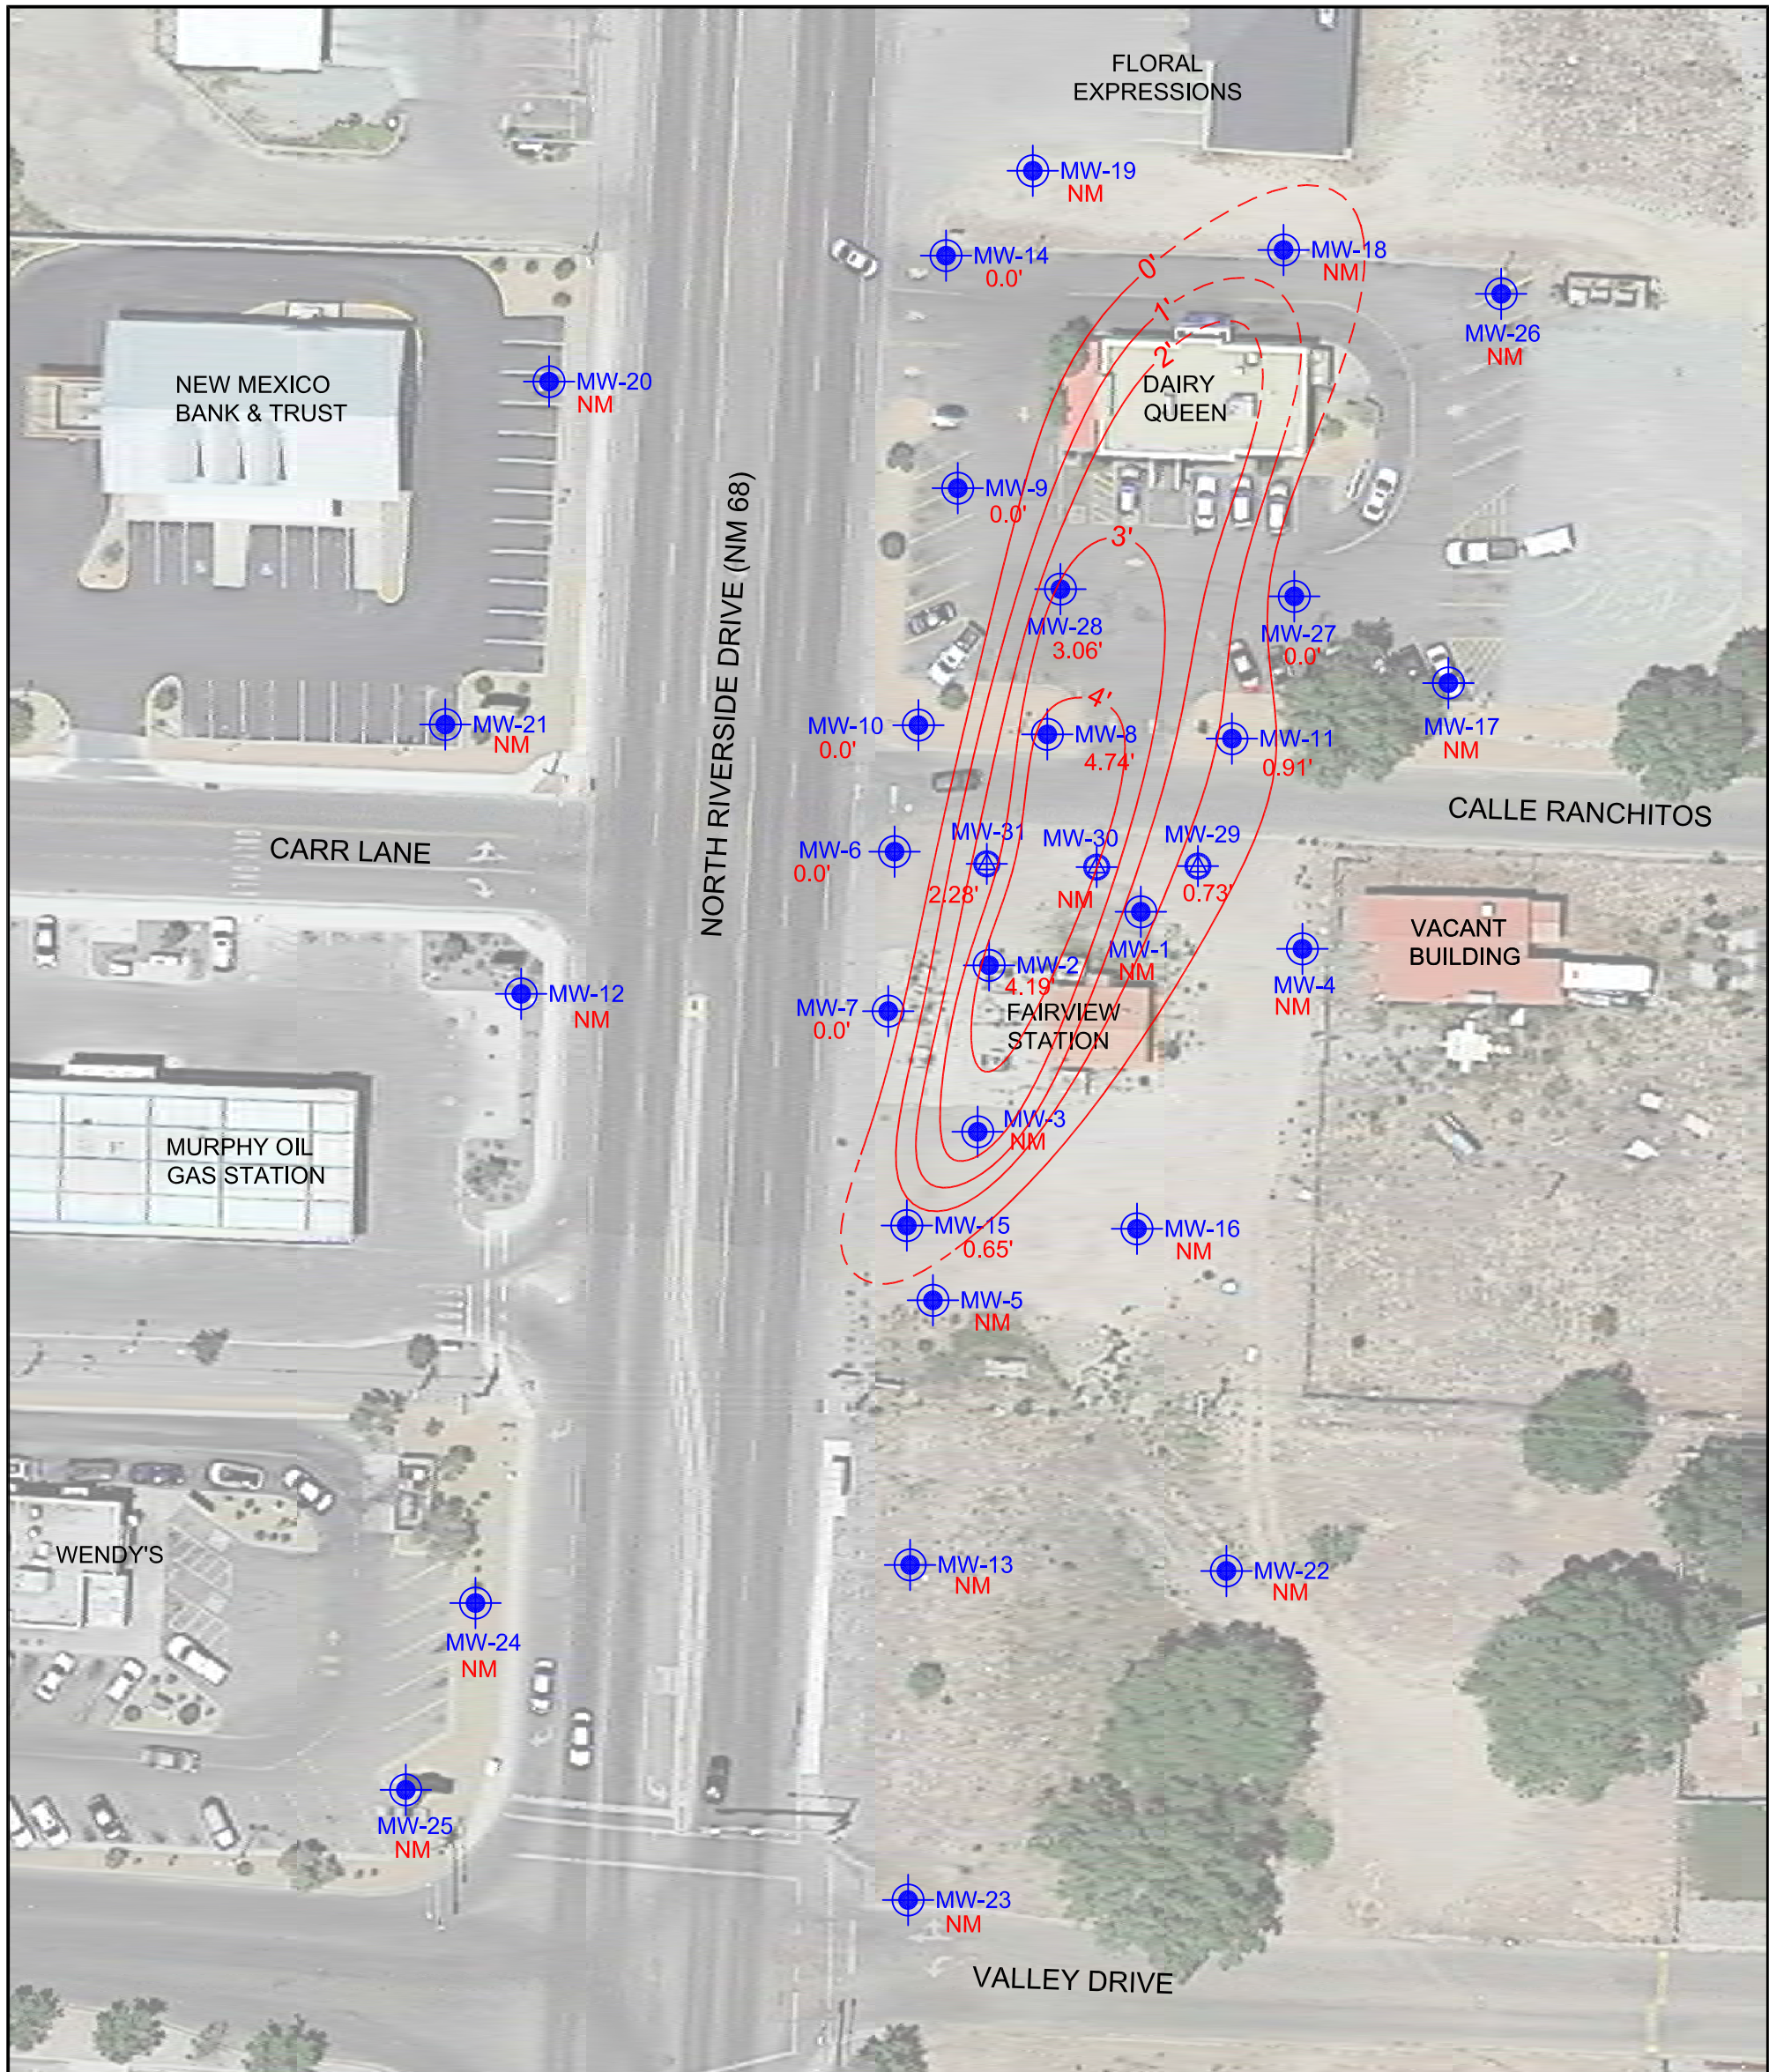
Designed AJE	Drawn AJE	Checked SAM
Date: JANUARY 2020		
Scale: Horiz: 1" = 50' Vert: N/A		
Project No:		
Sheet: <b>Figure 1</b>

On December 16, 2019, SMA performed the second monthly NAPL recovery. Fourteen monitoring wells were gauged for depth to NAPL and depth to water. Of these fourteen wells, seven monitoring wells contained NAPL with apparent thicknesses ranging from 0.65 to 4.74 feet. Three monitoring wells (MW-3, MW-18 and MW-30) were covered in frozen mud or inaccessible.

Figure 1 depicts the apparent NAPL thicknesses and NAPL contours during the December 2019 event. Table 1 presents the initial depth to NAPL and water measurements. Table 2 depicts the NAPL thicknesses before and after recovery with the NAPL amounts recovered.
