EA Engineering, Science, and Technology, Inc., PBC (EA) is pleased to submit this letter report documenting the MW-14 well vault repair and monitoring well assessment for the Santa Fe County Judicial Complex (SFCJC) State Lead Site (the site) in Santa Fe, New Mexico. The work was performed under EA's State Lead remediation contract number (#) 19-667-3200-0007 for the SFCJC Site and in accordance with work plan identification (WPID) number 4073, approved by the New Mexico Environment Department (NMED) Petroleum Storage Tank Bureau (PSTB) on July 11, 2019.

Monitoring Well Assessment

SANTA FE COUNTY JUDICIAL COMPLEX
SANTA FE, NEW MEXICO

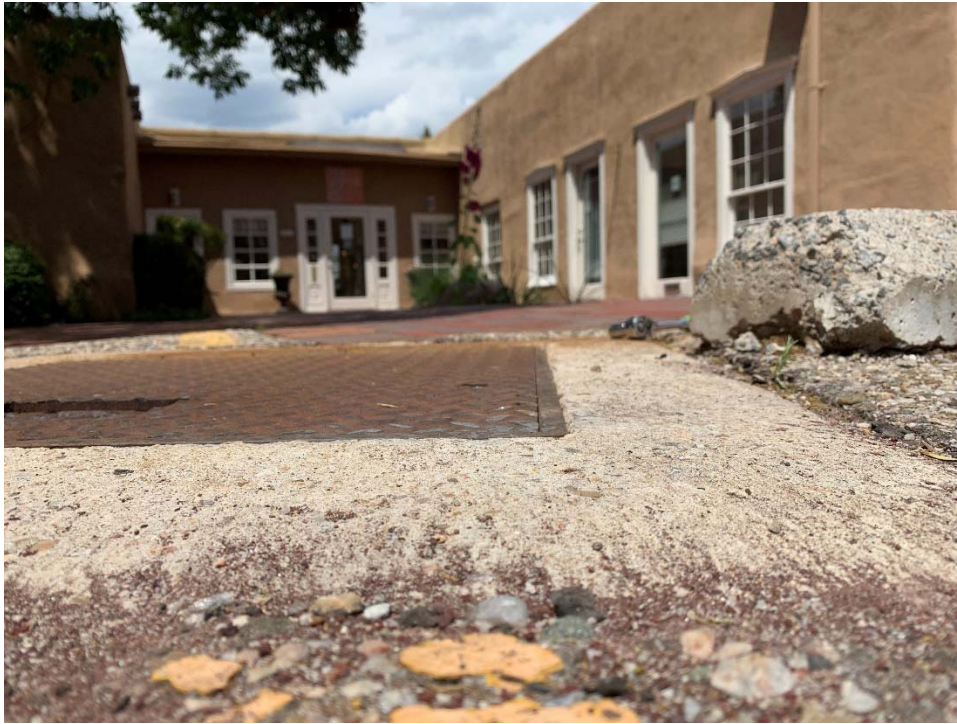
On July 25, 2019, Mr. Joe Canepa with the West De Vargas Condominium Association notified the NMED PSTB via email that the well vault lid for MW-14 was not closing properly and presented a potential trip hazard to the tenants. Photos of the MW-14 well vault provided to EA by the NMED PSTB showed that the lid was likely bent. EA contracted with Enviroworks, LLC (Enviroworks) to repair the bent lid so that it would close flush with the ground surface. Enviroworks heated up the lid with a welding torch and bent it back into proper alignment so that it would close flush with the ground surface once again. A photo of the completed repair is included in Attachment 1.

Description: MW-14 well vault repair completed.

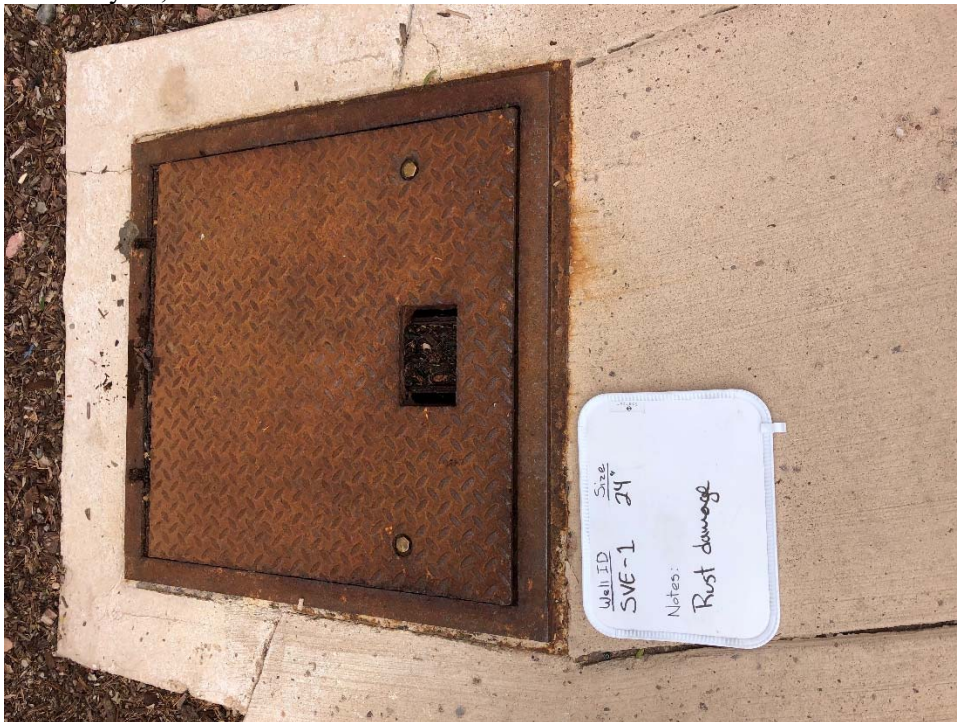
- The 24-inch square well vaults for SVE wells SVE-1, SVE-2, SVE-3, SVE-4, SVE-9, and SVE-11D are heavily rusted and have missing handles, broken hinges, and/or damaged or broken threaded bolt seats. The vault lids currently cannot be secured, which could result in unauthorized access to wells. The vault lids should be secured, if possible. If the vault lids cannot be secured, the well vaults should be replaced. Photos of SVE-1 and SVE-2 are included as examples in Attachment 1.

Description: SVE-1 well vault showing rusted out handle.

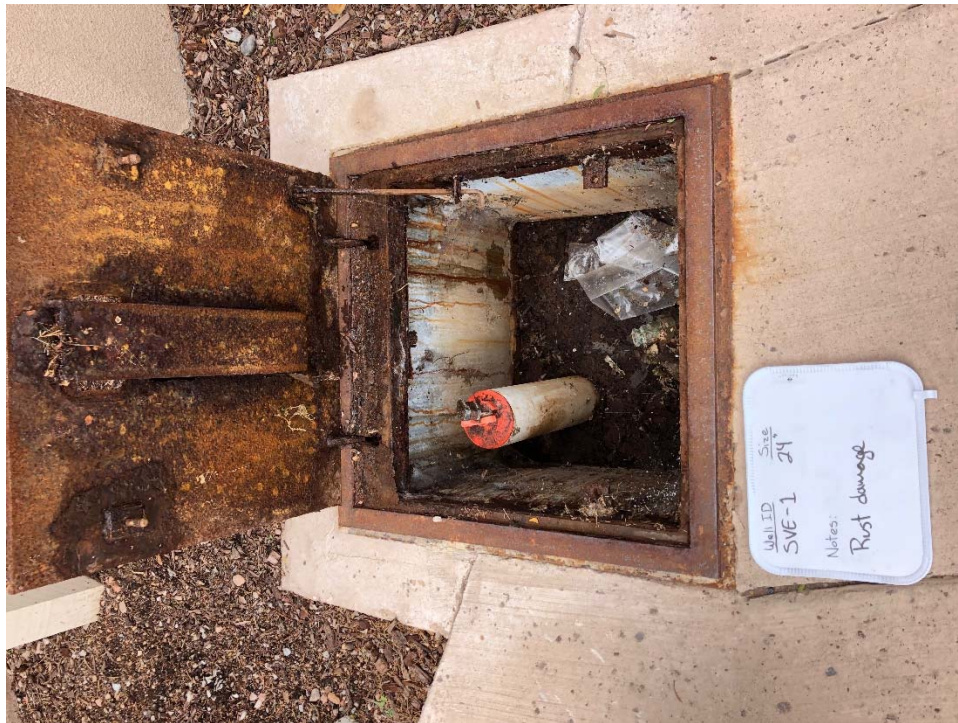
Description: SVE-1 well vault showing extensive rust.

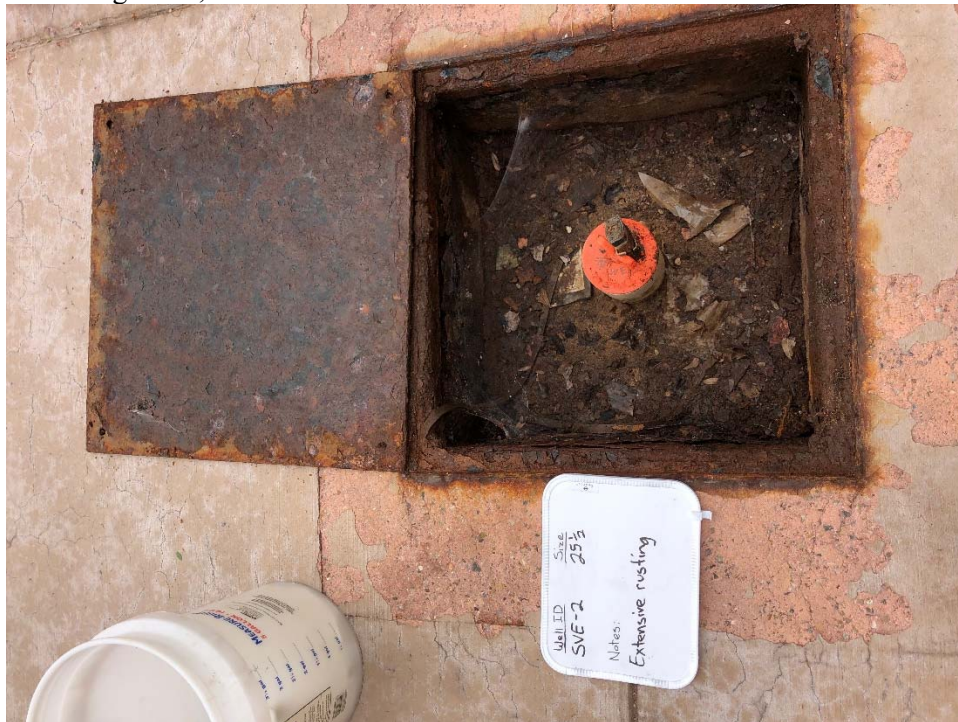
Description: SVE-2 well vault showing extensive rust.

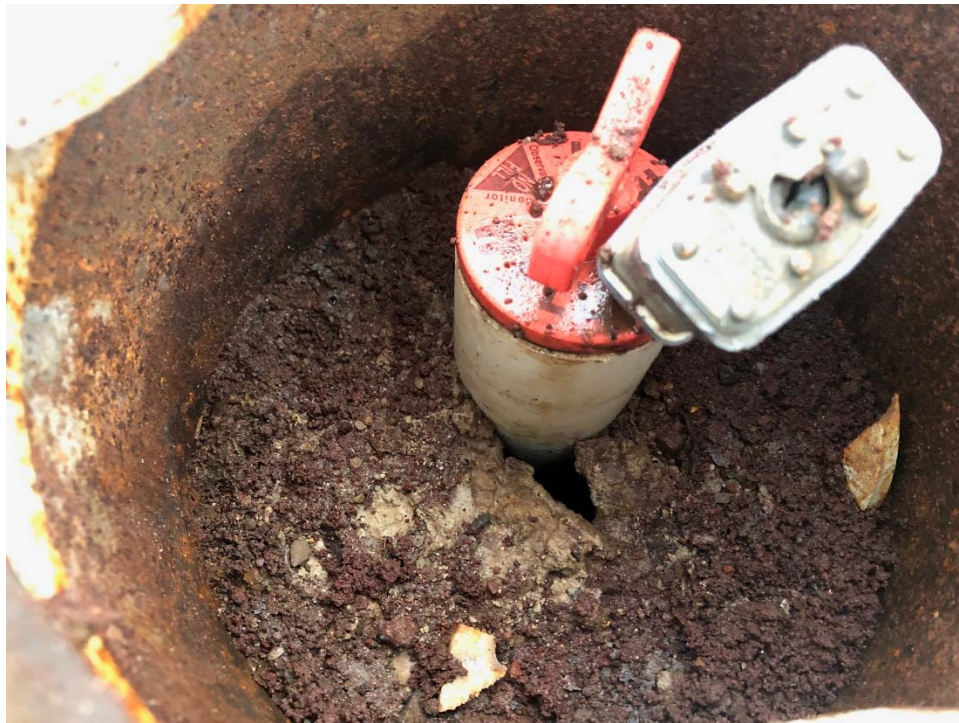
- The well vault lid for monitoring well MW-17 is cracked and there is a hole in the grout seal around the well casing. A photo showing the hole in the grout seal is included in Attachment 1. Since this well is located in the parking lot of the West De Vargas Condominiums, the well vault should be replaced and the grout seal around the casing repaired to prevent unauthorized access to the well and to prevent the potential migration of surface water, including road salt in the winter, down the annulus of the well.

Description: Well MW-17 showing hole in grout seal.

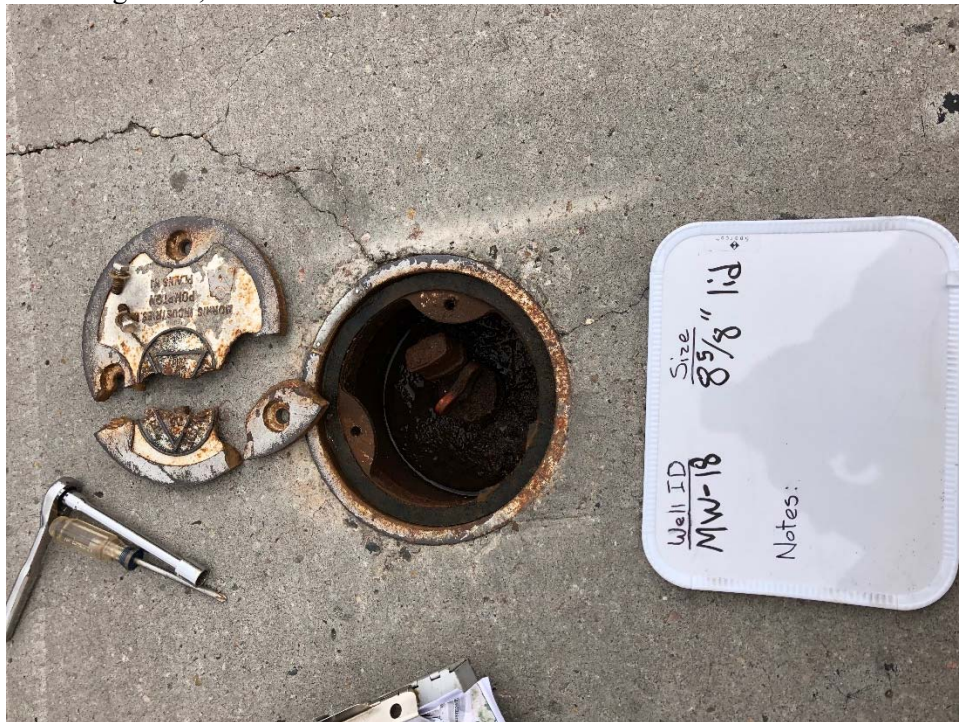
- The vault lid for monitoring well MW-18 (located in the west bound lane of Montezuma Avenue in front of the SFCJC) is broken and should be replaced. A photo showing the broken well vault lid is included in Attachment 1. If a new lid cannot be located for the vault, the entire well vault should be replaced.

Description: Well MW-18 showing broken well vault lid.
