Abandoned Uranium Mine Assessment for the White Flo Site (NM0184)

FINAL REPORT

NM0184

October 19, 2010

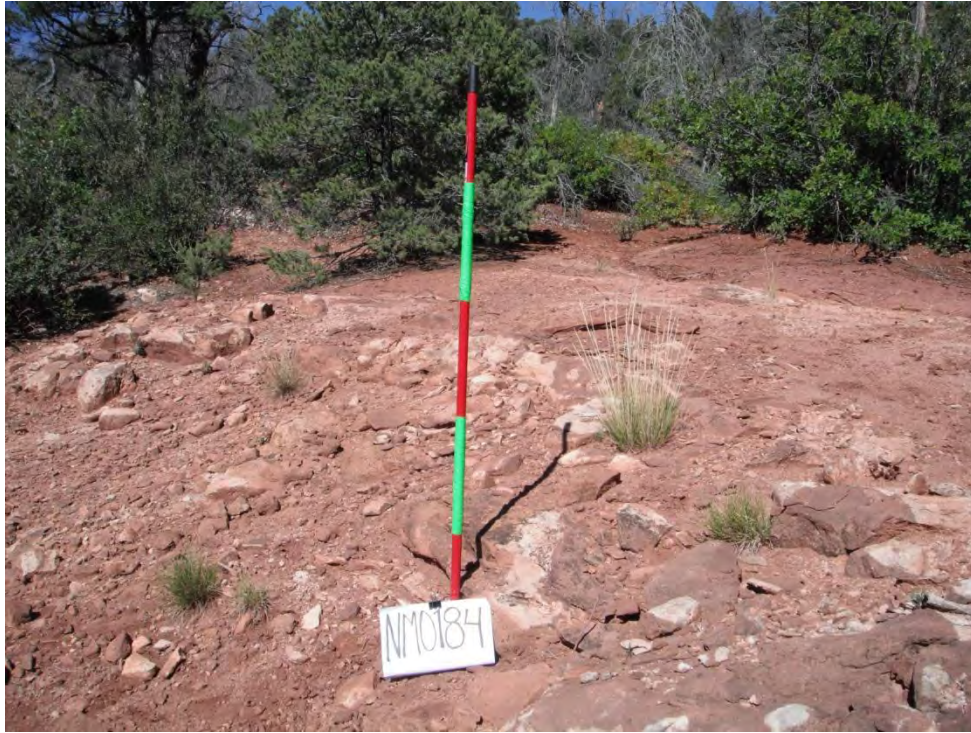
Photo 1-Site location photo, looking north at DistPly-1.

Photo 1 - Site location photo of DistPly-1 looking north

Rad-1 - DistPly-1; 0m - 10 $\mu\text{R/h}$; 1m - 10 $\mu\text{R/h}$

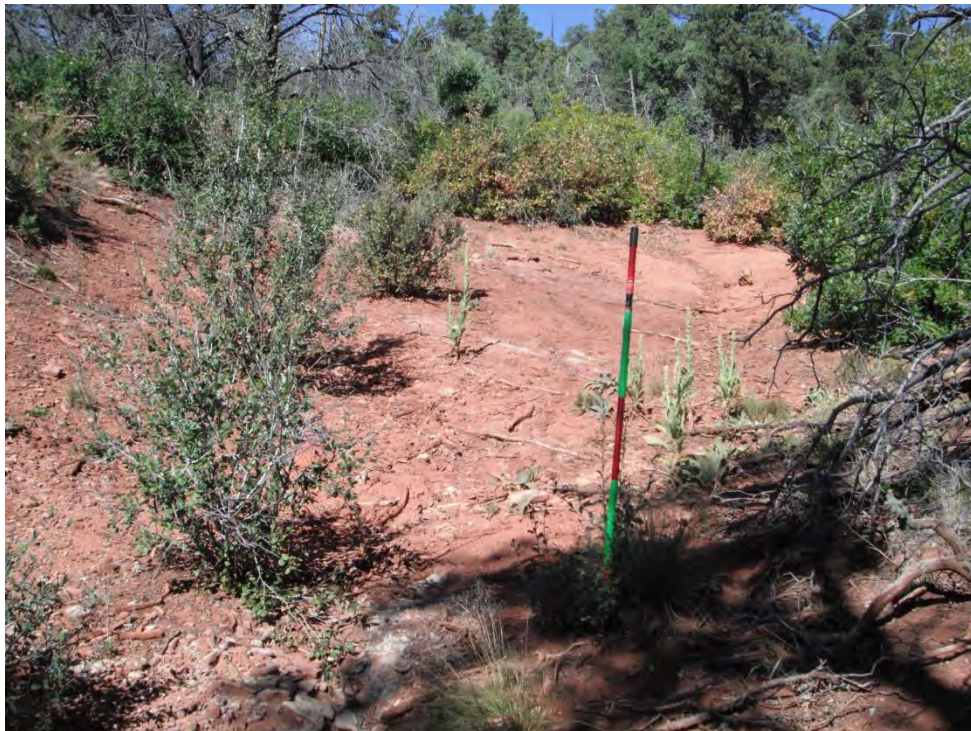
Photo 2-Looking north at DistPly-2.

DistPly-2: 20' wide, 106' long; bulldozed area

Photo-2 - DistPly-2 looking north

Rad 2 - DistPly-2; 0m - 16 $\mu\text{R/h}$; 1m - 13 $\mu\text{R/h}$

Rad 3 - DistPly-2; 0m - 13 $\mu\text{R/h}$; 1m - 11 $\mu\text{R/h}$

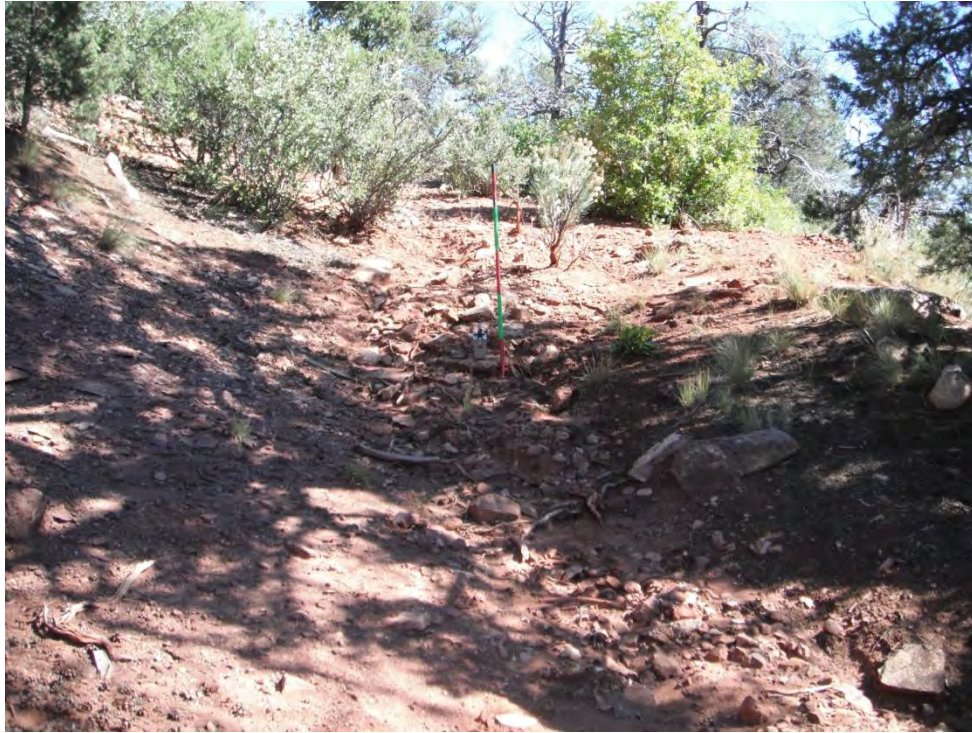
Two mine roads (Rd-1 and Rd-2) were found onsite. Rd-1 is located above CutLn-1 and leads up to the two disturbed areas from the west (see Figures 4a and 4b). Rd-2 leads south from CutLn-1 down to PilePly-1 and Corral Canyon Road below (see Figures 4a and 4b).

Photo 3-Looking east at Rd-1.

Photo 3 - MineRd-1 looking east

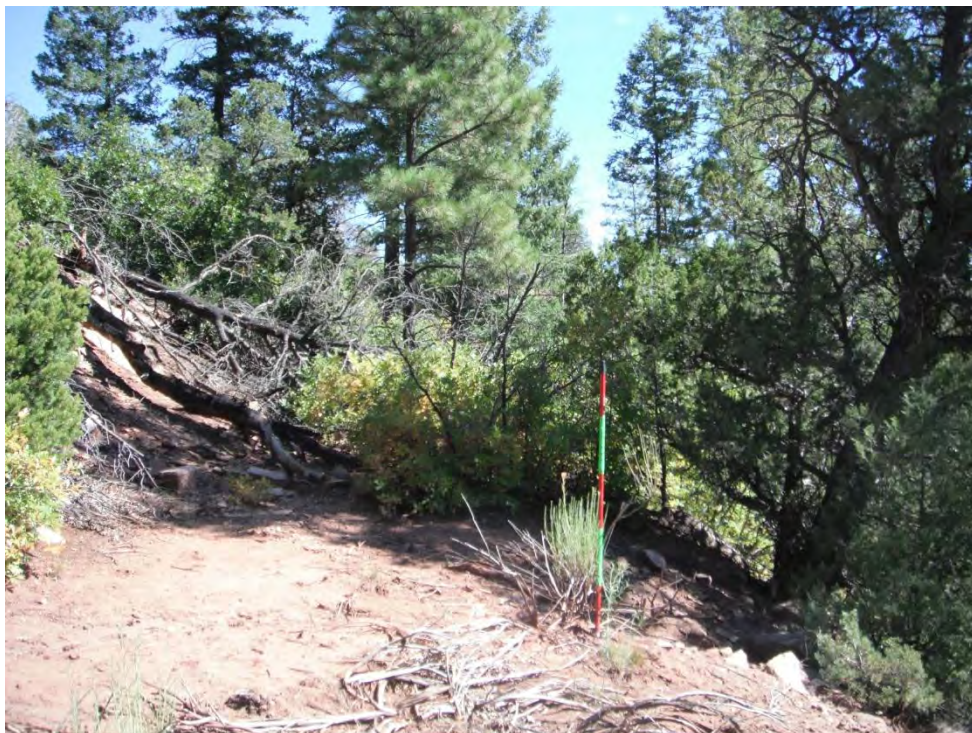
One open bench cut (CutLn-1) was found onsite. This feature is a surface excavation into the Permian sedimentary deposits exposed along the hillside at the AUM Site. The cut is overgrown and poorly exposed (see Photo 4 in Appendix A). Gamma radiation readings taken at the exposure were not significantly above background level.

Photo 4-Looking east at CutLn-1, replicating Anderson photo A.

CutIn-1; 10' wide, 100' long, 10' tall

Photo 4 - looking east at CutIn-1, replicating Anderson photo A

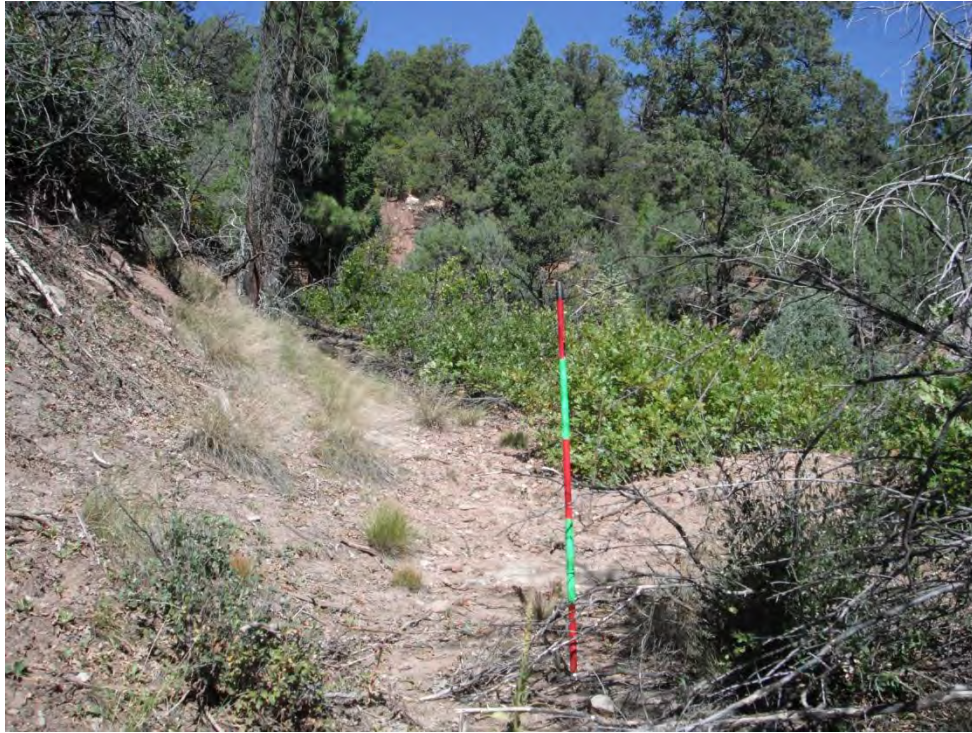
Photo 5-Looking north at Rd-2.

Rad 13 - Mine Rd-2; Om - 17 uR/h; Im - 15 uR/h

^{ACT} Photo 5 - looking north at Mine Rd-2

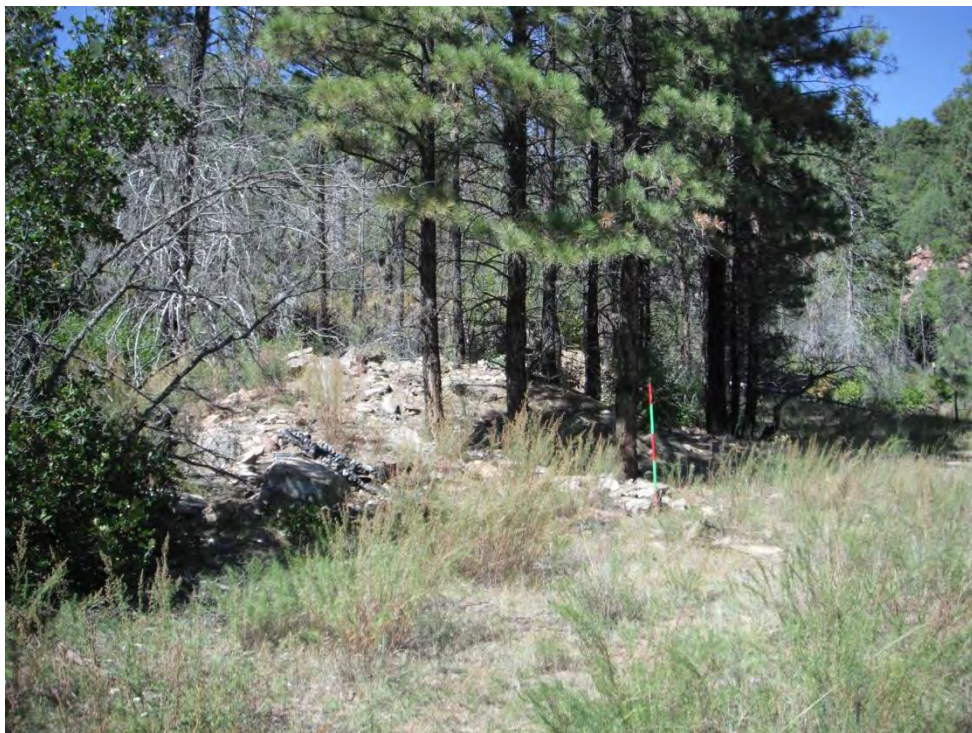
One waste pile and two disturbances were found onsite. The waste pile, PilePly-1, consists of waste rock and is located south of CutLn-1. PilePly-1 is an average of 8 ft tall, 20 ft wide, and 150 ft long (see Photos 6 and 7 in Appendix A). The disturbed areas (DistPly-1 and DistPly-2) were found upslope to the northeast of CutLn-1 (see Figures 4a and 4b). These disturbances appear to have been bulldozed areas (see Photos 1 and 2 in Appendix A). The maximum gamma radiation measurement for these features was 65 $\mu\text{R/hr}$ (microrentgens per hour) at 0 ft above ground at radiation survey point Rad-15 on PilePly-1 (see Table 2).

The maximum gamma radiation measured onsite was 65 $\mu\text{R/hr}$ at 0 ft above ground at radiation survey point Rad-15 on PilePly-1. A second gamma radiation measurement also taken at PilePly-1 (radiation survey point Rad-14) recorded 32 $\mu\text{R/hr}$ at 0 ft above ground.

Photo 6-Looking northwest at PilePly-1, replicating Anderson photo C.

Pile Ply-1 - 8' tall, 20' wide, 150' long; 45% slope

Photo 6 - looking at Pile Ply-1, northwest, replicating Anderson photo C

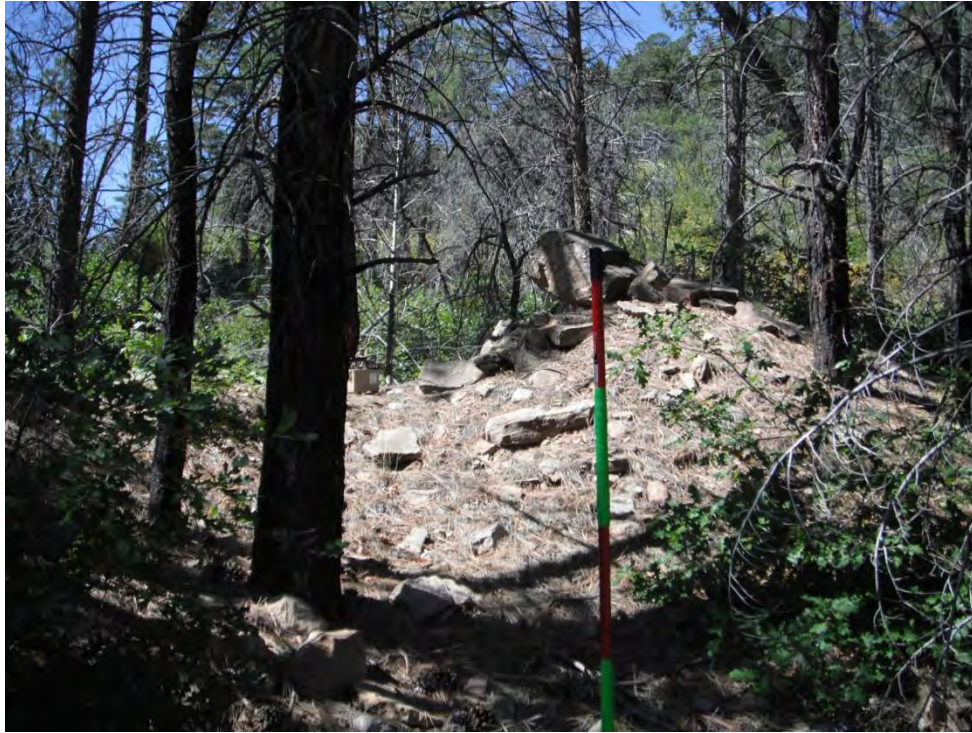
Photo 7-Looking west at PilePly-1.

Photo 7 - looking west at Pile Ply-1

Rad 14 - Pile Ply-1; Om - 32 uR/h; Im - 26 uR/h

Rad 15 - Pile Ply-1; Om - 65 uR/h; Im - 26 uR/h

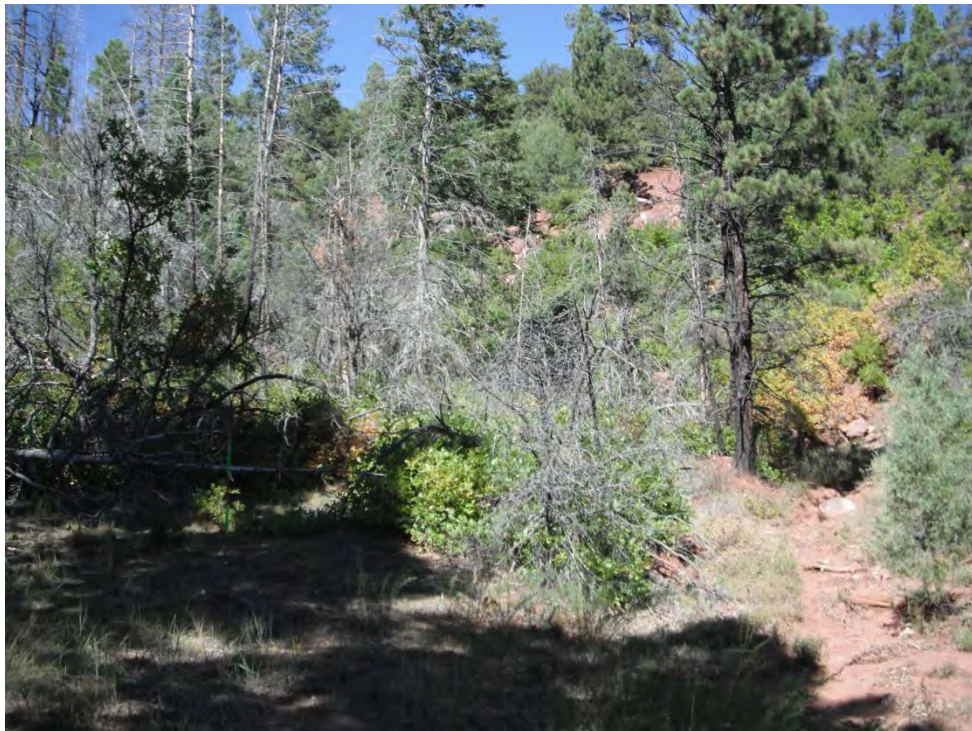
Photo 8-Looking northwest, replicating Anderson photo B.

Photo 1 - Photo 8 - northwest, replicating Anderson photo B
