Abandoned Uranium Mine Assessment for the Marie Site (NM0257)

FINAL REPORT

June 1, 2010

NM0257

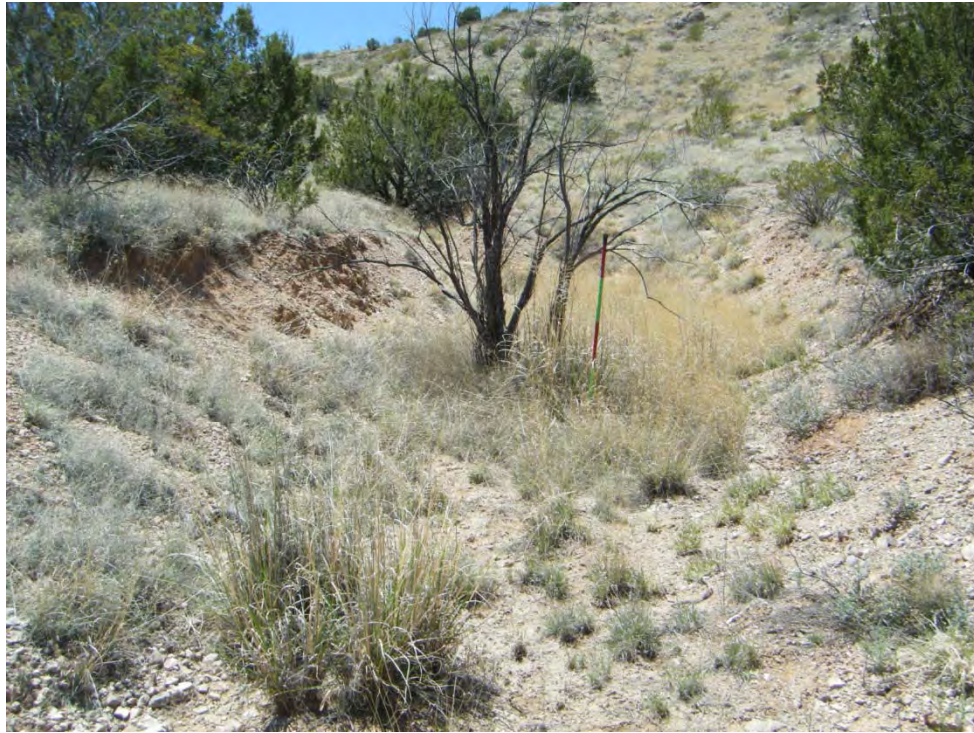
Five open cuts were found at the AUM Site. Four of the open cuts (CutPly-1, CutPly-2, CutPly-3, and CutPly-5) were shallow excavations into hillside alluvium with little exposed bedrock (see Photos 1, 3, 4, and 11 in Appendix A). CutPly-4 exposes Madera Group bedrock (see Photo 7) and may be the pit mentioned in McLemore (1983). The maximum gamma radiation measurement on these features was 150 μ R/hr at 0 ft above ground at radiation survey point Rad-5 in CutPly-3.

Photo 1-Looking west at CutPly-1.

Cut Ply 1 - 5' high; 20' wide; 75' long

Rad 1 - Cut Ply 1; 0m - 12 MR/h; 1m - 13 MR/h

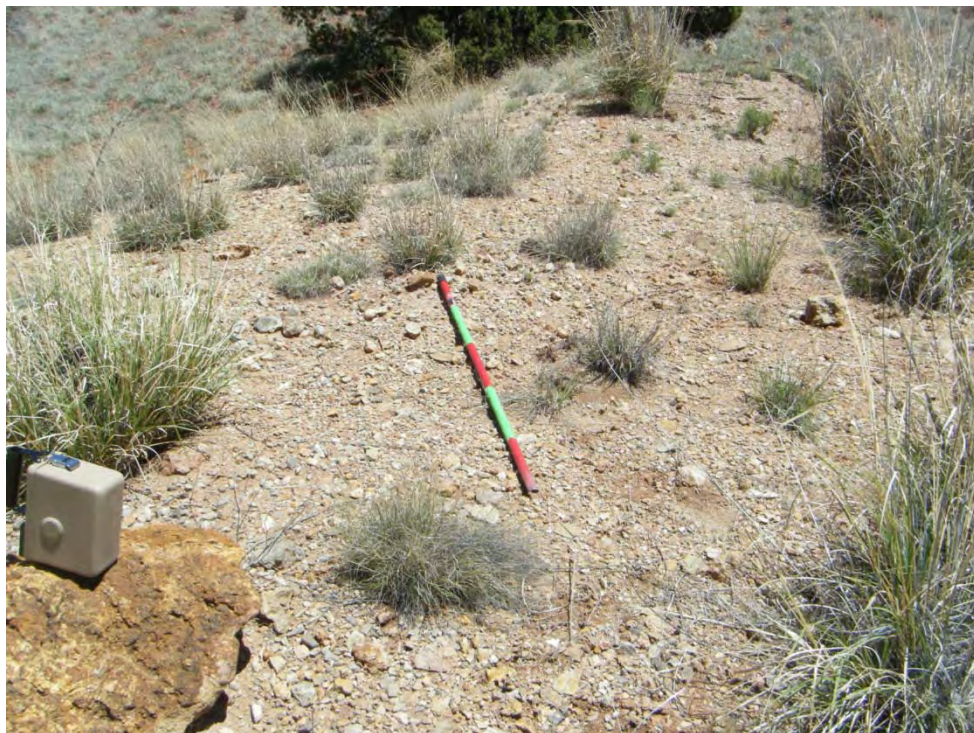
Five waste piles were found onsite. Three of the piles (PilePly-1, PilePly-2, and PilePly-3) were broad, low mounds of soil and rock (see Photos 2, 5, and 6 in Appendix A). The other two piles (PilePly-4 and PilePly-5) were isolated conical mounds (see Photos 4 and 5 in Appendix A). The

Photo 2-Looking west at PilePly-1.

Pile Ply 1 - 4' high, 30' wide, 44' long

Rad 3 - Pile Ply 1; 0m - 80 MR/h; 1m - 33 MR/h

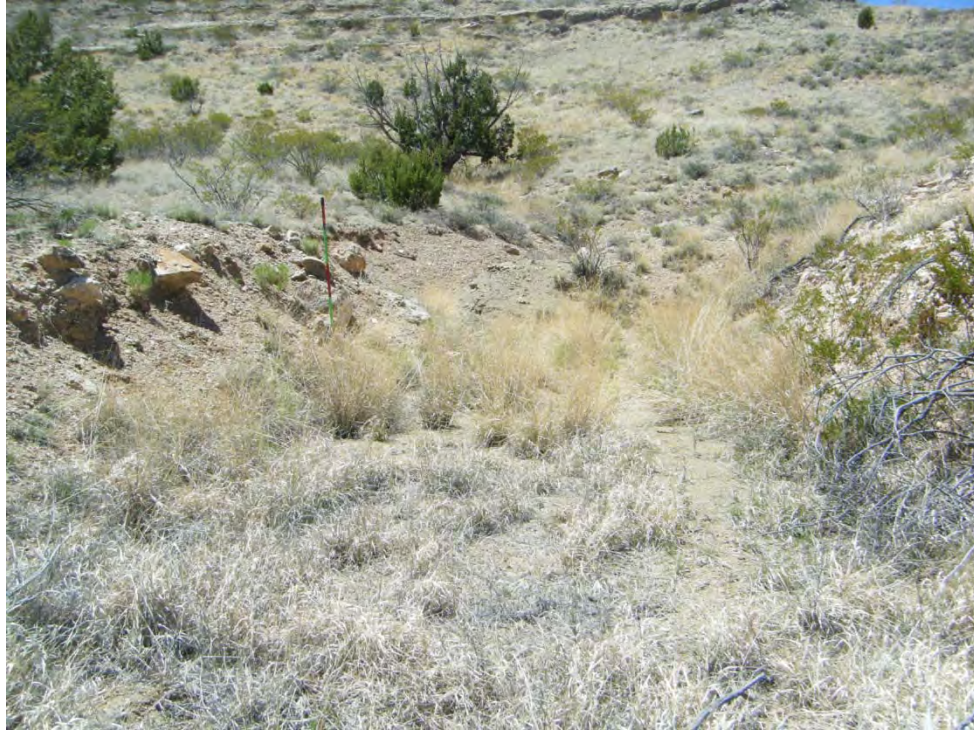
Photo 3-Looking west at CutPly-2.

Cut Ply 2 - 5' deep; 15' wide; 50' long

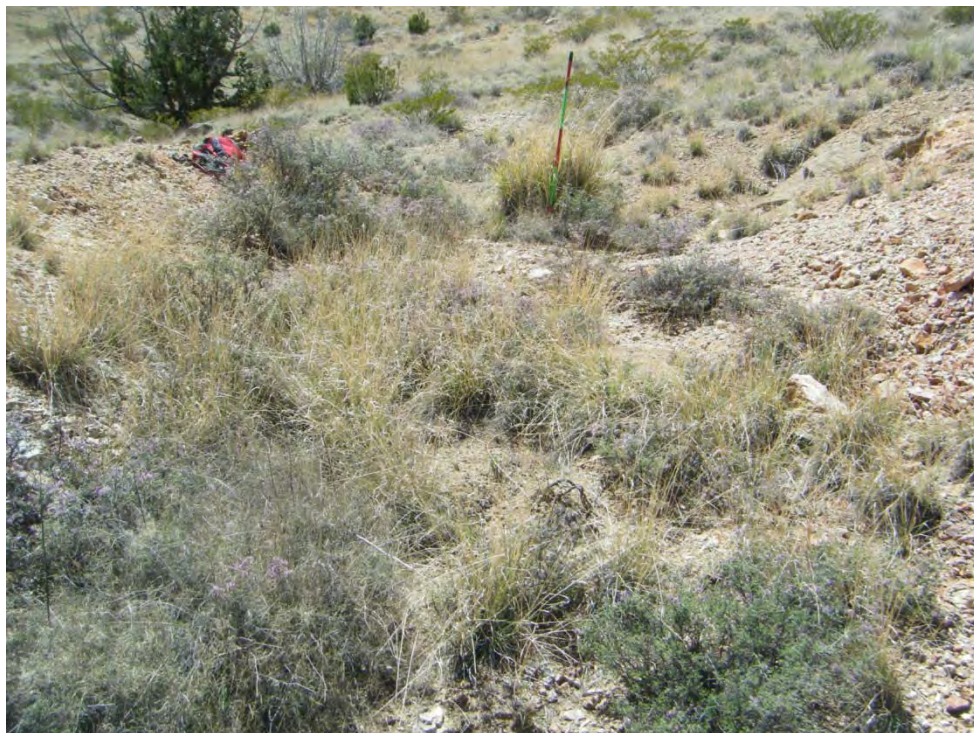
Photo 4-Looking west at CutPly-3.

Cut Ply 3 - 3' deep; 18' wide; 60' long

Rad 5 - Cut Ply 3; 0m - 150 MR/h; 1m - 90 MR/h

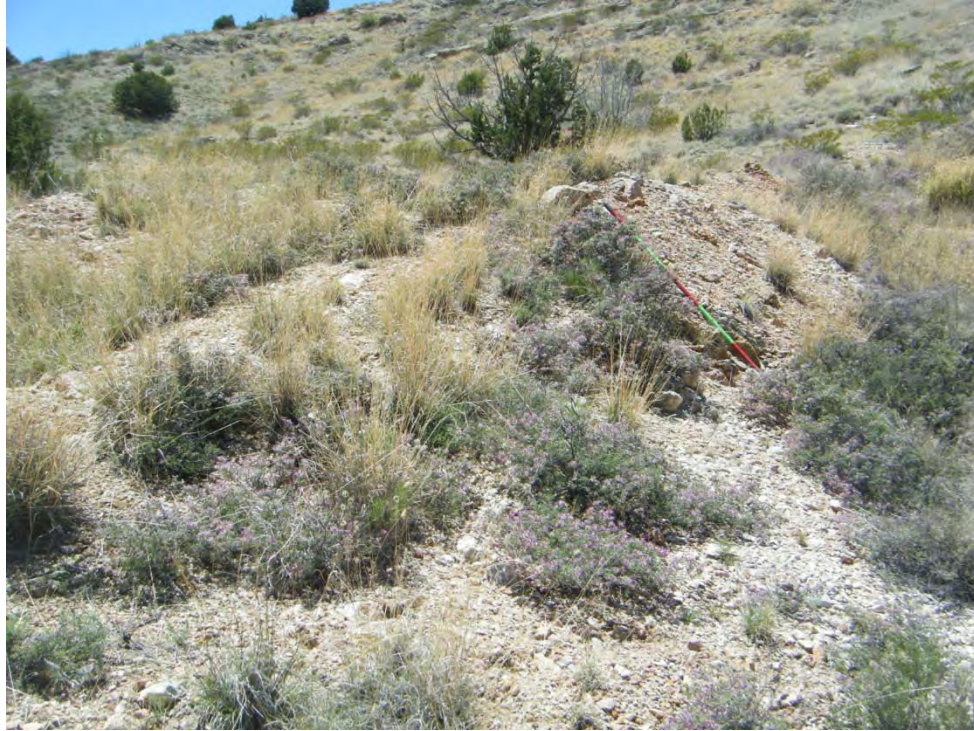
Photo 5-Looking southwest at PilePly-2.

Pile Ply 2 - 3' high; 6' wide; 40' long

Rad 6 - Pile Ply 2; 0m - 140 MR/h; 1m - 80 MR/h

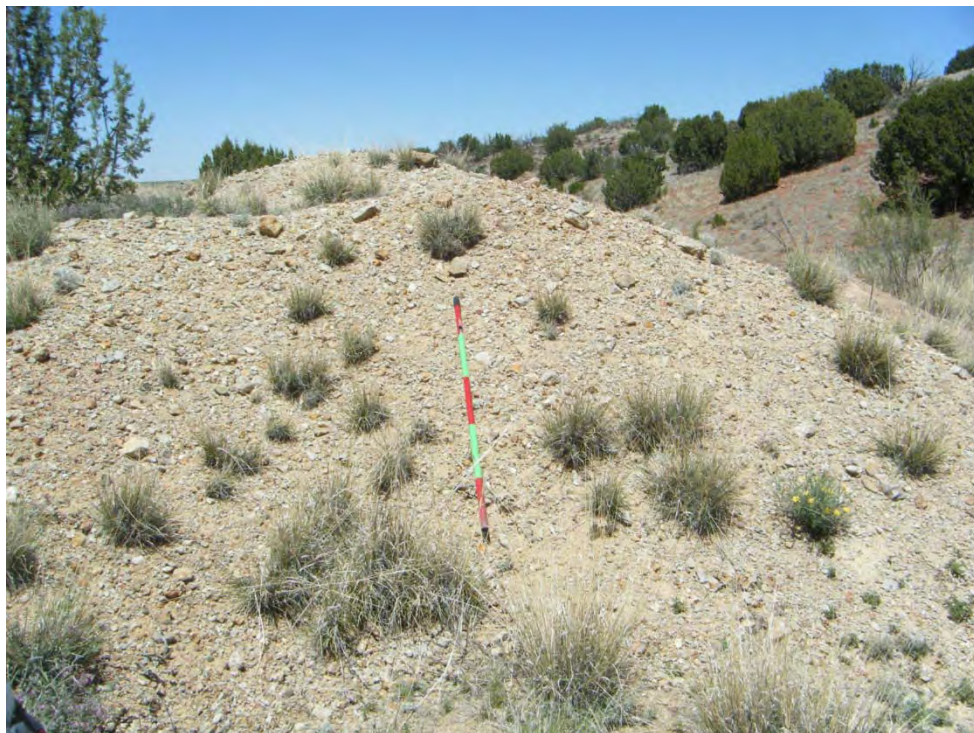
Photo 6-Looking north at PilePly-3.

PilePly 3 - 8' high; 60' wide; 60' long

Rad 7 - PilePly 3; Om - 120 MR/h; Im - 100 MR/h

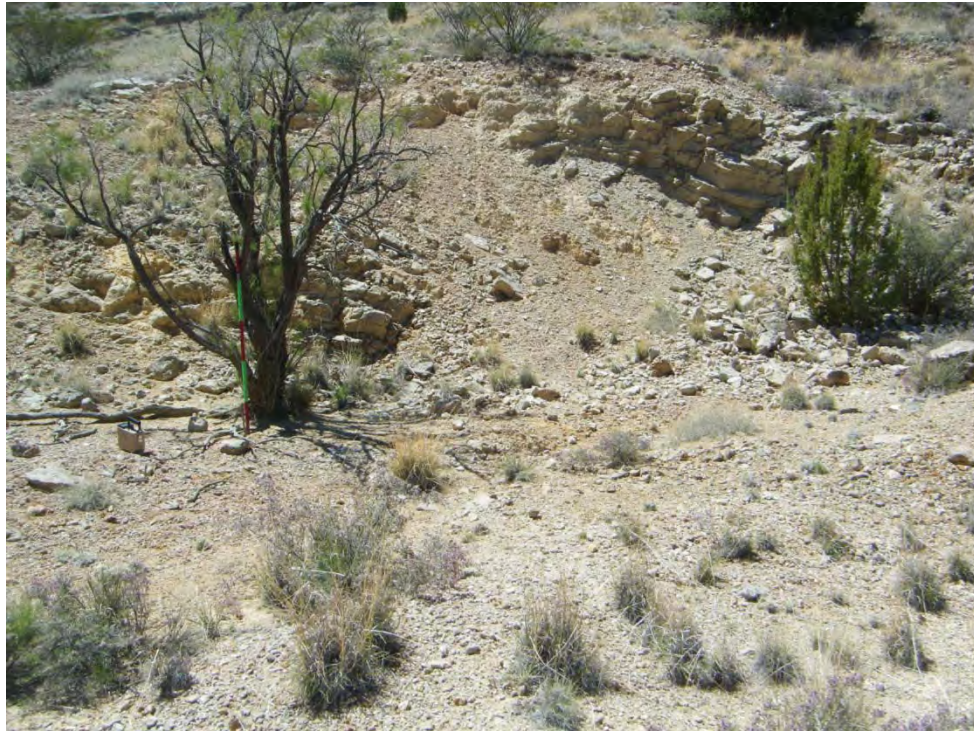
Photo 7-Looking west at CutPly-4.

CutPly 4 - 15' deep; 40' wide; 75' long

Rad 8 - CutPly 4; Om - 110 MR/h; Im - 60 MR/h

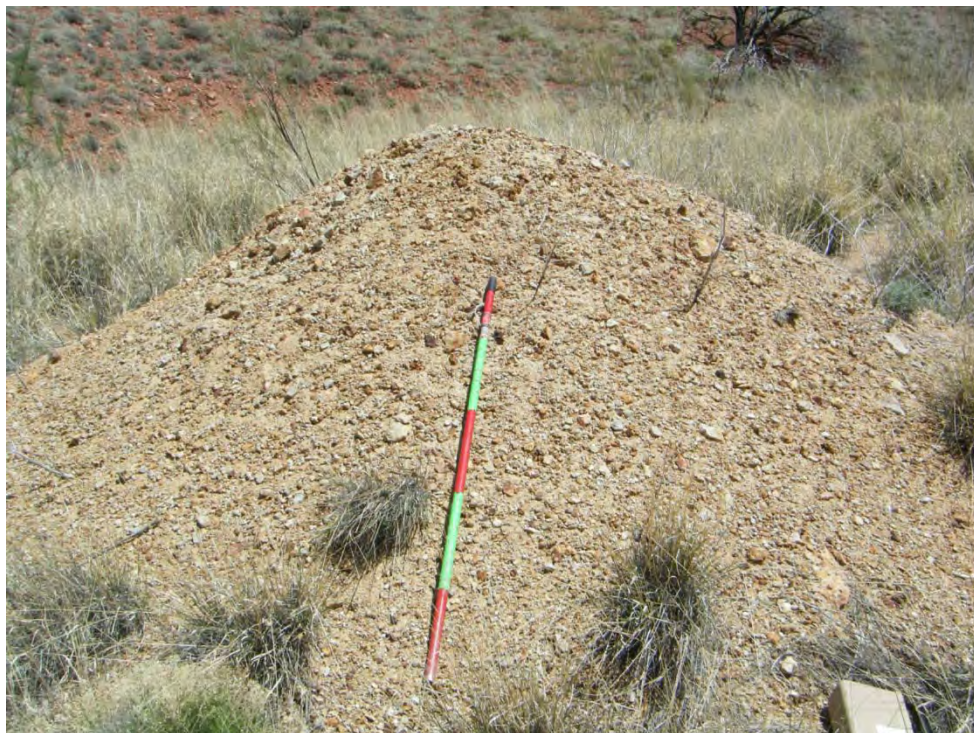
maximum gamma radiation measurement on these features was 1000 $\mu\text{R/hr}$ at 0 ft above ground at radiation survey point Rad-9 on PilePly-4.

The maximum gamma radiation measured onsite was 1000 $\mu\text{R/hr}$ at 0 ft above ground at radiation survey point Rad-9 on PilePly-4. A gamma radiation measurement taken on PilePly-5 (radiation survey point Rad-10) recorded 350 $\mu\text{R/hr}$ at 0 ft above ground.

Photo 8-Looking southeast at PilePly-4.

PilePly 4 - 5' high; 15' wide, 15' long

Rad 9 - PilePly 4; Om - 1000 MR/h; Im - 340 MR/h

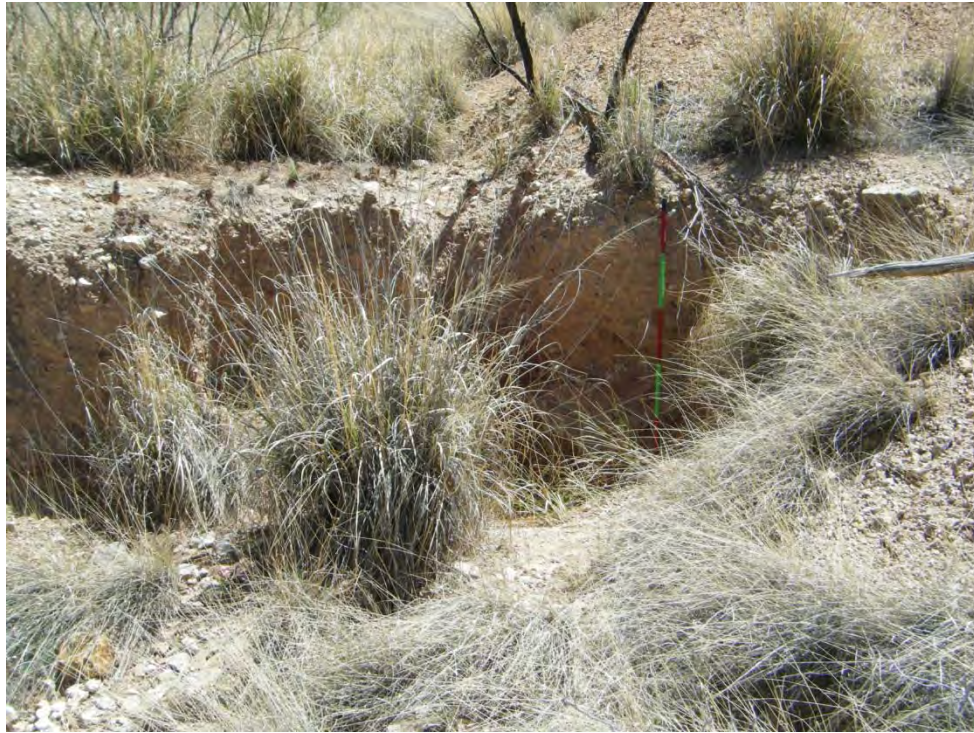
A drainage (ErosPt-1) runs south to north just east of the mine features (see Photo 9 in Appendix A). This drainage is eroding some material from nearby waste piles.

A gully is forming to the east of the mine features (see Photo 9 in Appendix A). Material from waste piles is being eroded into this gully.

Photo 9-Looking south at a gully (ErosPt-1).

ErosPt 1 - headcut in the drainage; 5' deep, 20' wide, 40' long

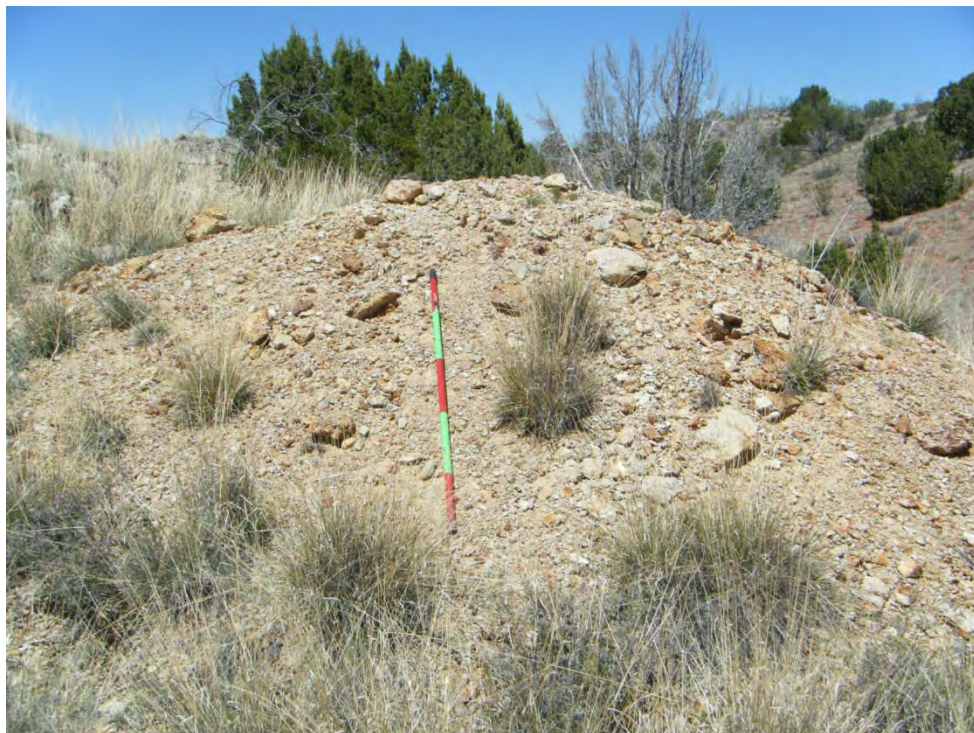
Photo 10-Looking north at PilePly-5.

PilePly 5 - 6' high; 15' wide; 18' long

Rad 10 - PilePly 5; Om - 350 MR/h; Im - 230 MR/h

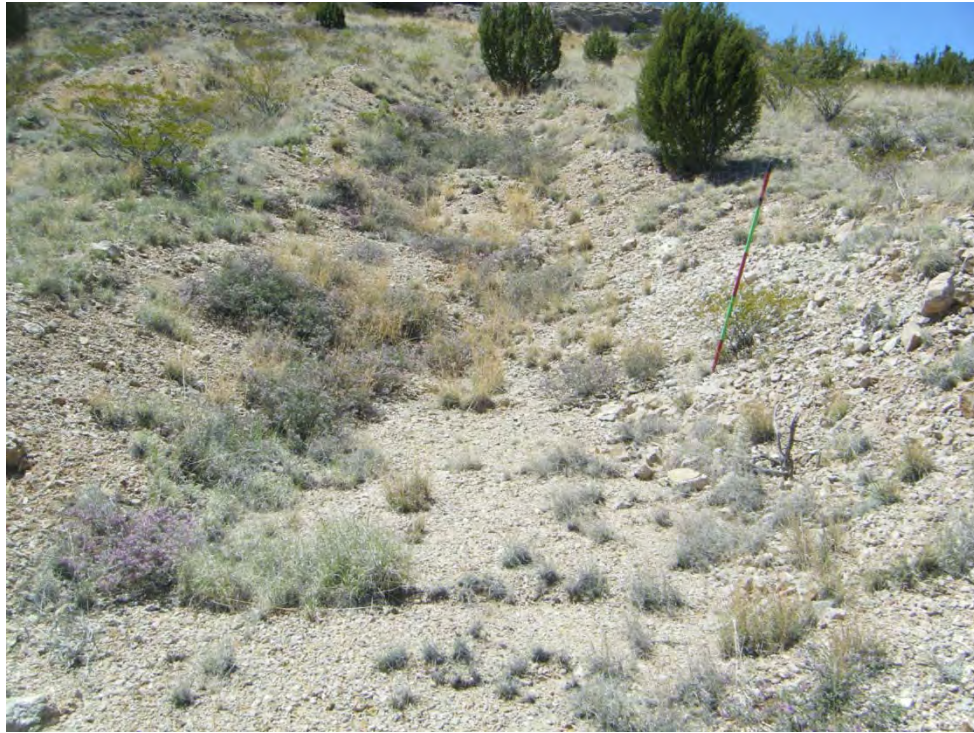
Photo 11-Looking west at CutPly-5.

CutPly 5 - 3' deep; 18' wide; ^{ALT} 20' long 60'

Rad 11 - CutPly 5; Om - 15 MR/h; Im - 14 MR/h

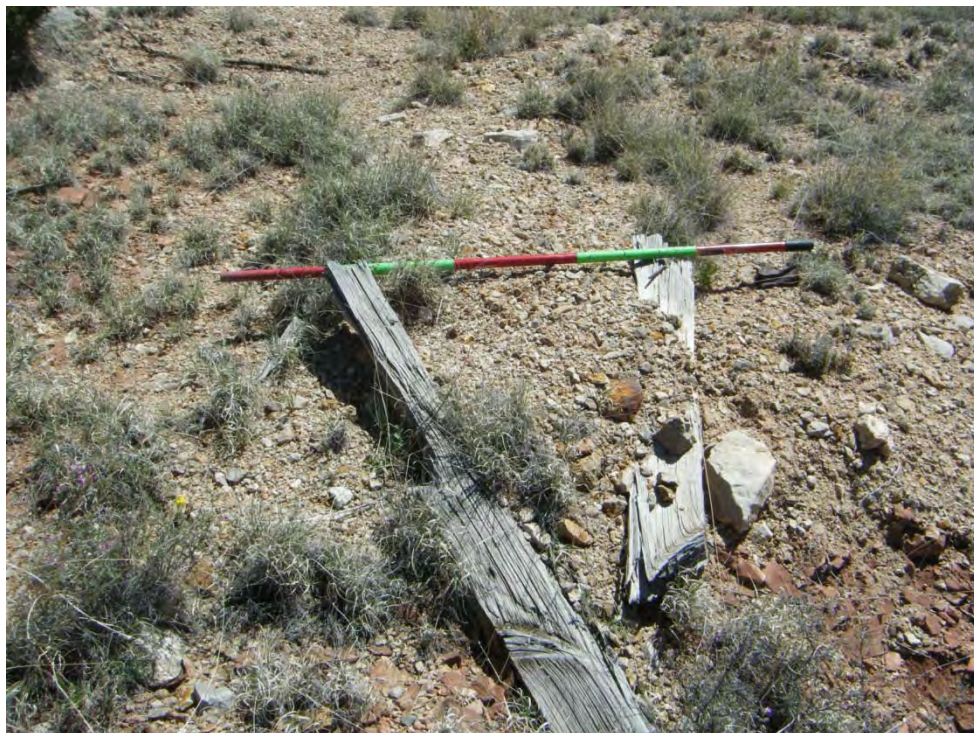
Scattered wooden boards (StrucPly-1, see Photo 12 in Appendix A) were found onsite.

Photo 12-Looking south at wooden planks (StrucPly-1).

StructPly 1 - 15' x 15', timber

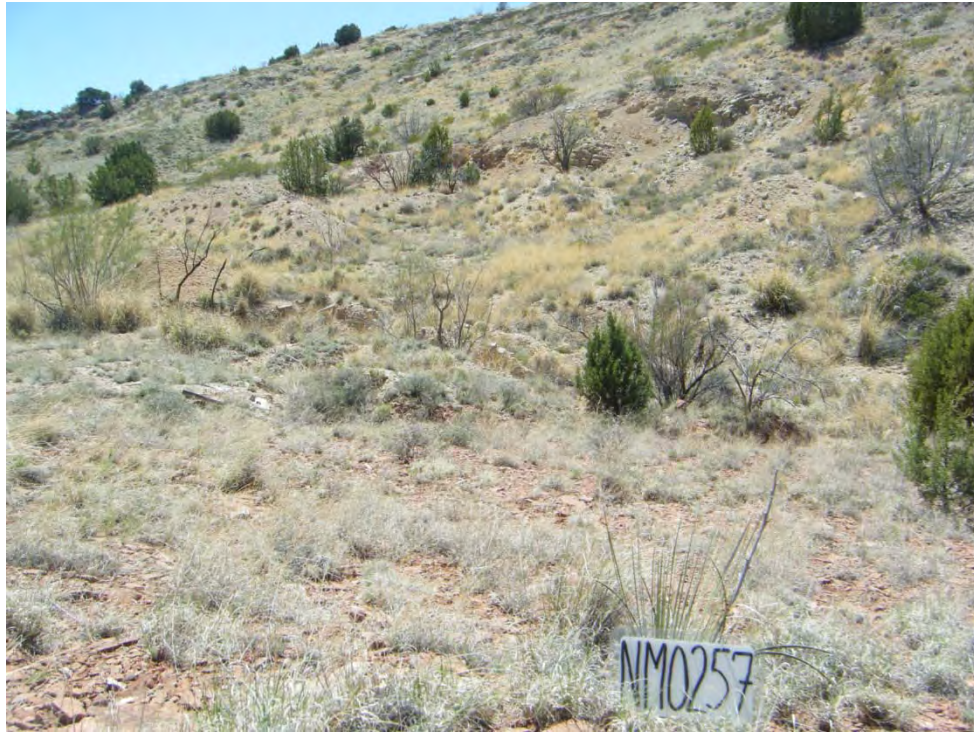
Photo 13-Site photo, looking west.
