**Memorandum**

**Subject:** Pre-CERCLIS Screening Assessment of Davenport Mine,  
McKinley County, New Mexico: Further action under CERLCA  
Recommended

<b>Site name</b>	Davenport Mine			
<b>City</b>	not applicable	<b>State</b>	New Mexico	<b>Zip code</b> not applicable
<b>County</b>	McKinley			
<b>Latitude</b>	35° 20' 27.10"	<b>Longitude</b>	107° 49' 15.38"

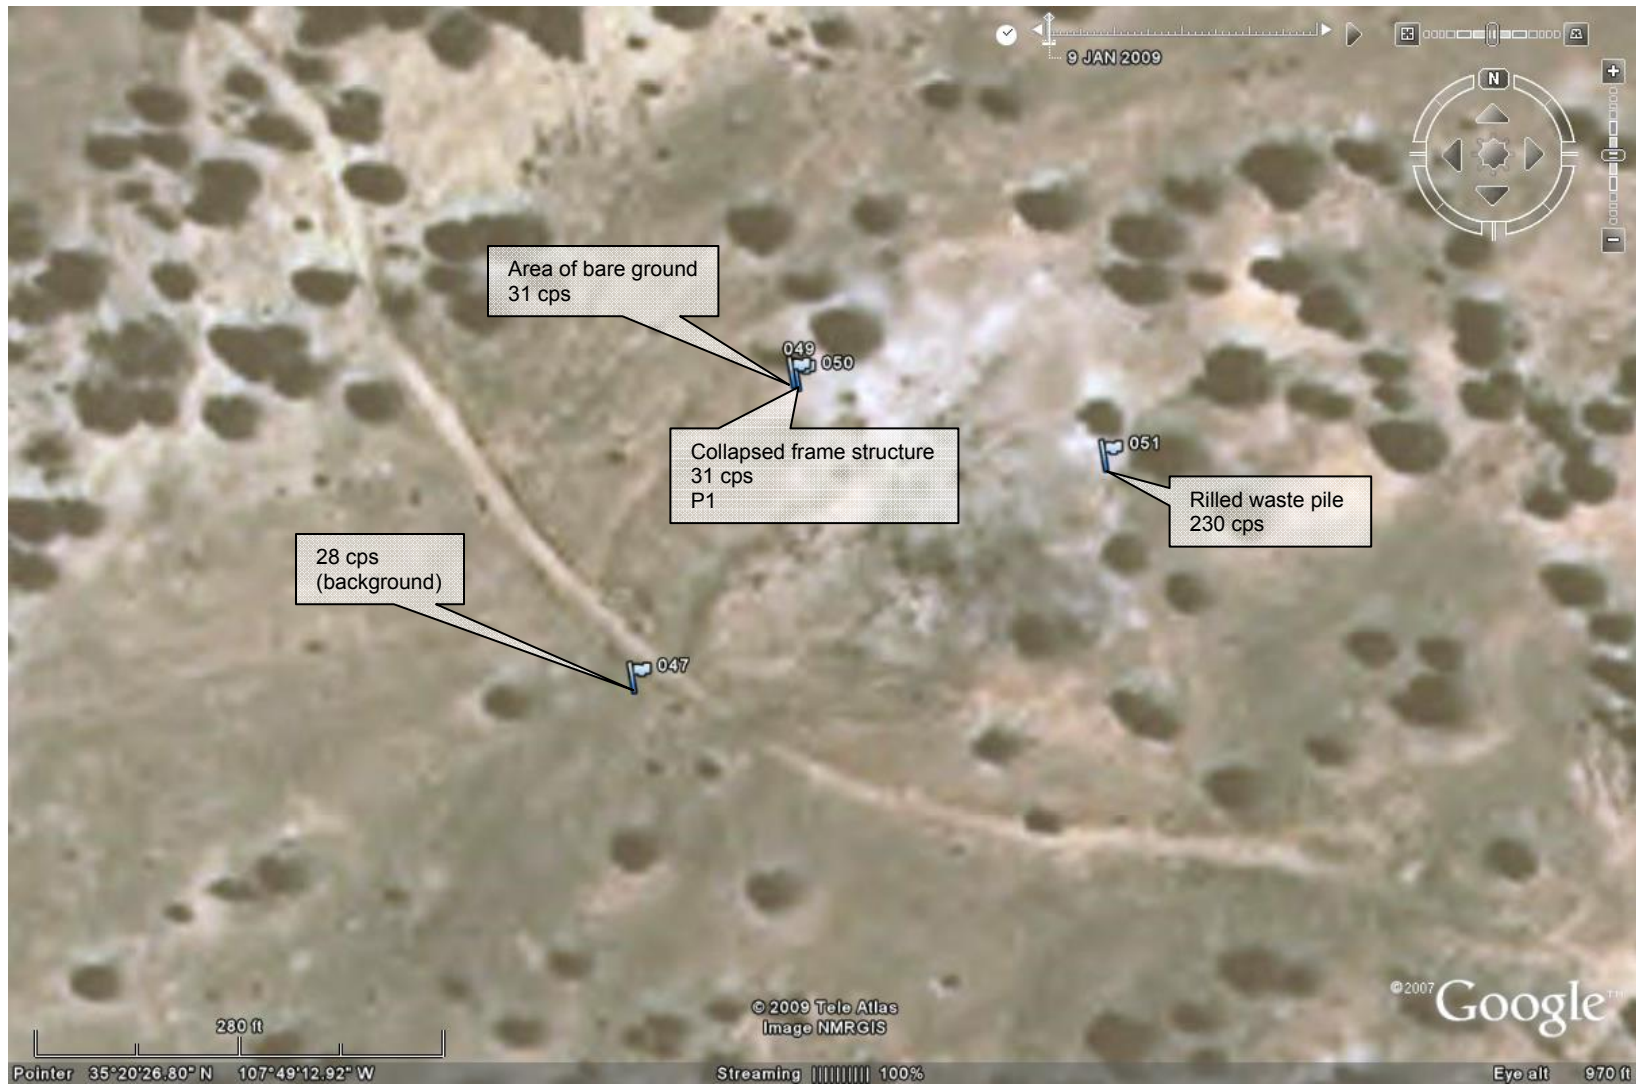
**Figure 1: Davenport Mine—measurements made on June 3, 2009**

**Site summary:** Observations made during NMED's Site reconnaissance are shown on the accompanying figures. One waste rock pile has slightly elevated radioactivity (230 counts per second [cps]; background=28 cps).

1. Remove waste with elevated radioactivity.

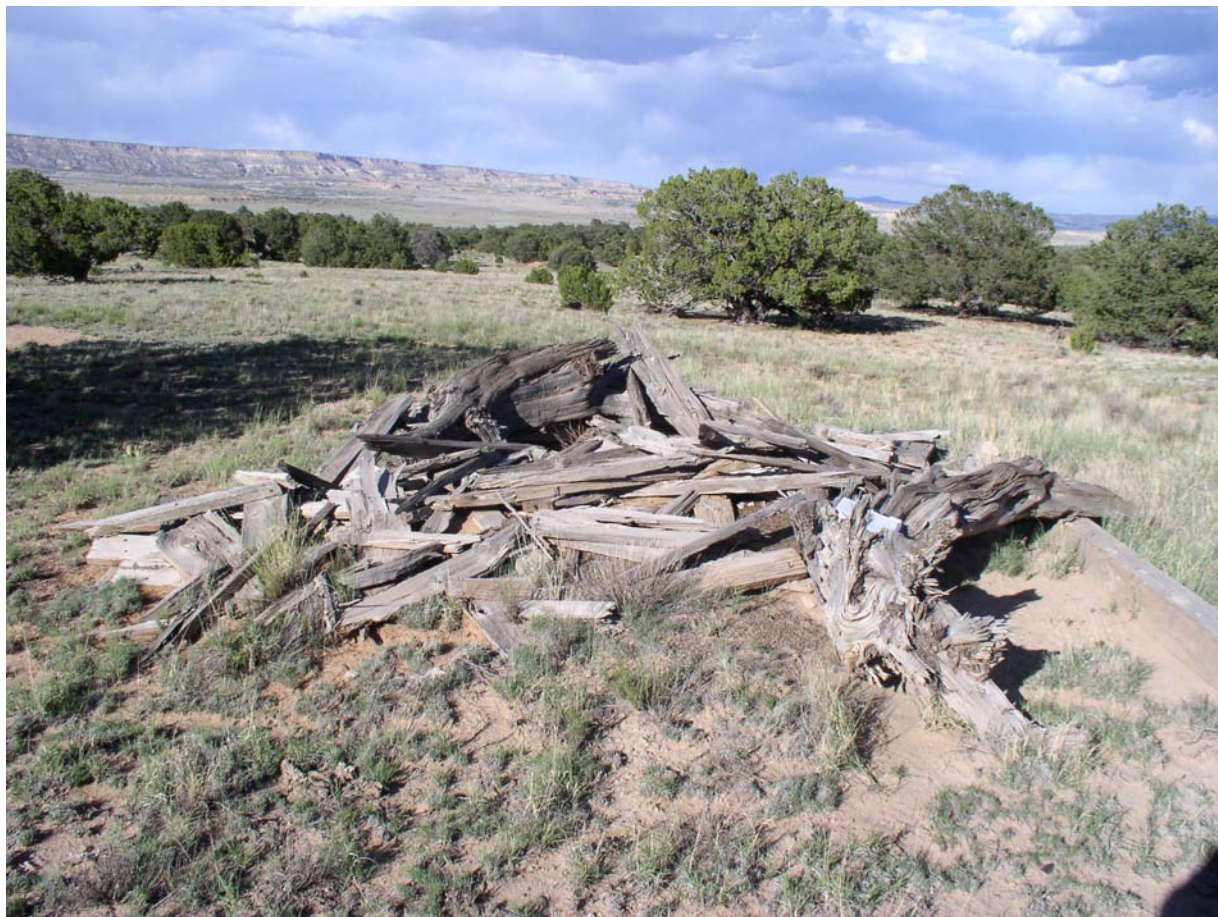
**Site physical description:** The Davenport Mine currently has waste rock piles and a collapsed frame structure. Little other evidence of the mine remains.

P1: Davenport Mine collapsed frame structure
