Abandoned Uranium Mine Assessment for the Hogback Site (NM0196)

FINAL REPORT

September 10, 2010

NM0196

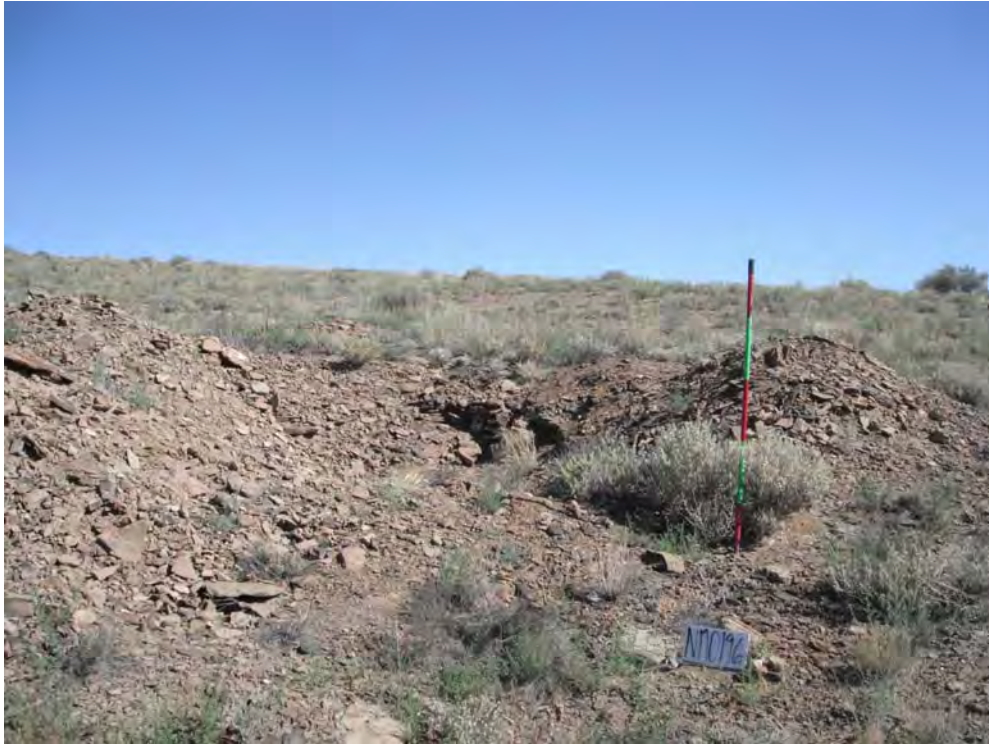
Photo 1-Site location photo, looking north at Pit-1.

Pit-1 - 10' x 10', 4' deep; may be ~~"main pit"~~ ^{ALT}

Rad-1 - Pit-1; Om - 225 uR/h; 1m - 105 uR/h

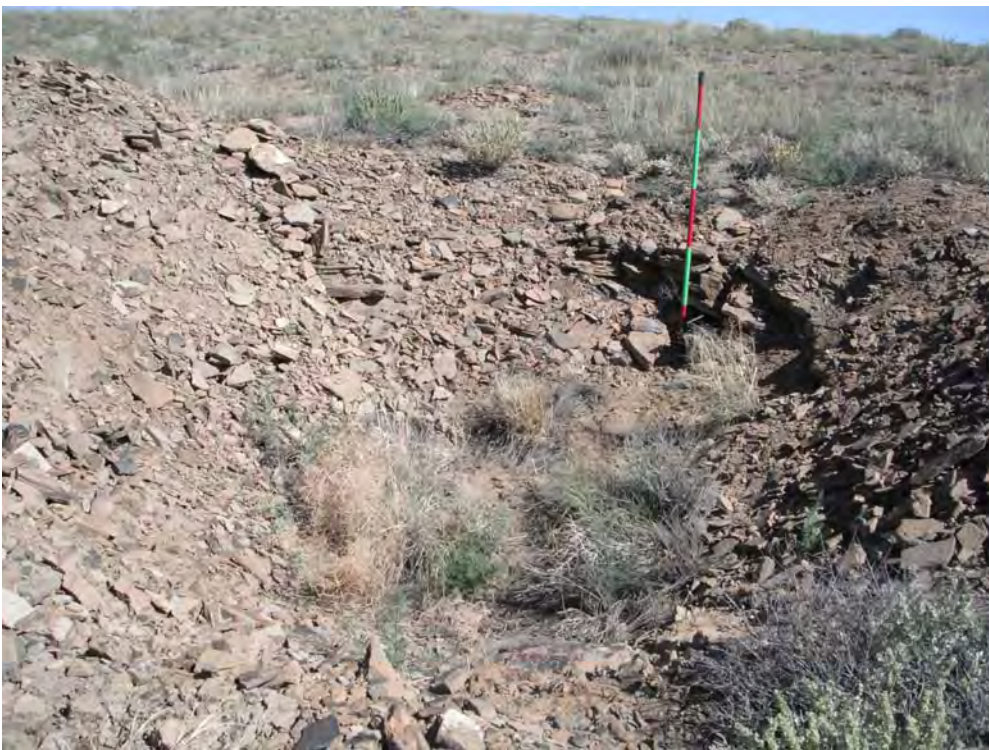
cuts (see Photos 1, 2, and 4 in Appendix A). The maximum gamma radiation measurement for these features was 300 $\mu\text{R/hr}$ at 0 ft above ground at radiation survey point Rad-5 in Pit-2.

The maximum gamma radiation measured onsite was 300 $\mu\text{R/hr}$ at 0 ft above ground at radiation survey point Rad-5 in Pit-2. A gamma radiation measurement taken within Pit-1 (radiation survey point Rad-1) recorded 225 $\mu\text{R/hr}$ at 0 ft above ground, and a measurement taken on PilePly-2 (radiation survey point Rad-6) recorded 160 $\mu\text{R/hr}$ at 0 ft above ground.

Photo 2-Looking north at Pit-1.

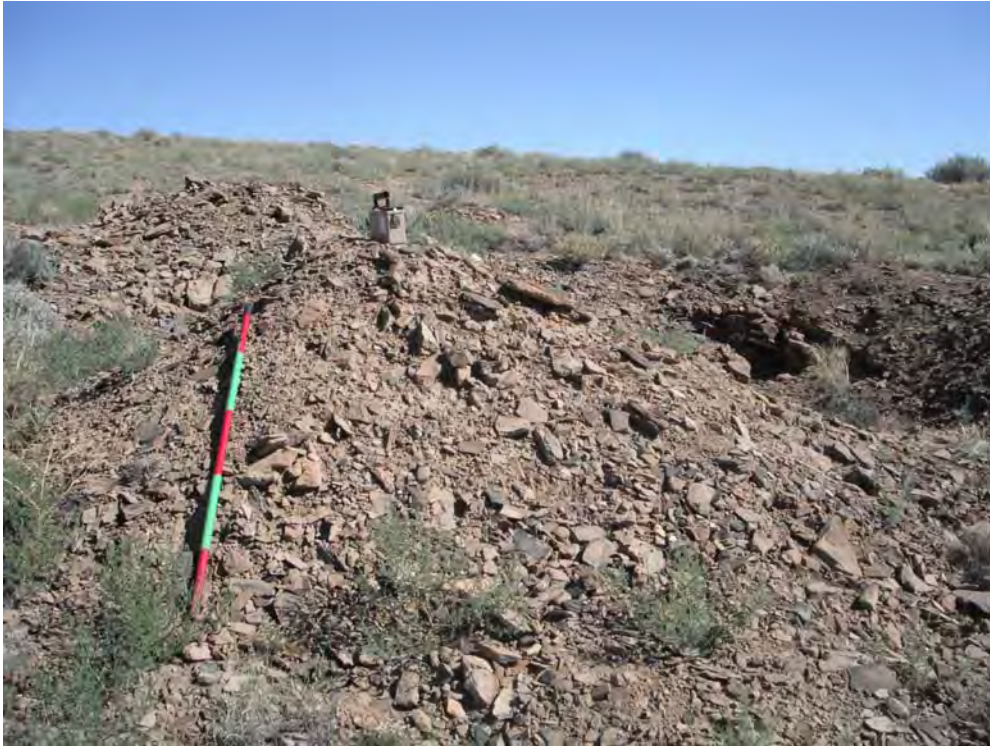
Photo 3-Looking north at PilePly-1.

PilePly-1 - waste pile associated with Pit 1; 15' long, 6' wide, 5' tall, 25% slope

Rad-2 - PilePly1; Om - 80 uR/h; 1m - 70 uR/h

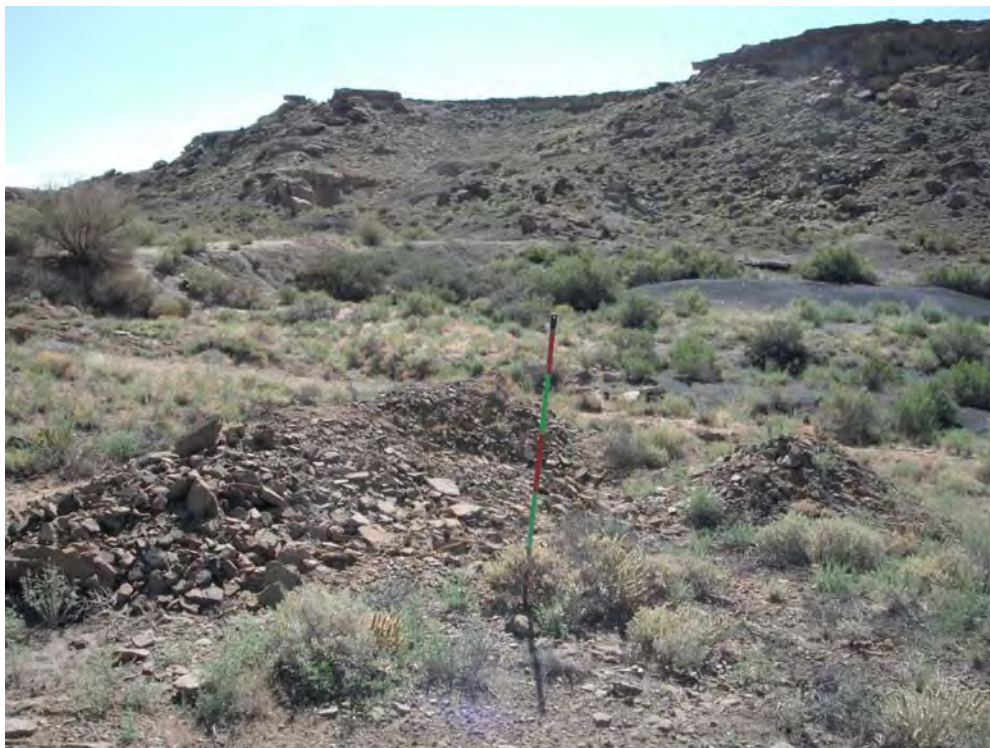
Photo 4-Looking east at Pit-1.

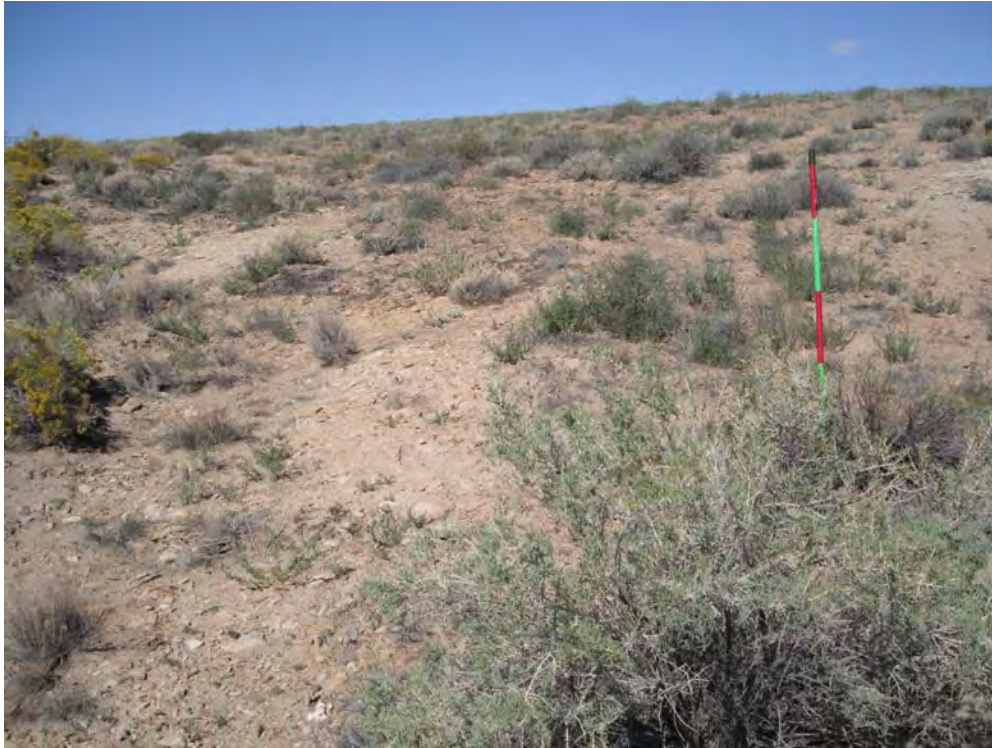
Photo 5-Looking west at DistPly-1.

DistPly-1 - may be self-remediating; 1' deep, 30' x 30'

Rad-3 - DistPly-1; Om - 25 uR/h; 1m - 23 uR/h

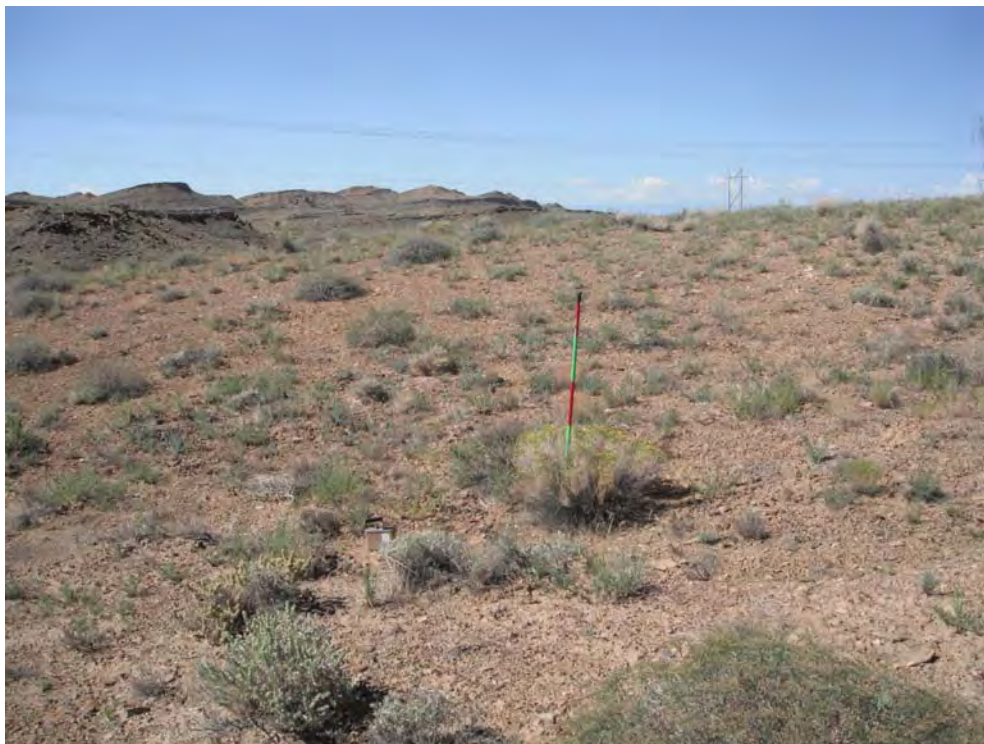
Photo 6-Looking south at DistPly-2.

DistPly-2 - 50' wide, 125' long, 2' deep, maybe self-remediating
dozer cut

Rad-4 - DistPly-2; Om - 45 uR/h; 1m - 38 uR/h

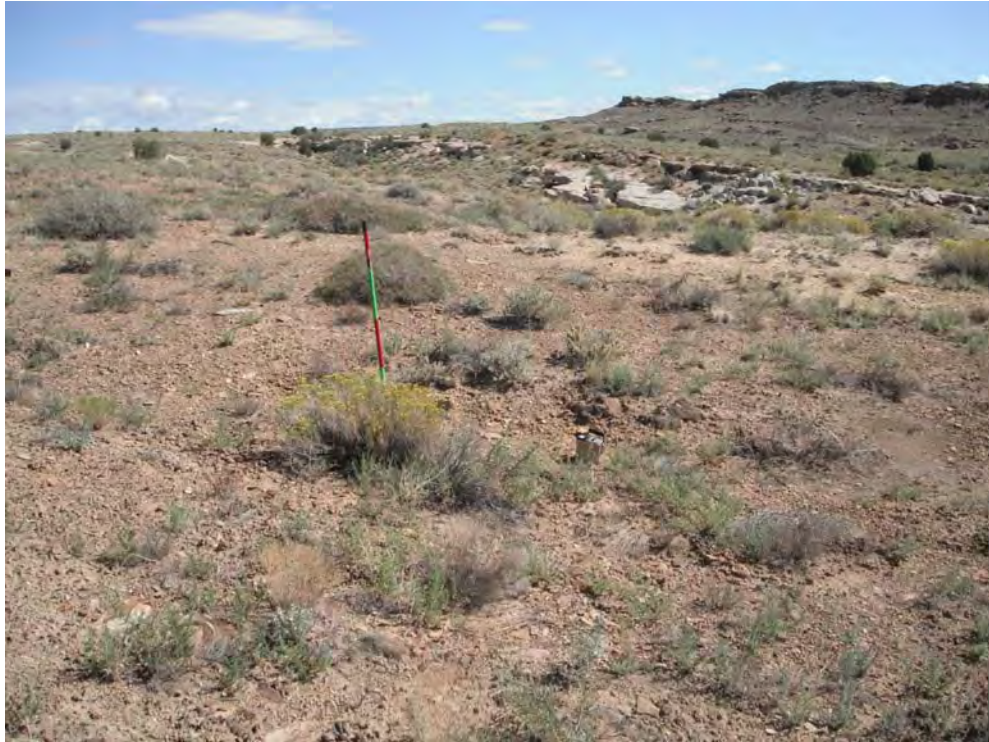
Photo 7- Looking north at DistPly-2.

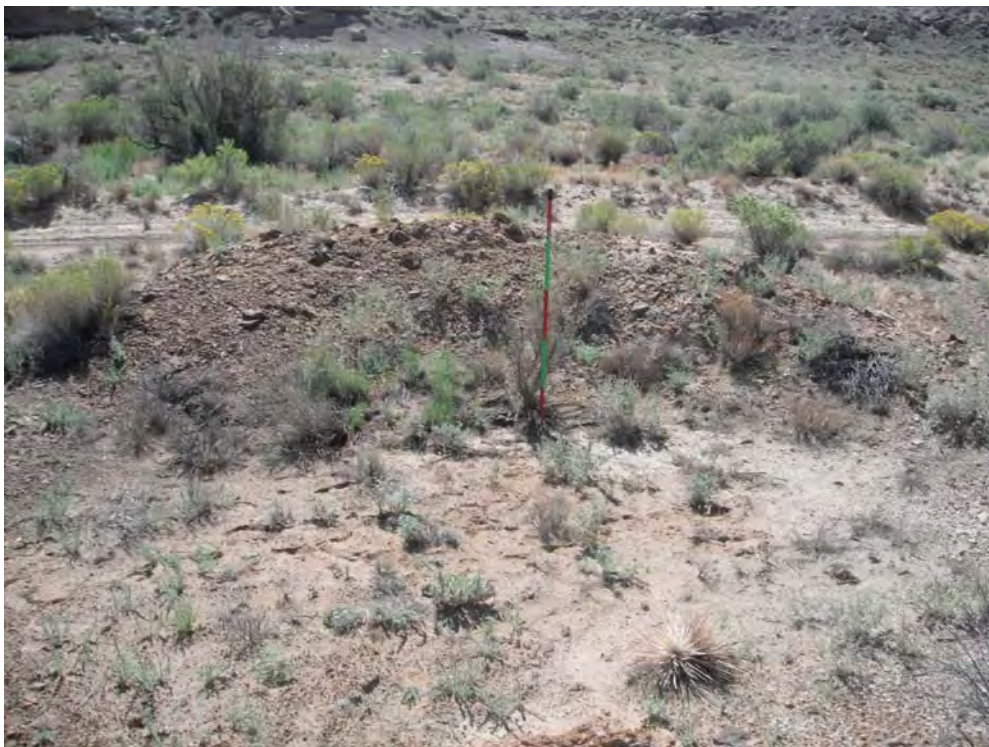
Photo 8- Looking east at Pit-2.

Pit-2 - 4' deep, 15' wide, 20' long; "main pit" in Anderson report

Rad-5 - Pit-2; Om - 300 uR/h; 1m - 180 uR/h

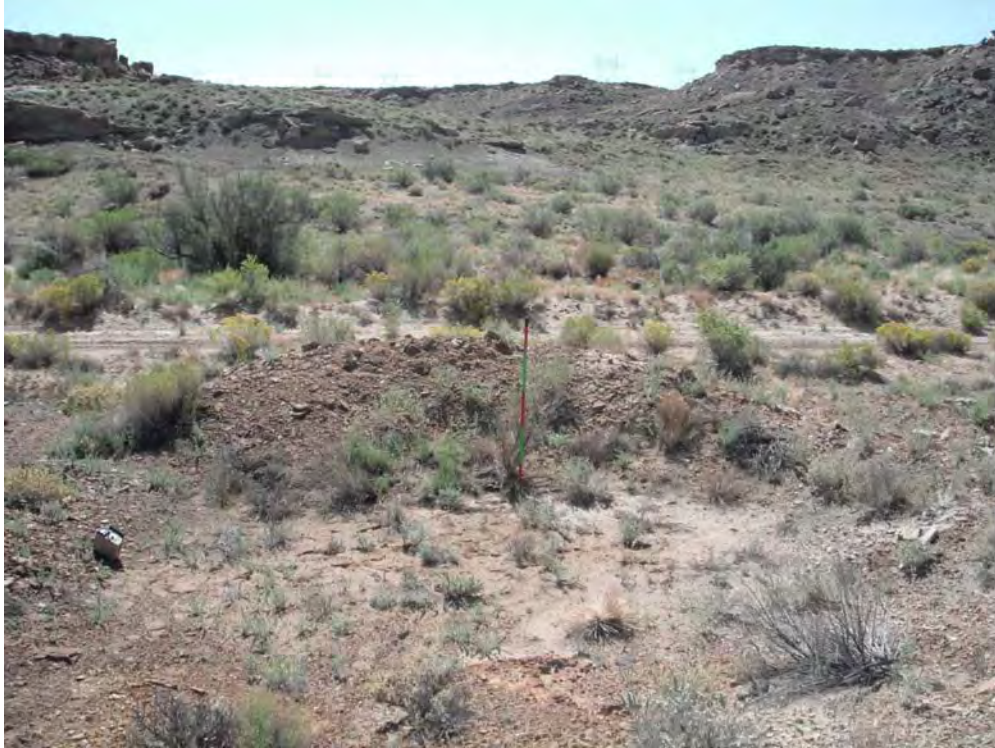
Photo 9- Looking east at Pit-2, replicating Anderson photo A.

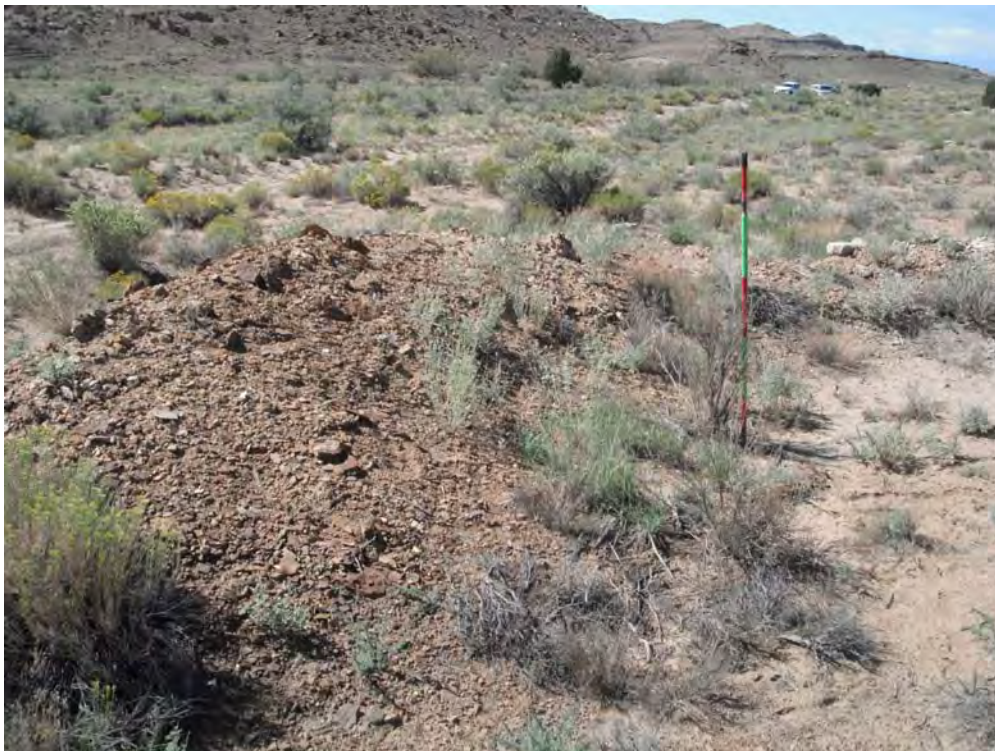
Photo 10-Looking south at PilePly-2.

PilePly-2 - with Pit-2 - 4' tall, 6' wide, 30' long; 30%

Rad-6 - PilePly-2; Om - 160 uR/h; 1m - 110 uR/h

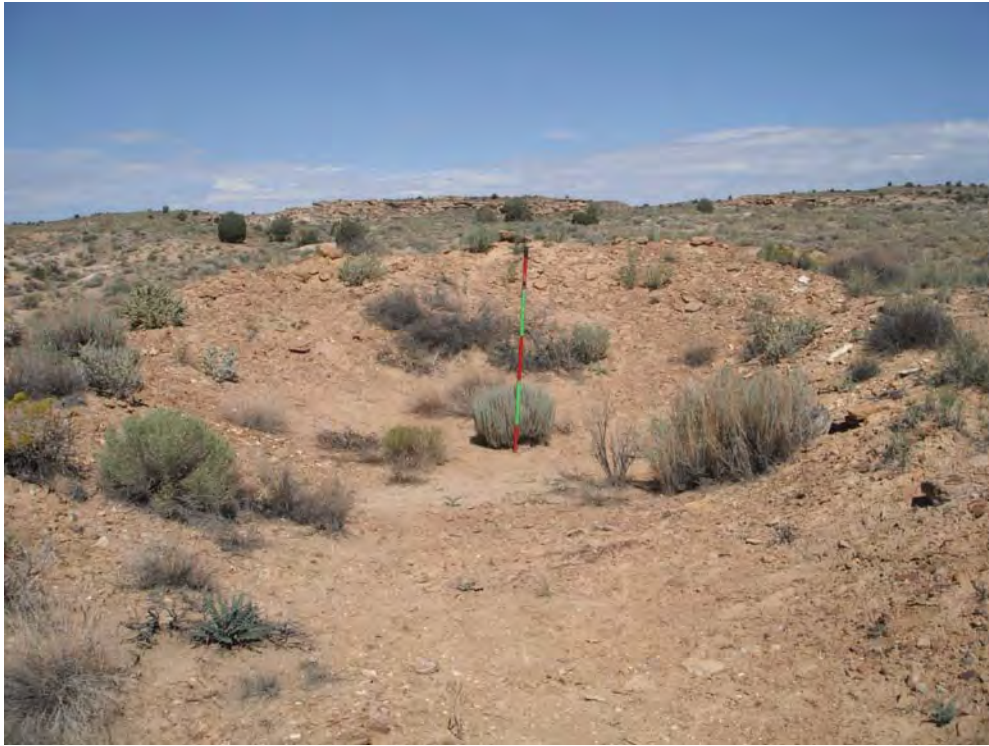
Photo 11-Looking west at Pit-3, replicating Anderson photo C.

Pit-3 - 3' deep, 10' wide, 20' long, dozer cut in Photo c

Rad-7 - Pit 3; Om - 90 uR/h; 1m - 60 uR/h

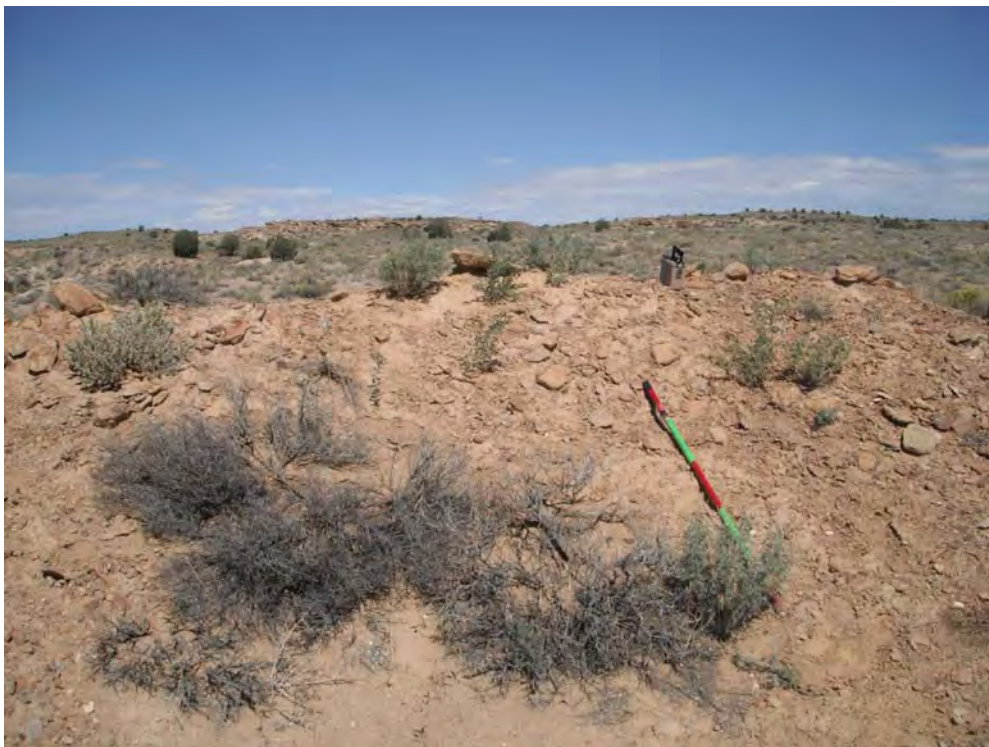
Photo 12-Looking west at PilePly-3.

PilePly-3 - with Pit 3; 6' high, 10' wide, 20' long 35%

Rad-8 - PilePly 3; Om - 60 uR/h; 1m - 38 uR/h

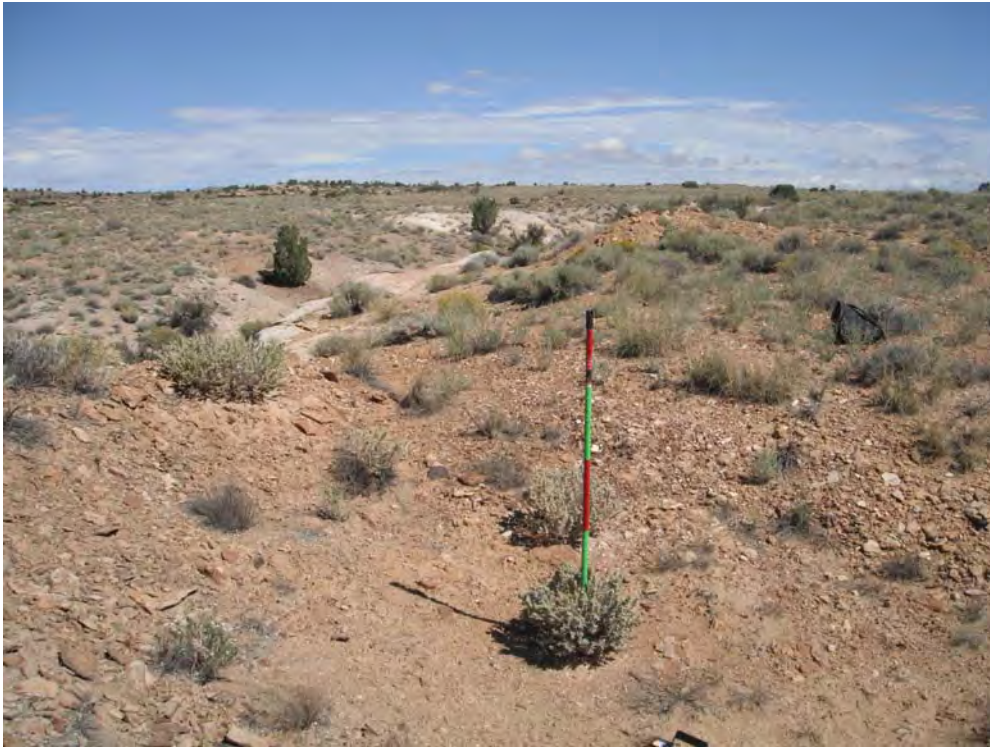
Photo 13-Looking northwest at Pit-4.

Pit-4 - 3' deep, 10' wide, 20' long; dozer cut in Anderson

Rad-9 - Pit 4; Om - 80 uR/h; 1m - 60 uR/h

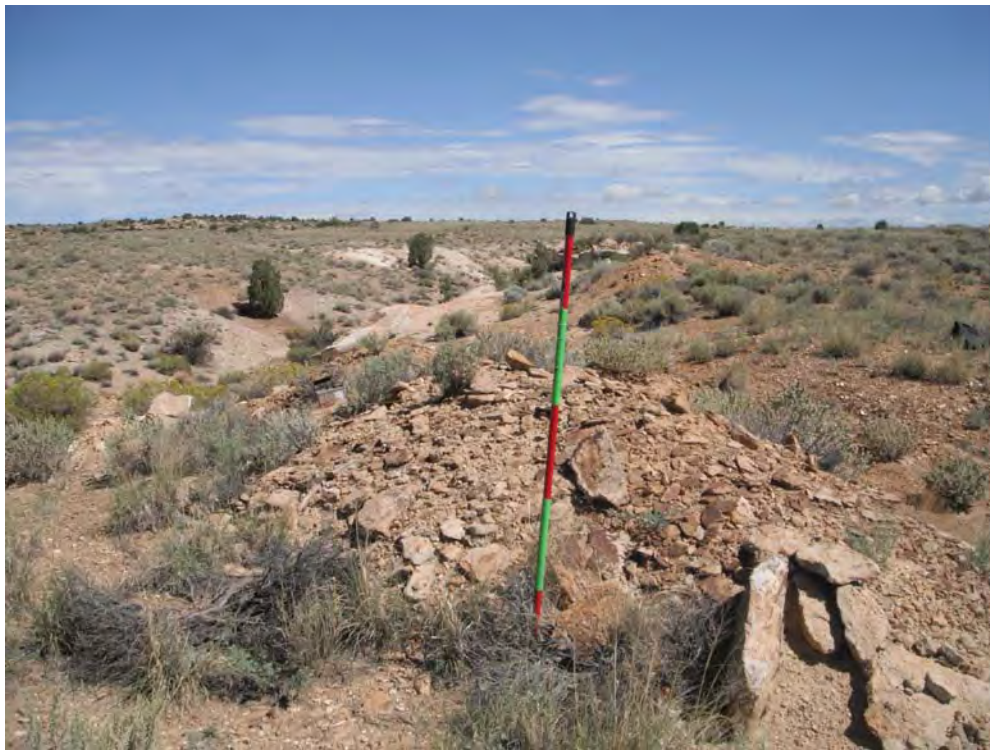
Photo 14-Looking north at PilePly-4.

PilePly 4 - 5' high, 8' wide, 30' long,

Rad-10 - PilePly-4; Om - 80 uR/h; 1m - 70 uR/h
