Abandoned Mine Assessment for the Black Copper Site (NM0258)

FINAL REPORT

NM0258

September 29, 2010

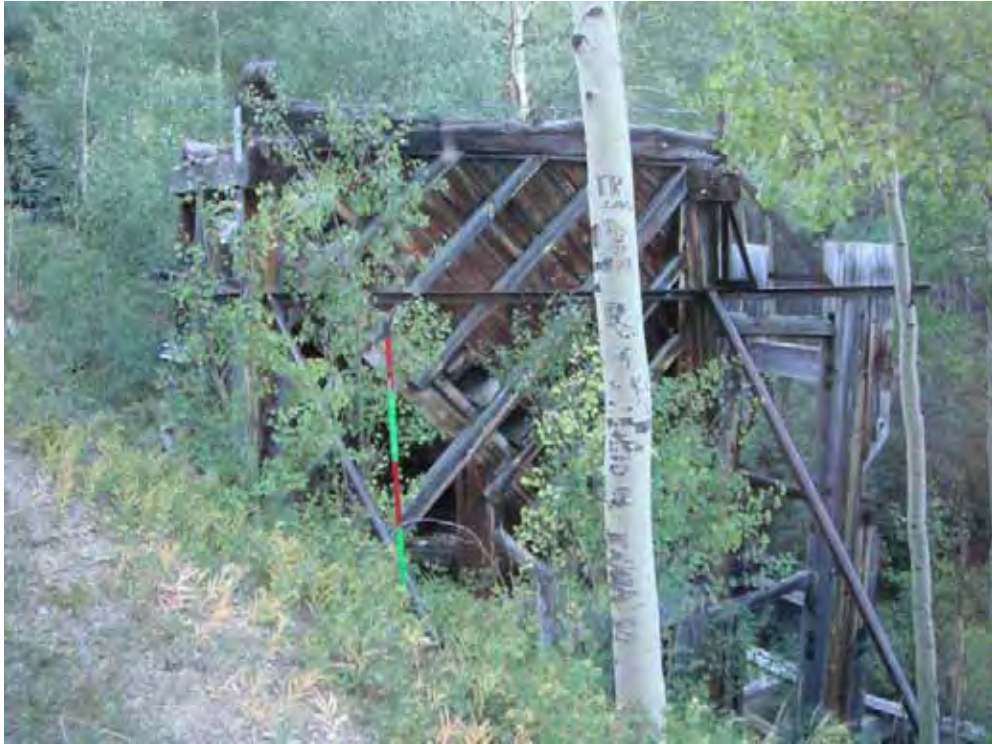
Four mining related structures (StrucLn-1, StrucPly-1, -2, and -3) were found onsite. StrucPly-1 is a 25 ft-tall stamp mill, approximately 25 ft wide and 30 ft long (see Photos 1-6 in Appendix A). StrucLn-1 is a partially collapsed wooden wall that is approximately 5 ft high, 1 ft wide and 35 ft long (see Photo 13 in Appendix A). StrucPly-2 is a collapsed wooden structure southwest of ShaftPly-1, possibly the headframe associated with the shaft (see Photo 10 in Appendix A). StrucPly-3 is a concrete support structure measuring approximately 2 ft tall, 5 ft wide and 6 ft long located northwest of ShaftPly-1 (see Photo 14 in Appendix A).

Photo 1-Looking south at StrucPly-1, the stamp mill in Anderson photo A.

Photo-1 - Struct-1 looking south

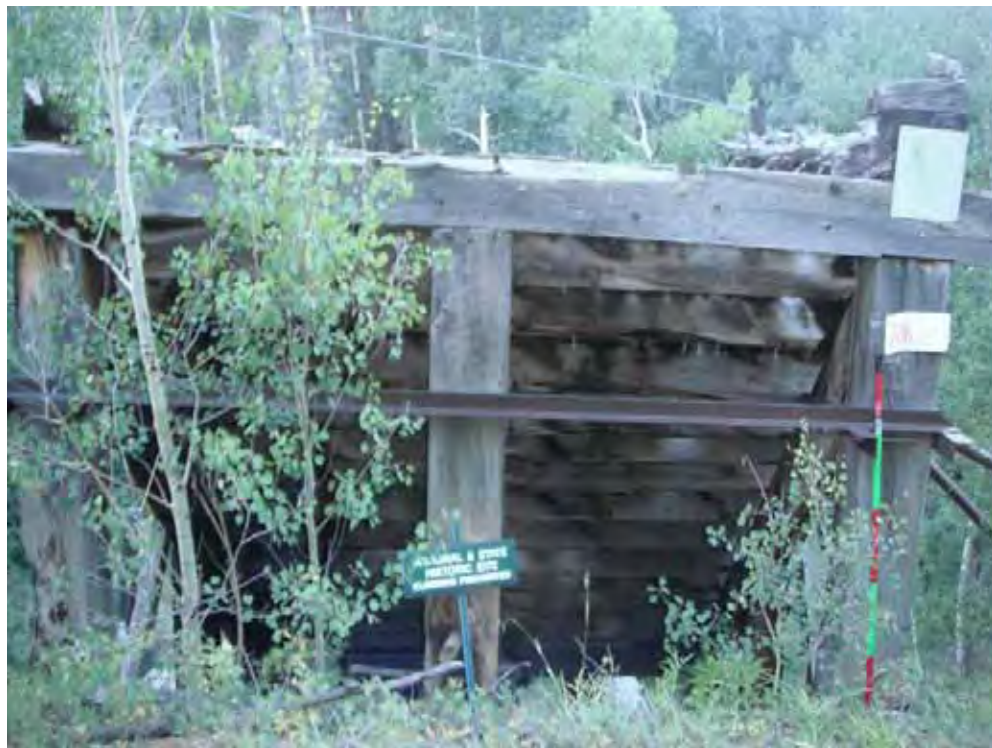
Photo 2-Looking west from Rd-2 at StrucPly-1, the stamp mill in Anderson photo A.

Photo-2 - Struct-1 looking ^{West} ~~South~~ ^{ALT} from Mine Rd-2

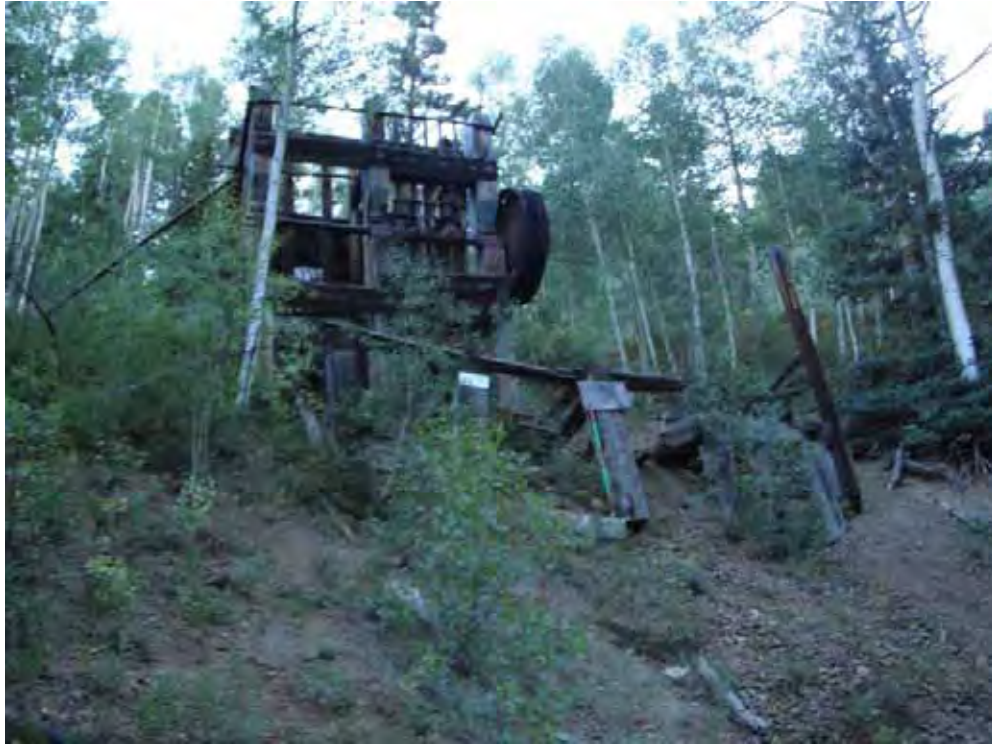
Photo 3-Looking east from Rd-1 at StrucPly-1, the stamp mill in Anderson photo A.

Photo-3 - Struct-1 looking east from Mine Rd-1

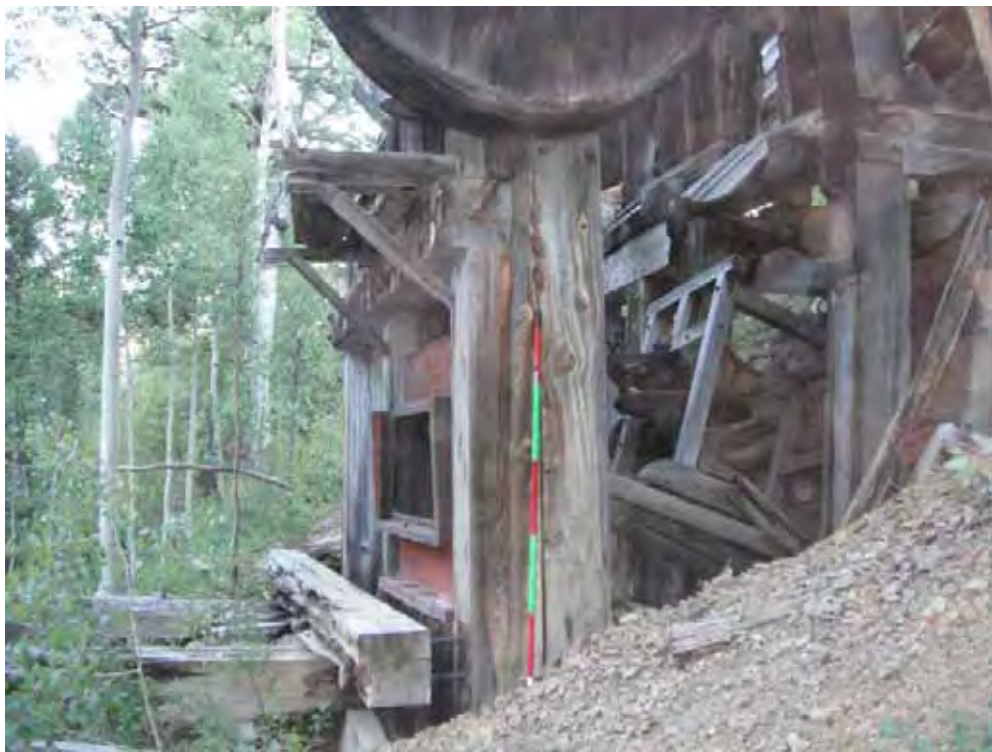
Photo 4-Looking north at StrucPly-1, the stamp mill in Anderson photo A.

Photo-4 - Struct-1 looking north

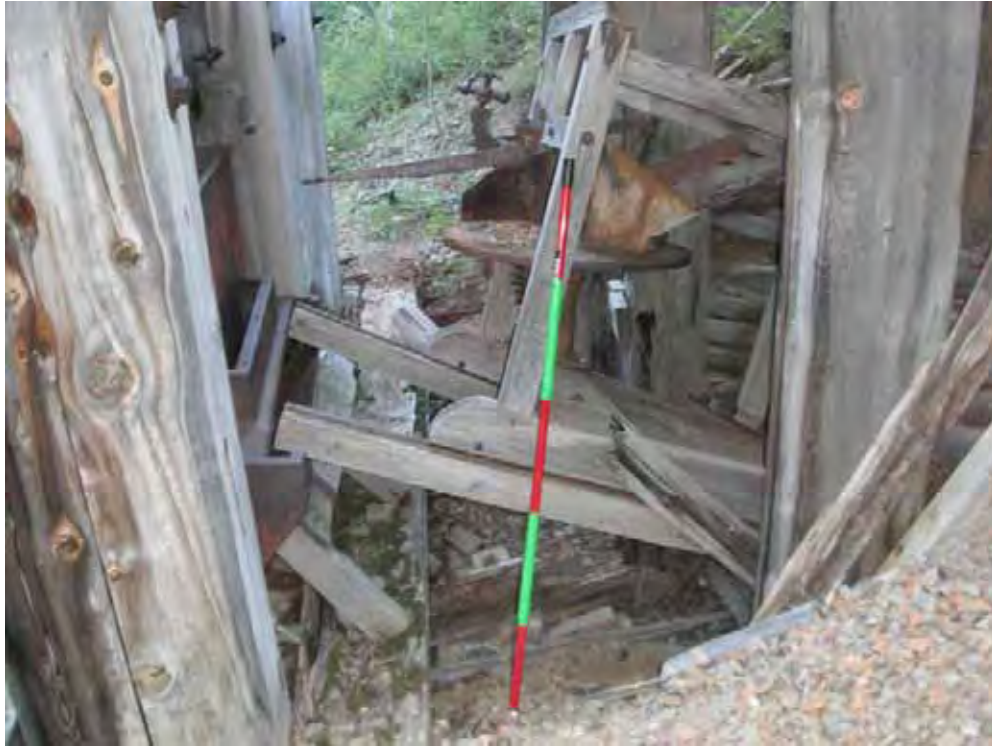
Photo 5-Looking north at StrucPly-1, the stamp mill in Anderson photo A.

Photo-5 - Struct-1 looking north

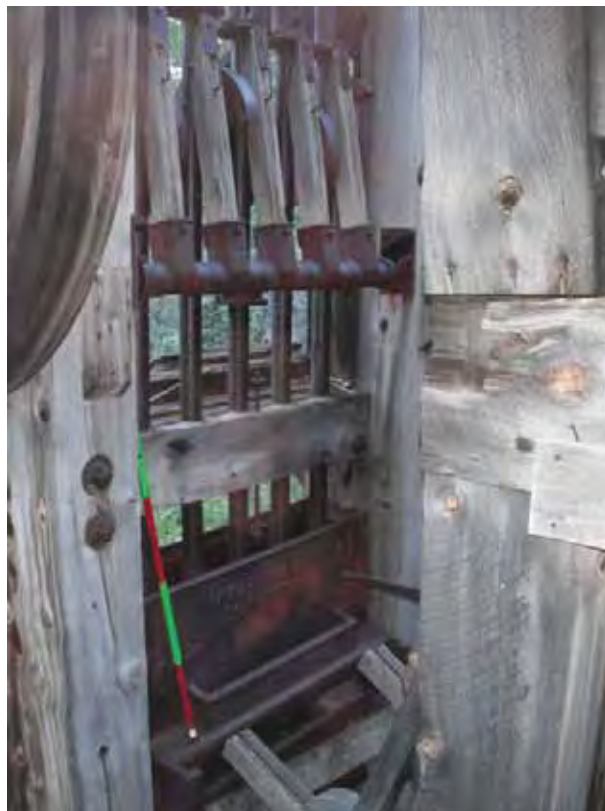
Three waste piles (PilePly-1, -2 and -3) and a debris pile (DumpPly-1) were found at the Site. PilePly-1 extends down slope to the south of StrucPly-1 (see Photo 6 in Appendix A). This pile consists of waste rock and is approximately 20 ft wide, 50 ft long and 1 ft high. PilePly-2 consists of waste rock and is approximately 100 ft wide, 150 ft long and 2 ft high. This pile covers the slope to the south of ShaftPly-1 and StrucPly-2 (see Photo 9 in Appendix A). PilePly-3 is a smaller waste rock pile located up slope of these features and is approximately 4 ft tall, 10 ft wide and 20 ft long (see Photo 15 in Appendix A). DumpPly-1 is a pile consisting of construction debris found at the bottom of the slope below StrucPly-2 (see Photo 10 in Appendix A). Gamma radiation for these features did not vary significantly above background levels.

Photo 6-Looking northwest at StrucPly-1, the stamp mill in Anderson photo A.

Photo-6 - Struct-1 looking ~~South~~ ^{ALT} north west

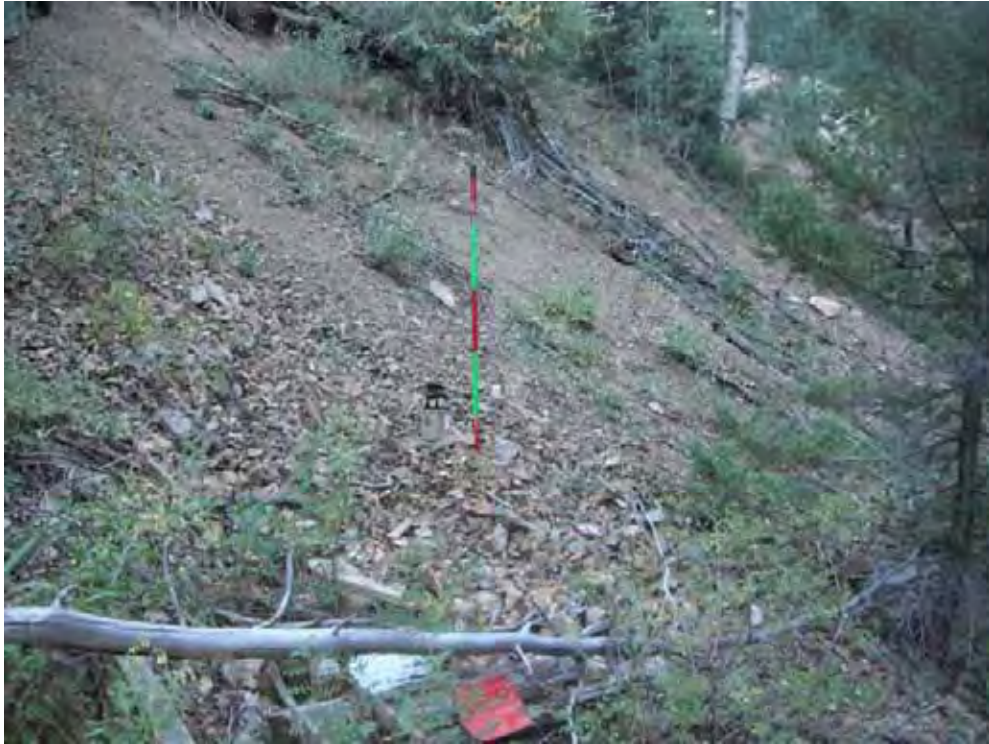
Photo 7-Looking south at PilePly-1.

Pile Ply-1 - 1' deep, 20' wide, 50' long; 50° slope; below stamp mill

Photo 7 - Pile Ply-1 looking south

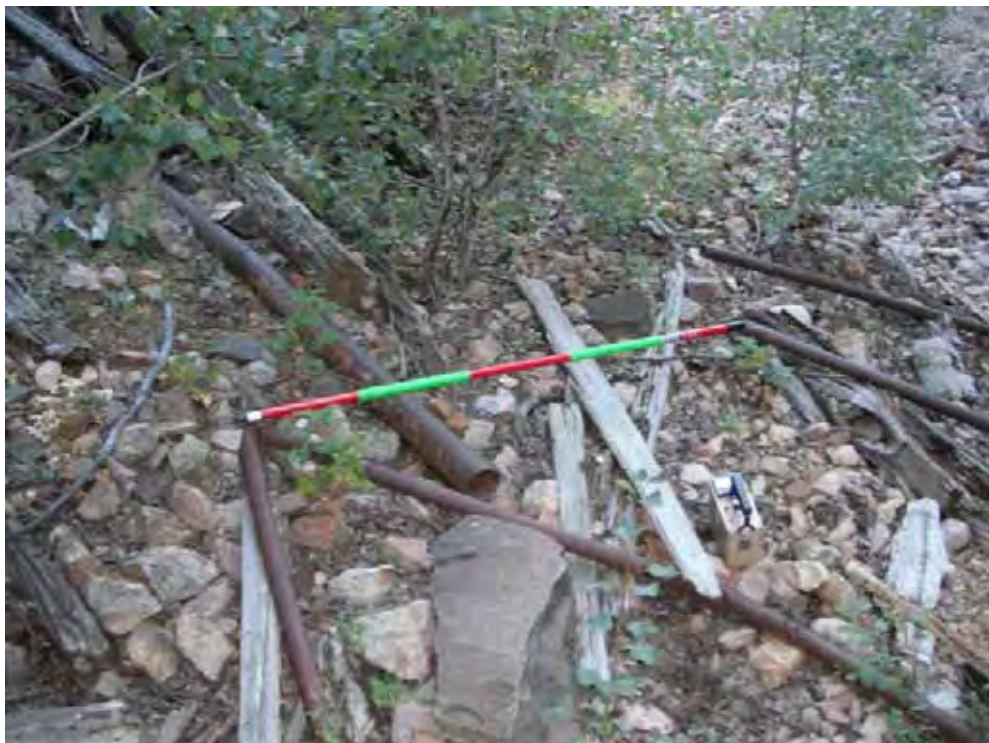
Photo 8-Looking east at DumpPly-1.

Dump Ply-1 - 1' high, 15' wide, 20' long; wood and steel pipe

Photo 8 - Dump Ply-1 looking east

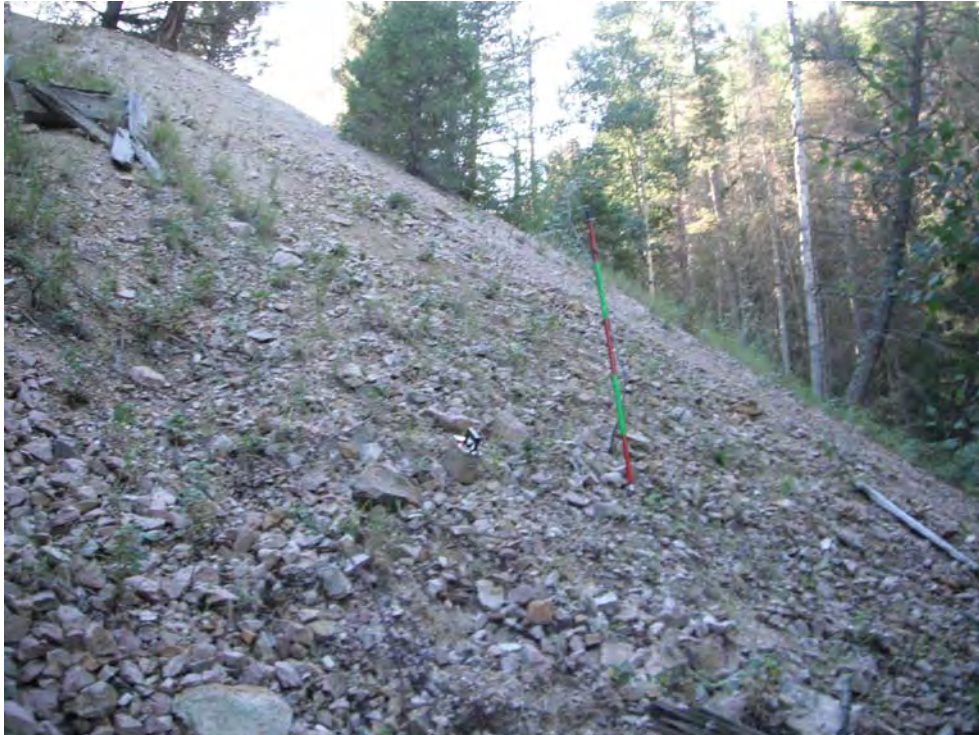
Photo 9-Looking southeast at PilePly-2.

Pile Ply-2 - 2' tall, 100' wide; 150' long, 50° slope waste rock below main shaft

Photo 9 - Pile Ply-2 looking southeast

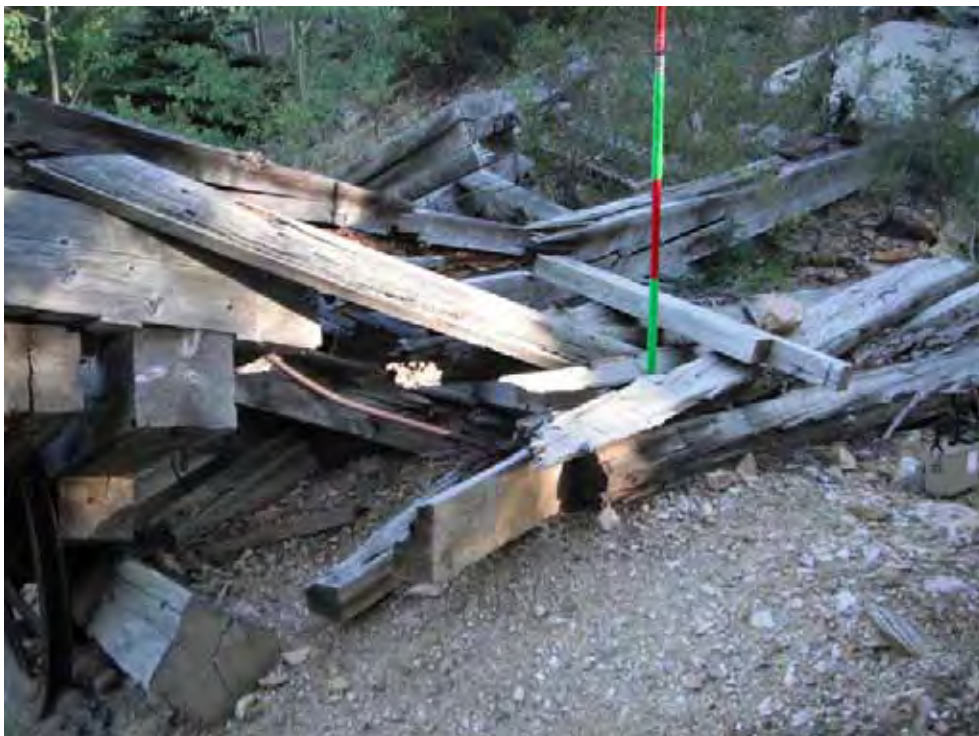
Photo 10-Looking north at StrucPly-2.

Struct-2 - Headframe, collapsed; 6' high, 20' wide, 30' long

Photo 10 - Struct-2, looking north

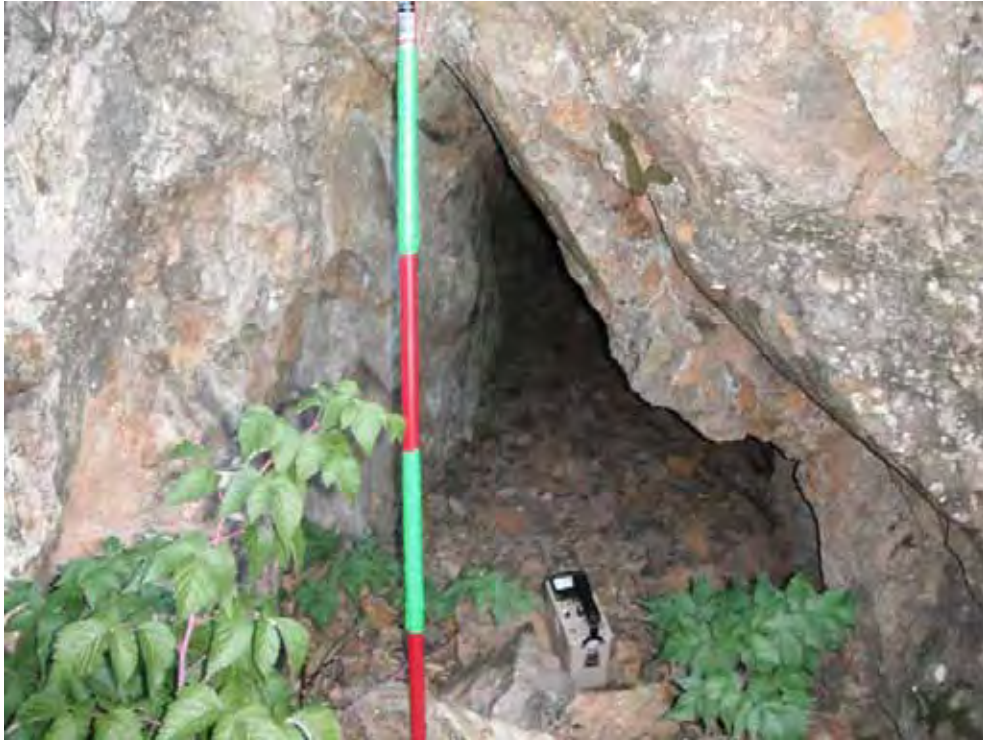
One shaft (ShaftPly-1) and one adit (Adit-1) were found at the Site. The shaft was capped by a 15 ft wide and 20 ft long concrete slab at the surface (see Photo 12 in Appendix A). Adit-1 is approximately 30 feet east of ShaftPly-1 and its opening measures approximately 4 ft high by 5 ft wide. Gamma radiation for these features did not vary significantly above background levels.

Photo 11-Looking southeast at Adit-1, replicating Anderson photo E.

Adit-1 - southeast, 4' high; 5' wide, unknown length

Photo 11 - Adit-1 looking southeast

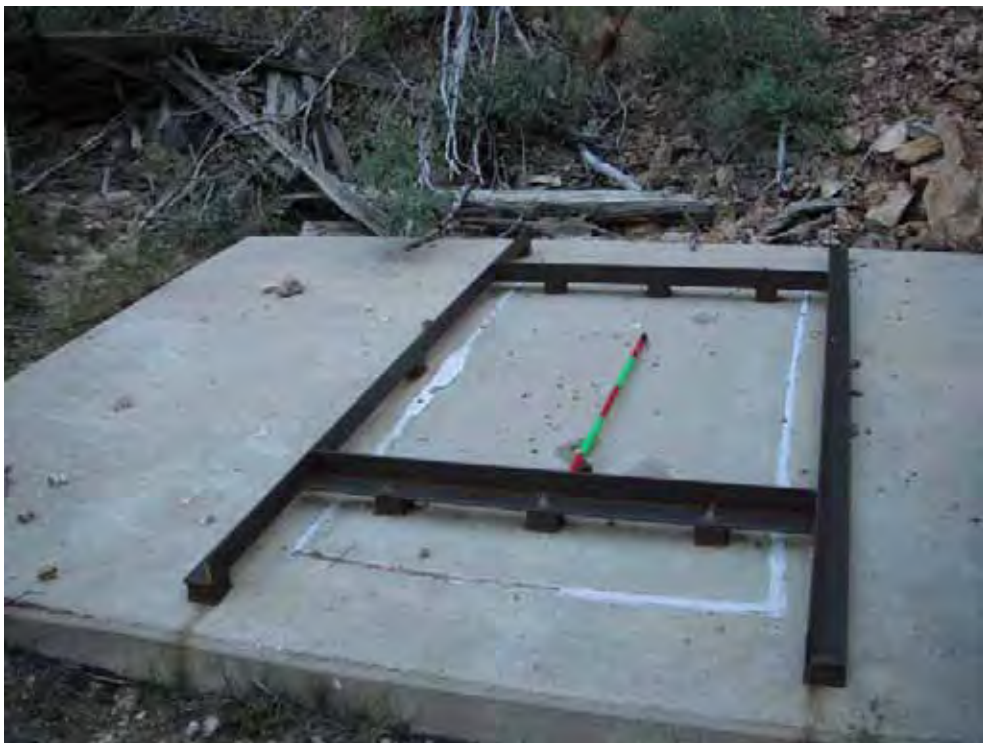
ShaftPly-1 is capped by a concrete block. Two other adits onsite were reportedly backfilled. These closures were put in place in 2000 (Rodarte, 2010).

Photo 12-Looking east at ShaftPly-1.

Shaft Ply-1 - sealed cement pad is 15' wide, 20' long; unknown depth

Photo 12 - Shaft Ply-1 looking east

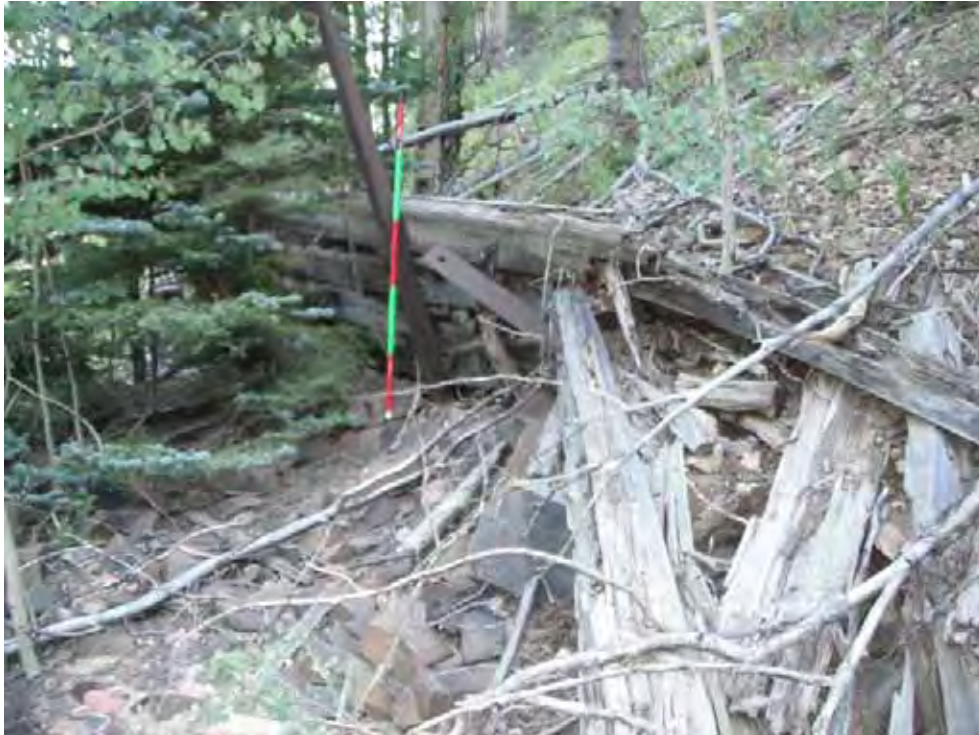
Photo 13-Looking north at StrucLn-1.

StructIn-1 - timber and steel wall; 5' tall, 1' wide, 35' long

Photo 13 - StructIn-1 looking north

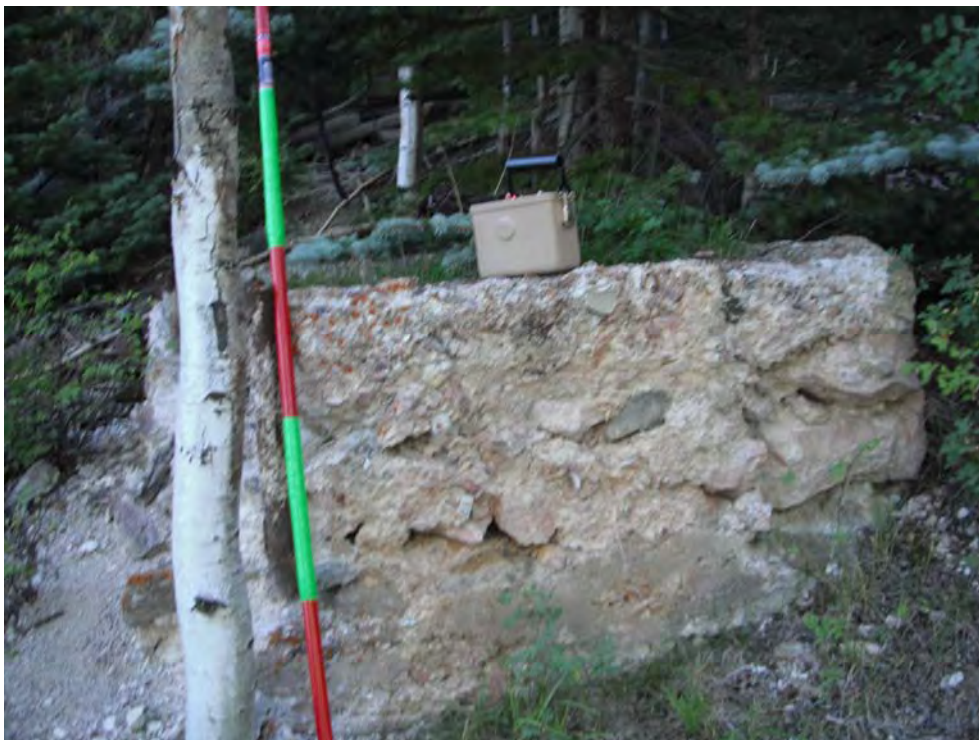
Photo 14-Looking east at StrucPly-3.

Struct Ply-3 - foundation support, cement; 2' tall, 5' wide, 6' long

Photo 14 - Struct-3 looking east

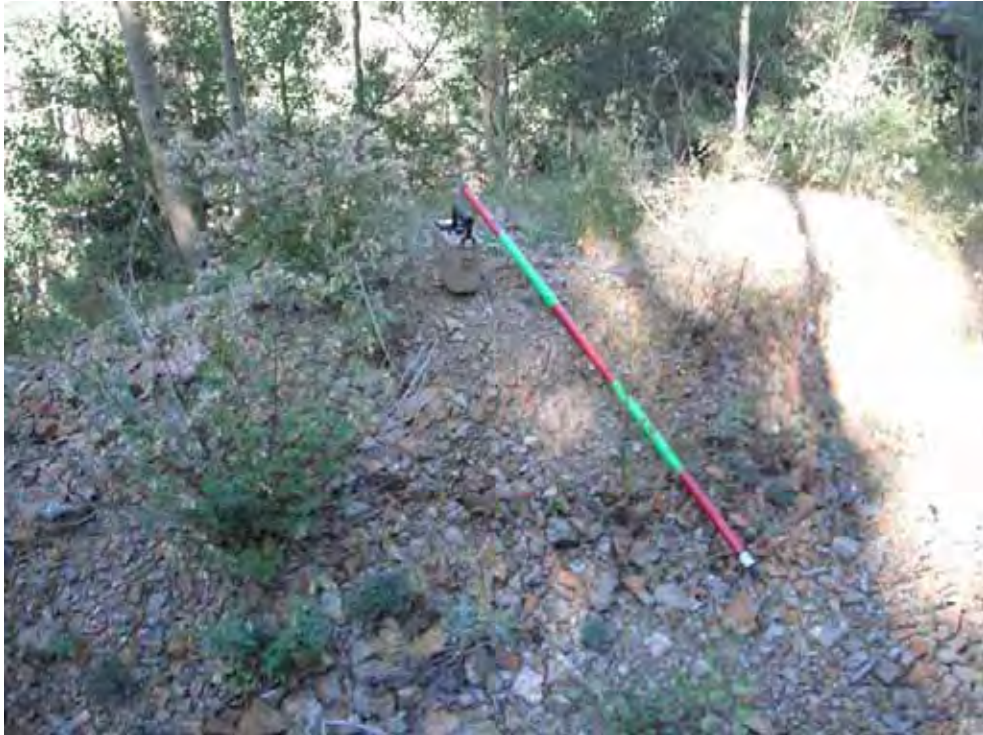
Photo 15-Looking northwest at PilePly-3.

Pile Ply-3; 4' tall, 10' wide, 20' long, 25° slope

Photo 15 - Pile Ply-3 looking northwest
