**RE: Fourth Monthly NAPL Recovery Report,  
Fairview Station Site, Española, New Mexico  
Facility #28779                      RID #4657                      WPID #4096-4**

Souder, Miller & Associates (SMA) is pleased to submit the third monthly NAPL recovery report. This report is submitted in accordance with the workplan dated August 16, 2019 and approved by NMED PSTB on September 30, 2019.

Figure 1 – Non-Aqueous Phase Liquid Map – February 13, 2020

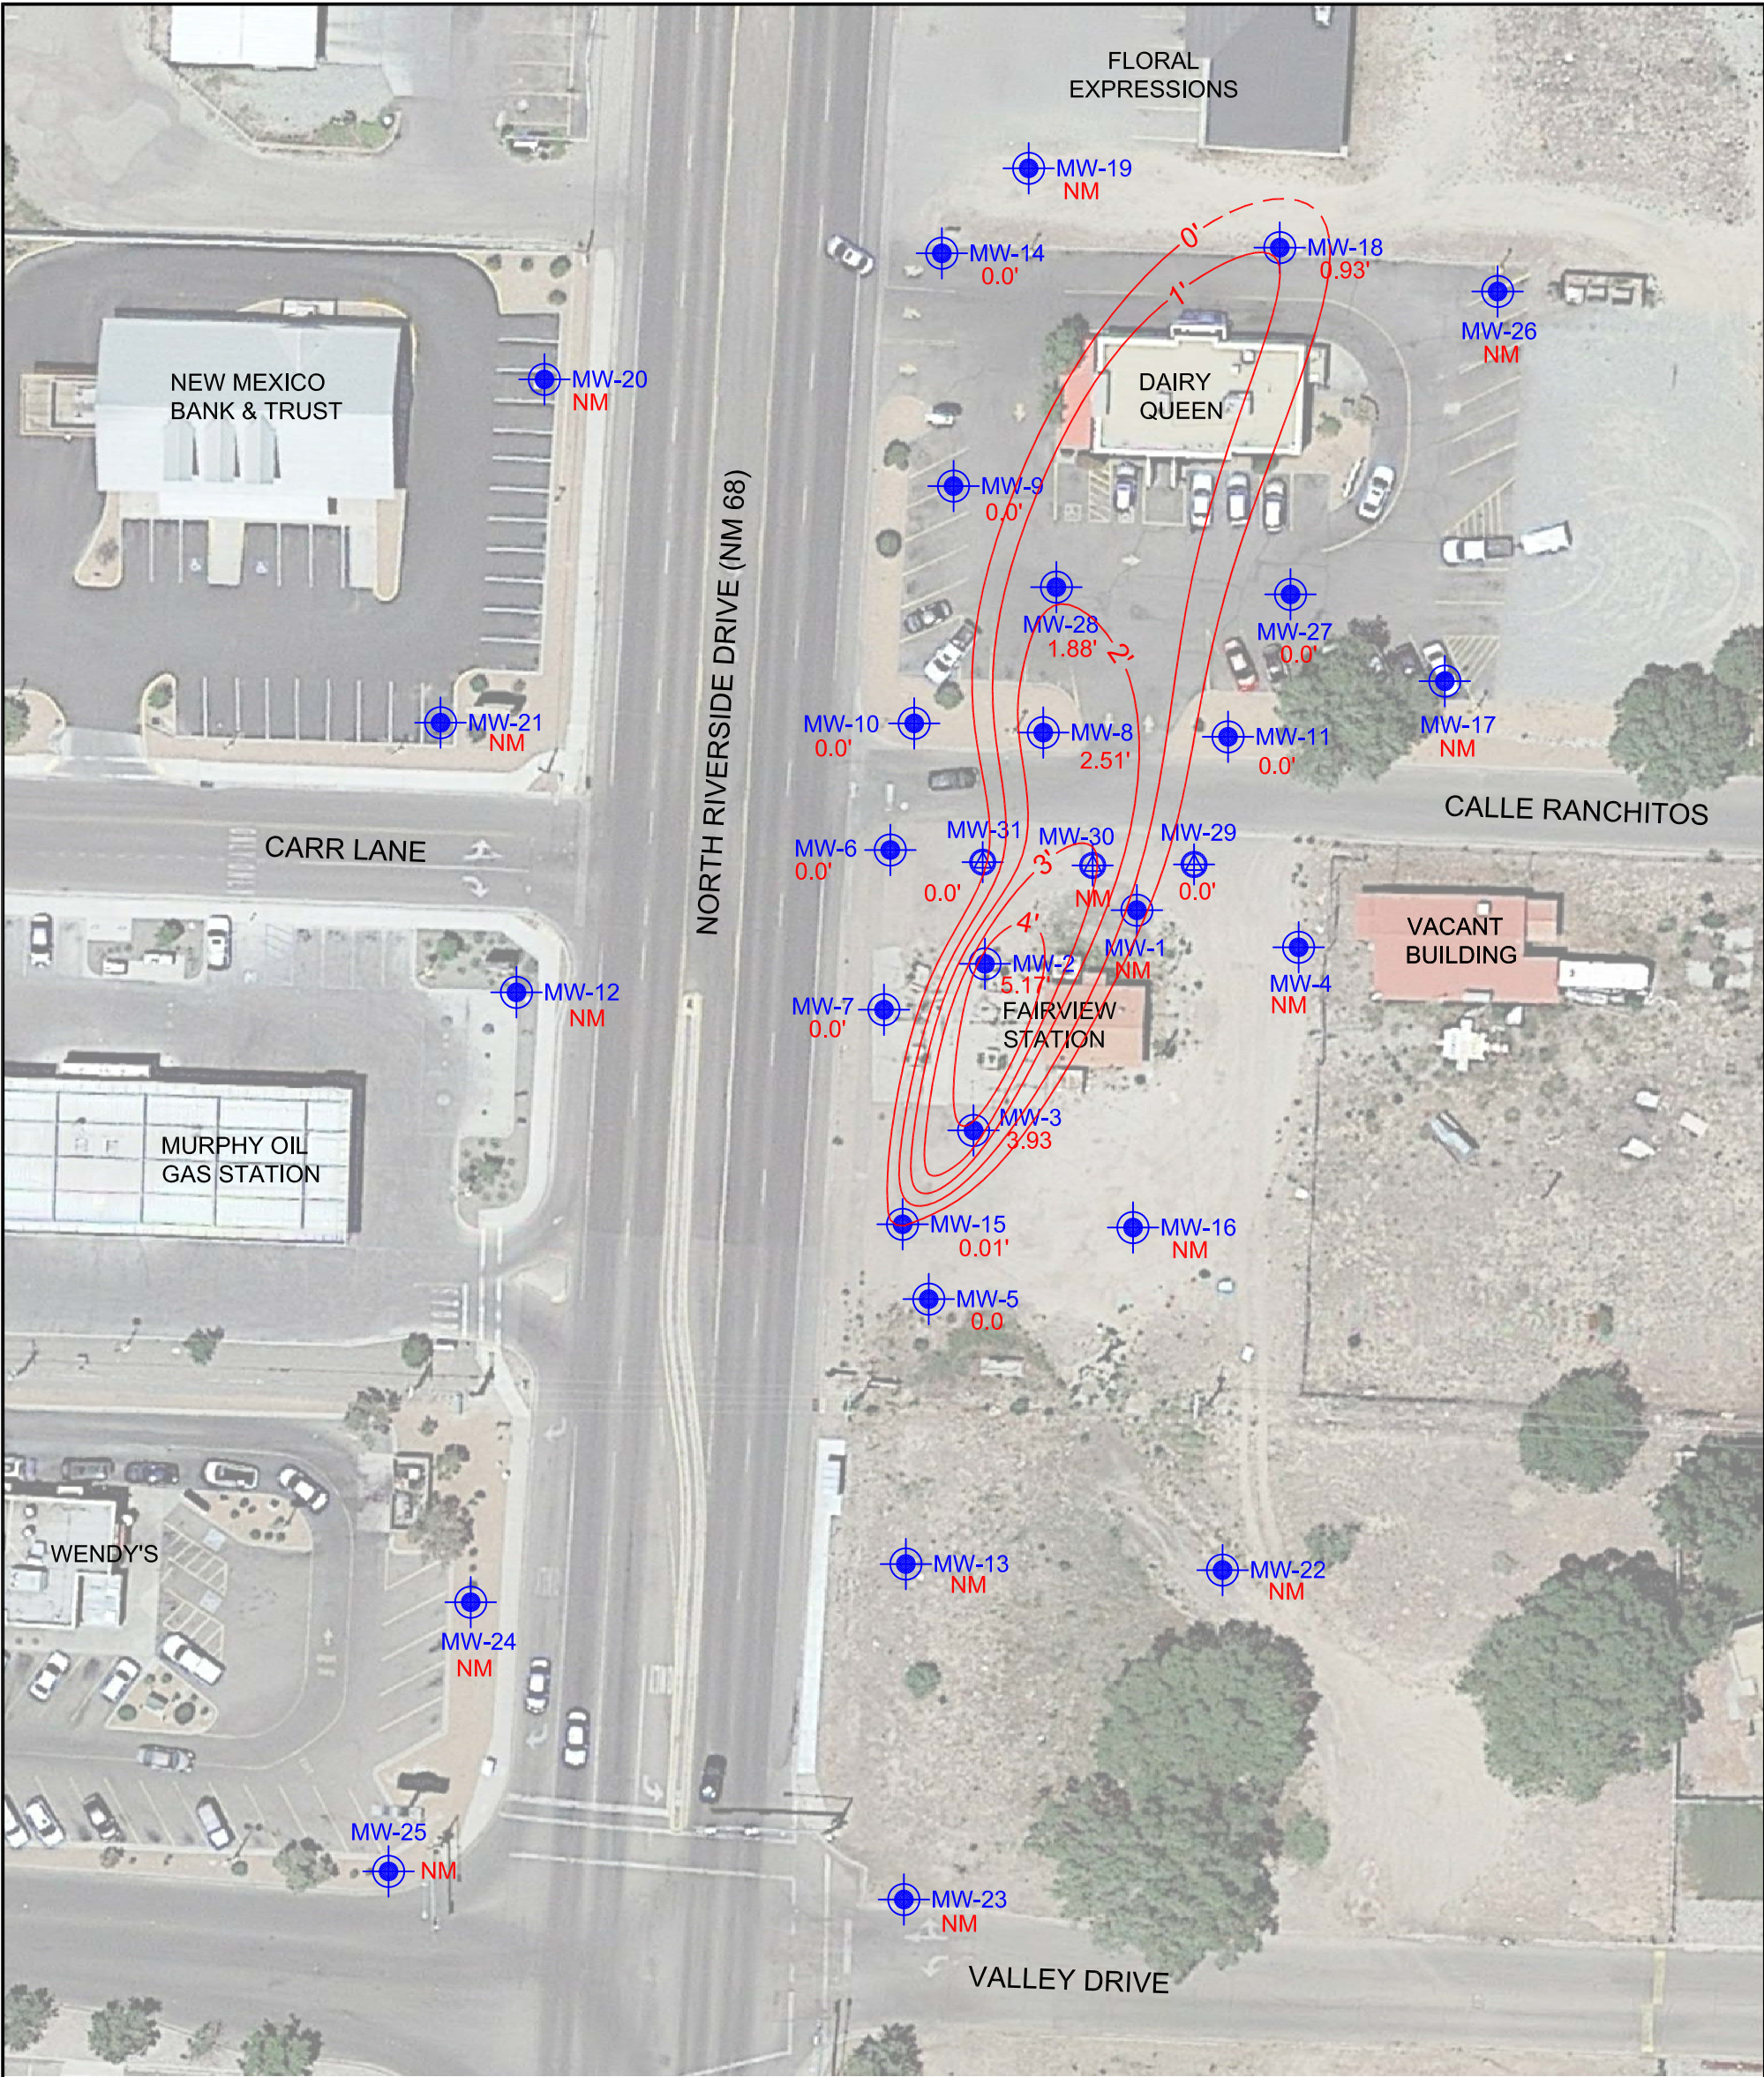
Overall, apparent NAPL thicknesses have decreased in the down-gradient side of the NAPL plume (MW-3 and MW-15) compared to the previous NAPL recovery events. Whereas, NAPL thicknesses increased somewhat in the northern portion of the NAPL plume (MW-8, MW-18, and MW-28).

Figure 1 depicts the apparent NAPL thicknesses and NAPL contours during the February 2020 event. Table 1 presents the initial depth to NAPL and water measurements. Table 2 depicts the NAPL thicknesses before and after recovery with the NAPL amounts recovered.
