NEW MEXICO
ENVIRONMENT DEPARTMENT

Memorandum

Subject: Pre-CERCLIS Screening Assessment of the Section 12 Mine
(Grants Mining District), McKinley County, New Mexico:
Further action under CERCLA recommended

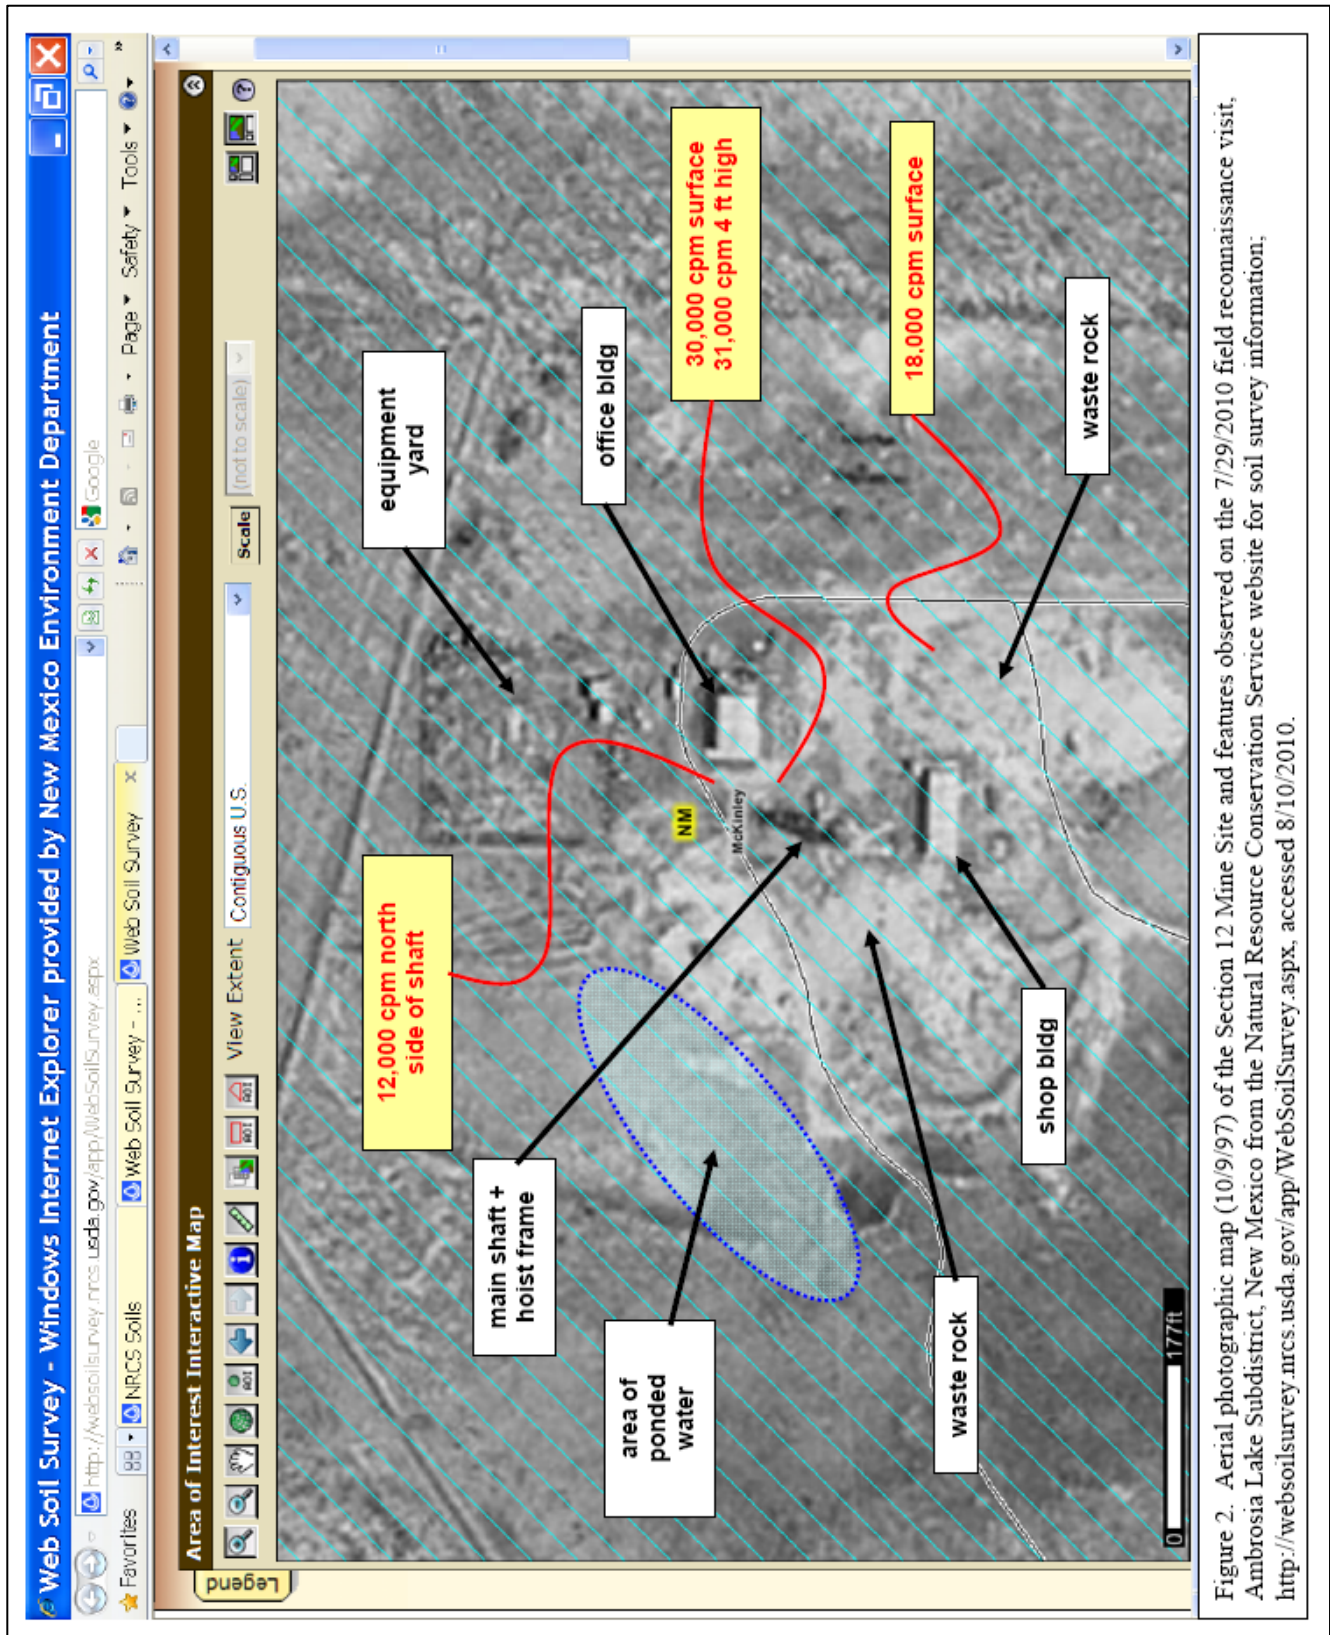
Figure 2. Aerial photographic map (10/9/97) of the Section 12 Mine Site and features observed on the 7/29/2010 field reconnaissance visit, Ambrosia Lake Subdistrict, New Mexico from the Natural Resource Conservation Service website for soil survey information; <http://websoilsurvey.nrcs.usda.gov/app/WebSoilsurvey.aspx>, accessed 8/10/2010.

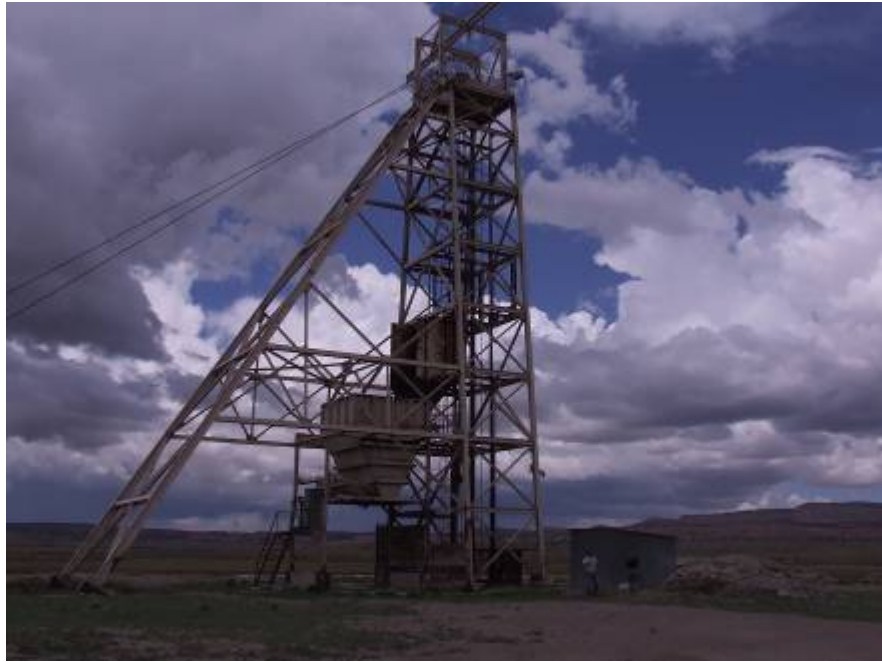
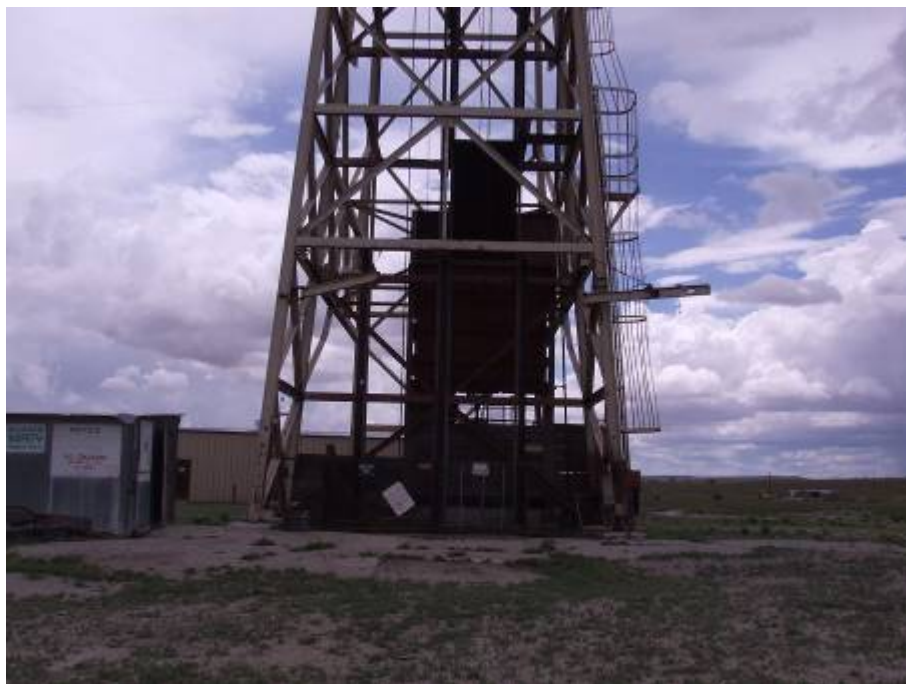
There is a 30-foot high hoist frame structure with a large sheet metal hopper above the sealed mine shaft. The mine shaft is covered with wooden timbers and concrete sections. The hoist control shack is also present. The one story mine office building is located to the northeast of the shaft, and it is approximately 100 feet (ft) long X 40 ft wide. An equipment yard is located on the north side of the office building that is approximately 177 ft long X 177 ft wide. A shop building is located south of the main shaft and it is approximately 80 ft long X 20 ft wide. No pits or open cuts were found at the Site. The area contains noticeable waste rock piles that are over 100 feet long and several feet high. Photographs 1-6 from July 29, 2010 site visit are contained in Attachment B. Currently, underground access to the Section 12 mine is through the Section 11 (Dysart #2) mine shaft which is an air shaft for Section 12. Another air shaft structure and pipe is located approximately 400 ft NNW of the main shaft. There are two other vent shafts on the property. The Section 12 main shaft is approximately 700 ft deep.

Photographs Section 12 Mine: No. 1, main shaft and hoist structure (view from east looking west) and No. 2, main shaft with lower part of hoist visible (view from north looking south).

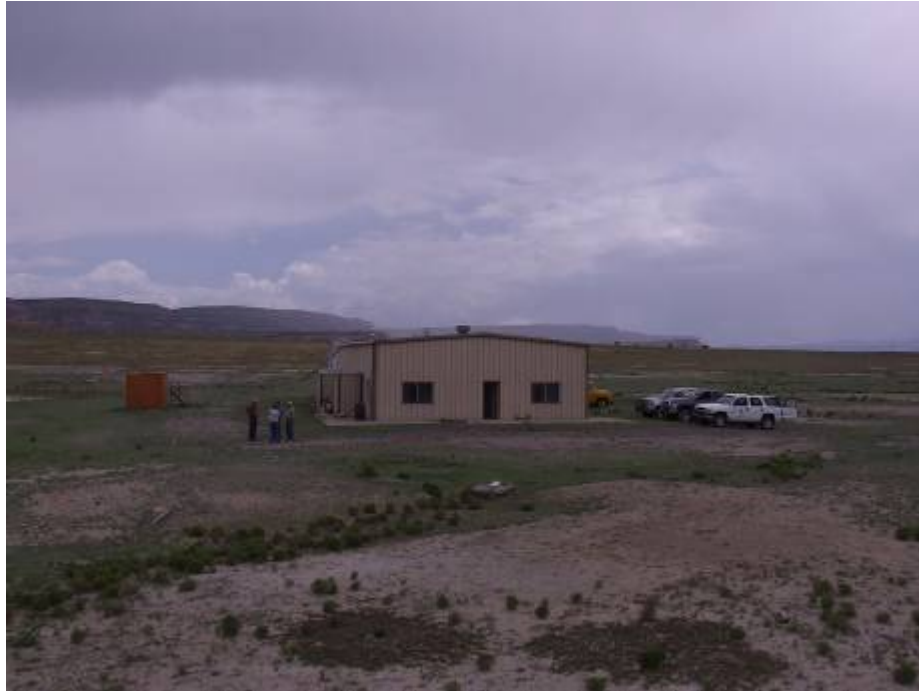
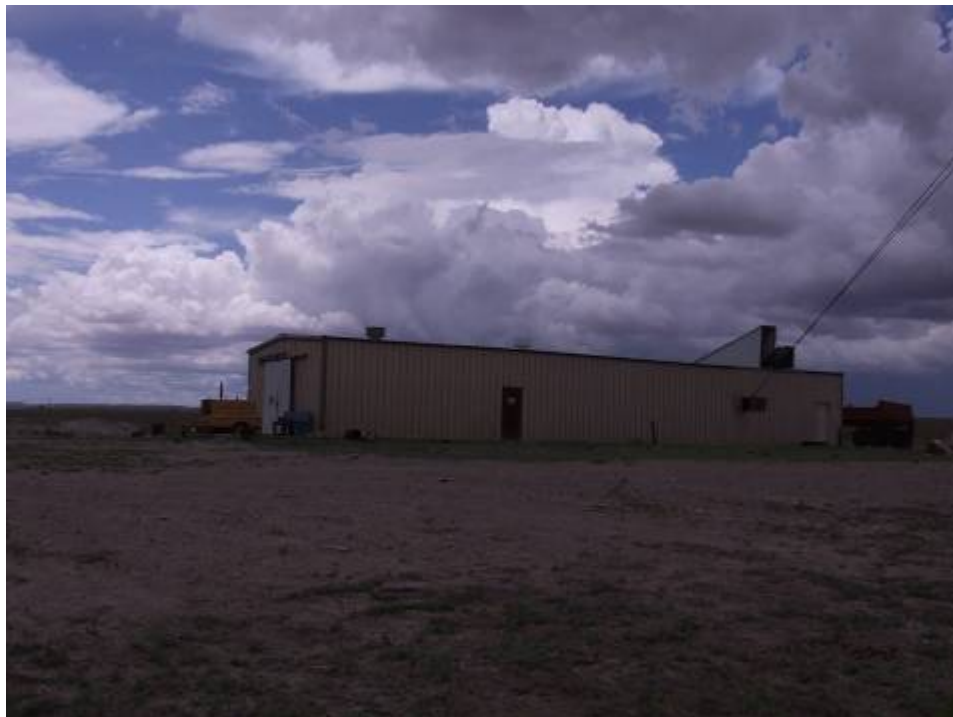
Photographs Section 12 Mine: No. 3, office building (view from waste pile looking east) and No. 4, shop building (view looking south).

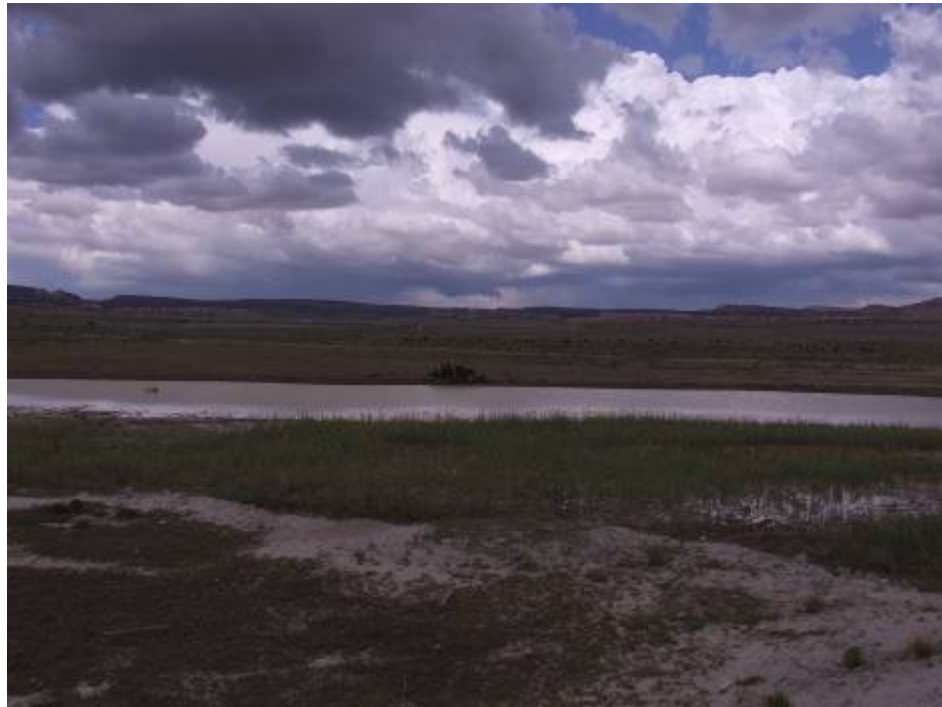
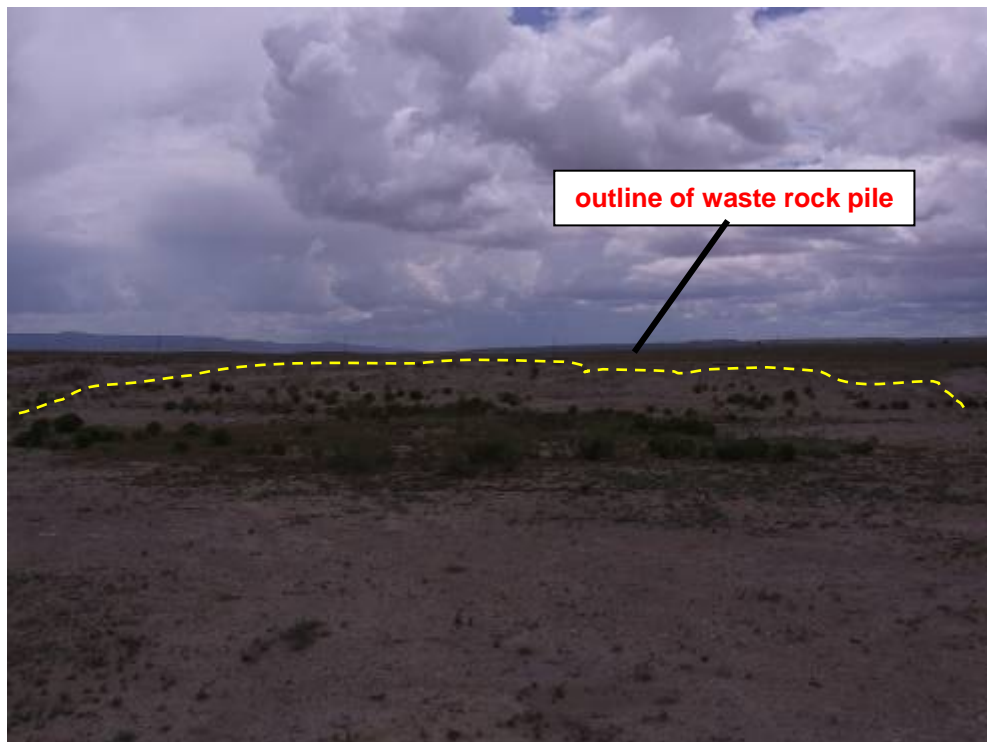
Background readings for the Section 12 area are generally less than 5,000 cpm and more commonly about 3,000 cpm. The gamma readings for the Site ranged from a low of 7,000 cpm (40 μ R/hr) at the surface of the concrete side walk on the west side of the office building to a high of 100,000 cpm (571 μ R/hr) at the surface and 80,000 cpm (456 μ R/hr) at 4 ft over by some waste rock on the east side of the north trending main access road. Waste rock piles averaged about 40,000 cpm (228 μ R/hr).

Photographs of Section 12 Mine: No. 5, ponded surface water on west side of Site (aka Ambrosia Lake) and No. 6, waste rock pile on south side of Site.
