**RE: First Monthly NAPL Recovery Report,
Fairview Station Site, Española, New Mexico
Facility #28779 RID #4657 WPID #4096-1**

NON-AQUEOUS PHASE LIQUID MAP - NOVEMBER 11, 2019
FAIRVIEW STATION
ESPAÑOLA, NEW MEXICO

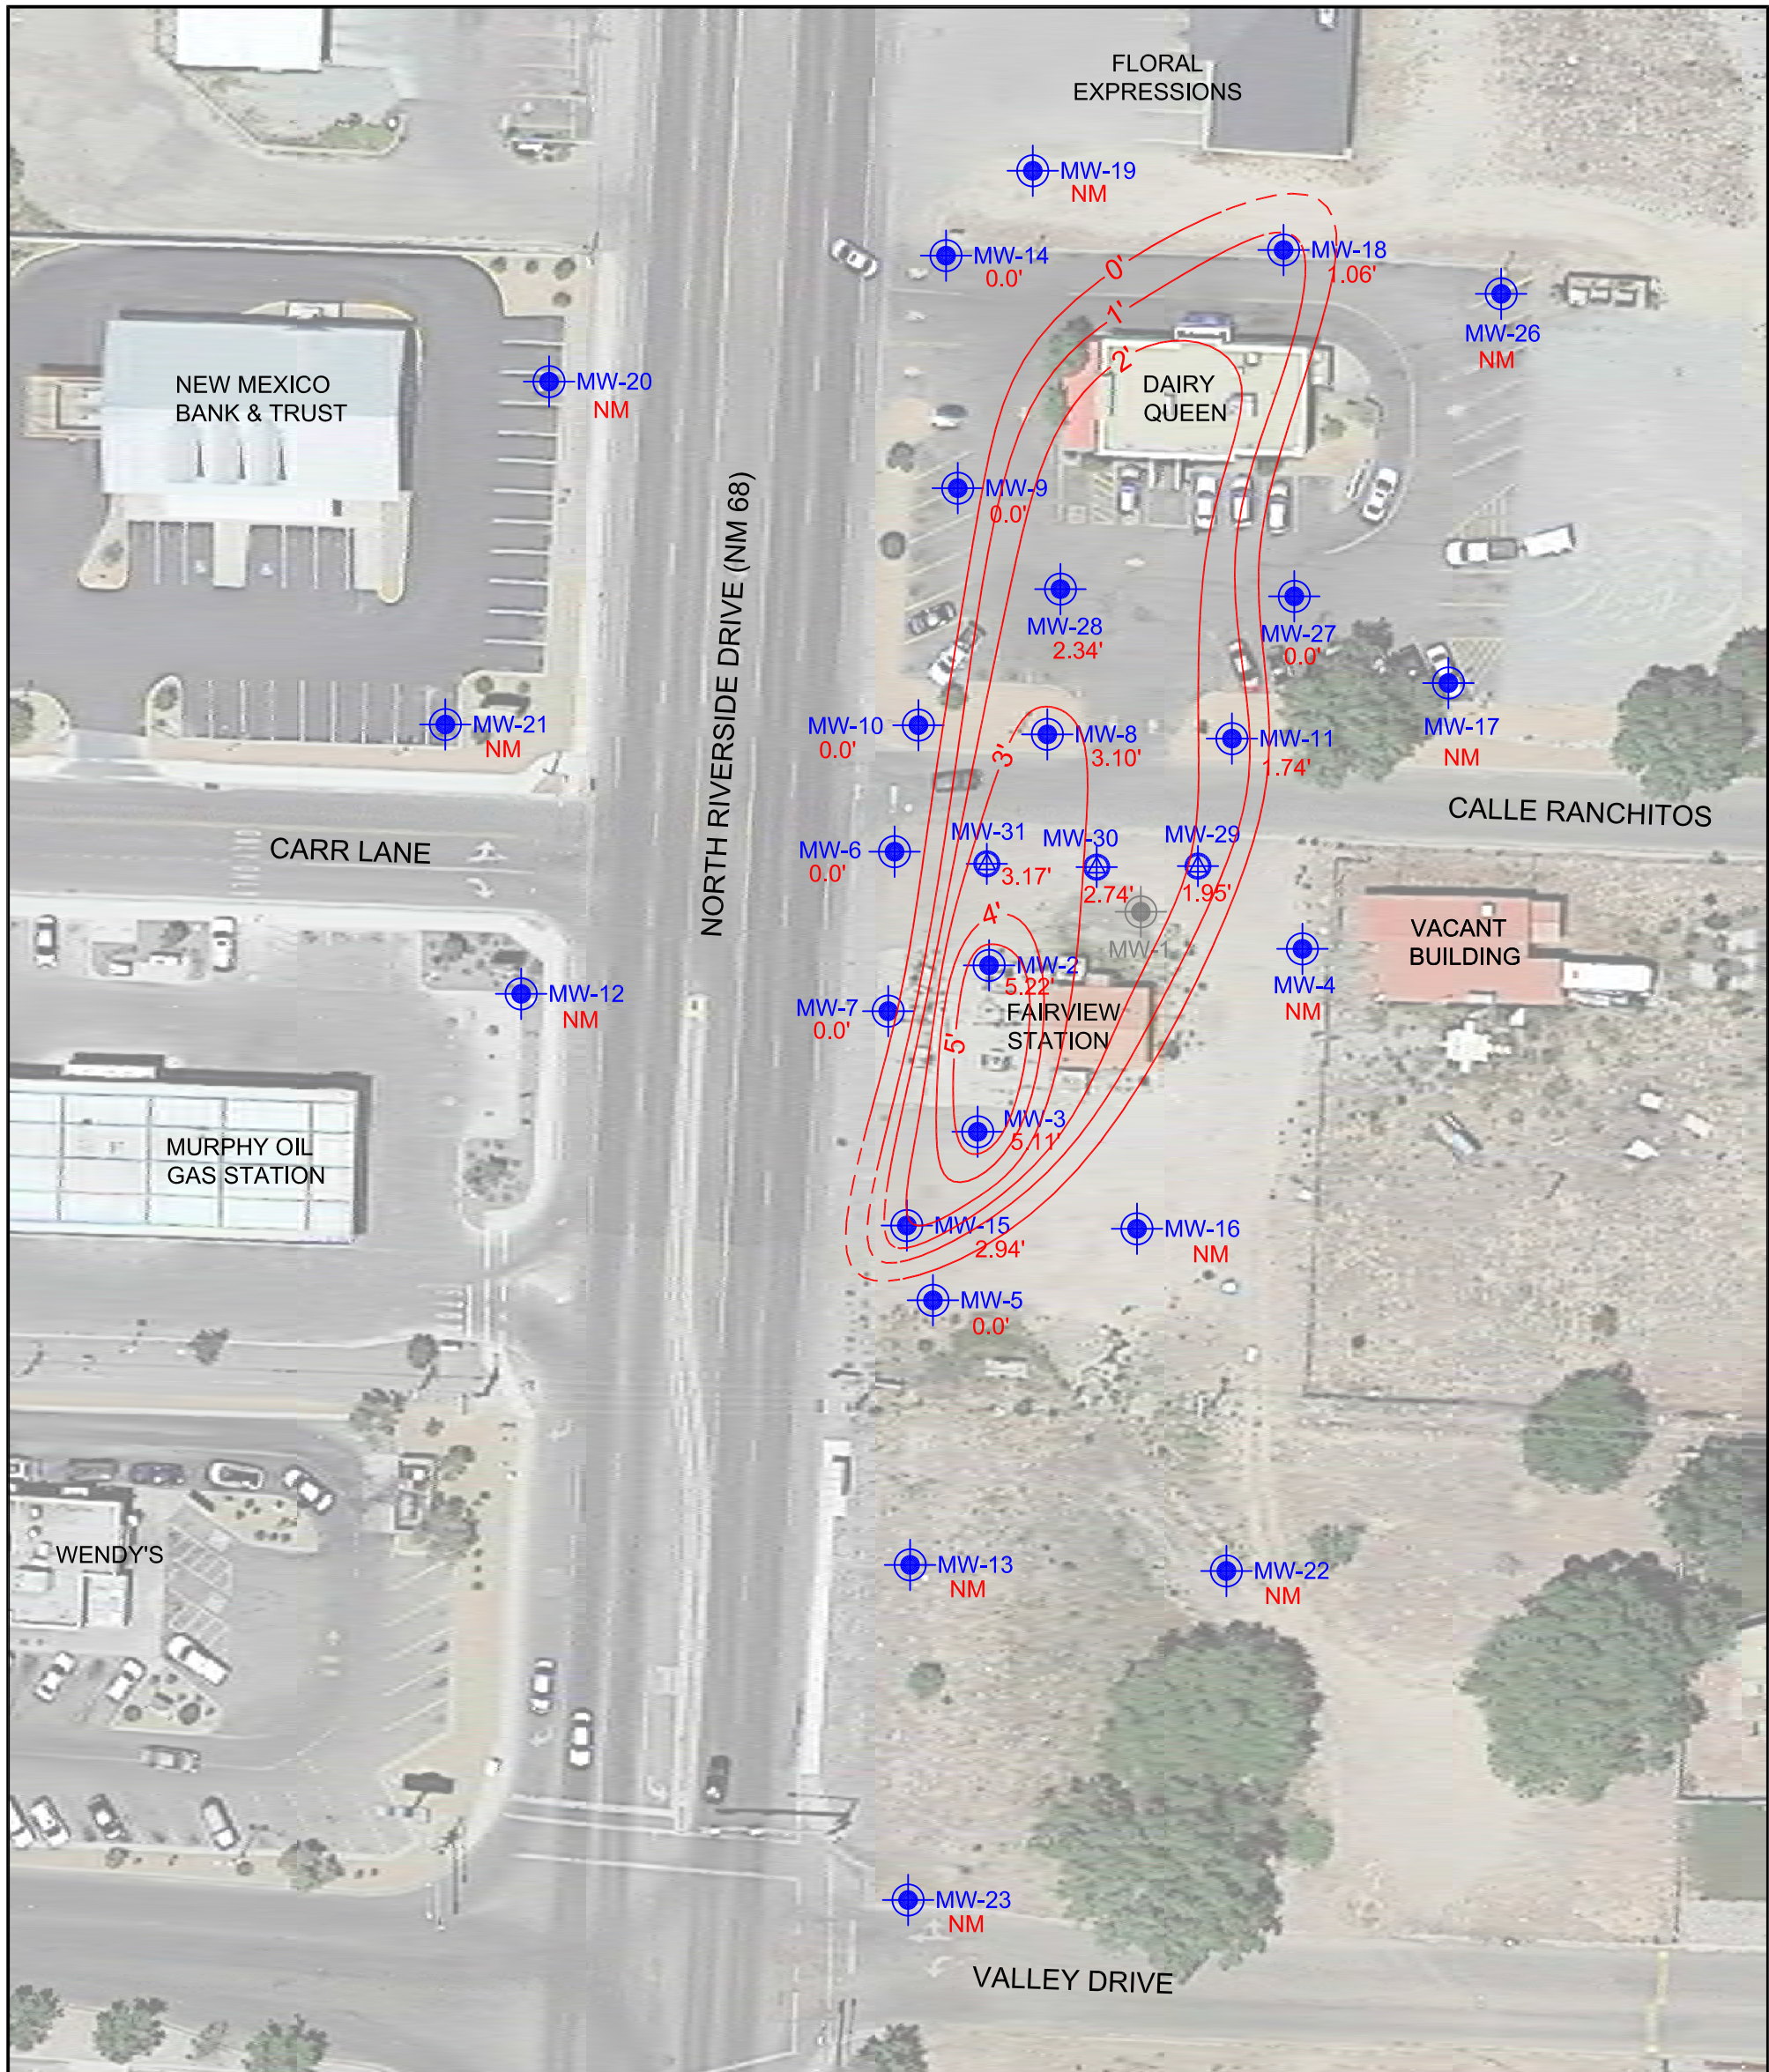
Figure 1 – Non-Aqueous Phase Liquid Map – November 11, 2019

On November 11, 2019, SMA performed the first monthly NAPL recovery. Seventeen monitoring wells were gauged for depth to NAPL and depth to water. Of these seventeen wells, ten monitoring wells contained NAPL with apparent thicknesses ranging from 1.06 to 5.22 feet. Two monitoring wells (MW-30 and MW-31) had poor NAPL/water signals possibly due to emulsified NAPL in the water. The NAPL thickness measurements in these wells may be inaccurate.

Figure 1 depicts the apparent NAPL thicknesses and NAPL contours during the November 2019 event. Table 1 presents the initial depth to NAPL and water measurements. Table 2 depicts the NAPL thicknesses before and after recovery with the NAPL amounts recovered.
