Abandoned Uranium Mine Assessment for the Tusas East Slope Site (NM0179)

FINAL REPORT

September 29, 2010

NM0179

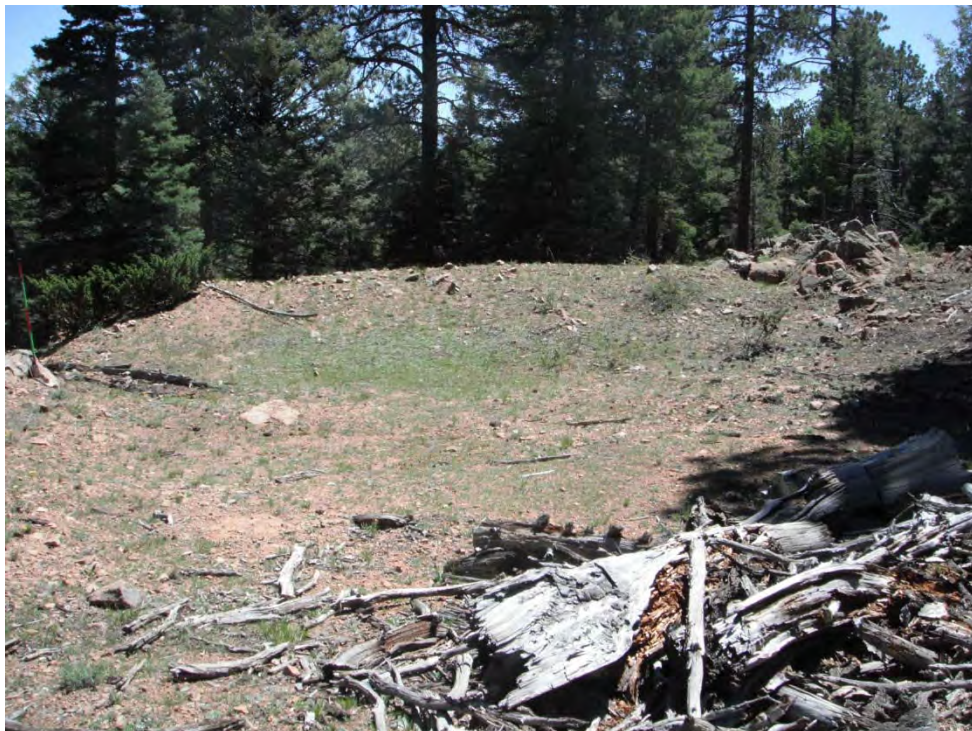
Two pits (Pit-1, Pit-2) were found at the AUM Site. Pit-1, the main excavation pit, is a shallow bulldozer cut approximately 40 ft wide and 40 ft long. The maximum gamma radiation measurement for this feature was 230 $\mu\text{R/hr}$ (microroentgens per hour) at 0 ft above ground at radiation survey point Rad-1 (see Table 2). Pit-2 is a small surface excavation into igneous bedrock approximately 200 feet to the east. Gamma radiation for Pit-2 measured 310 $\mu\text{R/hr}$ at 0 ft above ground at radiation survey point Rad-1 (see Table 2).

Photo 4-Looking east at Pit-1.

Pit-1 - 5' deep, 40' x 40'

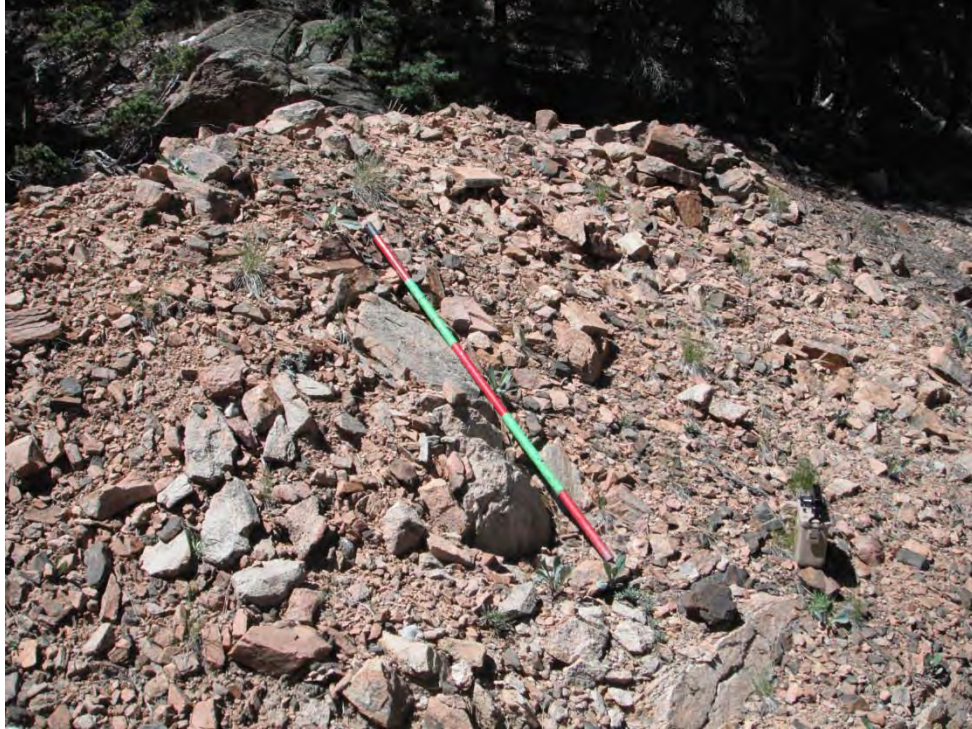
Photo 5-Looking west at PilePly-1.

Pile Ply-1 - 3' tall, 10' wide, 15' long, 40° slope

Rad 4 - Pile Ply-1; 0m - 180 uR/h; 1m - 70 uR/h

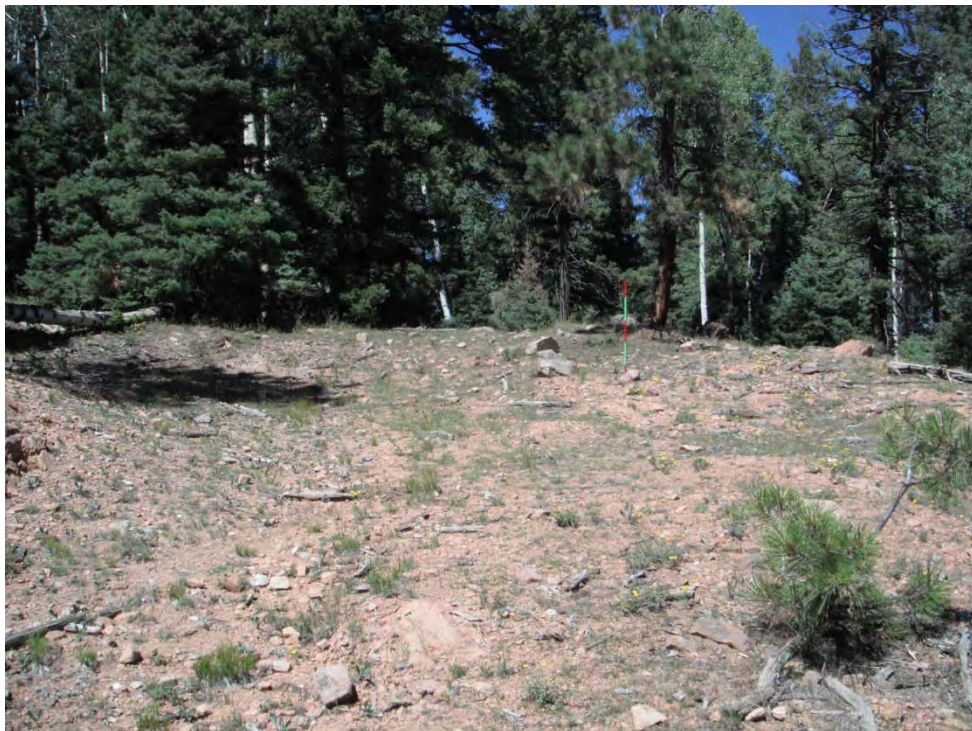
Photo 6-Looking west at DistPly-2.

Dist Ply-1 - 60' x 40', bulldozed area

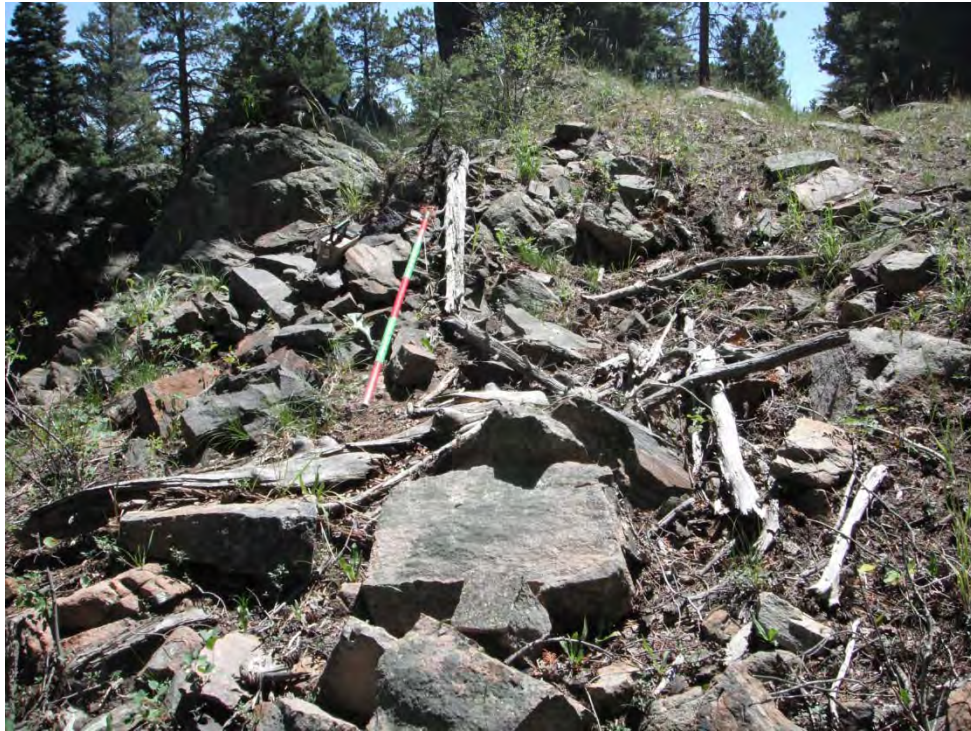
Photo 7-Looking east at PilePly-2.

Pile Ply 2 - 1' tall, 8' wide, 10' long, 10° slope

Rad 8 - Pile Ply 2; Cm - 425 uR/h; 1m - 130 uR/h

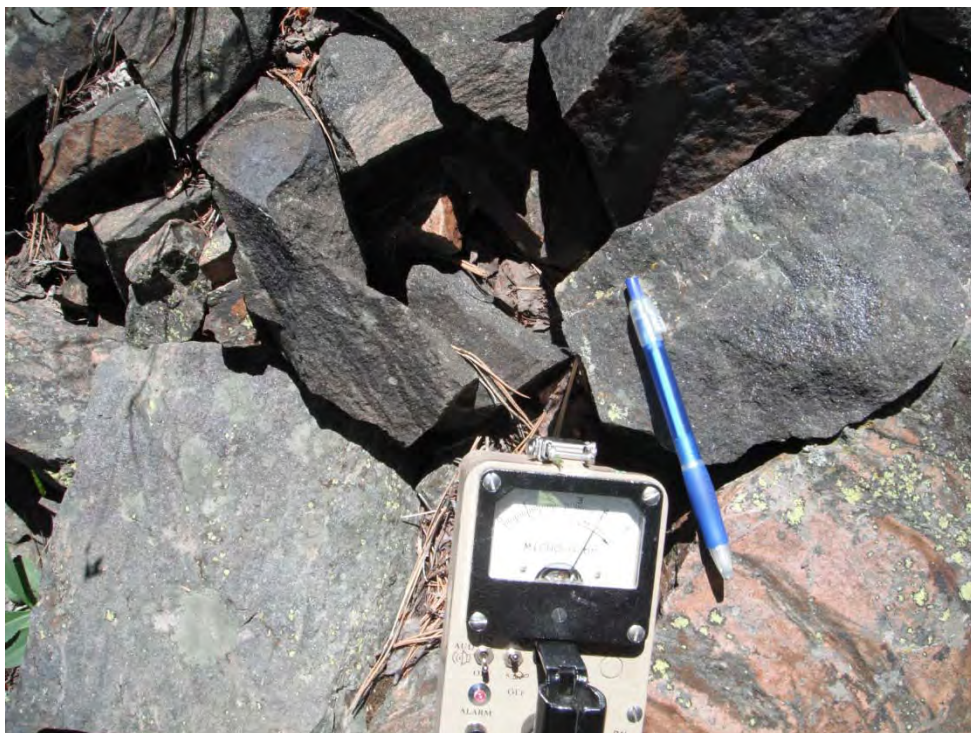
The maximum gamma radiation measured on site was 425 $\mu\text{R/hr}$ at 0 ft above ground and 130 $\mu\text{R/hr}$ at 4 ft above ground at radiation survey point Rad-8 at PilePly-2 (see Photo 8 in Appendix A). A gamma radiation measurement taken at Pit-2 (radiation survey point Rad-10) recorded 310 $\mu\text{R/hr}$ at 0 ft above ground.

Photo 8-Closeup of rocks at Rad-8.

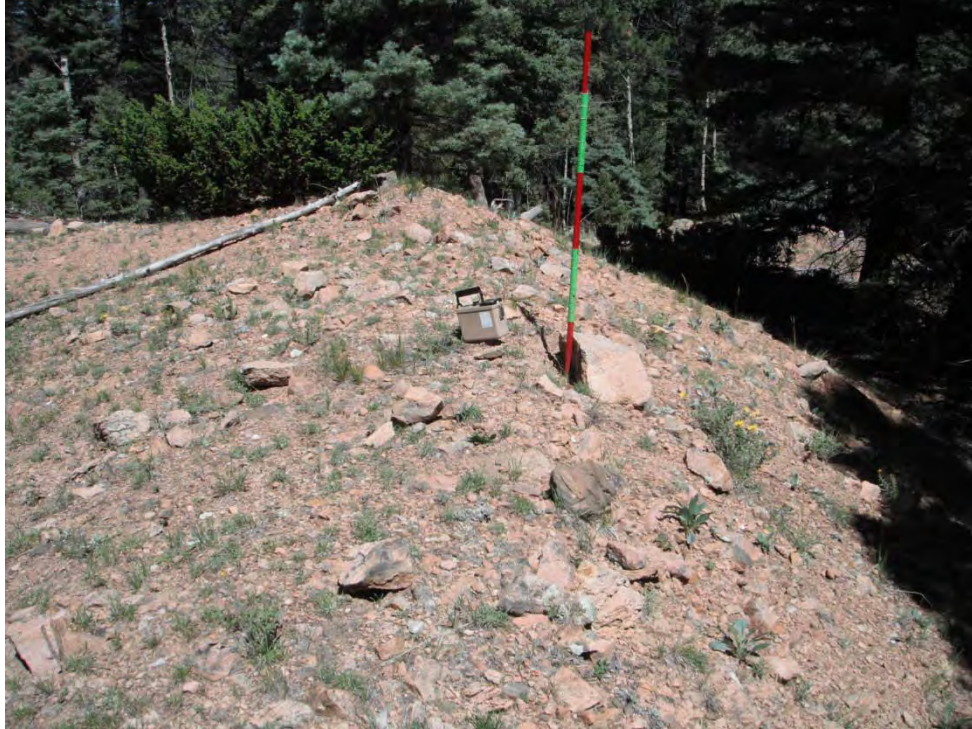
Photo 9-Looking north at PileRidge-1.

Pile Ridge-1 - 2' tall, 5' wide, 100' long

Rad 9 - Pile Ridge-1; Cm - 230 uR/h; 1m - 70 uR/h

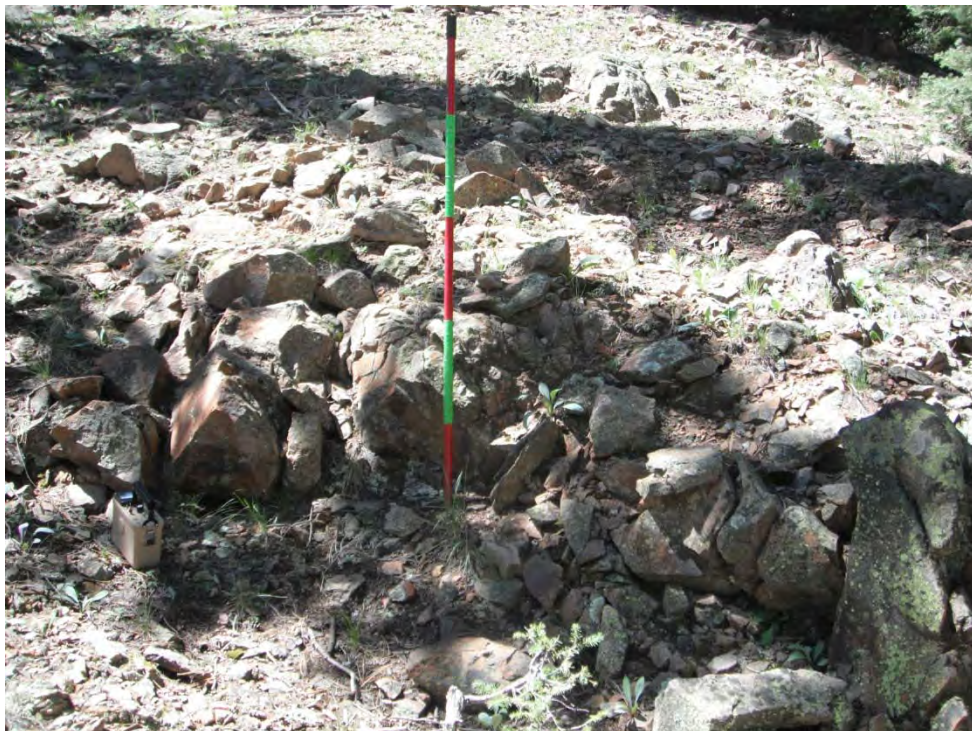
Photo 10-Looking south at Pit-2.

Pit-2; 2' deep, 20' long, 15' wide

Rad 10 - Pit-2; Cm - 310 uR/h, 1m - 140 uR/h
