Abandoned Uranium Mine Site Assessment for the Paran Mine (NM0251)

FINAL REPORT

January 20, 2010

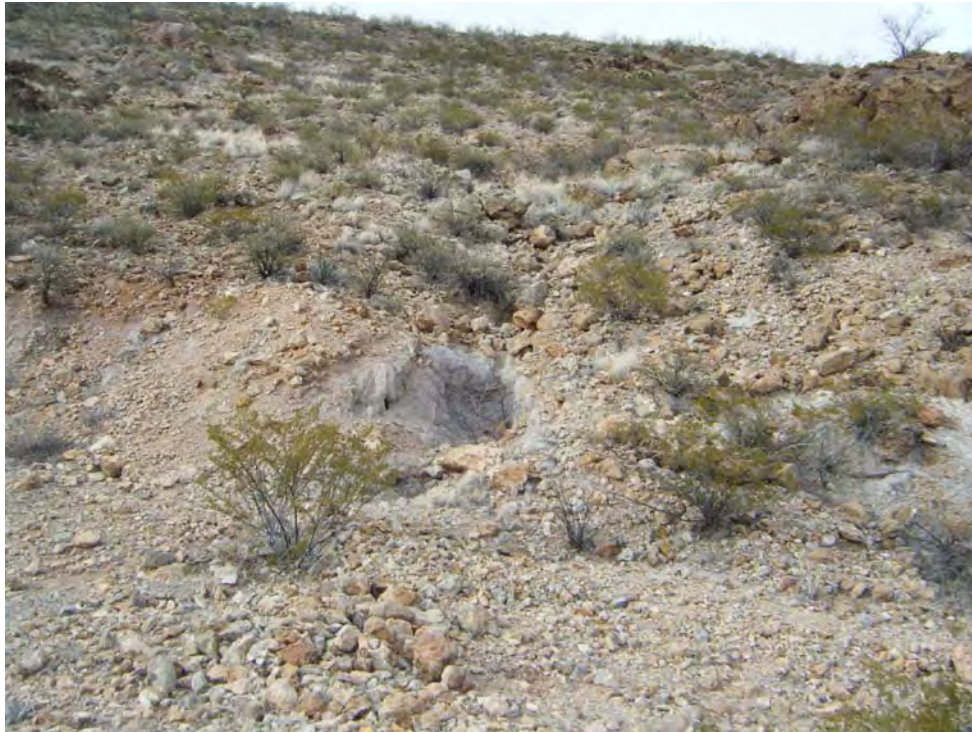
There is one notable erosional feature near the AUM Site, above the intersection of roads 1, 2, and 3. This erosion is due to water runoff on the steep road banks created when the roads were cut into the hillside.

Photo 4 – View of road (rd-1) in foreground and erosion (erospt-1) on slope southeast of the AUM Site, looking north.

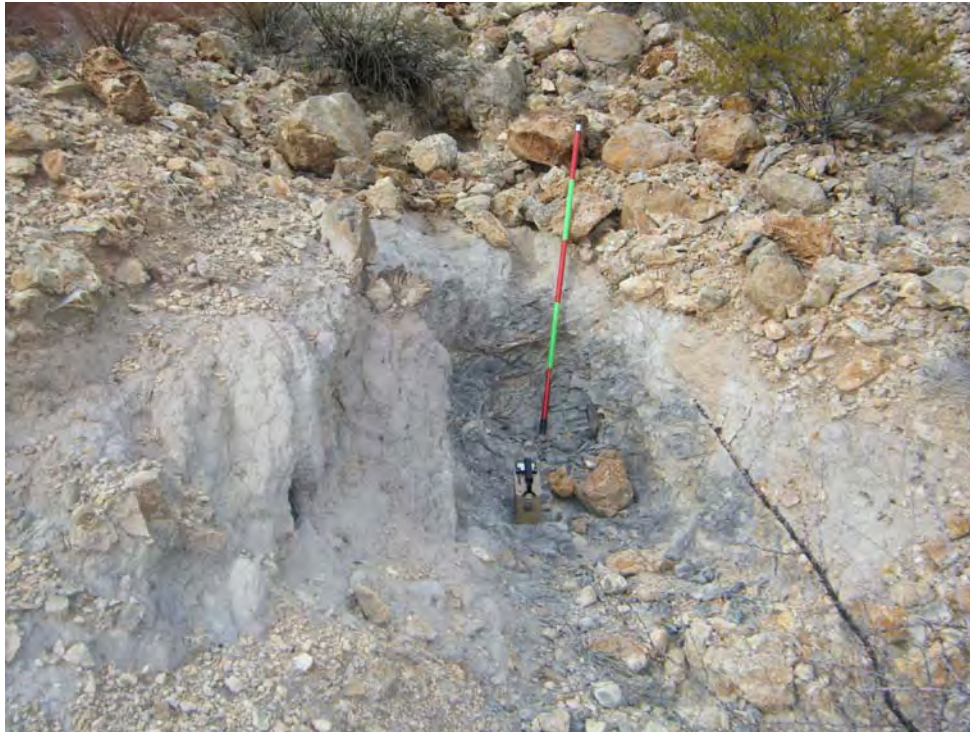
The offsite gamma radiation readings for the prospect site to the east ranged from 120 $\mu\text{R/hr}$ (rad-4) at the ground surface inside cut-2 to 12 $\mu\text{R/hr}$ (rad-1) at the erosion area near the access roads.

Photo 7 – Erosion area (erospt-1), looking north.

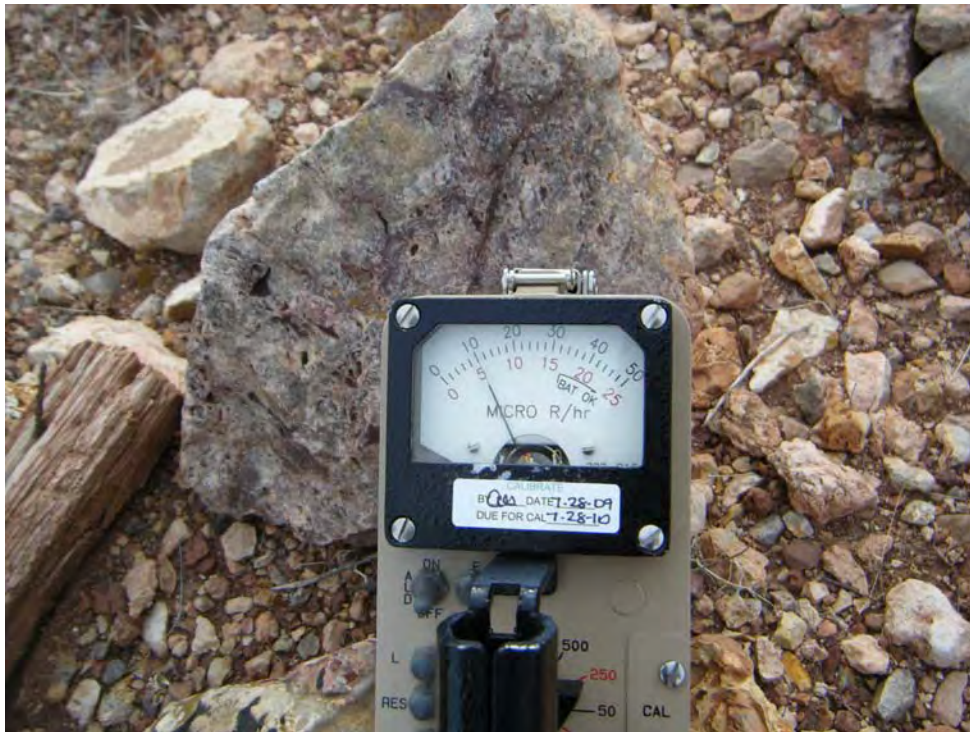
Photo 10 –Ludlum reading of 50 μ R/hr (rad-3) on a rock on the west side of the bench (bench-1).

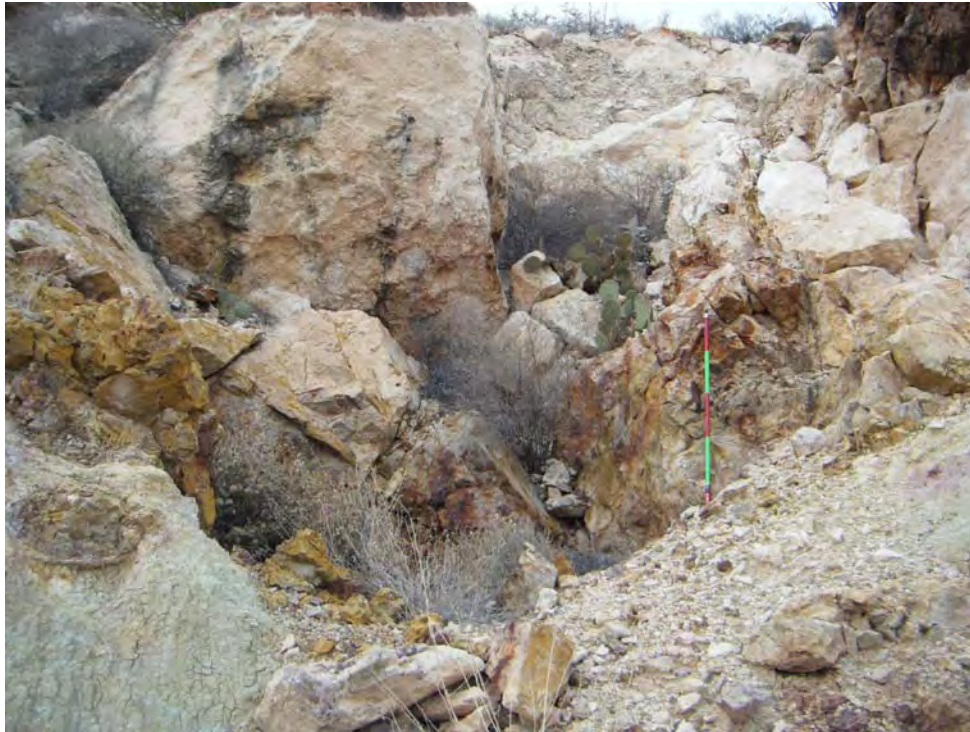
Two open cuts (cut-1 and cut-2) were found offsite near the AUM Site. The material from one of these cuts (cut-1) was used to create a bench (bench-1), and a flat area for mining activities. The other cut (cut-2) was perpendicular to the main cut (cut-1) and followed a mineralized zone into the hillside. Another bench (bench-2) is located below the cuts, and appeared to be a staging area for mining activities.

Photo 12 – Open cut (cut-2), looking north.

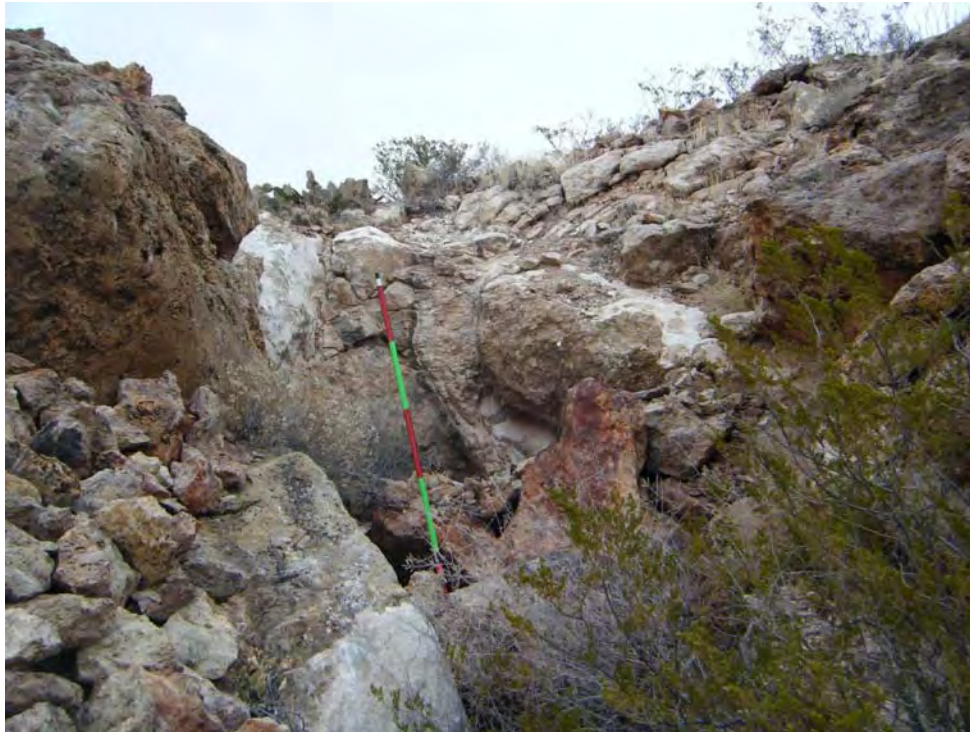
The Paran Mine AUM Site consists of one cut (cut-3) extending about 10 feet north into the hillside. The cut dimensions are approximately 6 feet wide, 10 feet long, and 6 feet deep. The cut was made perpendicular into the hill to access veins of secondary mineralization formed in the fault zone.

The gamma radiation readings at the AUM Site were highest inside of cut-3. The highest reading in the cut was rad-5, recorded above loose rock on the floor of the cut and had readings of 200 $\mu\text{R/hr}$ at the ground surface and 50 $\mu\text{R/hr}$ at 4 feet above the ground surface. Gamma radiation readings were taken along the vein inside cut-3 as well (rad-6 and rad-7). The highest was 140 $\mu\text{R/hr}$ on the vein and 50 $\mu\text{R/hr}$ 4 feet away from the vein. Readings for the pile of rocks (pile-1) just outside of the cut were 120 $\mu\text{R/hr}$ at ground surface and 50 $\mu\text{R/hr}$ 4 feet above the pile.

Photo 24 – Inside open cut (cut-3) (replicating Anderson Report photo).

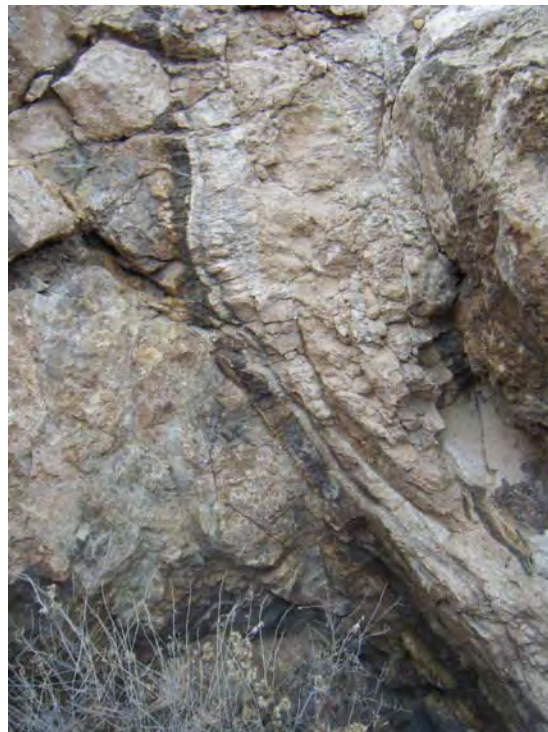
Photo 25 – Vein inside open cut (cut-3, rad-6).

Road 6 - inside cut 3, off: 60 uR/hr, ~~off~~: 50 uR/hr
on vein

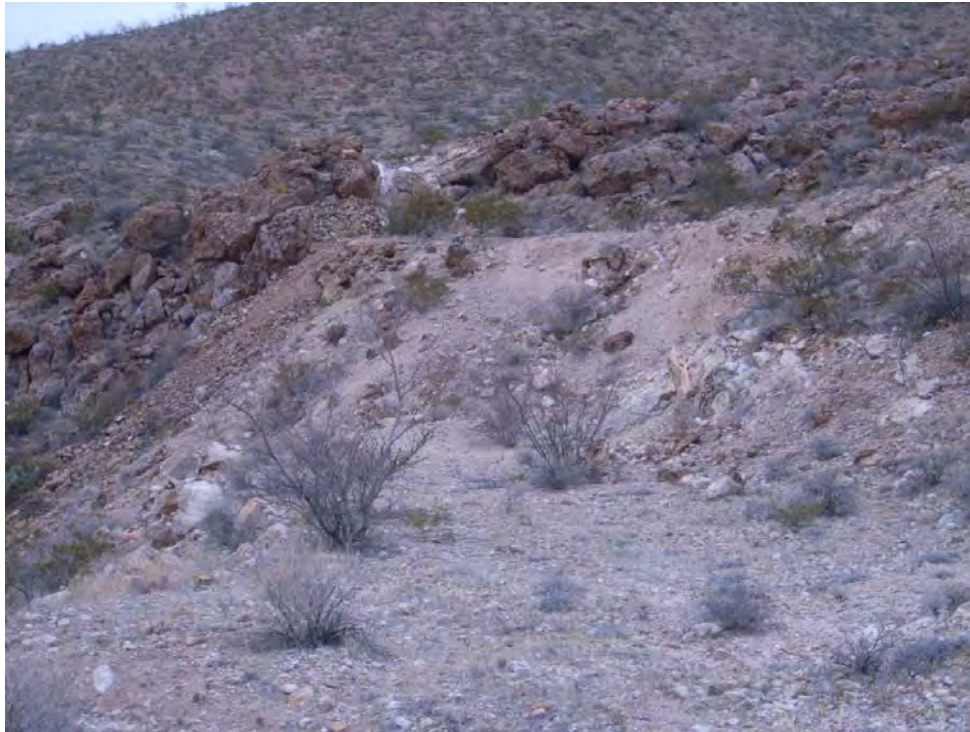
Photo 28 –Road (rd-6) towards the AUM Site, looking north.

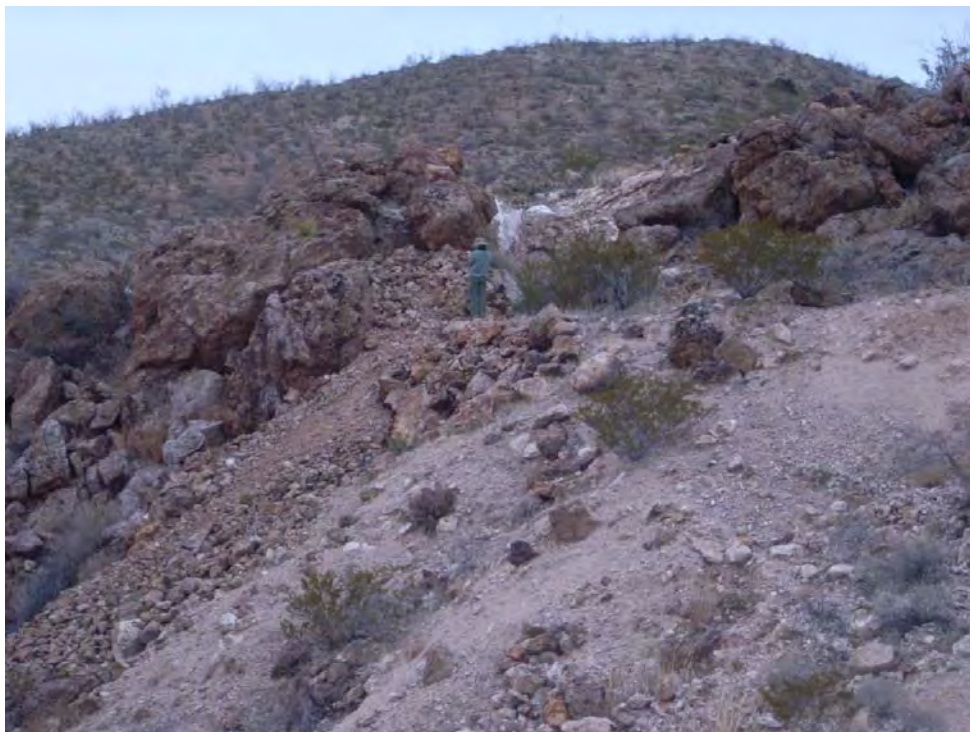
One waste rock pile (pile-1) was found at the AUM Site. This pile is located at the entrance to the cut (cut-3), and the material appears to have been removed from the cut during excavation. This pile extends in a thin layer down the hill to the southwest for about 50 feet. There is no evidence of soil staining or runoff below this pile.

Photo 29 – AUM Site from road (rd-6), looking north.
