**Subject: Grants, NM Abandoned Mine Lands Closure Project**

# GRANTS AML CLOSURE PROJECT

## **AML PROJECT SUMMARY**

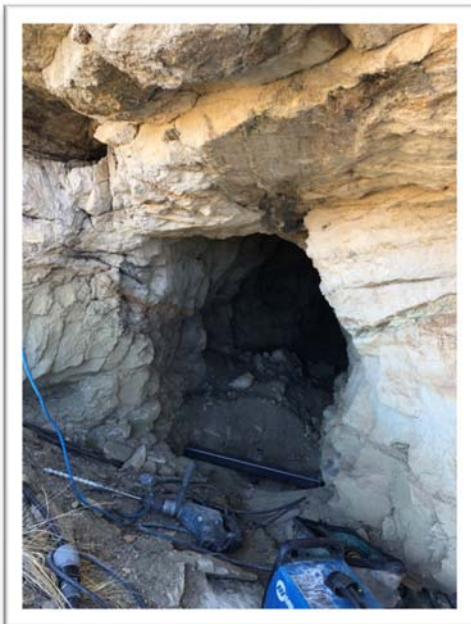
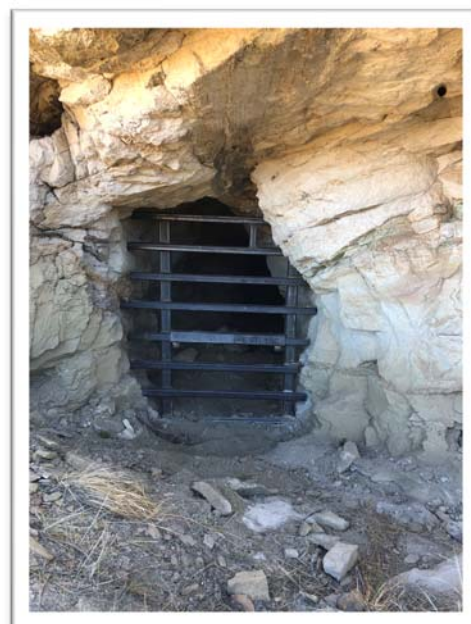
Francis 01 - A 4x6 adit that required a bat compatible closure with removable access door. A 3” sill plate and 3” vertical risers were installed into the mine feature to act as the framework. Horizontal 2” tube steel was then used to create the bat flyways. A total of nine rebar pins were drilled into the bedrock to secure the mine gate in place. A removable bar was secured to the gate using McGard bolts.

- Installed bat gate in Francis 06. Accessed thru Francis 02 since the mine opening was on a vertical cliff face. Did not install a door on this feature
- Installed bat gate with an access door on Francis 01.
- Chris Teske delivered all McGard bolts to the site
- Rolled 36" x 10-foot CSP down to Francis 02. Set loose in the adit. Bat flyways and access door are already welded in place on the CSP
- Rolled 24" x 4-foot CSP to Francis 04. Set loose in the adit. Bat flyways are already welded in place. No door.
- Started work on Francis 05. Got the sill plate and uprights in place. Will install flyways tomorrow

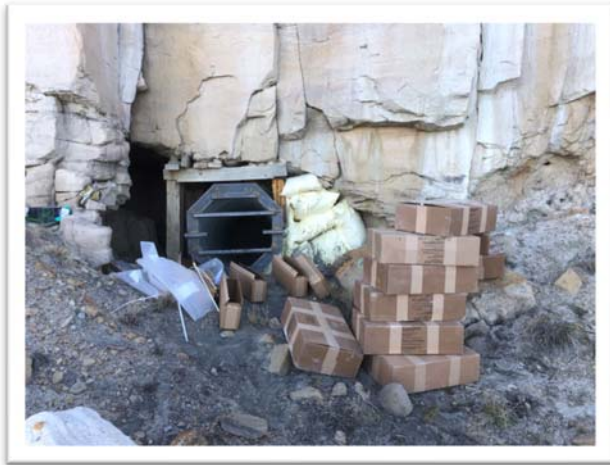
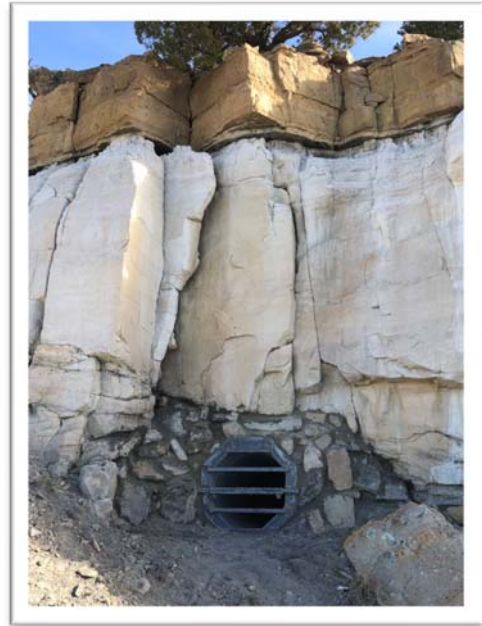
Francis 02 - A 4x10 adit that required a bat compatible closure with removable access door. This mine opening had failing roof supports and is used to access Francis. A 36” x 10’ corrugated steel pipe (CSP) was inserted into the opening between the wooden timbers. An octagon frame was continuously welded to the CSP followed by horizontal bat flyways and a removable access door. The removable bar was

secured to the CSP using McGard bolts. The CSP was then locked into the mine opening using 12 cubic yards (CY) of polyurethane foam (PUF). Once the PUF had cured, a concrete rock wall was constructed over the PUF and in line with the face of the CSP. A total of 600 pounds of concrete and mortar was used in construction of the rock wall.

- Completed bat gate on Francis 05. No access door as hole is only 15 feet deep.
- Installed 12 CY of PUF into Francis 02. A rock wall was built up over the face of the installed PUF. Rock held in place with 480 pounds of Redi mix and 120 pounds of mortar mix. Removable bar secured in place with McGard bolts.
- Used 1CY of PUF to secure Francis 04 CSP into place. CSP is 24" x 4 feet. Used 120 pounds of mortar mix and a series of stacked rocks to cover the PUF and complete the closure. No access door as hole is only 20 feet deep.

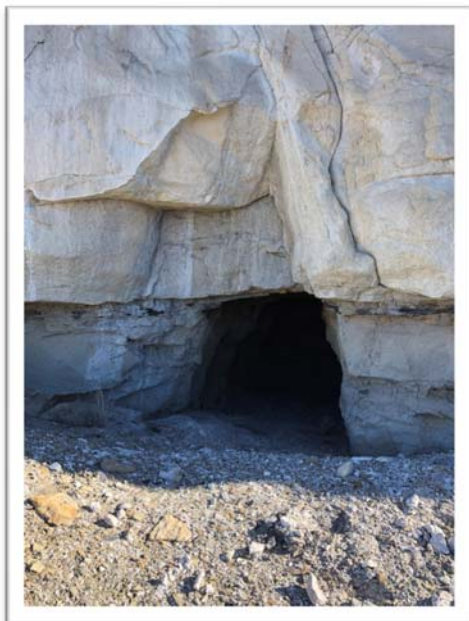
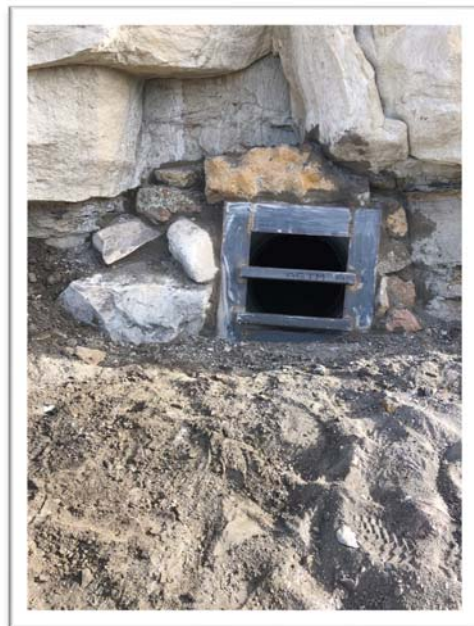
Francis 04 – A shallow 3x3 prospect adit with bat compatible closure. A 24” x 4’ CSP was inserted into the opening. A square frame was continuously welded to the CSP followed by horizontal bat flyways. The CSP was then secured into the mine opening using 1 CY of PUF. Once the PUF had cured, a concrete rock wall was constructed over the PUF and in line with the face of the CSP. A total of 120 pounds of concrete and mortar was used in construction of the rock wall.

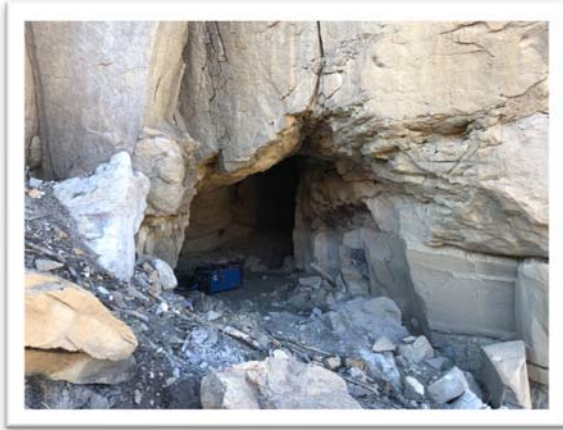
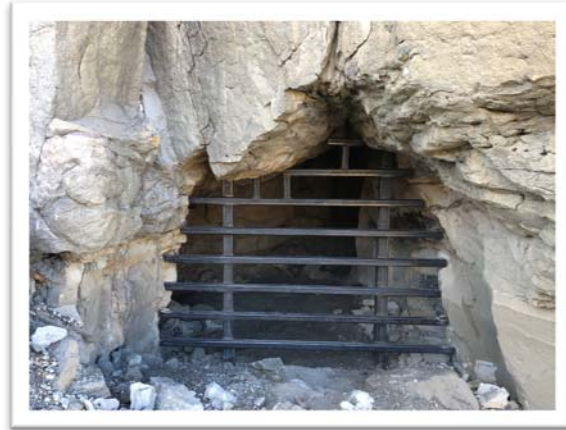
Francis 05 – A 6x6 prospect adit with bat compatible closure. A 3” sill plate and 3” vertical risers were installed into the mine feature to act as the framework. Horizontal 2” tube steel was then used to create the bat flyways. A total of nine rebar pins were drilled into the bedrock to secure the mine gate in place.

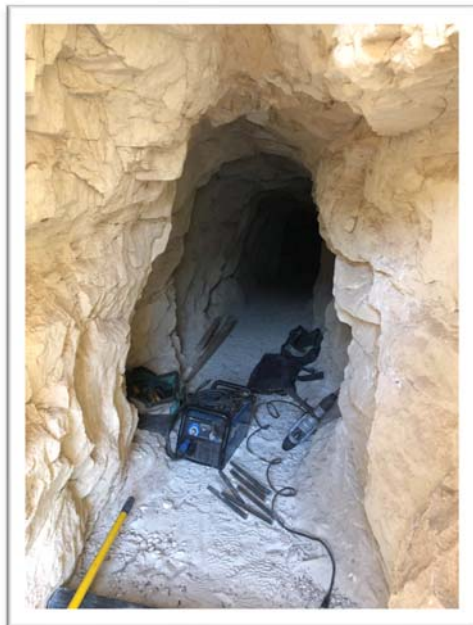
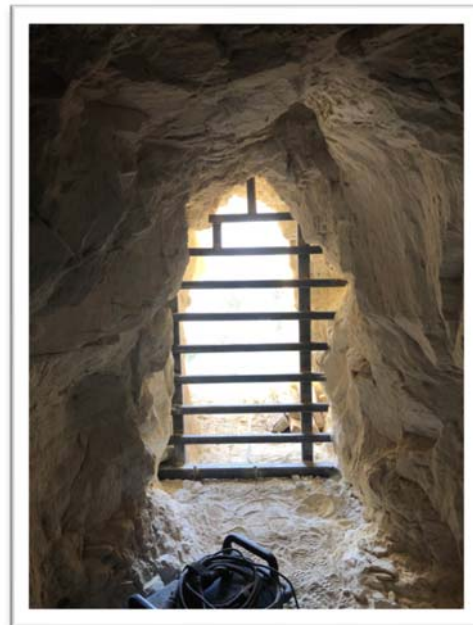
Francis 06 – A 4x6 mine tunnel exit with bat compatible closure. The opening is located in the face of cliff with the only access through the Francis 02 mine opening. A 3” sill plate and 3” vertical risers were installed into the mine feature to act as the framework. Horizontal 2” tube steel was then used to create the bat flyways. A total of nine rebar pins were drilled into the bedrock to secure the mine gate in place. All materials were hauled through the mine working and the closure was constructed from the inside.

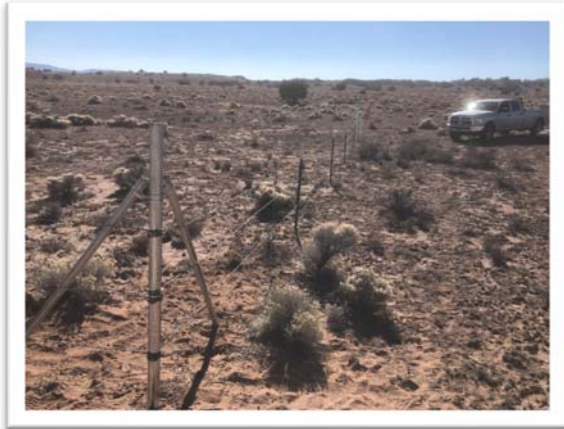
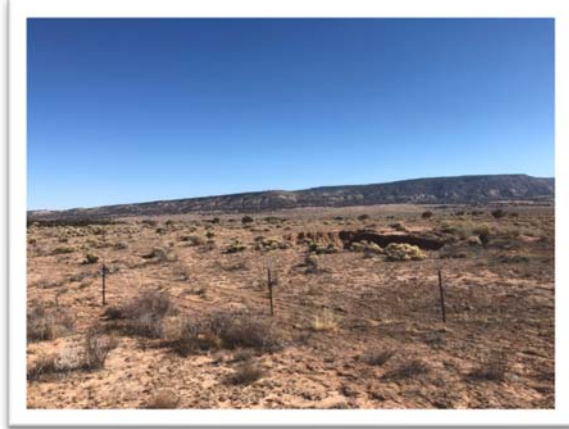
Flat Tops 48 – A roughly 30 x 30-foot subsidence measuring 20 feet deep. It appears this area is actively subsiding with a much larger shallow depression (1-3 feet) trending to the south. In order to make the area safe while allowing future monitoring of the subsidence, a three-strand barb wire fence was installed around the mine. The fence measured 650 feet in total length, was secured in place with corner posts set in concrete as well as line posts and T-posts set at 12 feet spacing. All fence was pulled tight using a fence stretcher followed by installing fence stays between every T-post.

- Periodic inspection of the mine gates for vandalism.
- Periodic inspection of three machine backfills for additional subsidence
- Monitoring of Flat Tops 48 followed by a more secure closure
- Closure of two mine shafts adjacent to NM605 as indicated by the landowner, Robert Schmidt. Features had previously been fenced off with orange fencing which has failed. Features are near GPS location 35.338442°/-107.797339°.

- Installed fence at Flat Tops 48. Four corner galvanized posts installed with two 45 degree angle braces on each. Set all braces in concrete. 500 pounds of fast set concrete used on the fence. Line posts installed in the center along each of the four runs. 650 feet of total fence run. 12 foot spacing between fence posts. Three strands installed around the feature. Fence stays placed between each T-post.
- Hand Backfilled Mesa Top (Road hole). This was a 12" borehole that was 40 feet deep.
- Chris Teske on site to inspect all work to date. Approved.

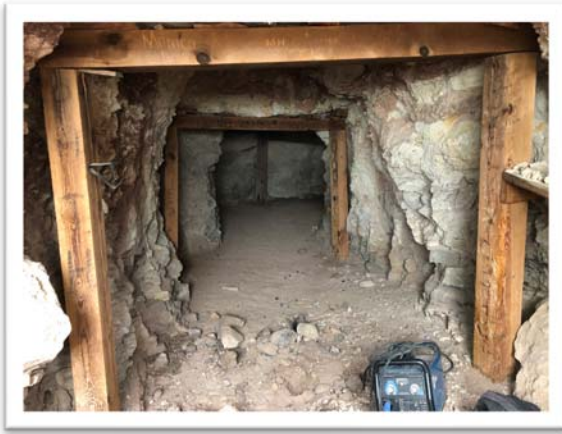
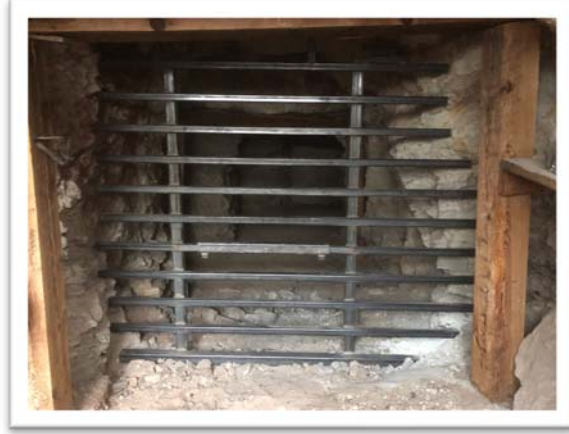
Lone Pine 01 - A 8x8 adit that required a bat compatible closure with removable access door. A 3” sill plate and 3” vertical risers were installed into the mine feature to act as the framework. Horizontal 2” tube steel was then used to create the bat flyways. A total of thirteen rebar pins were drilled into the bedrock to secure the mine gate in place. A removable bar was secured to the gate using McGard bolts. This mine directly connects to Lone Pine 02.

- Completed bat gate at Lone Pine 1. Feature is 8x8. Used 13 pins. Removable bar installed.

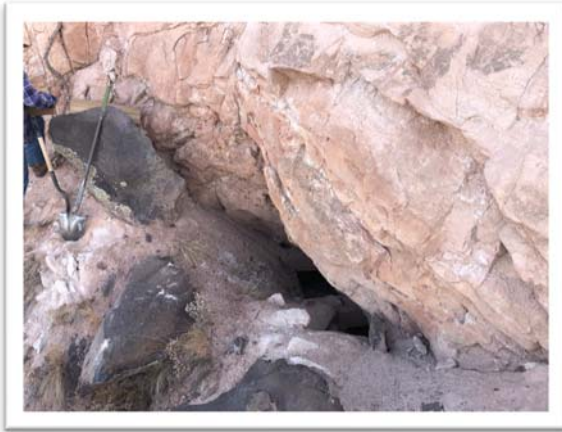
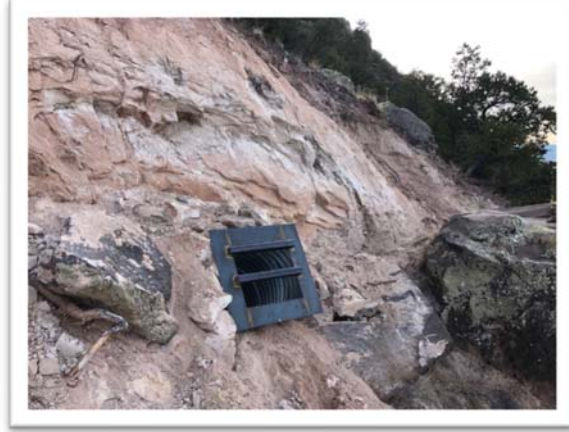
Lone Pine 02 - A mostly collapsed adit with bat compatible closure. A 24" x 6' CSP was inserted into the opening following hand excavation of opening which was required to fit the CSP. A square frame was continuously welded to the CSP followed by horizontal bat flyways. The CSP was then secured into the mine opening using 1.67 CY of PUF. Once the PUF had cured, loose backfill was placed over the PUF to a depth of 2-3 feet.

- Received delivery of backhoe and improved road up to Lone Pine features
- Installed 24" x 10 foot CSP into Lone Pine 02. Steel previously welded onto the CSP. Used 1.67 CY of PUF to secure in place. Backfilled

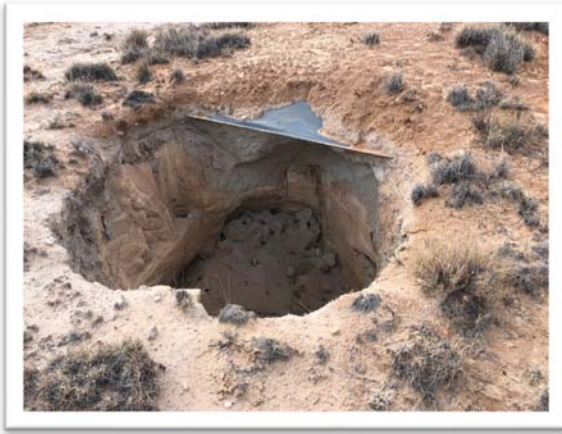
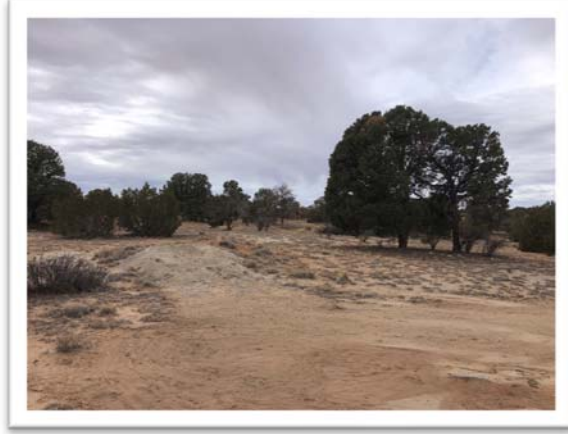
Malpais 70 - An 8x8x10 foot shaft that required backfill. This mine shaft was previously closed by others but has since subsided. A Case 580 backhoe was used to fill the mine subsidence. Borrow materials were harvested from adjacent waste rock and dumped in to the subsidence until a 3 to 5 foot mound was achieved over the mine. A total of 35 CY was used to backfill the mine subsidence. All disturbances from backhoe use were then raked.

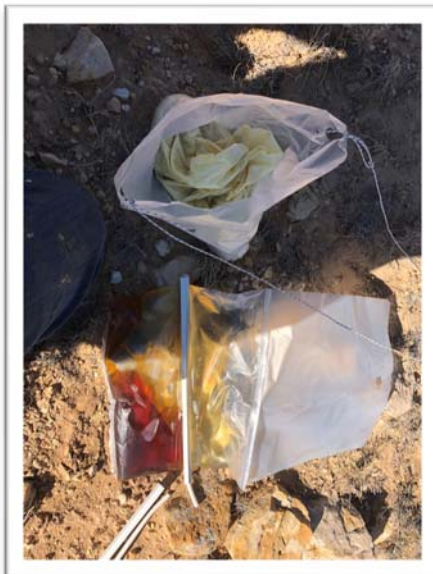
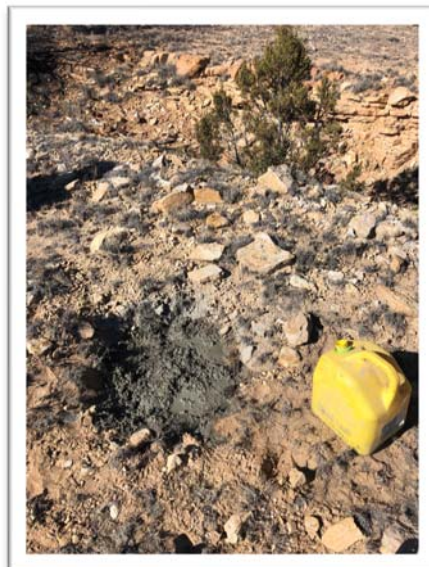
Mesa Top 62 – A 8” diameter borehole by unknown depth required sealing. A specially designed PUF borehole plug was used to seal this borehole. The borehole plug consisted of a known premade PUF quantity designed by the manufacturer for specifically plugging 8” boreholes. The PUF was mixed and lowered into the borehole to a depth of 8 feet where it reacted to cause 2.5-foot rise in PUF within the borehole. A second plug was lowered onto the completed first plug and allowed to react. Once completed this created a 5-foot plug in the 8-inch borehole from 3 to 8 feet below ground surface (bgs). A total of 160 pounds of concrete was then placed over the PUF followed by dirt to surface grade.

- Installed 3 CY of PUF into Blue Peak 06. Hand backfilled remainder of the feature.
- Installed the borehole PUF bags into Mesa Top 62. Two bags used. Set at 8 foot depth. 2 sets of the bags rose in the borehole to minus 2 feet bgs. Installed 160 pounds of redicrete over the PUF to minus 1 foot bgs then backfilled to grade
- Installed two borehole PUF bags into Beacon Hill 35c. Same process as previously discussed
- Cut and staged steel for Lone Pine

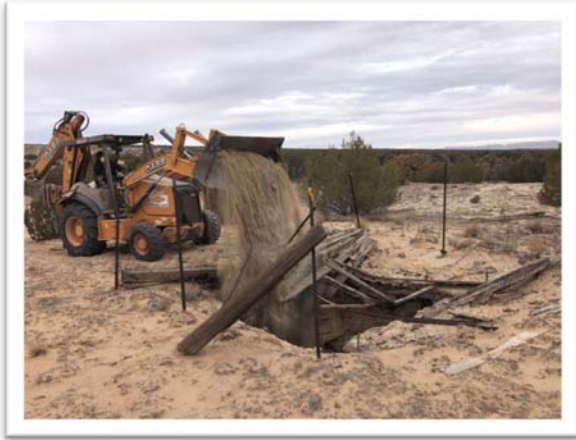
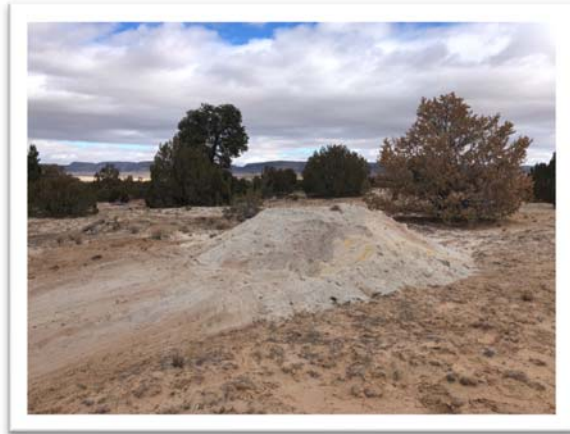
Mesa Top 65 - An 10x11x75 foot shaft that required backfill. A Case 580 backhoe was used to fill the mine shaft. Borrow materials were harvested from adjacent waste rock and dumped in to the shaft until a 3 to 5 foot mound was achieved over the mine. A total of 360 CY of backfill was dumped into the mine shaft. All disturbances from backhoe use were then raked.

- Completed backfill of Mesa Top 65. Raked all tracks.
- Only 1 holes left Beacon Hill 35d.

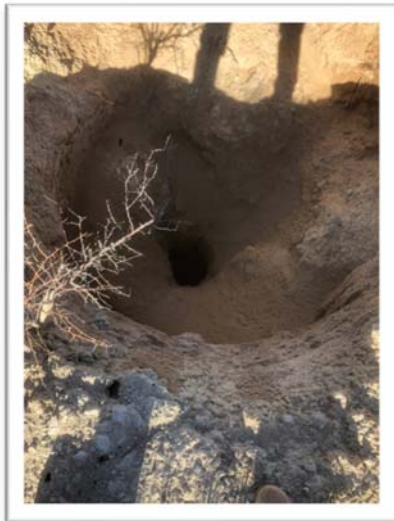
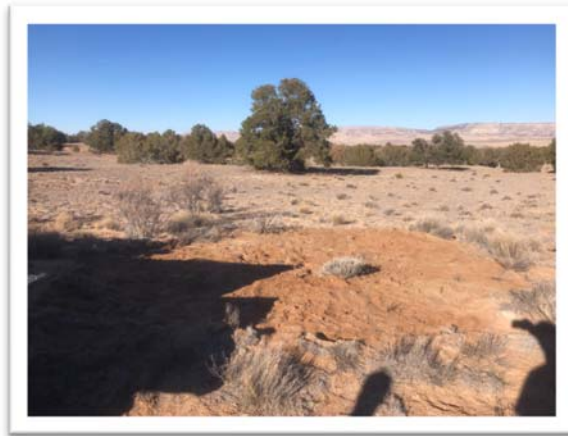
Mesa Top (Road) – A 12” diameter borehole x 30 feet was identified during the preconstruction meeting and added to the project. Due to its shallow depth this borehole was hand backfilled.

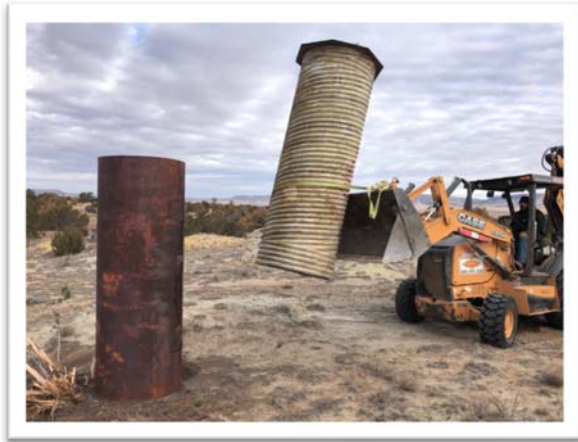
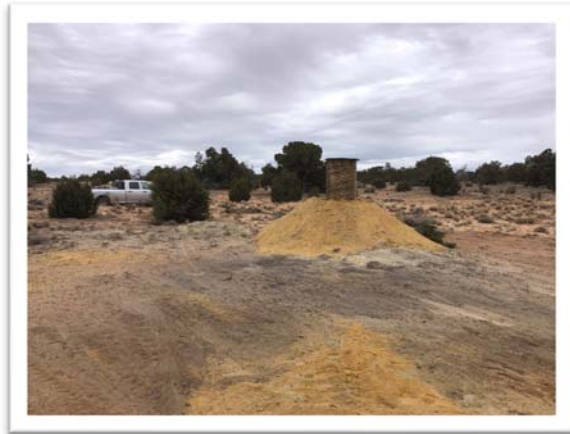
Mesa Top 39a – This feature is an 8-foot tall by 36” diameter vent pipe or manway hatch that has been welded closed. However, many small holes near ground level are in the steel which are actively venting radon. In order to vent the air higher up, above the breathing zone, a 42” diameter CSP was used to sleeve the existing pipe. Once in place 1CY of PUF was installed at the ground surface to seal the contact point and the CSP was backfill to 5 feet above ground surface. An octagon frame was continuously welded to the CSP followed by 1-1/4” bar grating. Two coats of Natina were then applied to the exposed CSP to reduce visibility. All disturbances from backhoe use were then raked.

- Installed 42" x 10' CSP over the existing 36" x 8' vertical access pipe at Mesa Top 39a. Grating previously welded to the face. Installed 0.67 CY PUF around the bottom and backfilled 60%. Top 40% was painted with Natina by Chris Teske. Raked all tracks.
- Backfilled Malapis 70. Raked all tracks.
- Started backfill of Mesa Top 65. Big hole, going to take a while.
- Chris Teske approved all closures to date. Only 2 holes left (Mesa Top 65 and Beacon Hill 35d).

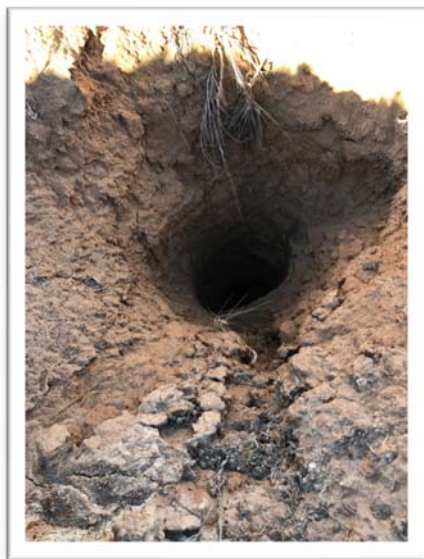
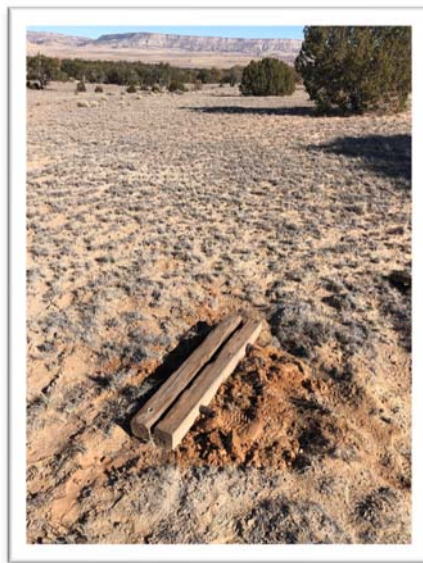
Beacon Hill 35c - A 8” diameter borehole by unknown depth required sealing. Closure of this borehole was exactly like Mesa Top 62.

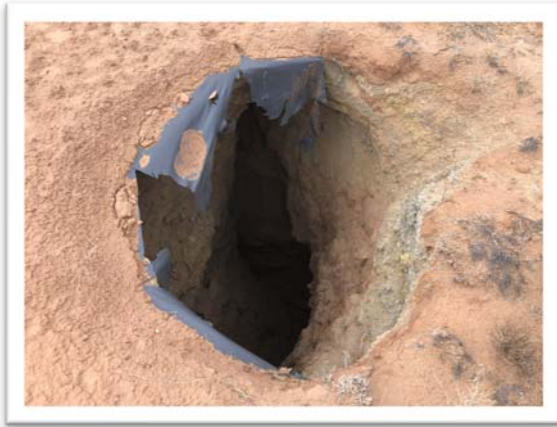
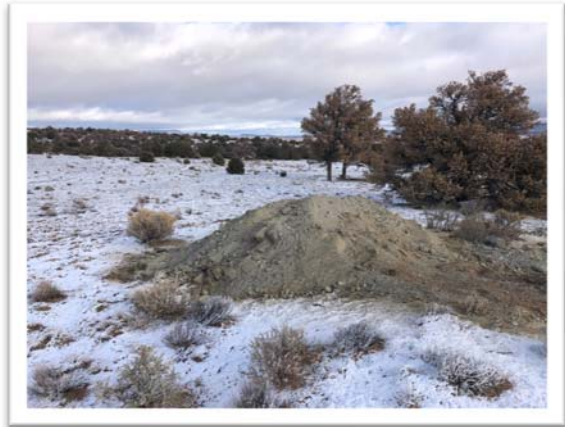
Beacon Hill 35d - An 5x8x75 foot shaft that required backfill. This mine shaft was previously closed by others but has since subsided. A Case 580 backhoe was used to fill the mine subsidence. Borrow materials were harvested from adjacent waste rock and dumped in to the subsidence until a 3 to 5 foot mound was achieved over the mine. A total of 200 CY of backfill was dumped into the mine shaft. Due to limited materials for backfill the adjacent areas were harvested as needed, then graded out to achieve a positive drainage swale through the center of borrow area. All disturbances from backhoe use were then raked.

- Completed backfill of Beacon Hill 35d. 200CY estimated to backfill. Installed a low point swale in the borrow area to release any overland flow to the existing drainage below the site. Raked all tracks.
- Roaded backhoe to pick up point. Picked up at 1400 by Ahern Rentals
- Returned key to Robert (landowner)
- Job Completed, all 17 features have been closed per specifications

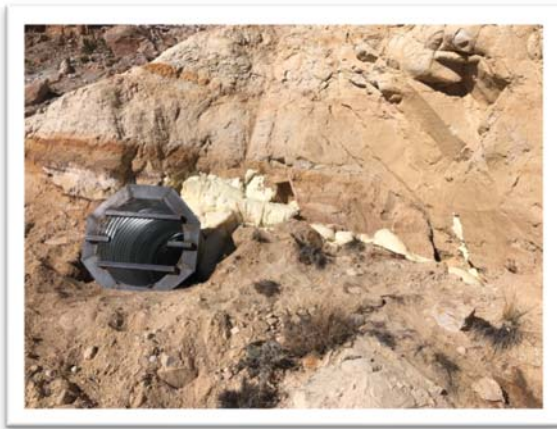
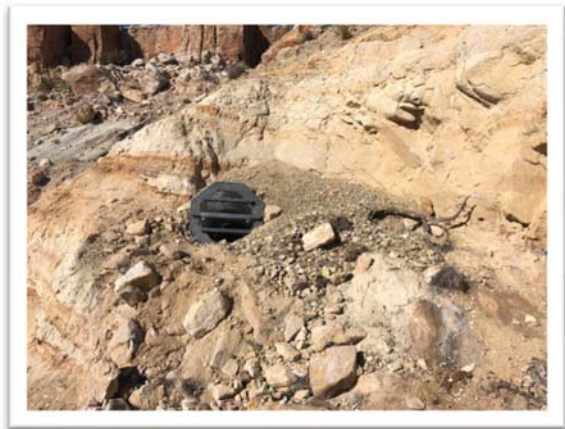
Blue Peak 05 - A 2x10 adit that required a bat compatible closure with removable access door. This mine opening had been slowly closing itself thru erosion and required significant hand excavation to achieve space for the CSP install. Due to having to hike over rugged terrain to the mine the 30" x 10' corrugated steel pipe (CSP) was cut into two five-foot sections. On one CSP section an octagon frame was continuously welded to the CSP followed by horizontal bat flyways and a removable access door. The removable bar was secured to the CSP using McGard bolts. These two sections were then transported to the mine, secured together with a steel band, and locked into the mine opening with 7 CY of PUF. Once the PUF had cured hand backfill was used to cover the PUF at a thickness of 2 to 3 feet.

- Dug out Blue Peak 05. Installed 30" x 10 foot CSP which was lowered in two sections and strapped together in the mine with a band. Bat flyways and removable bar already welded to the CSP. Installed 7CY of PUF to secure in place. Backfilled.

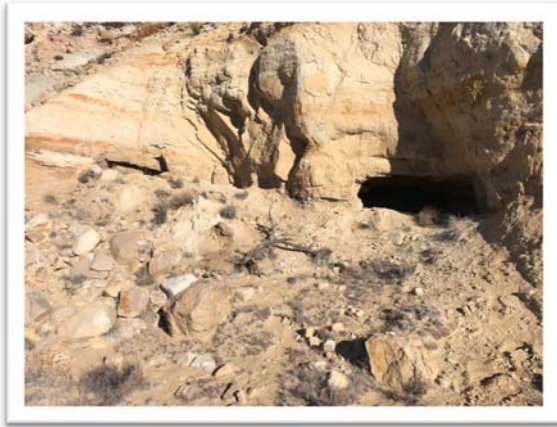
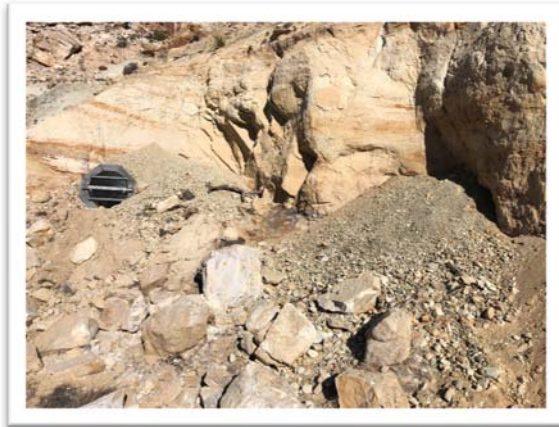
Blue Peak 06 – A 6x6x8 foot deep prospect adit that required hand backfill. A total of 3 CY of PUF was installed in the adit followed by 2 to 3 feet of hand backfill cover the all PUF. This mine was immediately adjacent to Blue Peak 05.
