Abandoned Uranium Mine Assessment for the Boyd Site (NM0190)

FINAL REPORT

NM0190

INTERA Incorporated (INTERA) has prepared this Abandoned Uranium Mine (AUM) Site Assessment Report for the Mining and Minerals Division (MMD) of the New Mexico Energy, Minerals and Natural Resources Department (EMNRD) in compliance with the Professional Service Agreement dated November 2, 2009. INTERA visited the Boyd Site (AUM Site), MMD ID: NM0190 on August 18, 2010.

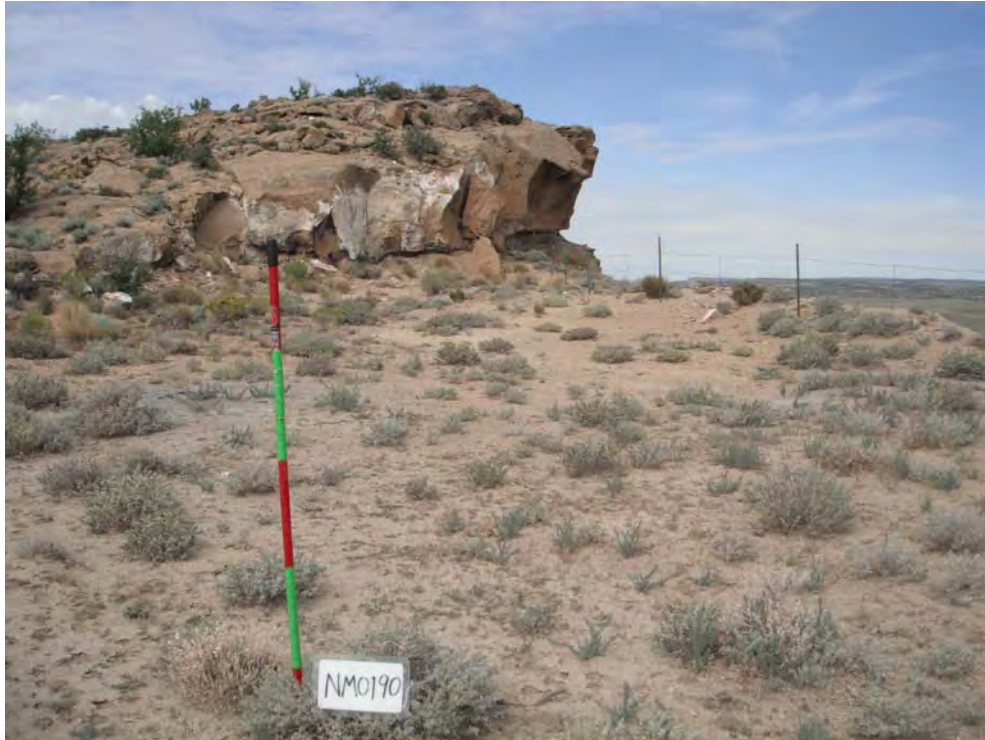
area (DistPly-1) was observed near radiation survey point Rad-2, at the location referred to as the “main pit” in Anderson (1980). The area appeared to have been partially excavated and may have been bulldozed (see Photos 1, 2 and 6 in Appendix A). The maximum gamma radiation measurement on these features was 470 $\mu\text{R/hr}$ at 0 ft above ground at radiation survey point Rad-2, within DistPly-1.

Photo 1-Site location photo, looking southwest at “main pit” (Claim No. 5) labeled in Anderson Report.

Photo 1 - site location photo looking southwest at "main pit" (Claim No 5) labeled in Anderson Report replicating Photo B

Dist Ply-1 - 50' wide, 150' long; described as "main pit" in Anderson.

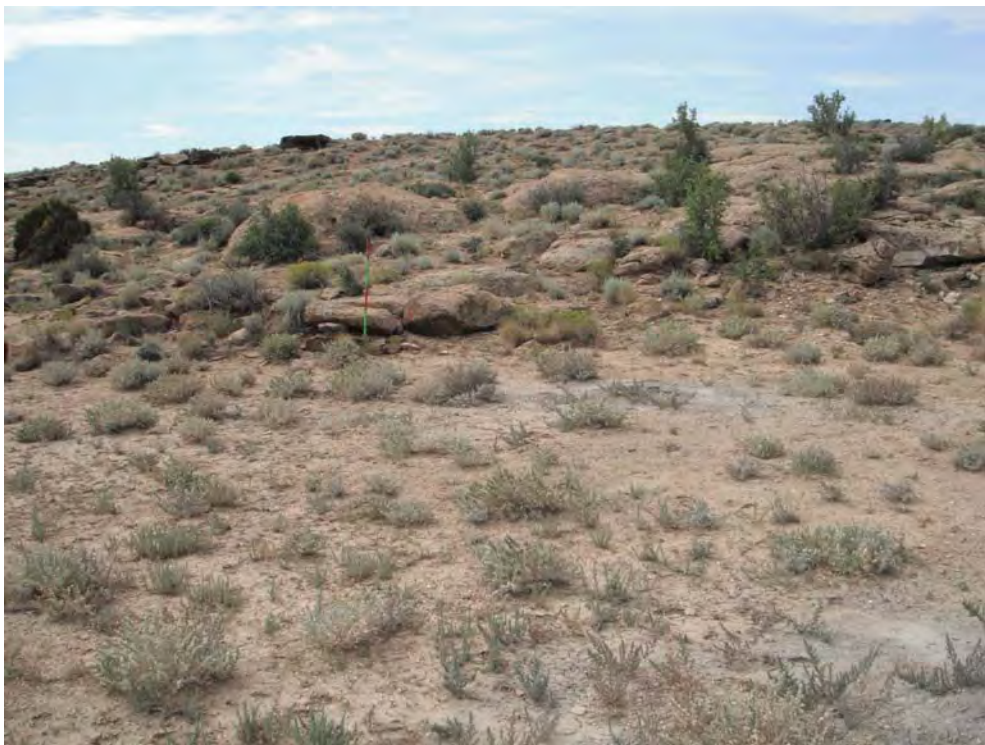
Photo 2-Looking south-southeast at DistPly-1.

Photo 2 - Dist Ply-1 looking south, southeast

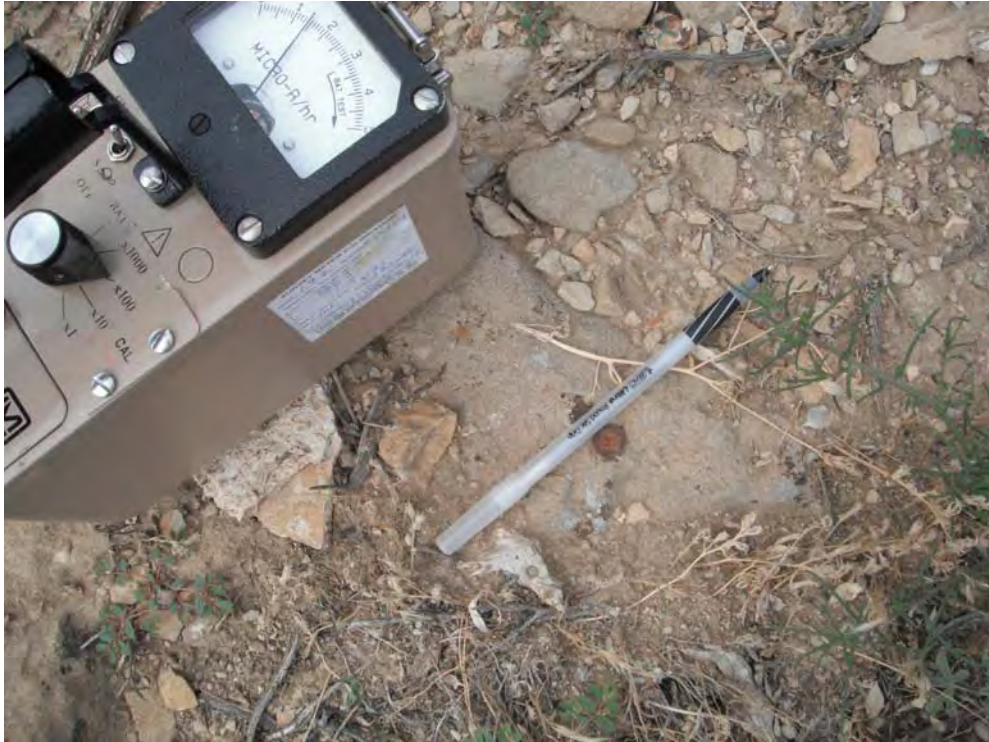
Photo 3-At Rad-1, closeup of gray sandstone.

Rad 1 - Dist Ply-1 north end. Om-150 uR/h; Im-70 uR/h on grey sandstone.

Photo 3 - grey sandstone at Rad 1, looking south

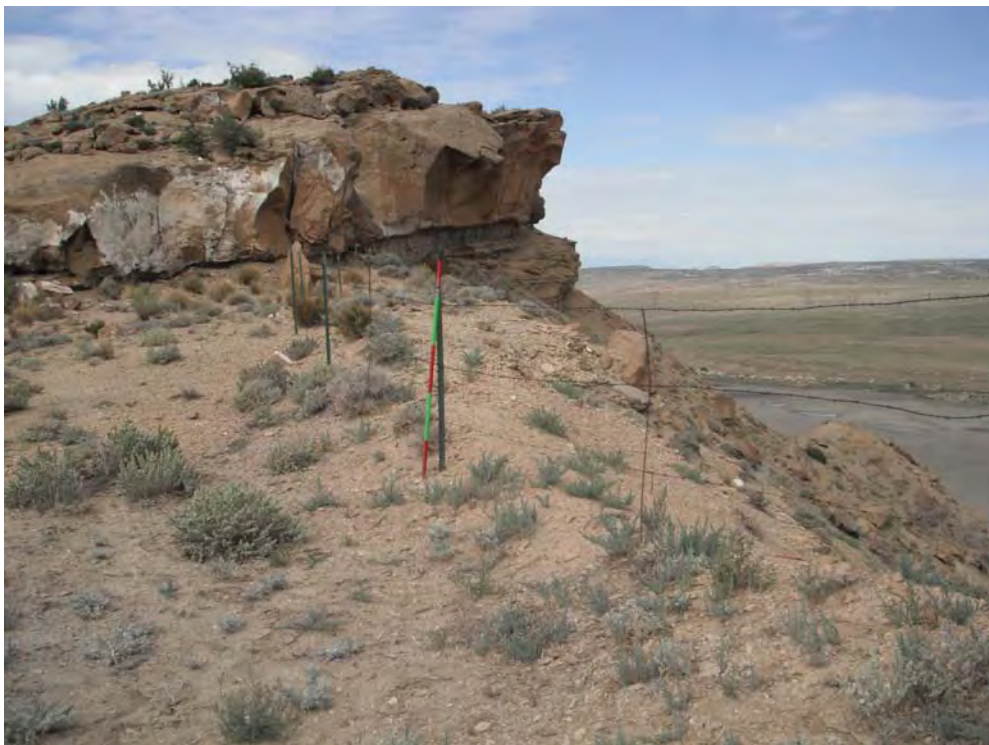
A steep cliff immediately to the north of DistPly-1 appears to be eroding, and a barbed-wire fence has been constructed (Fenc-1) along the rim of this cliff.

Photo 4-Looking southwest at Fenc-1.

Fence ln - 1 - 150' long barbed wire, along cliff edge

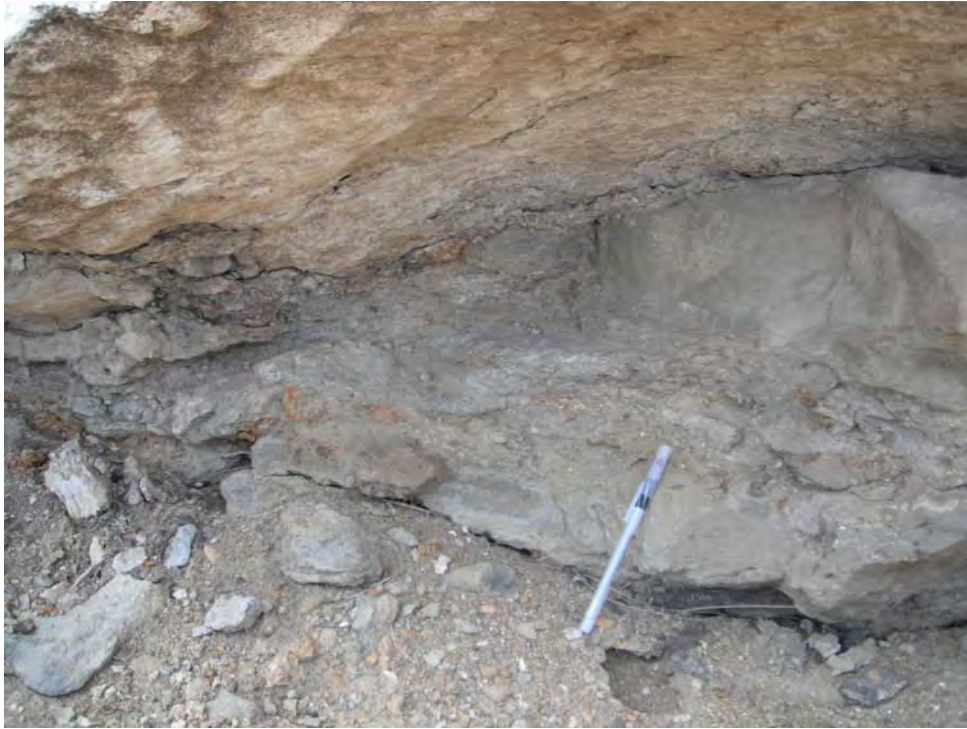
The maximum gamma radiation measured onsite was 600 $\mu\text{R/hr}$ at 0 ft above ground at radiation survey point Rad-5 in Pit-1. A gamma radiation measurement taken within DistPly-1 (radiation survey point Rad-2) recorded 470 $\mu\text{R/hr}$ at 0 ft above ground.

Photo 5-Closeup of ore-bearing sandstone outcrop, location of Rad-2.

Rad 2 - Dist Ply-1 outcrop off south side; Om-470 uR/h; Im-150 uR/h

Photo 5 - outcrop, ore-bearing rock grey sandstone/limestone

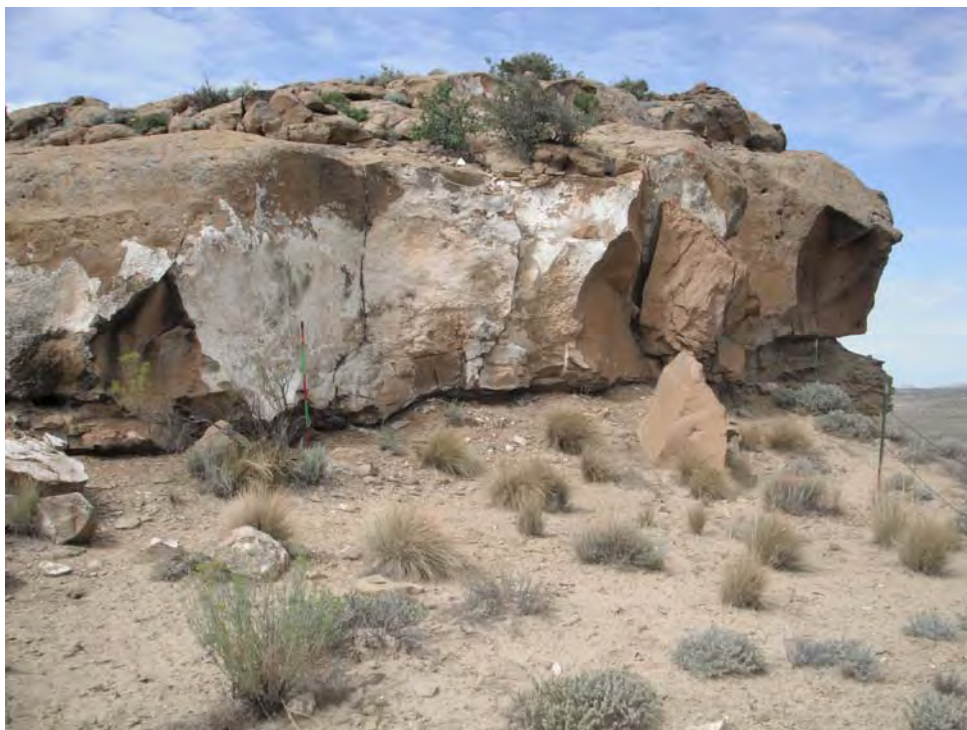
Photo 6-Looking southwest at outcrop, replicating Anderson photo B.

Photo 6 - outcrop looking southwest, replicating Anderson Photo B

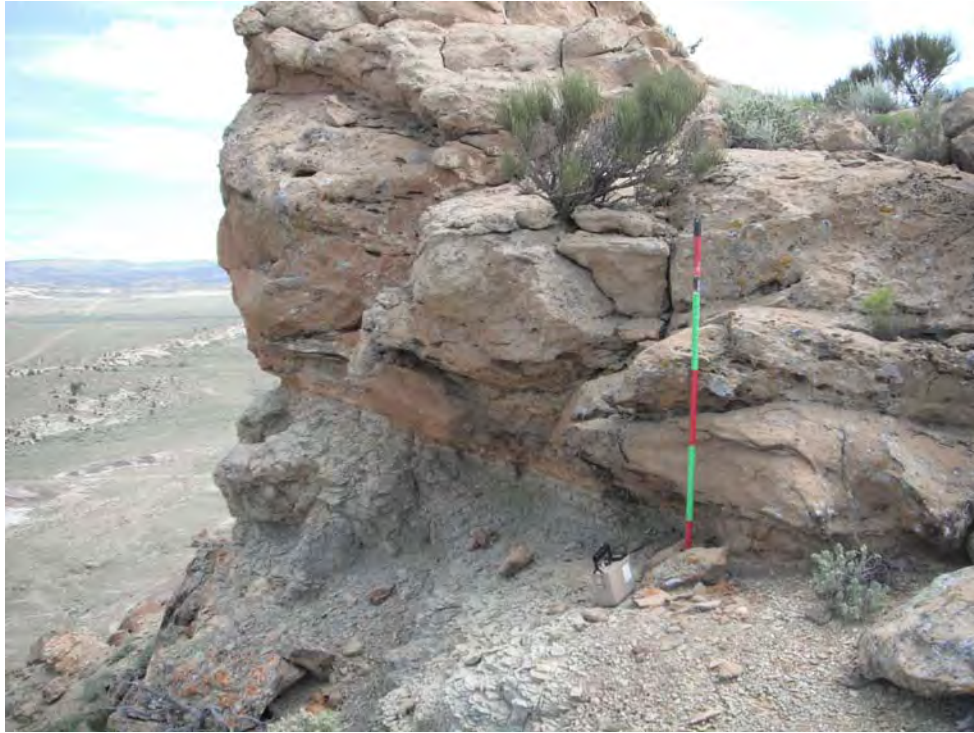
Photo 7- Looking northeast at outcrop in northern part of Claim No. 4, location of Rad-3.

Rad 3 - Claim No. 4, no visible mine features; Om-140 uR/h; Im-60 uR/h

Photo 7 - outcrop at Claim No. 4, no visible mine features

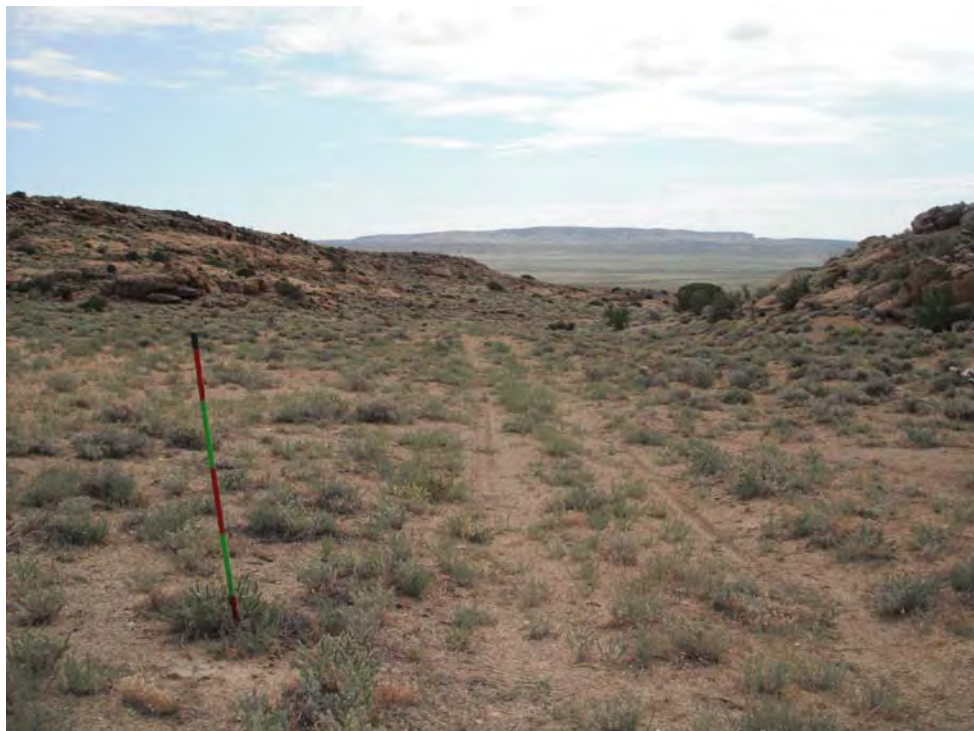
Two mine roads (Rd-1, Rd-2) were found onsite. Rd-1 runs north through the extent of the site in Claims No. 4 and 5 identified in Anderson (1980) and ends at DistPly-1. This road also runs past PilePly-1, Pit-1, and Pit-2 (see photo 8 in Appendix A, and sketch in field notes in Appendix B). Rd-2 diverges from Rd-1 at its southern extent, and runs southeast approximately 1000 ft before ending along the rim of a shallow canyon (see Figures 4a and 4b, and photo 17 in Appendix A).

Photo 8- Looking east at Rd-1, location of Rad-4.

Rad 4 - Rd-1, near "main pit"; Om-44 uR/h; Im-28 uR/h

Photo 8 - Mine Rd-1 looking east

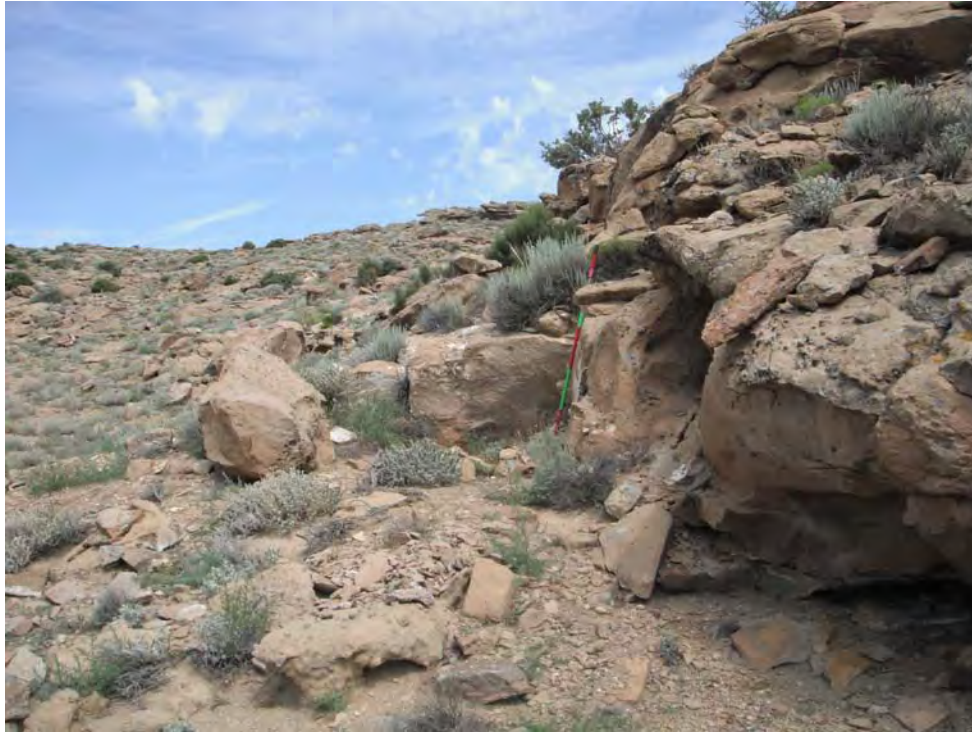
Three open pits were found at the AUM Site. Two of the pits (Pit-1, Pit-2) are shallow excavations into surface alluvium fronting sandstone outcrops (see Photos 9 and 11 in Appendix A). Pit-2 shows evidence of blasting in the adjacent outcrop (see Photo 12 in Appendix A). Pit-3 is an exploration cut into the side of a cliff formed by Kirtland Formation Sandstone (see Photos 15 and 16). All three pits are documented in Anderson (1980). The maximum gamma radiation measurement on these features was 600 $\mu\text{R/hr}$ at 0 ft above ground at radiation survey point Rad-5 in Pit-1.

Photo 9- Looking northwest at Pit-1 in southern part of Claim No. 4, replicating Anderson photo C.

Pit-1 - 5' wide, 10' long, 3' depth; Photo C from Anderson

Photo 9 - Pit-1 looking northwest in southern part of Claim No. 4, replicating Anderson Photo C

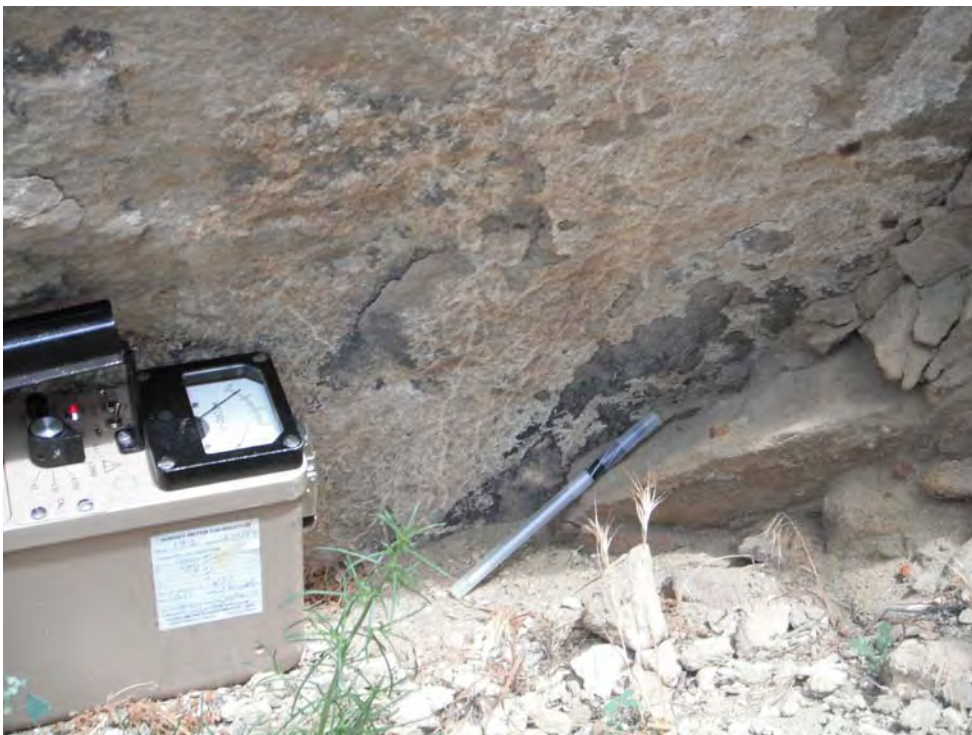
Photo 10-At Rad-5, looking at black staining on gray sandstone outcrop.

Rad 5 - Pit-1; Om-600 uR/h; Im-110 uR/h

Photo 10 - Rad-5; black staining on grey sandstone

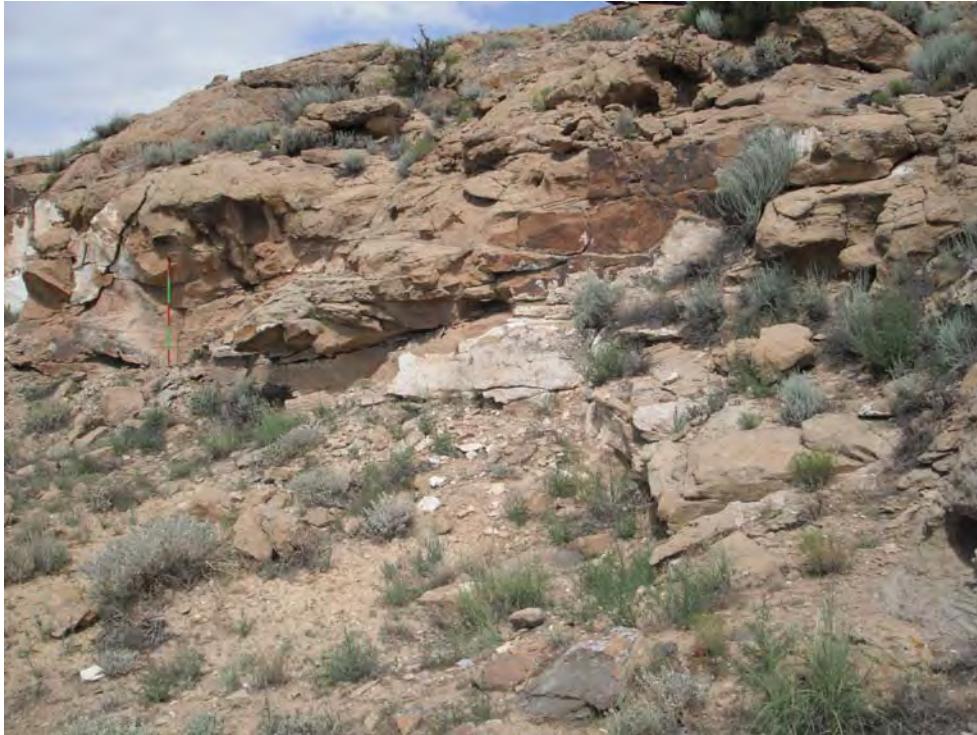
Photo 11-Looking west at Pit-2 in southern part of Claim No. 5, replicating Anderson photo A.

Pit-2 - 8' deep (outcrop), 15' wide, 30' long, south end of Claim No 5

Photo ~~10~~¹¹ - Pit-2 looking west in southern part of Claim No 5, replicating Anderson Photo D

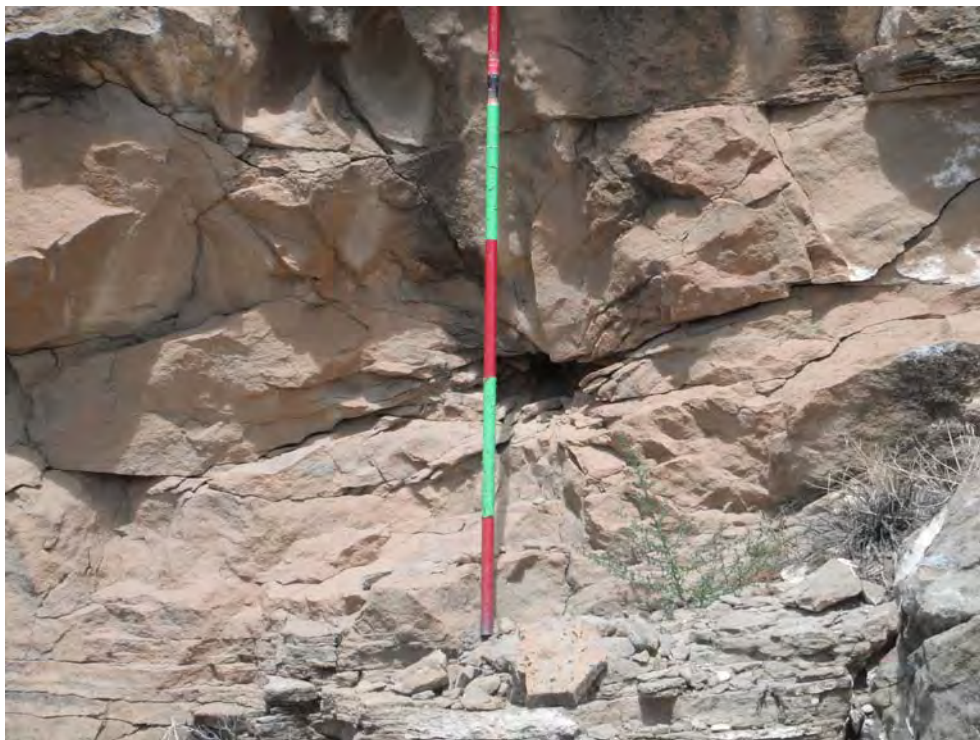
Photo 12-Blast hole in outcrop at Pit-2.

Rad 6 - Pit-2 outcrop; Om-300 uR/h; Im-80 uR/h

Photo 12 - blast hole in outcrop in Pit 2

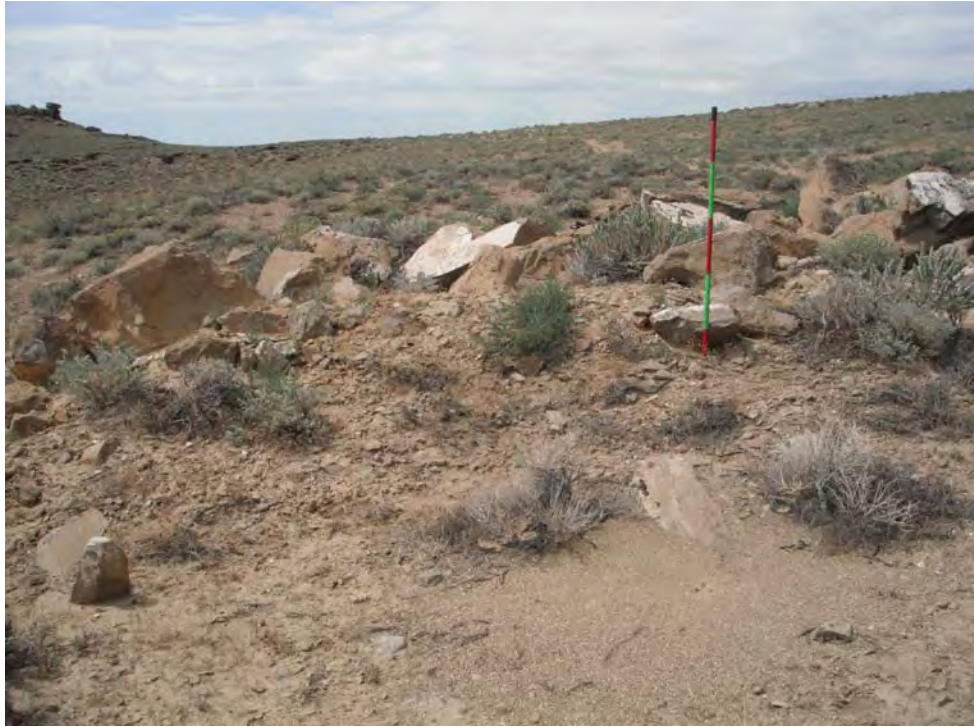
One waste pile and one disturbance area were found onsite. The waste pile, PilePly-1, is a broad, low mound consisting of soil and large boulders (see Photo 13 in Appendix A). The disturbance

Photo 13-Looking southwest at Pileply-1.

Pile-1 - 5' high, 20' wide, 30' long, 10% slope; waste rock + soil

Photo 13 - Pile-1 looking southwest

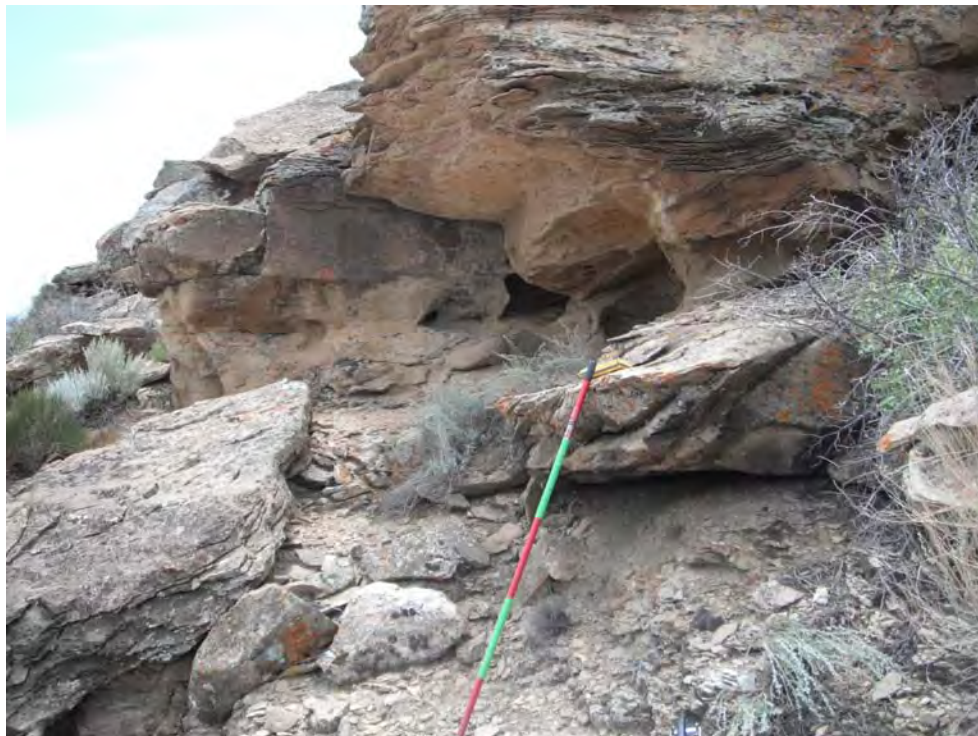
Photo 14-Looking southeast at Rad-10.

Rad 10 - northern part of polygon; Om-380 uR/h; Im-130 uR/h

Photo 14 - Rad 10 looking southeast, no visible mine features

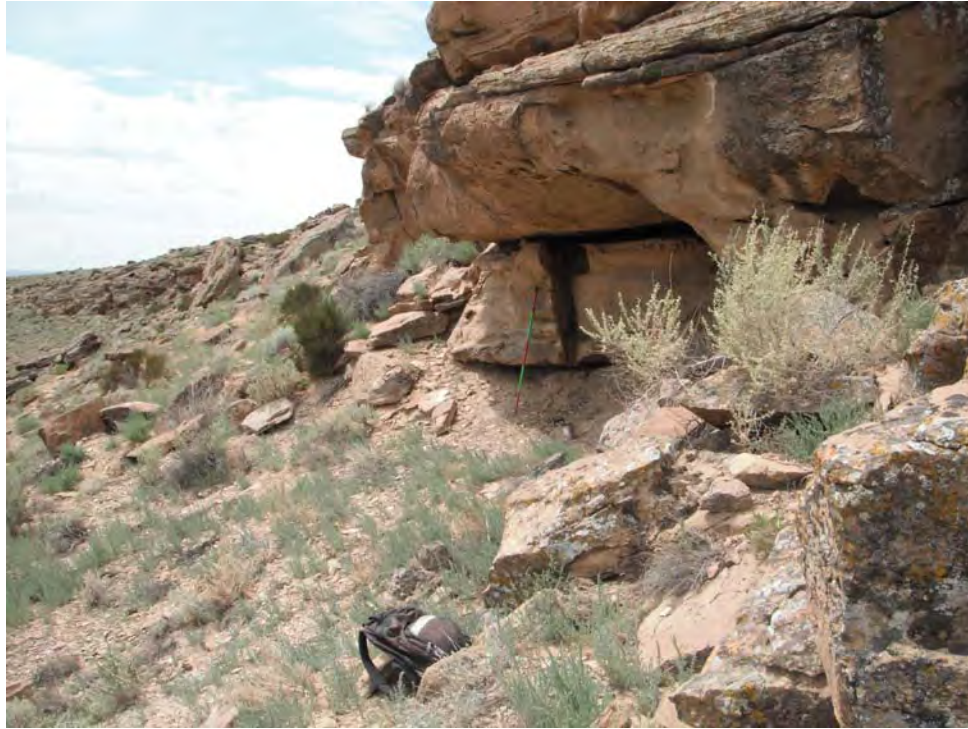
Photo 15-Looking southwest at Pit-3, replicating Anderson Photo A.

Pit 3 - on eastern end of claim No 10, may be natural cave
20' deep, 25' wide, 30' long

Photo 15 - looking SW at Pit 3, replicating Anderson Photo A.

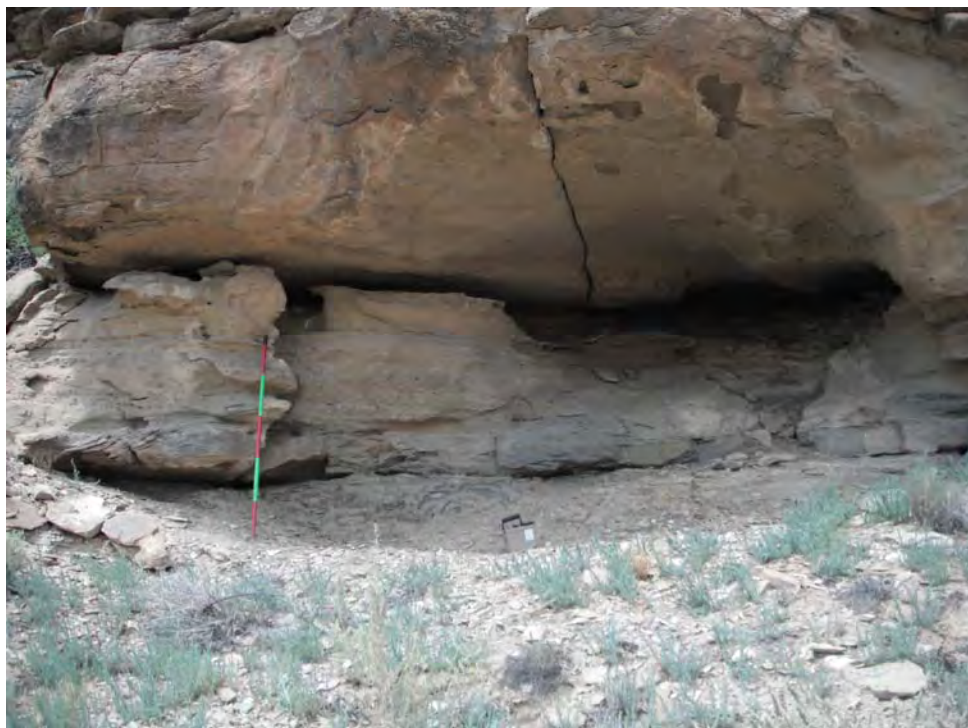
Photo 16-Looking west at Pit-3.

Photo 16 - looking west at Pit 3

Rad-11 - Pit 3; 0m-150 uR/h; 1m-55 uR/h

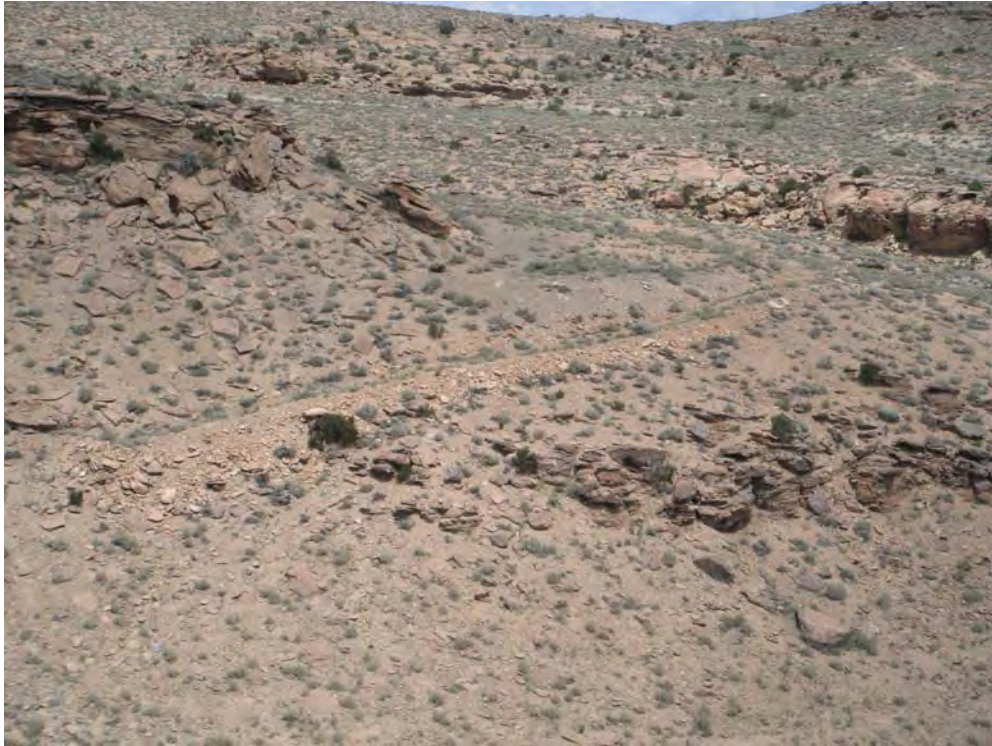
Photo 17-Looking north from above at southeastern end of Rd-1.

Photo 17 - looking north from above at southeastern end
of Mine Rd-2 - may be "rim stripping" referred to in
Anderson report.
