Letter Report – As-Built

ATEX #213 State Lead UST Site
3501 Isleta Blvd. SW, Albuquerque, NM
Facility ID #31815 RID #28 WPID #2783, D3

**RE: LETTER REPORT – AS-BUILT, ATEX #213 UST RELEASE SITE, 3501
ISLETA BLVD. SW., ALBUQUERQUE, NEW MEXICO
FACILITY #18774007/31815 SID #28 WPID #2783**

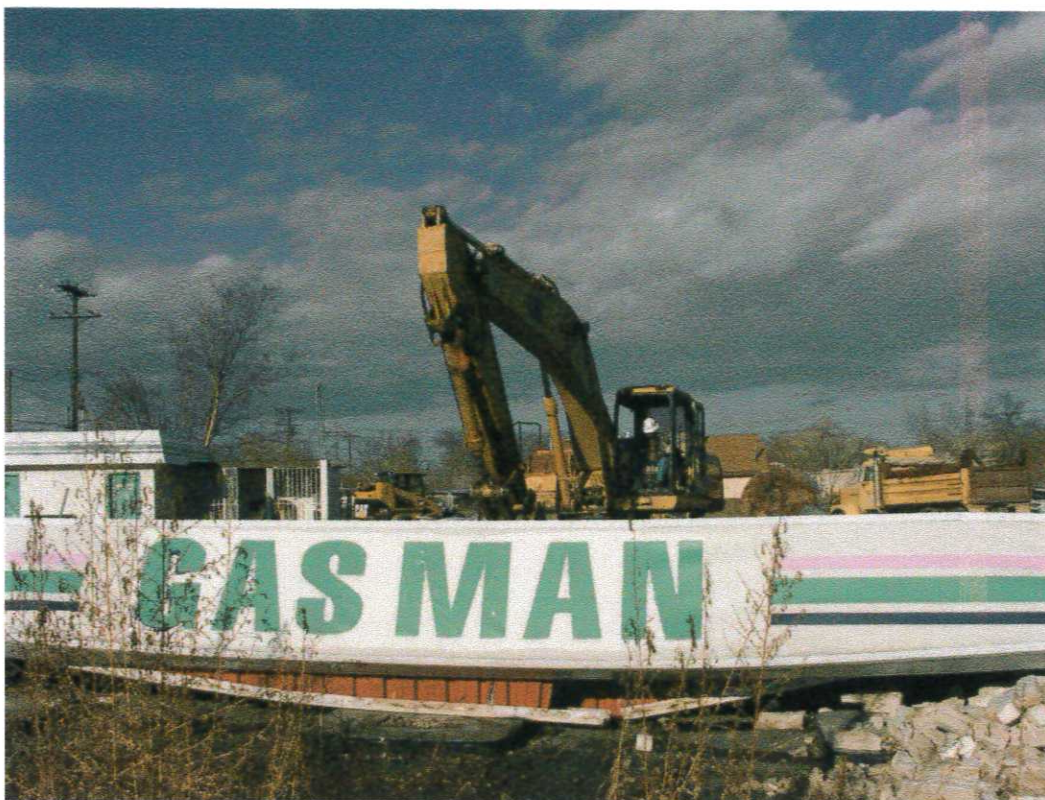
Photo 1. Demolition of canopy and pay booth.

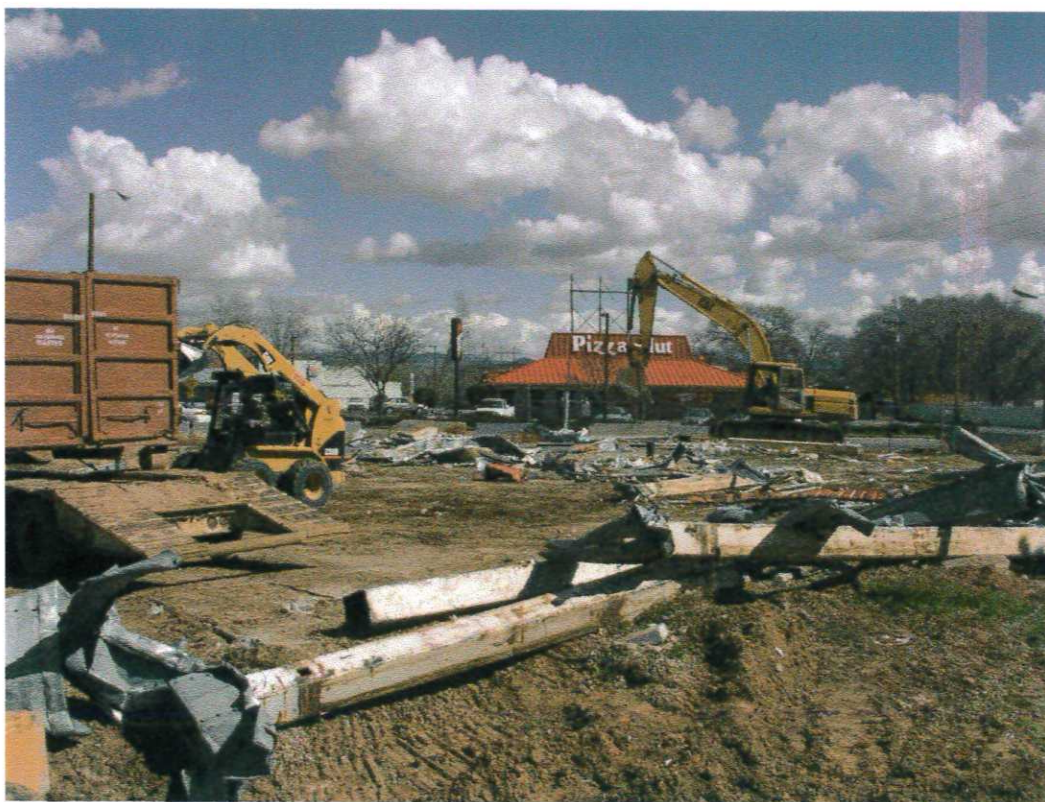
Photo 2. Demolition of canopy and pay booth.

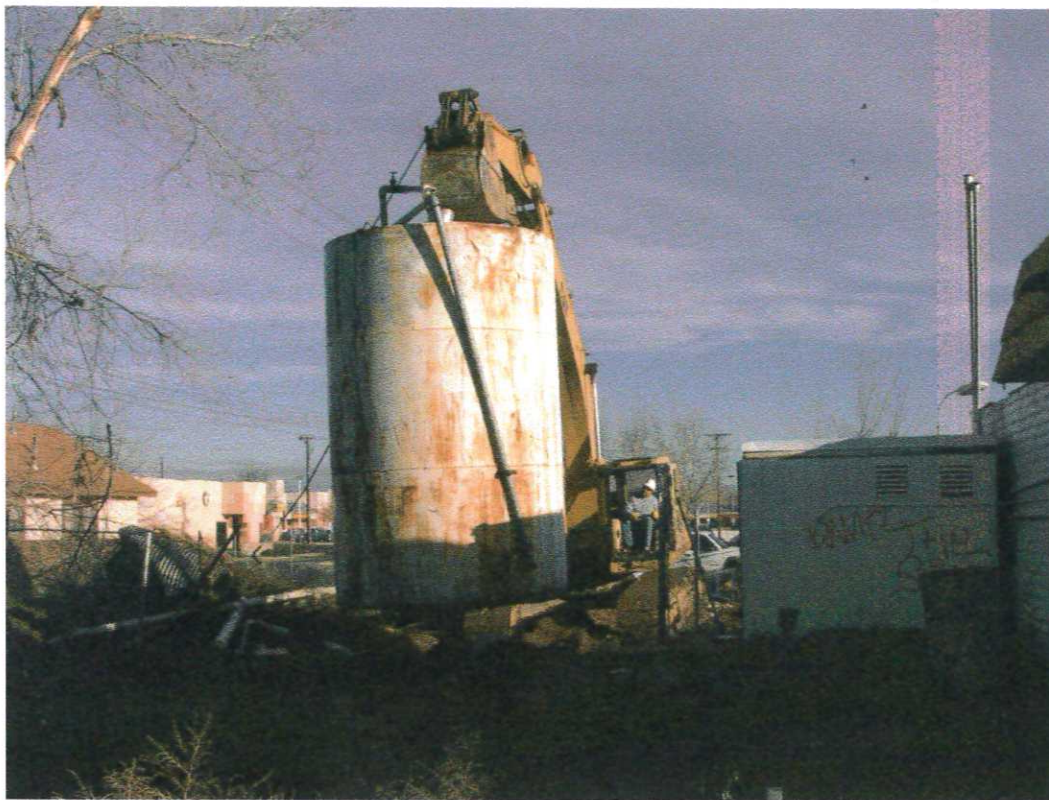
Photo 3. Removal of steel above ground influent settling tank.

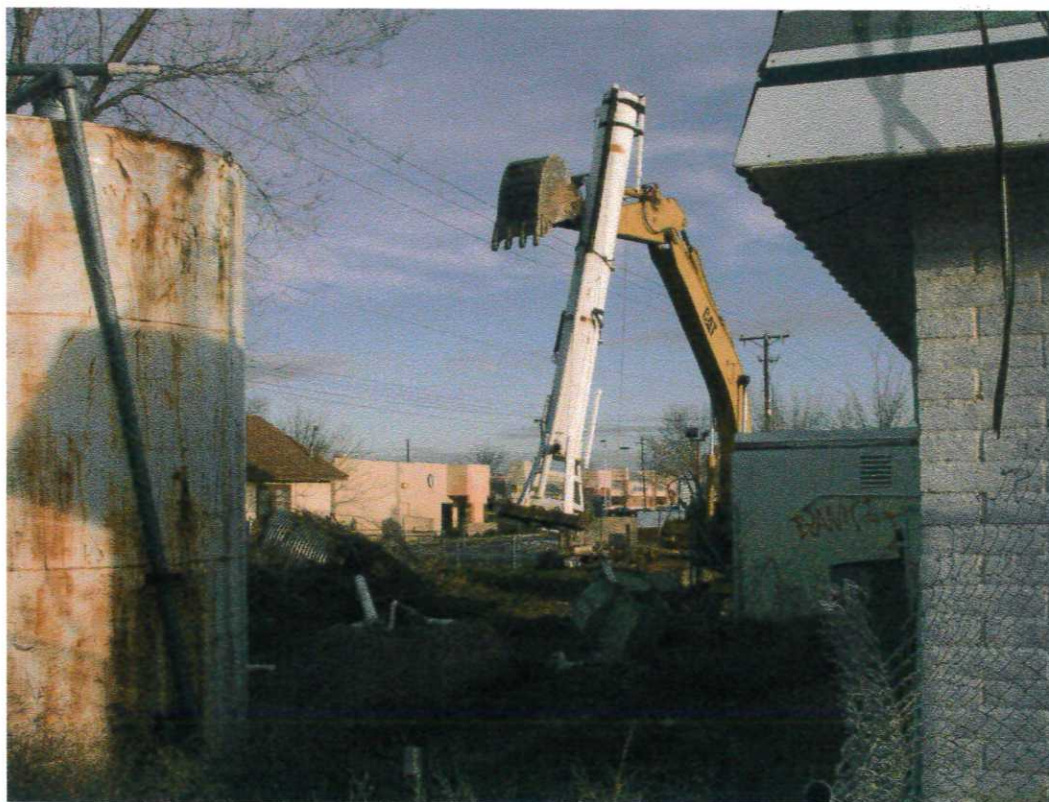
Photo 4. Removal of air stripper tower.

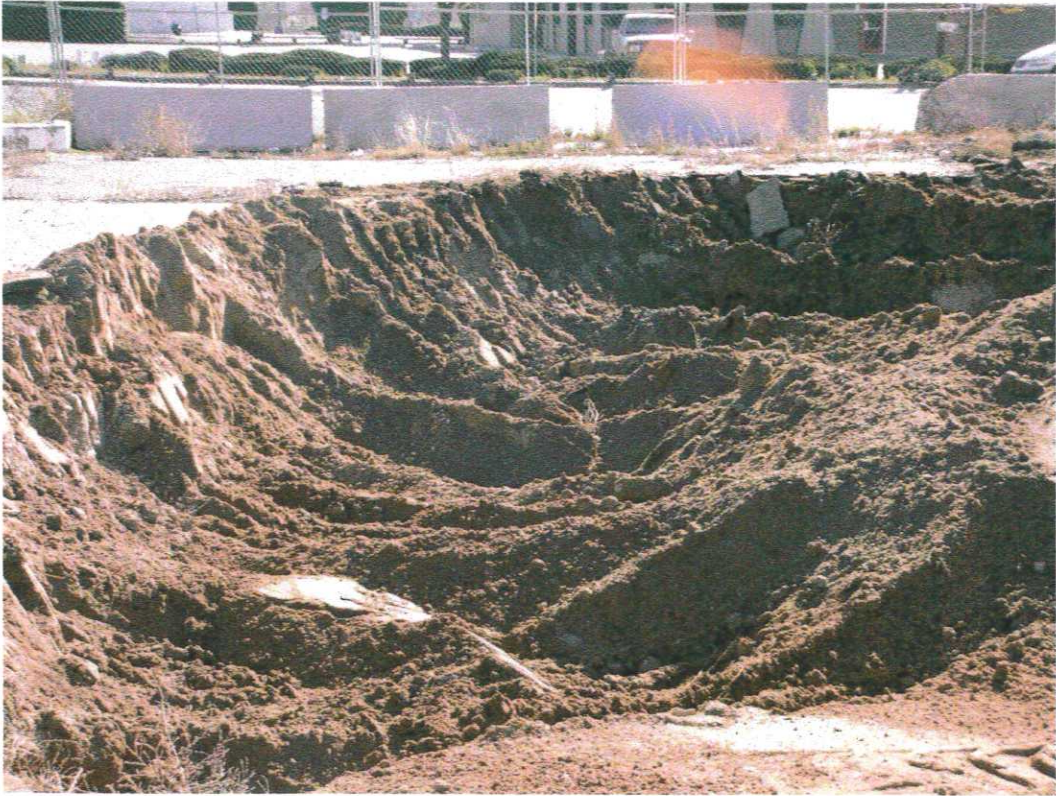
Photo 5. Removal of clean overburden on north end of excavation.

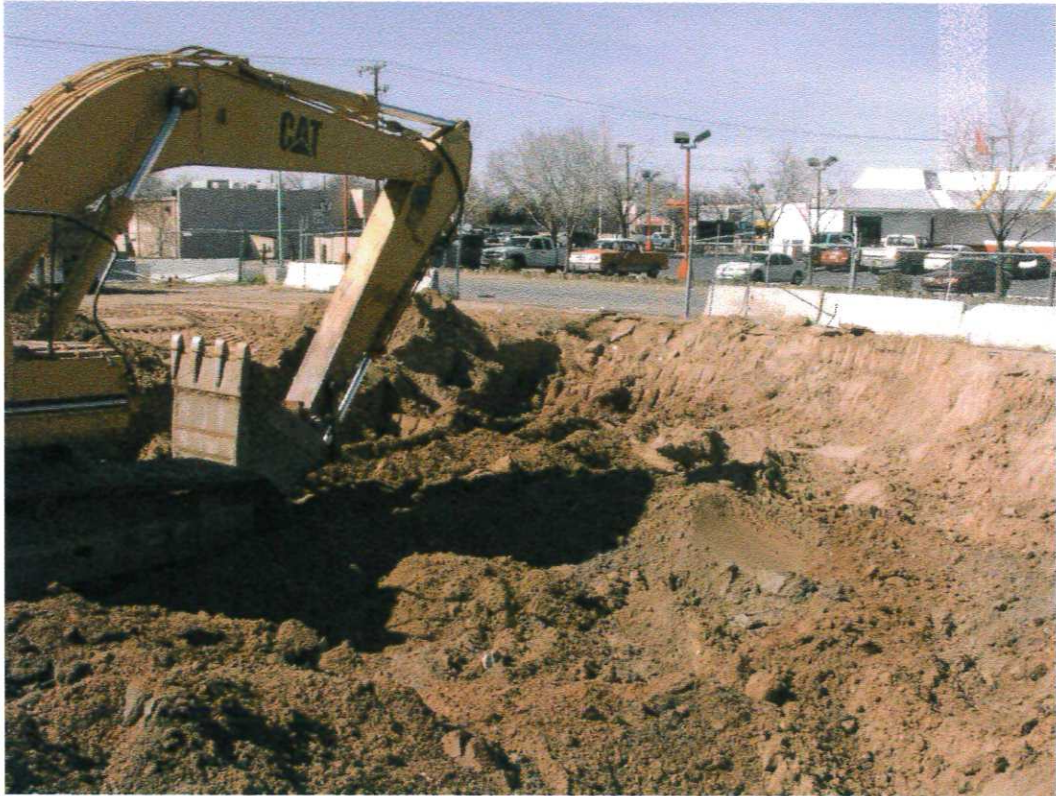
Photo 6. Continued removal of clean overburden.

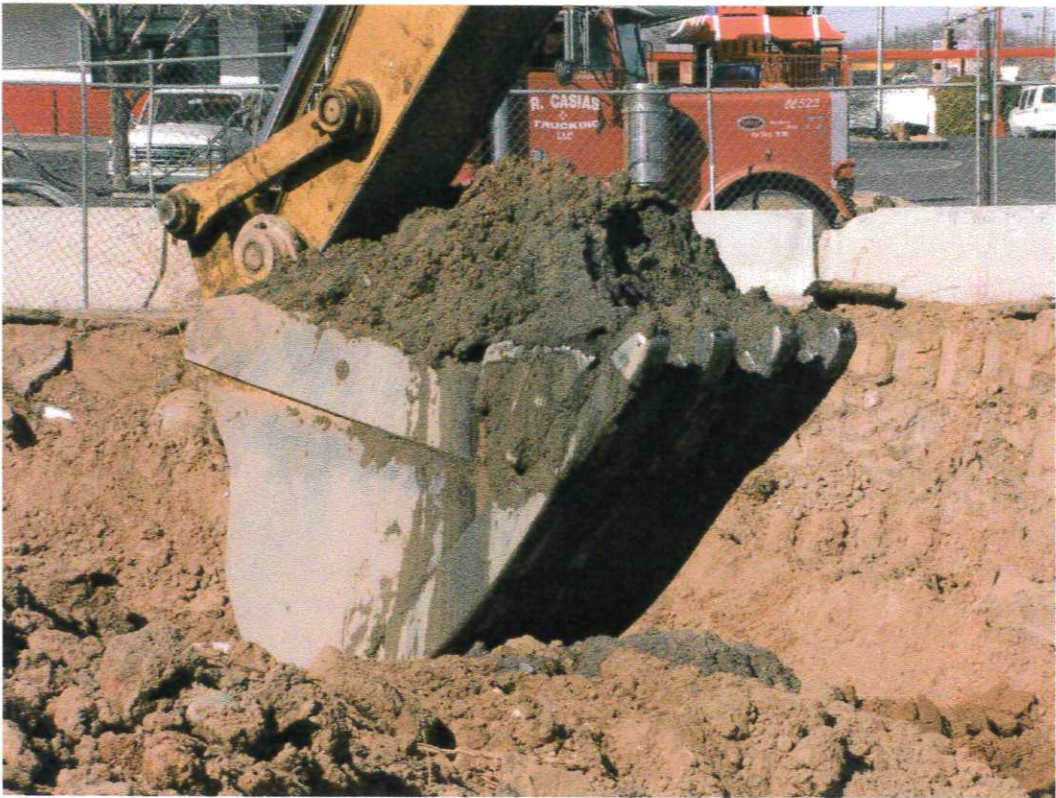
Photo 7. Removal of contaminated soil

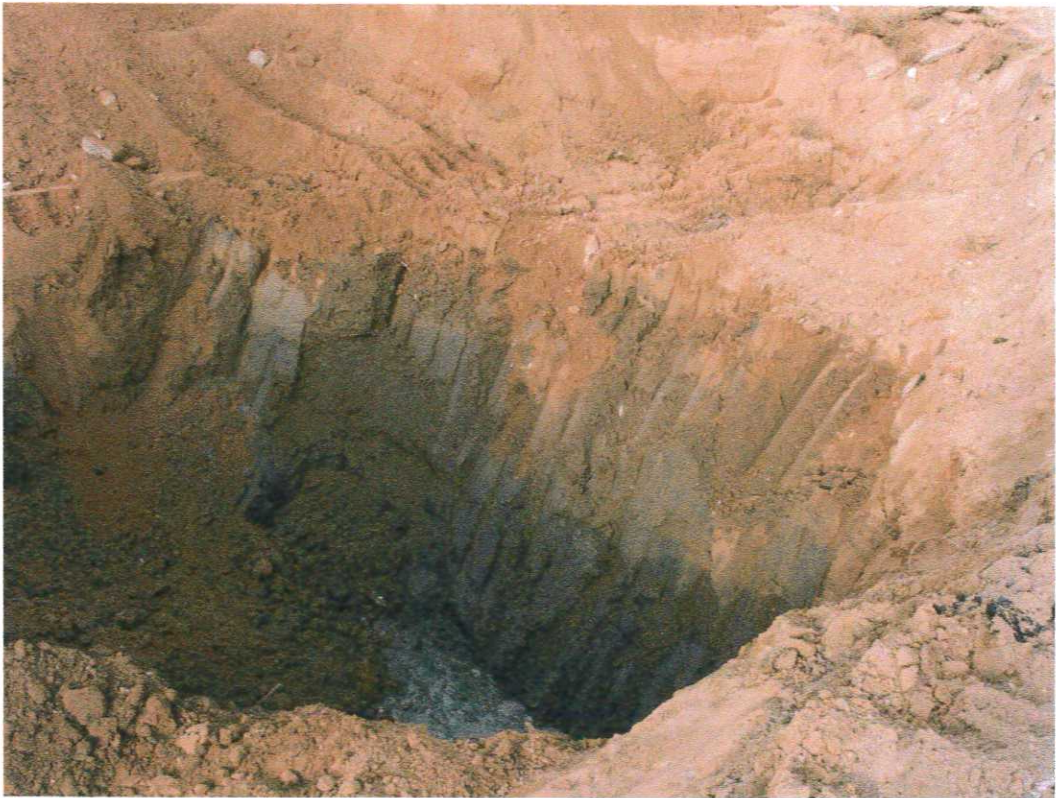
Photo 8. Boundary line of lighter uncontaminated soil above and darker contaminated soil below.

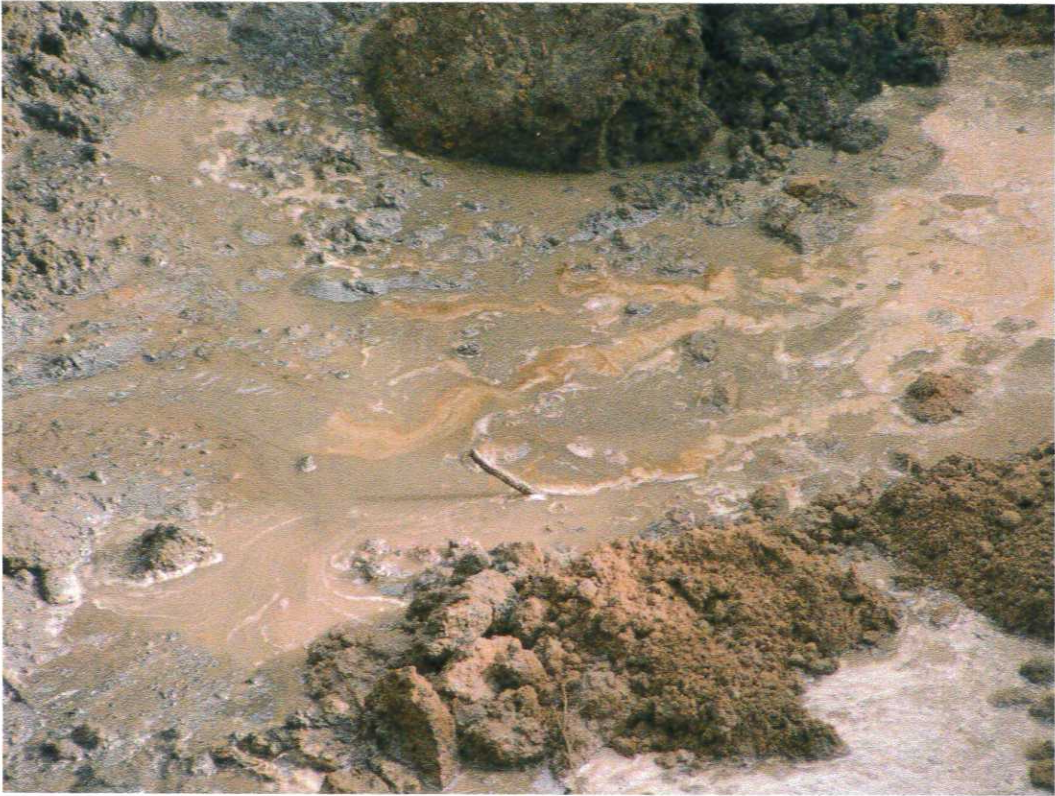
Photo 9. Groundwater with a thin layer of NAPL seeping out of saturated soil.

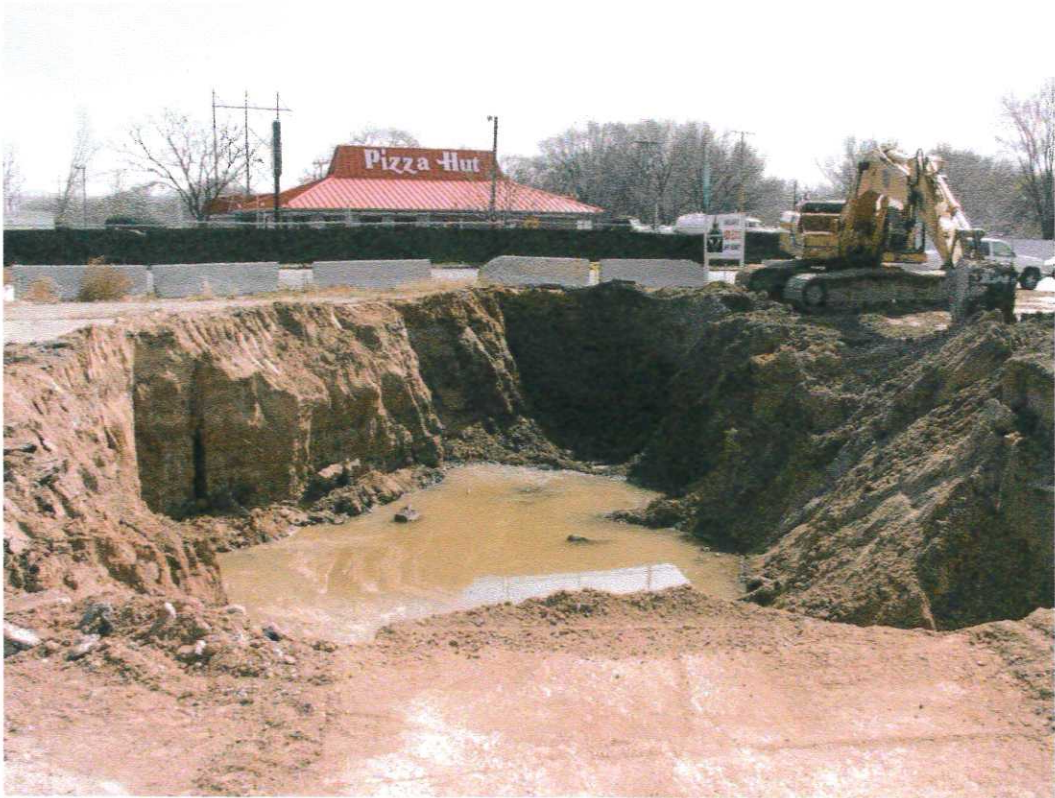
Photo 10. Continued removal of contaminated soil at north end of excavation area.

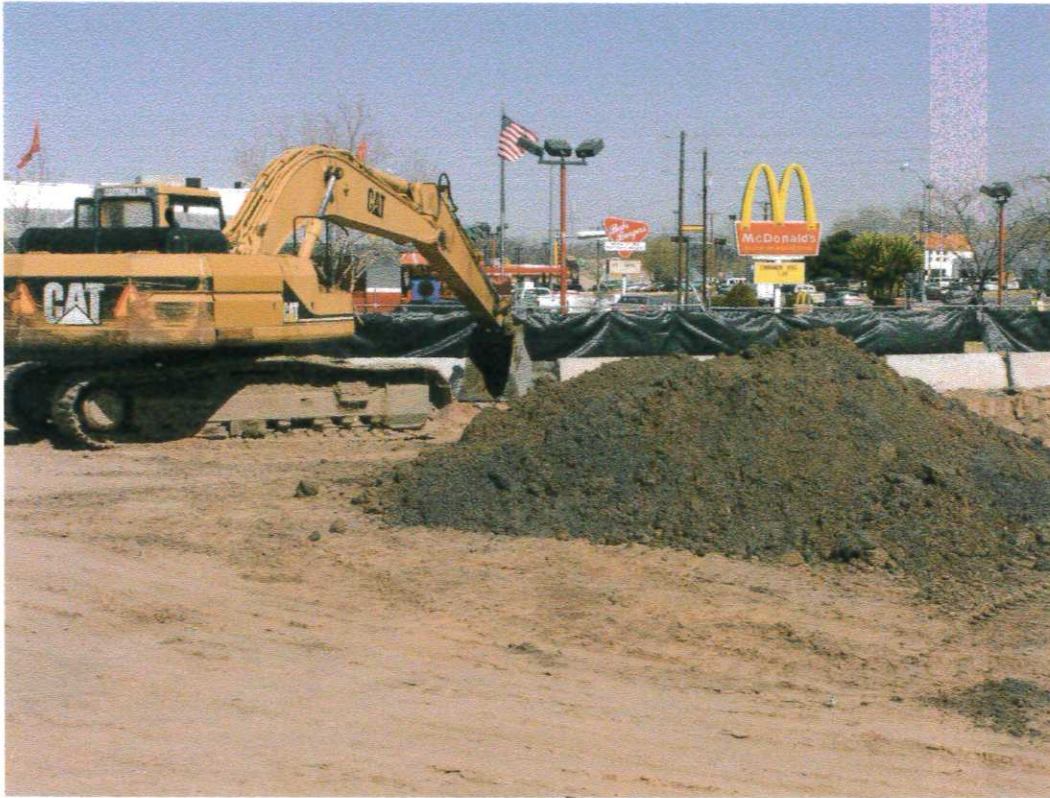
Photo 11. Stockpiling of contaminated soil.

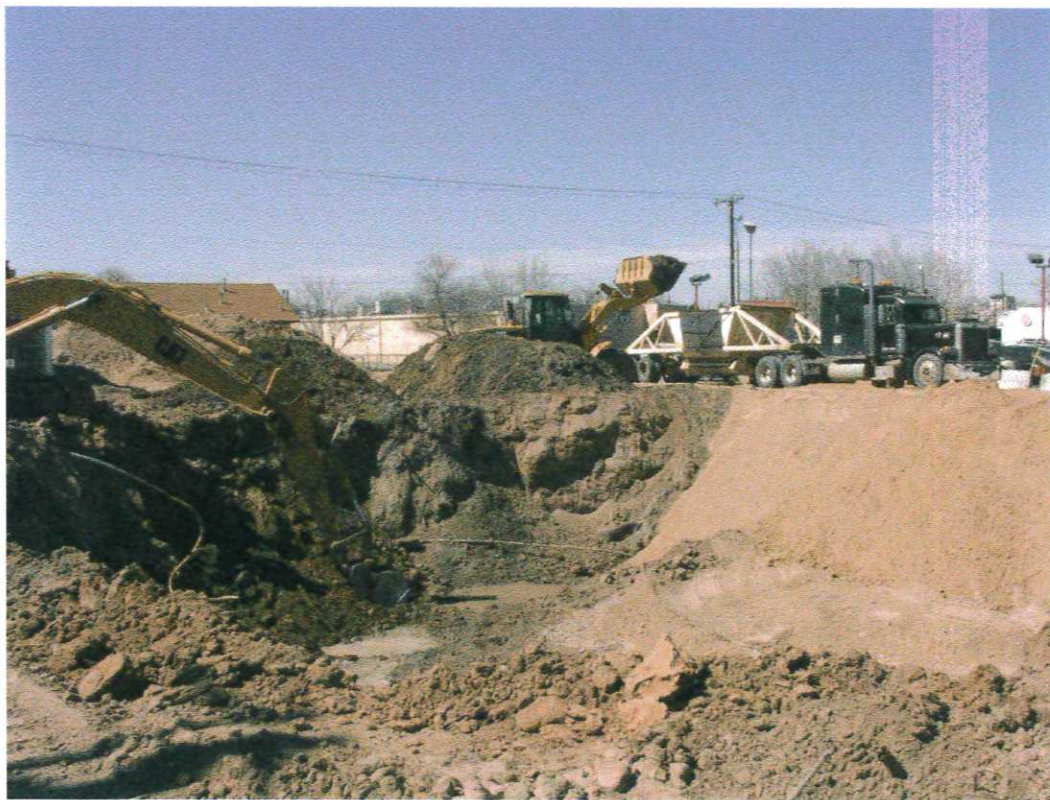
Photo 12. Loading contaminated soil into belly dumps

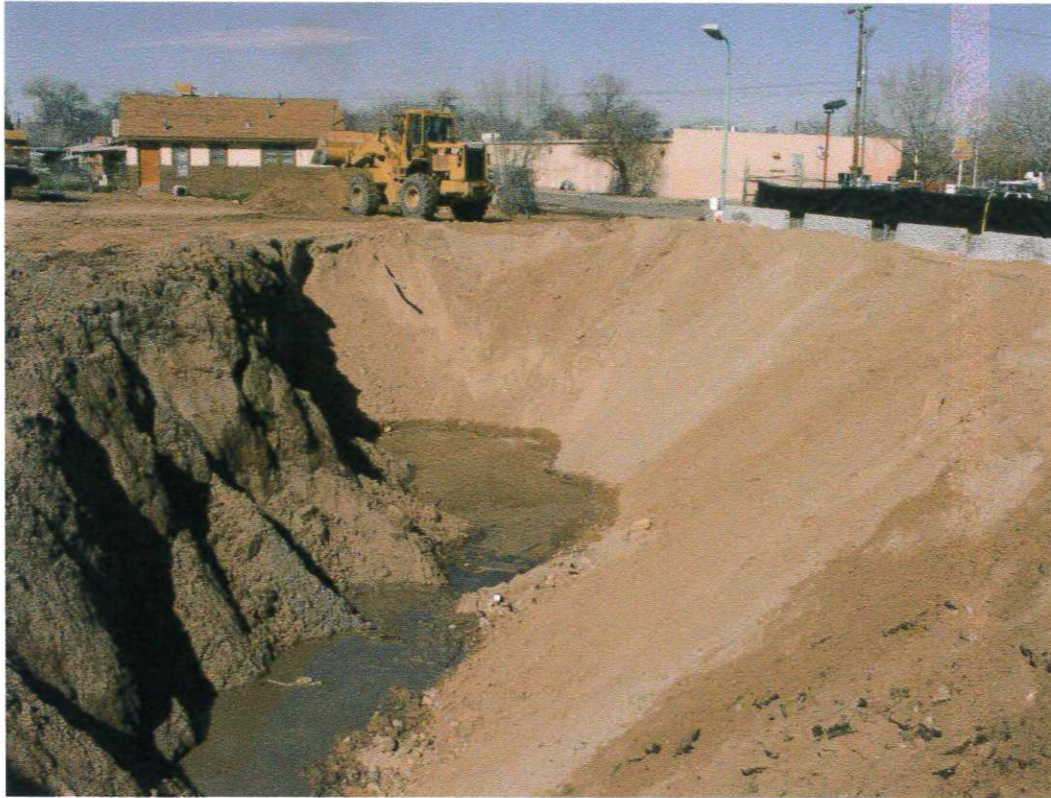
Photo 13. Backfilling with clean gravel and sand as the excavation moves southward.

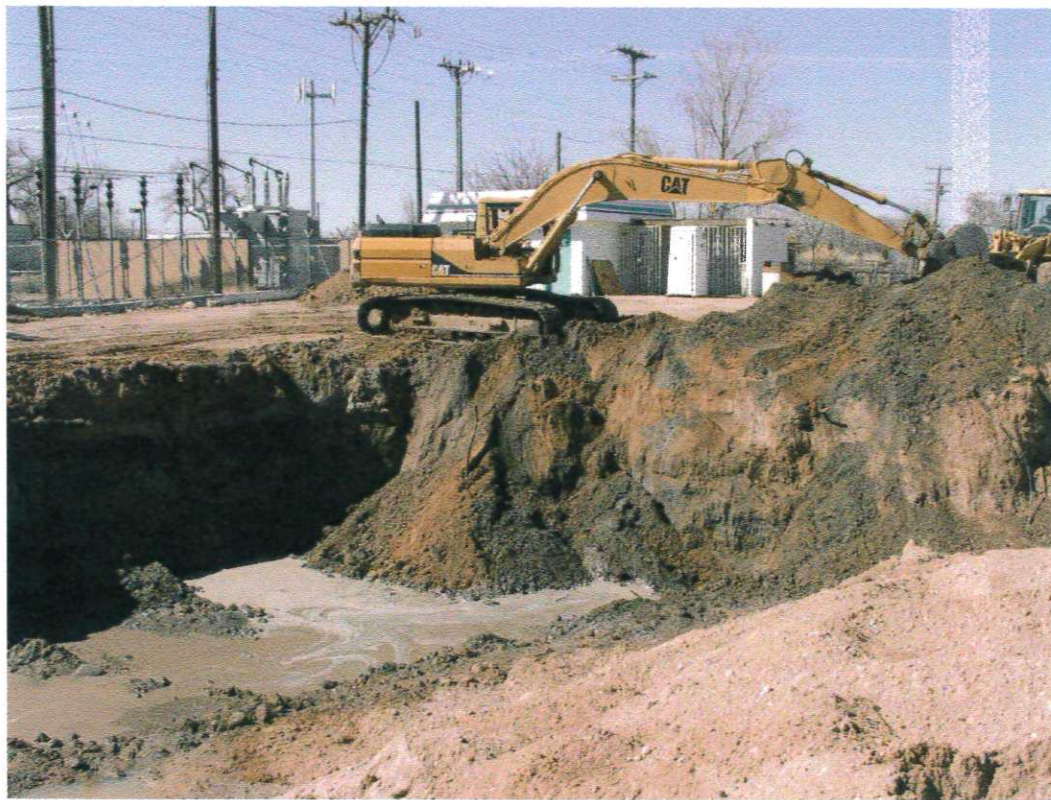
Photo 14. Removal of contaminated soil at southwest corner of excavation area.

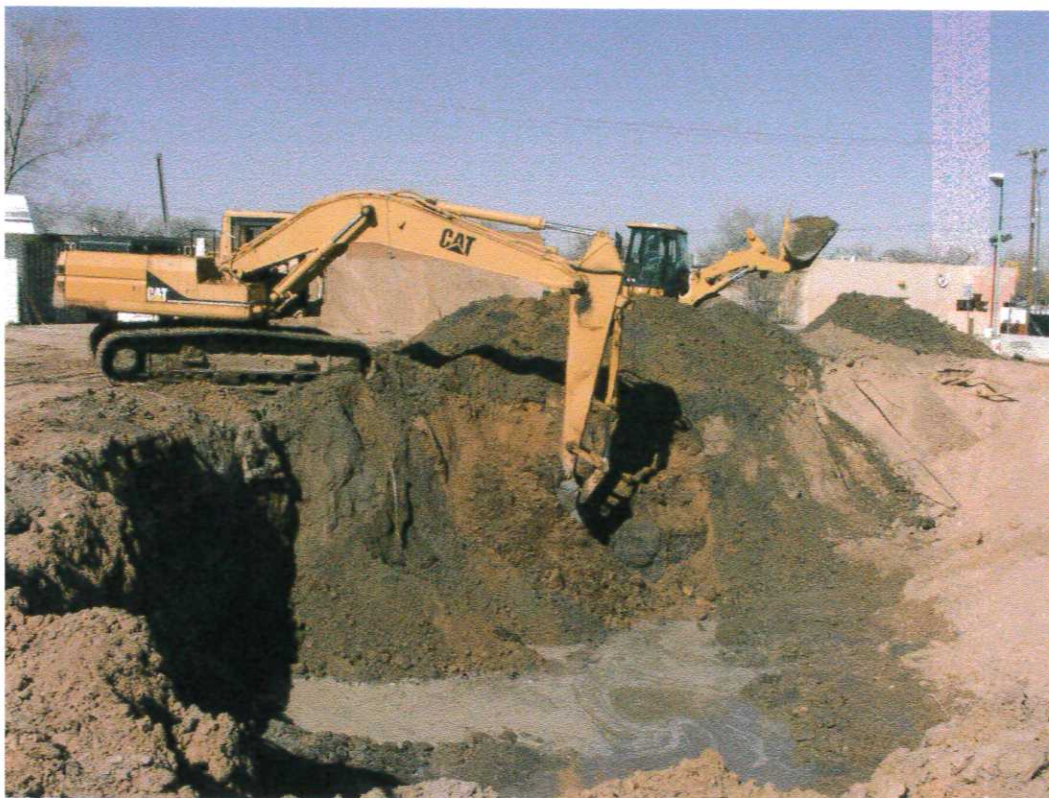
Photo 15. Removal and stockpiling of contaminated soil at southwest corner of excavation area.

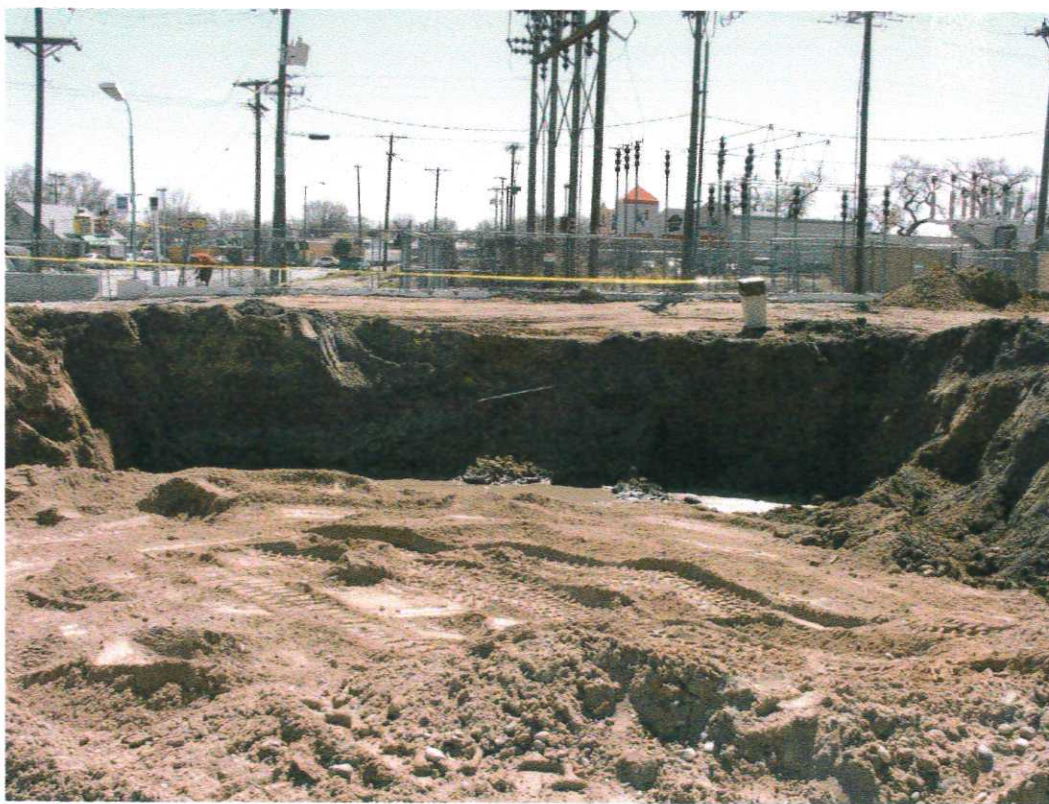
Photo 16. Excavation area looking south with clean backfill in the foreground.

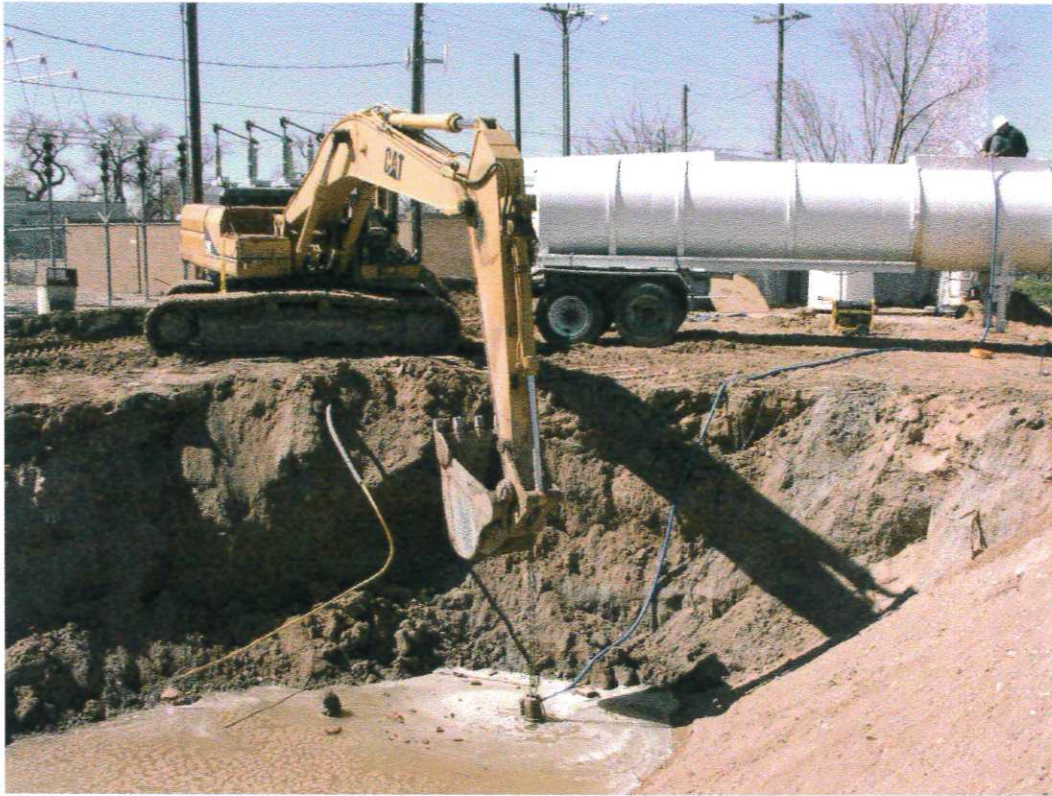
Photo 17. Removal of contaminated groundwater and a small amount of NAPL.

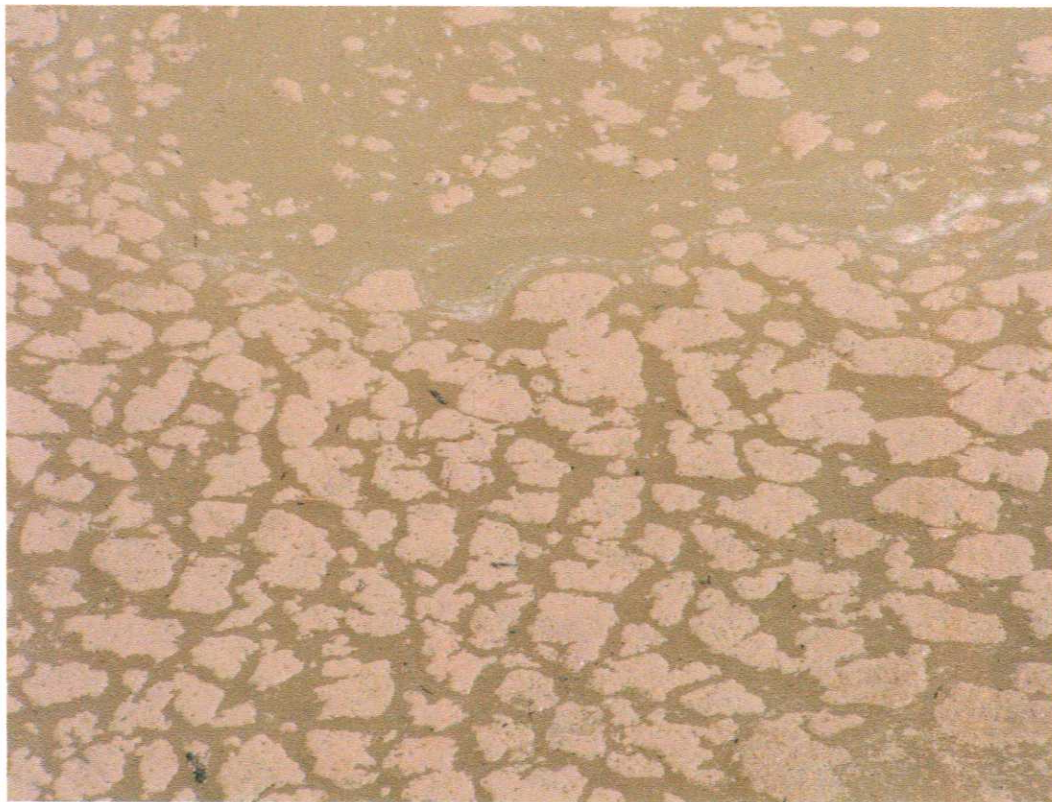
Photo 18. Close-up of groundwater and NAPL that was removed from the excavated area.

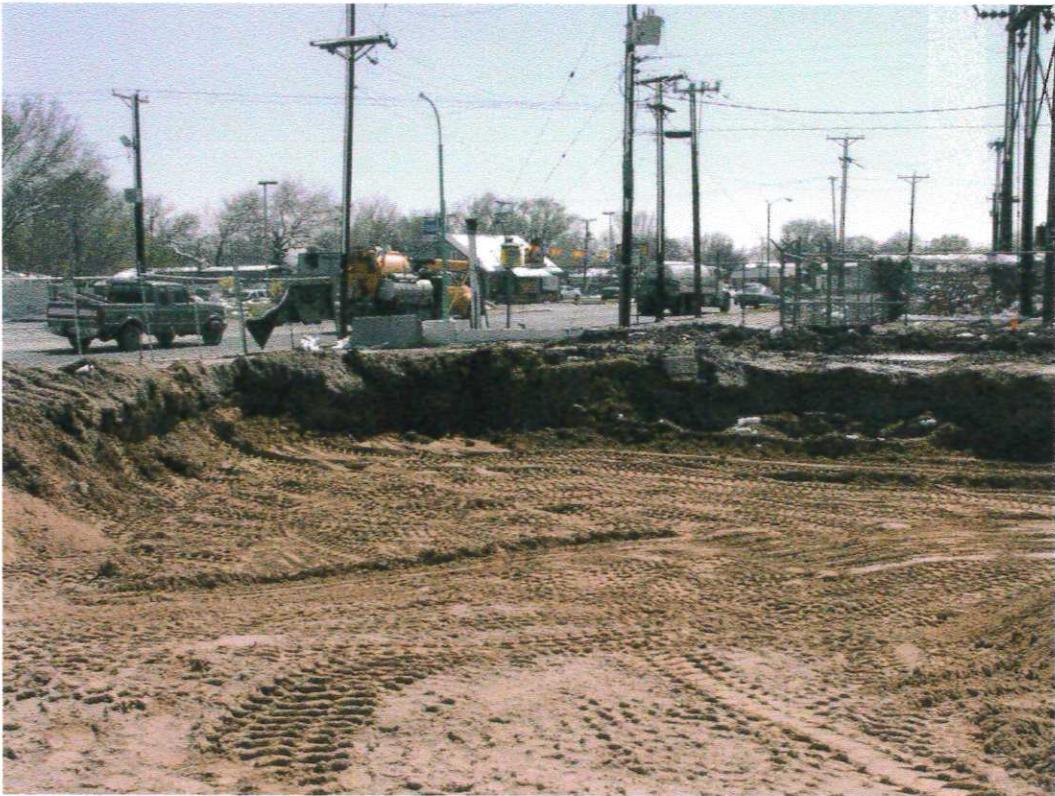
Photo 19. Backfilling and compaction of the excavated area.

As of March 19, 2005, the excavation area was completely backfilled and recompactd as per the approved work plan. Each lift was compacted to 95% of proctor density. Backfill density was verified using a nuclear densitometer deployed to the field by Amec. The re-compaction reports are enclosed in this report. Following re-compaction, the site was restored. Site restoration included leveling the site and adding a 6" layer of crushed gravel to the top of the disturbed area for erosion control.

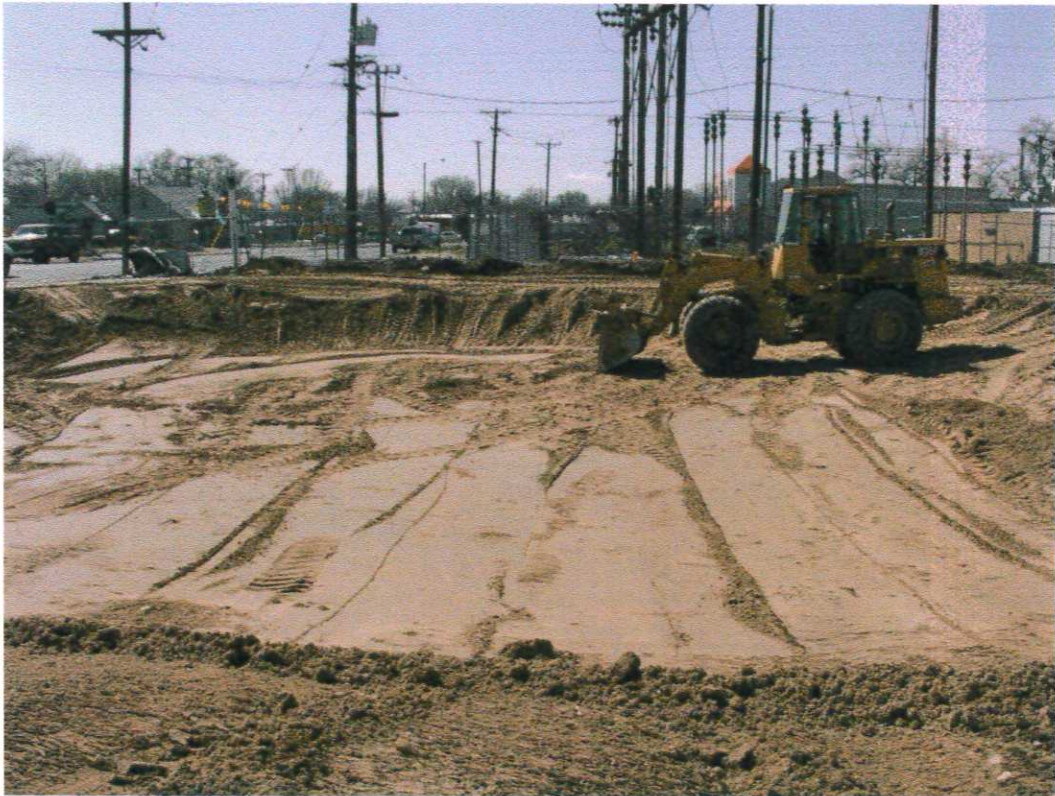
Photo 20. Continued backfilling and compaction of the excavated area.

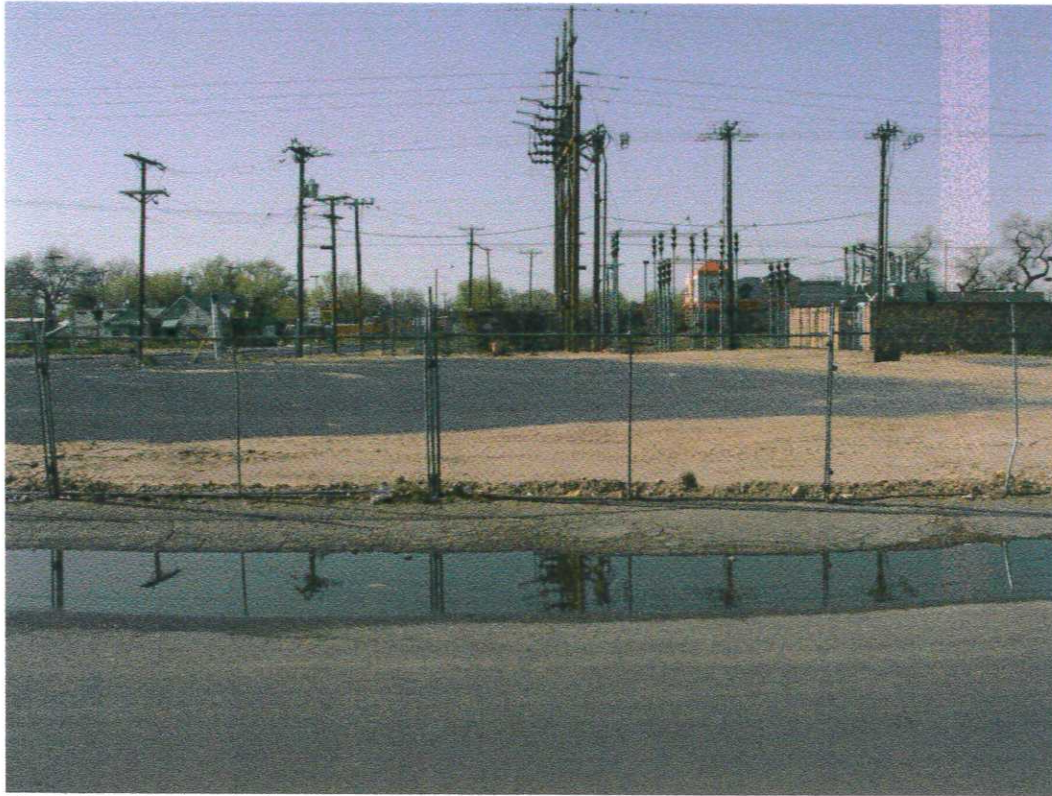
Photo 21. Restored site with crusher gravel over excavated area.

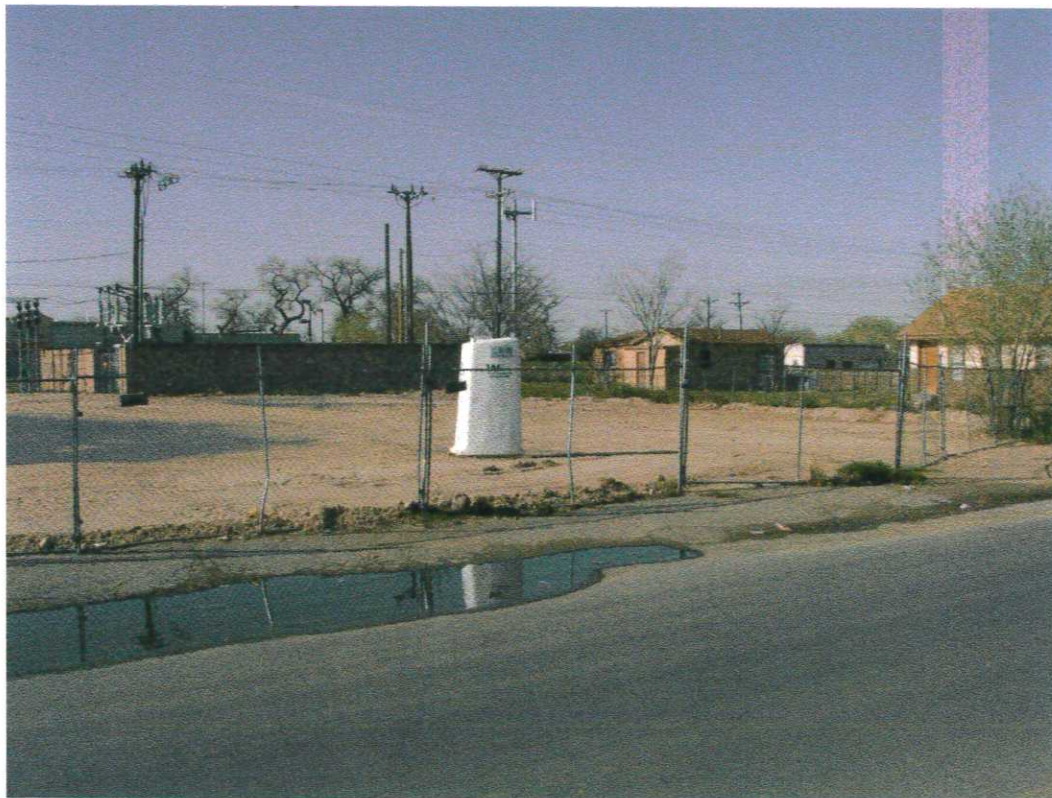
Photo 22. Restored site with all structures and old remediation equipment removed.
