Cieneguilla Creek Riparian Ecosystem Restoration Project

2012 Final Report

Date: June 2012

**Prepared by:
Implementation Task Manager: William "Hoot" Gibson
and Monitoring Coordinator: Alán Huerta**

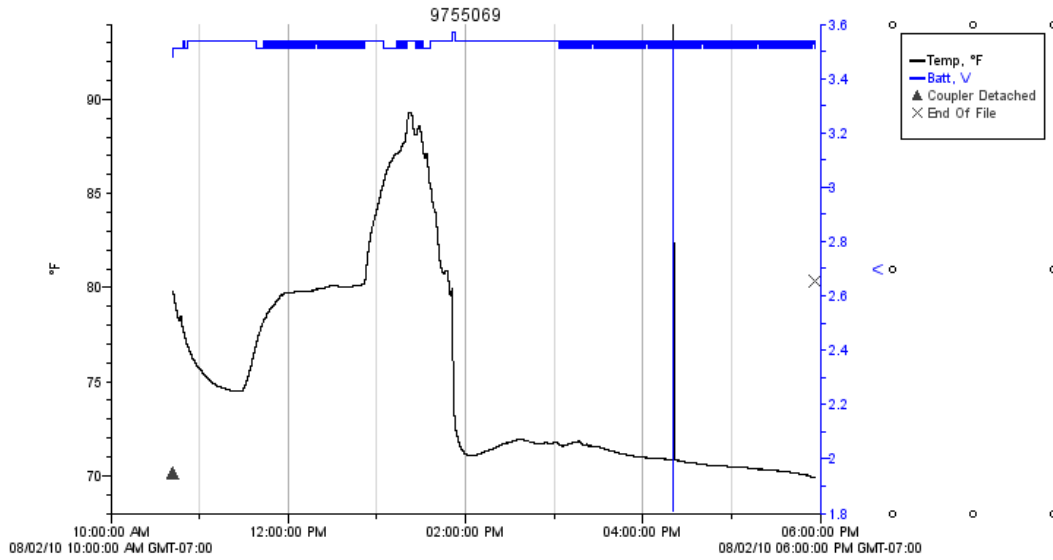
*1. Improper launch calibration limited data collection in 2010. Logger recorded data by seconds not hours.

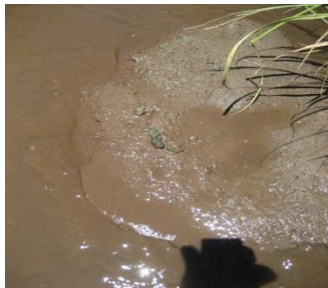
Low water levels in June 2011 reveal avian droppings and tracks on mud flats. Bird and rodent populations have been increasing as visible by more burrows and bird nests present.

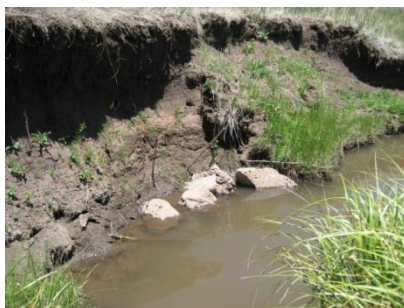
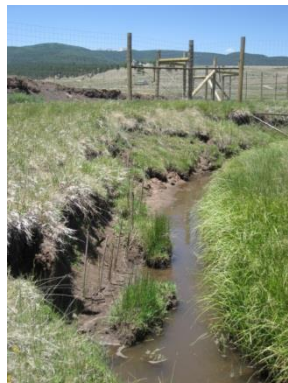
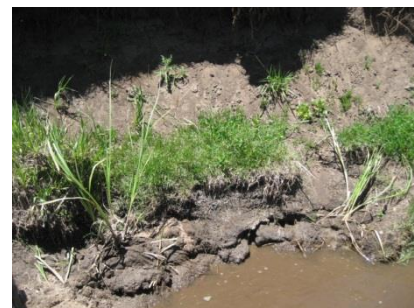
Natural objects within the creek such as sunken logs and boulders cause scouring of holes on the down flow side. Project structures; one rock dams and post vanes altering the flow effectively where placed allowing for calving banks to seed grasses.
