Lee Ranch Mine Use Attainability Analysis

May 2018

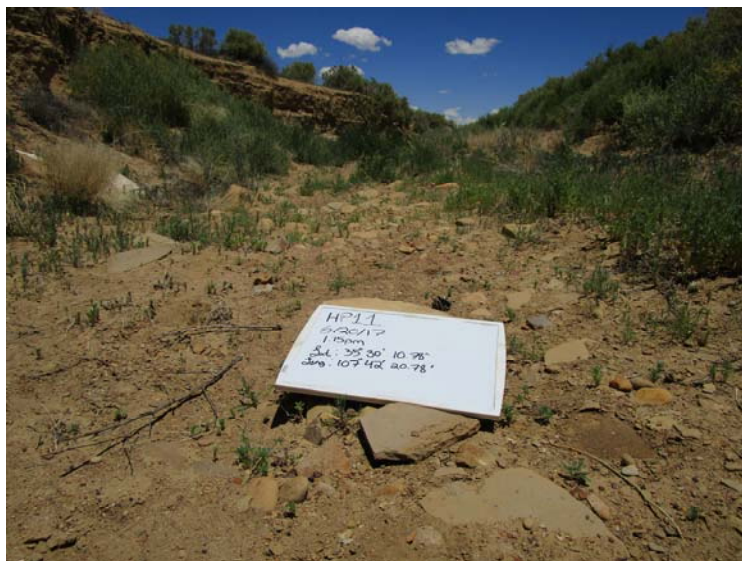
3 - HP11 rooted plants and cobble in the channel

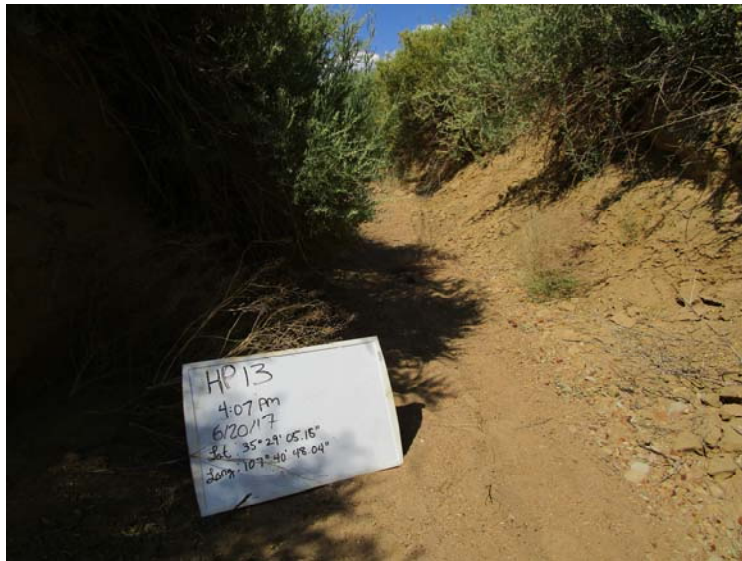
7 - HP13 stream channel

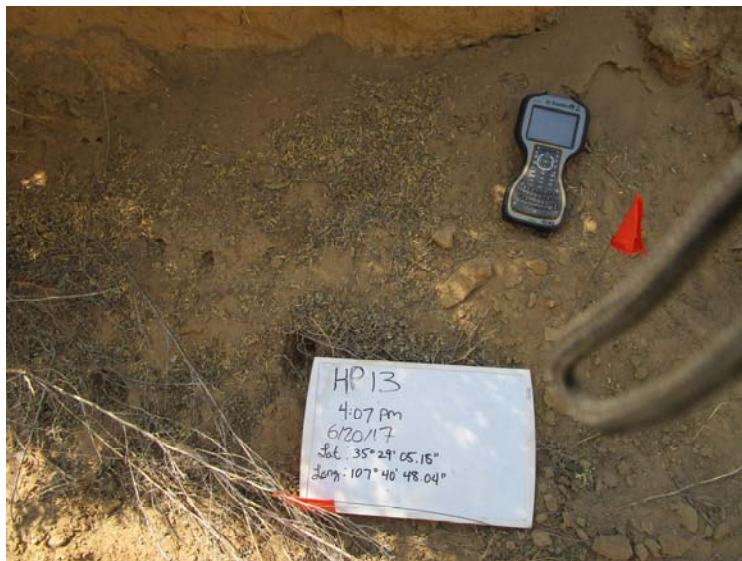
8 - HP13 side slope with vegetative debris

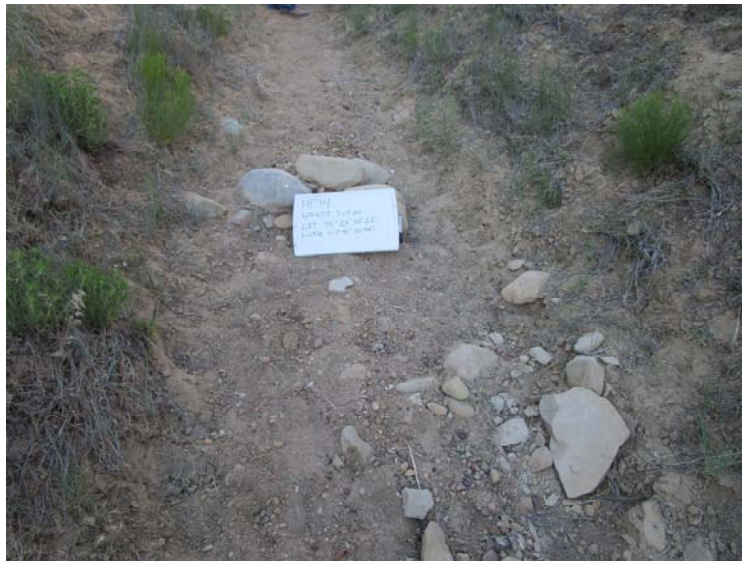
14 - HP14 cobble at base of channel

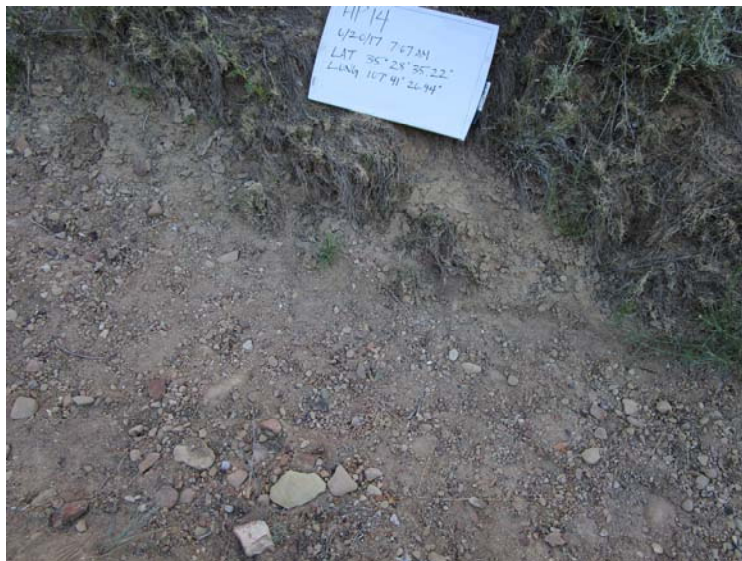
Various: Debris found along vegetation in channel. Sinuosity approximately 1.15 ratio.

15 - HP14 example of debris at base of channel

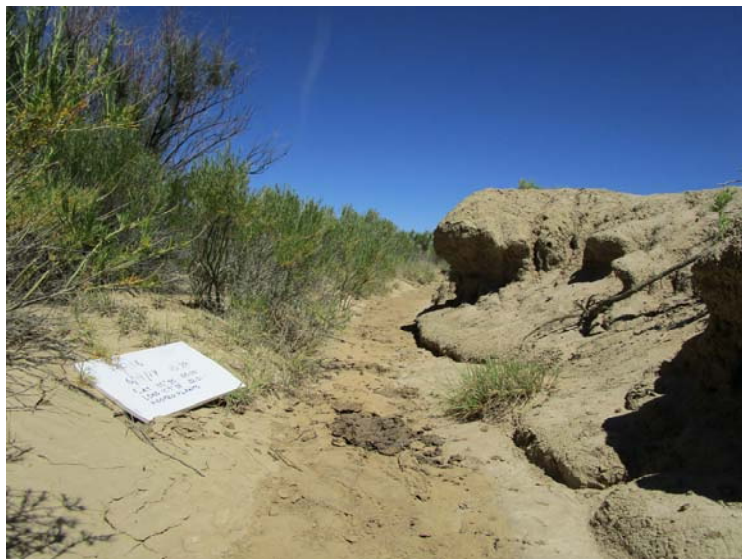
23 - HP16 rooted plants (1)

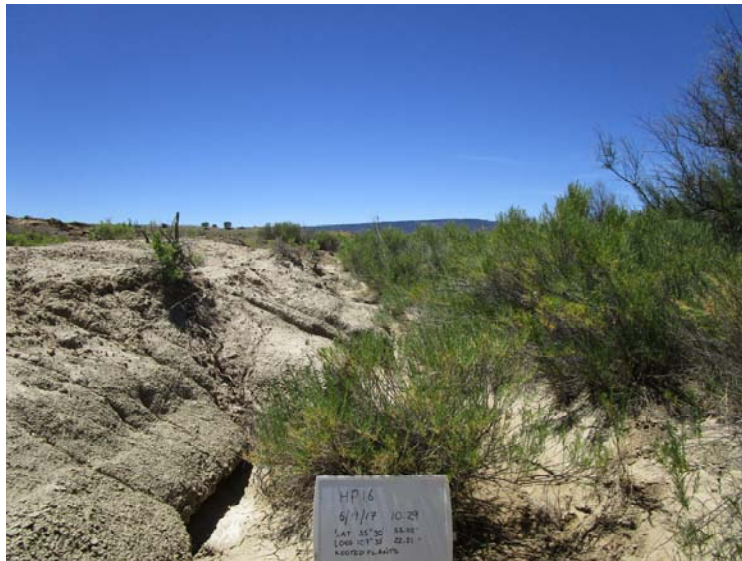
24 - HP16 rooted plants (2)

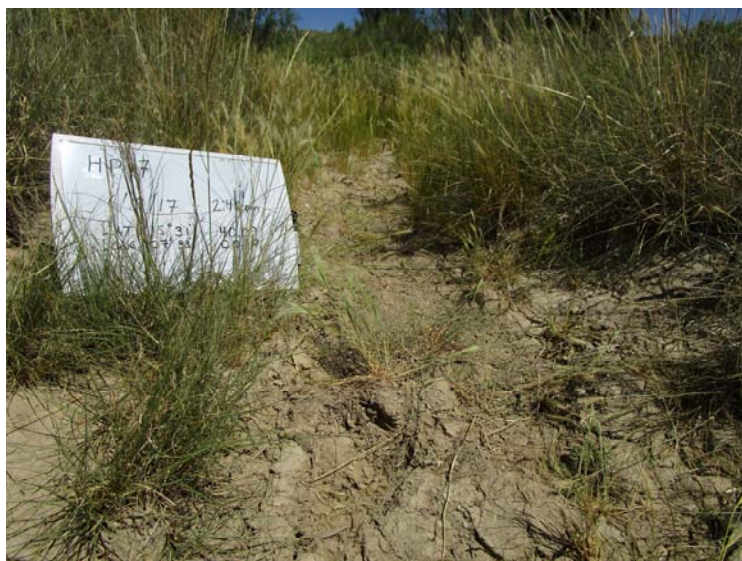
27 - HP17 base of stream channel

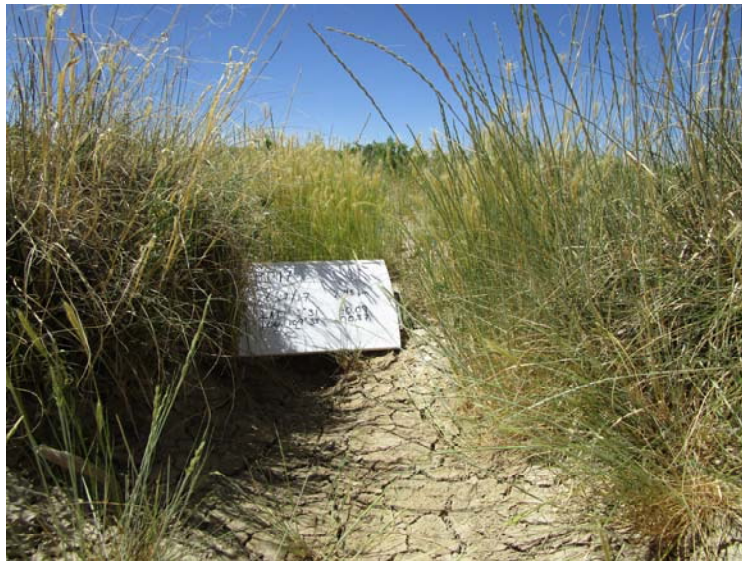
28 - HP17 vegetation in channel

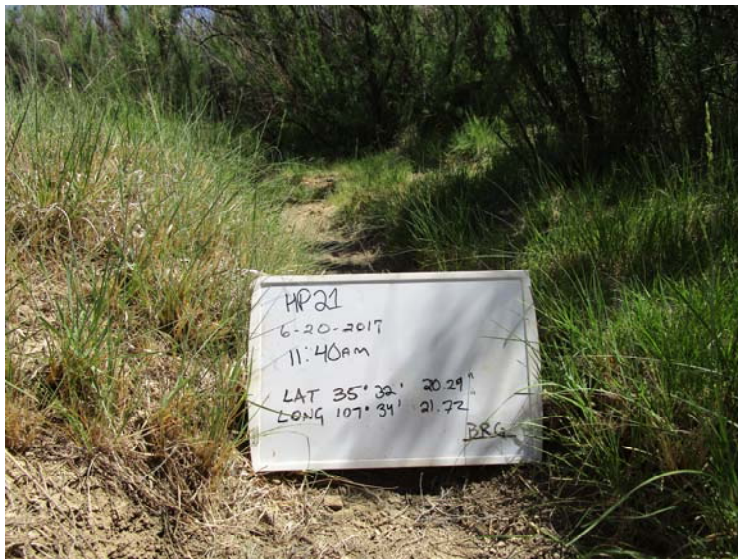
P35 - HP21 vegetation in channel

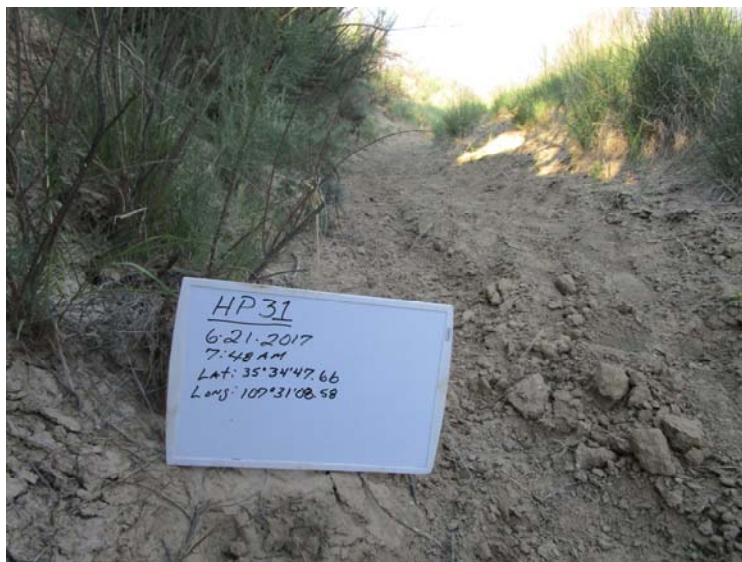
38 - HP31 channel bottom
