July 26, 2019

**RE: STAGE 2 ABATEMENT PLAN MODIFICATION PROPOSAL AND DAD-06
MONITORING WELL REHABILITATION FOR DONA ANA DAIRIES, DONA
ANA COUNTY, NEW MEXICO, REVISION 02**

NEW MEXICO ENVIRONMENT DEPARTMENT FIELD TRIP REPORT

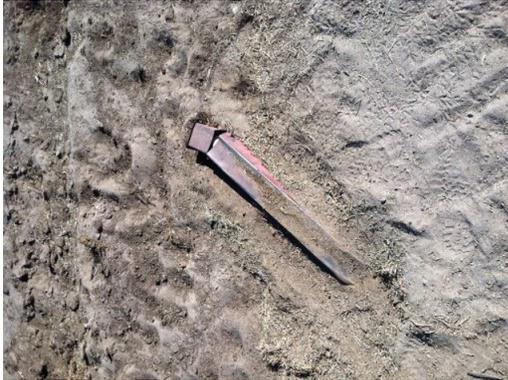
Figure 1 - MW TH-2

Some wells had obstructions in them such as bailers or other debris. Bailers were removed from the wells when possible by using a 3-pronged fish hook. Wells TH-1 and TH-2, as identified in historic maps for River Valley Dairy were located. TH-1 had a bailer which was removed. TH-2 was bent over and lying on its side and could not be cameraed. Several wells had older vertical-slotted screens (see findings attachment and Figure 1). All wells at Del Oro had pumps in them, with the exception of 692-02 and 692-04, and therefore were not able to be cameraed.

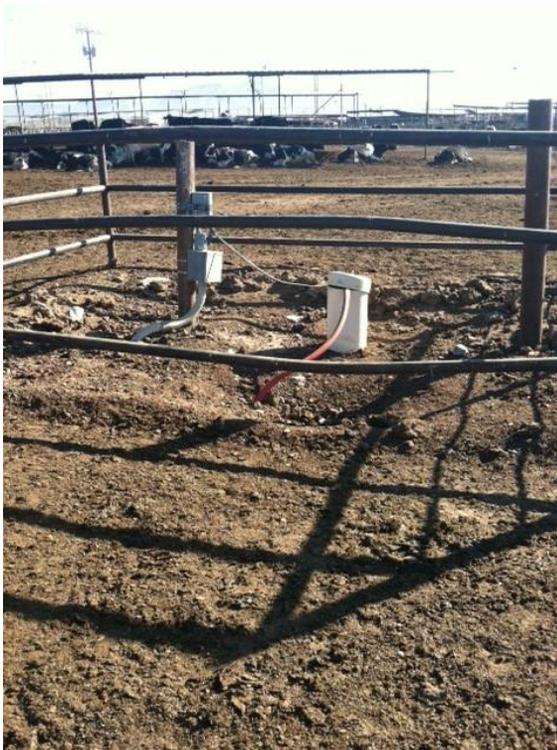
Figure 2 - MW 692-01

Well 692-01 was found to be pumping and was not cameraed (Figure 2). Paragraph 43 of the Settlement Agreement states that the plugging and abandonment of well 692-01 and the installation of a vertical delineation well is to be deferred until well evaluation is completed. Given that this well had a pump and could not be cameraed, comparison of past depth to water measurements when pumping and not pumping shows at least 20 feet of water column, no lithologic logs, and the well is in a corral, indicate this well should be plugged and abandoned and a new vertical delineation well should be installed.
