Abandoned Uranium Mine Site Assessment for the Blue Star Site (NM0129)

FINAL REPORT

February 23, 2010

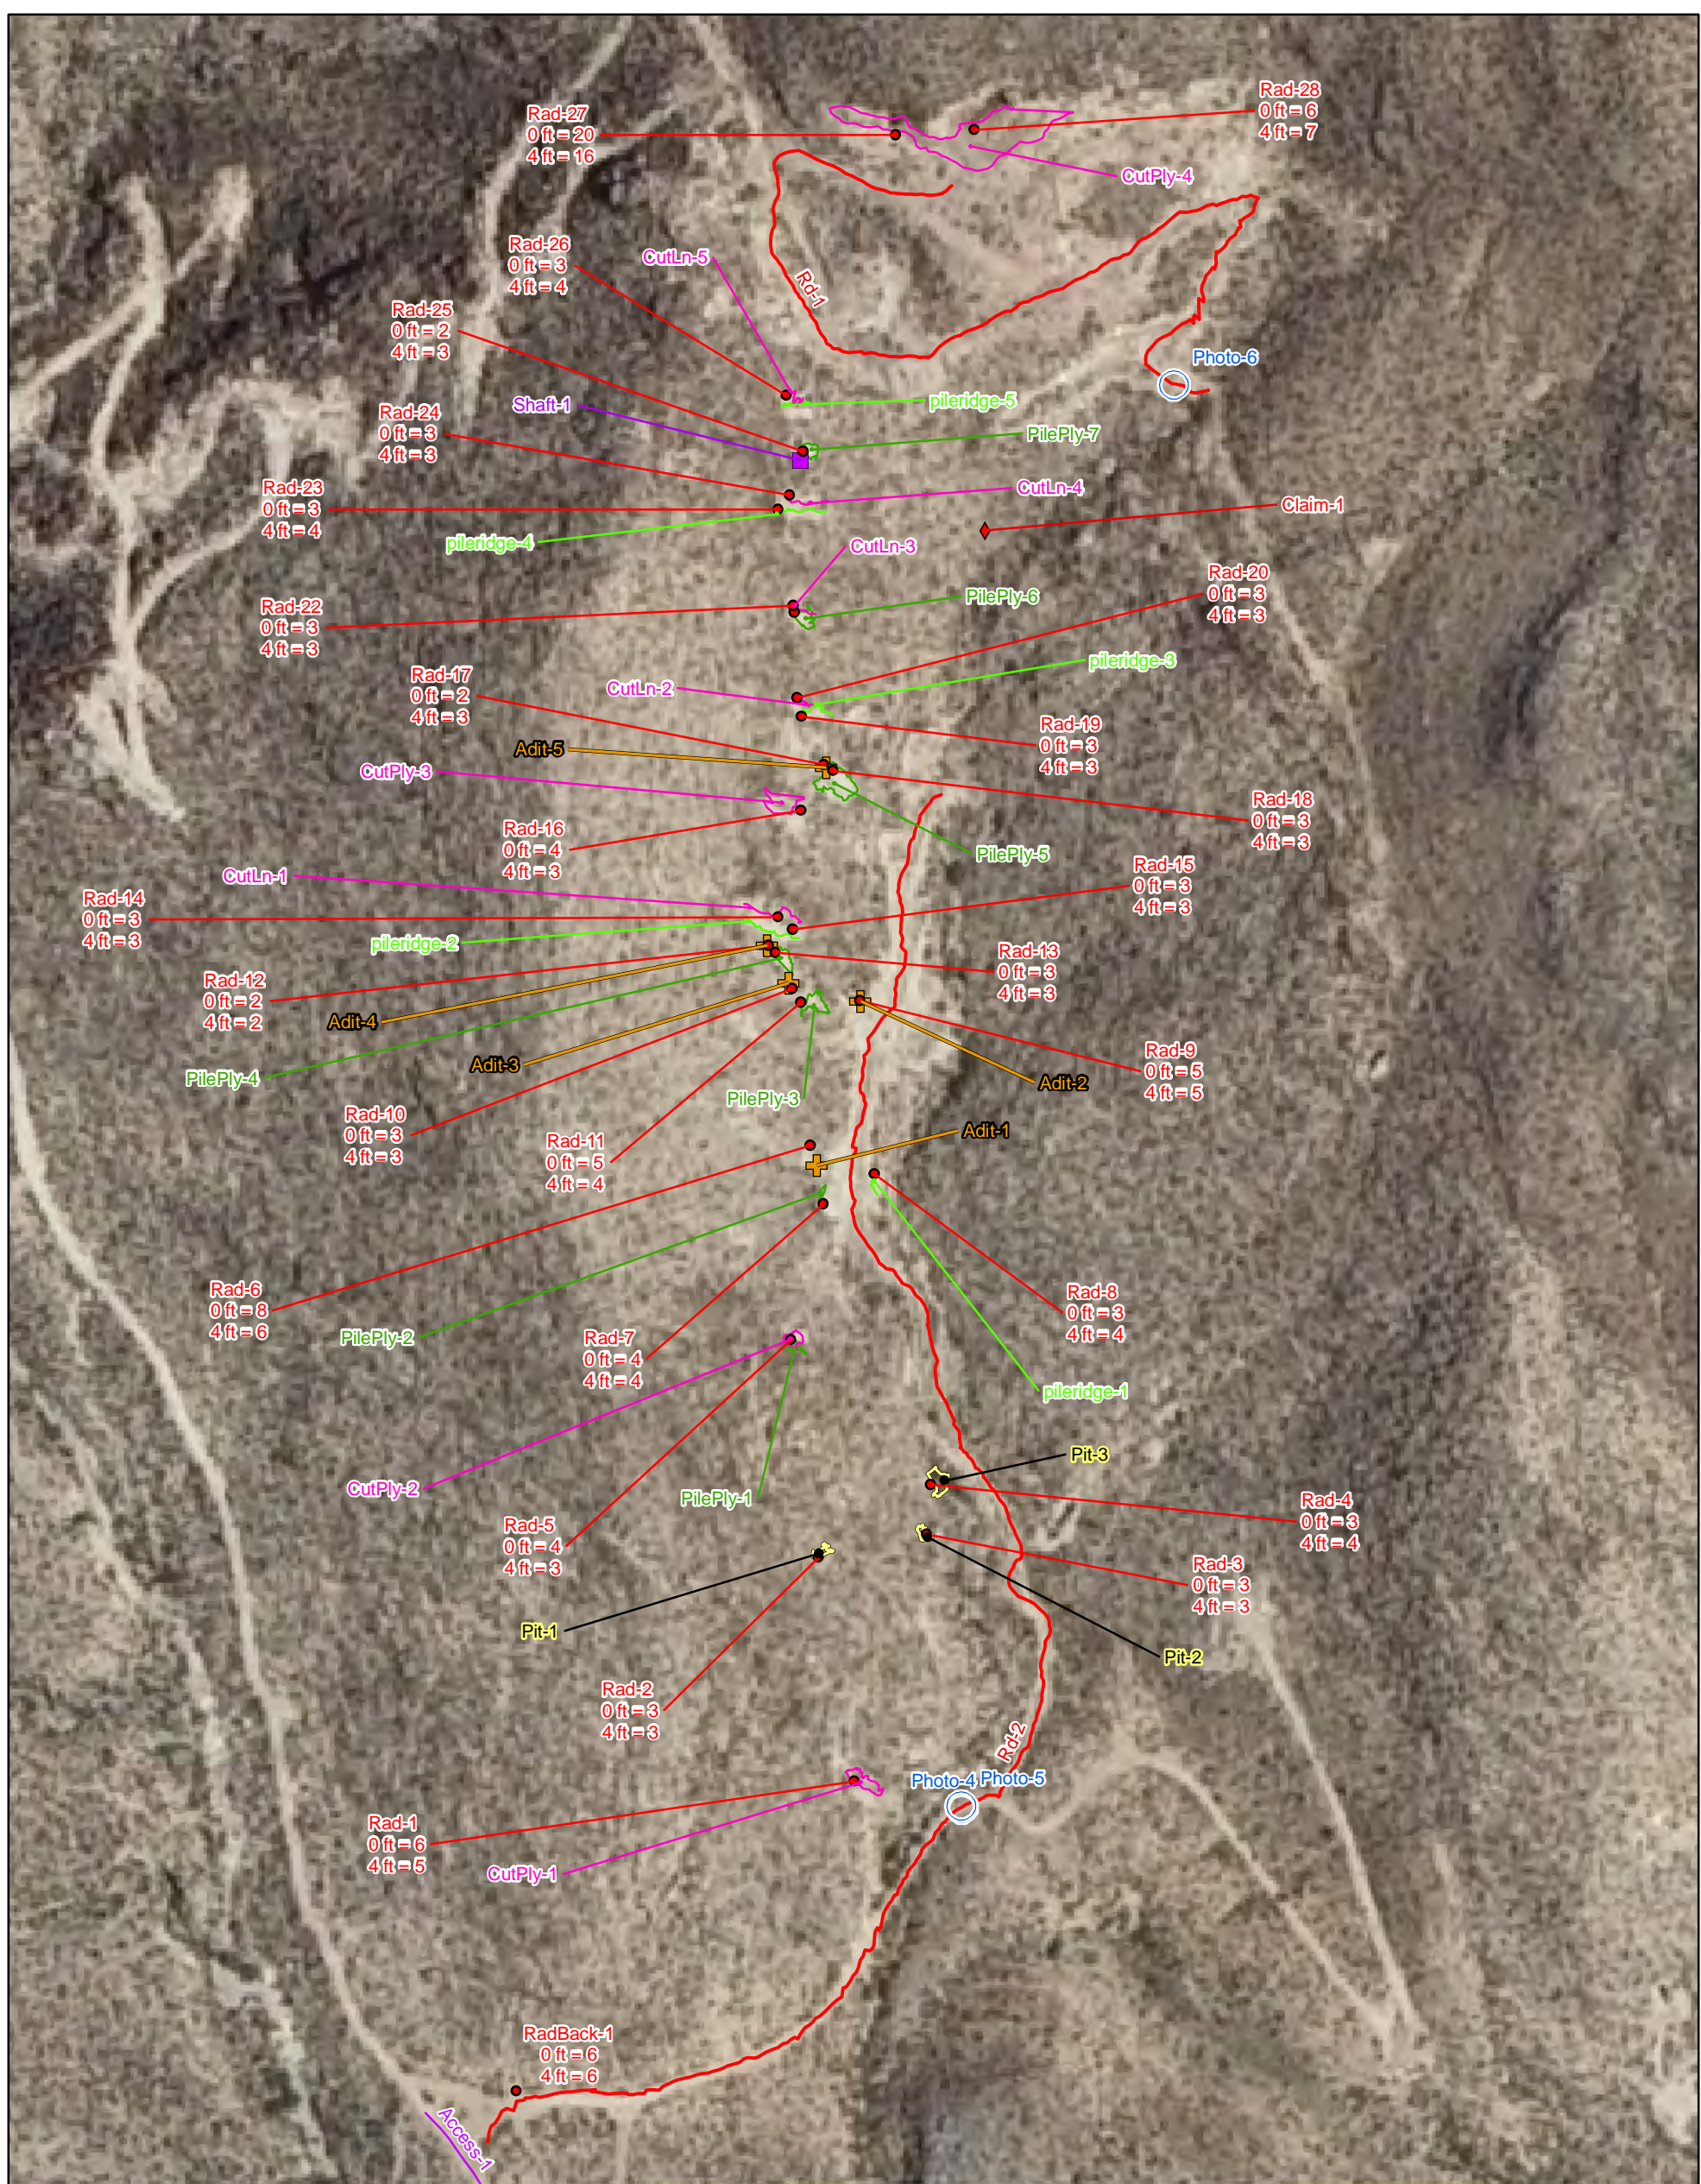
Figure 4a
Site Map on Aerial Photo
NM0129-Blue Star
 Abandoned Uranium
 Mine Assessment

The mine features described below are based on the features provided to INTERA by MMD in the GIS Data Dictionary (MMD, 2009). INTERA marked the locations of the AUM Site features using a Trimble Global Positioning System (GPS) and entered details about the features into the GPS using the MMD data dictionary. The AUM Site consists of five adits, nine cuts, thirteen piles, three pits, one shaft, and two roads. Please see the Photo Log in Appendix A for photos, Table 1 for a list of all AUM Site features, and Figures 4a and 4b for the locations of the AUM Site features.

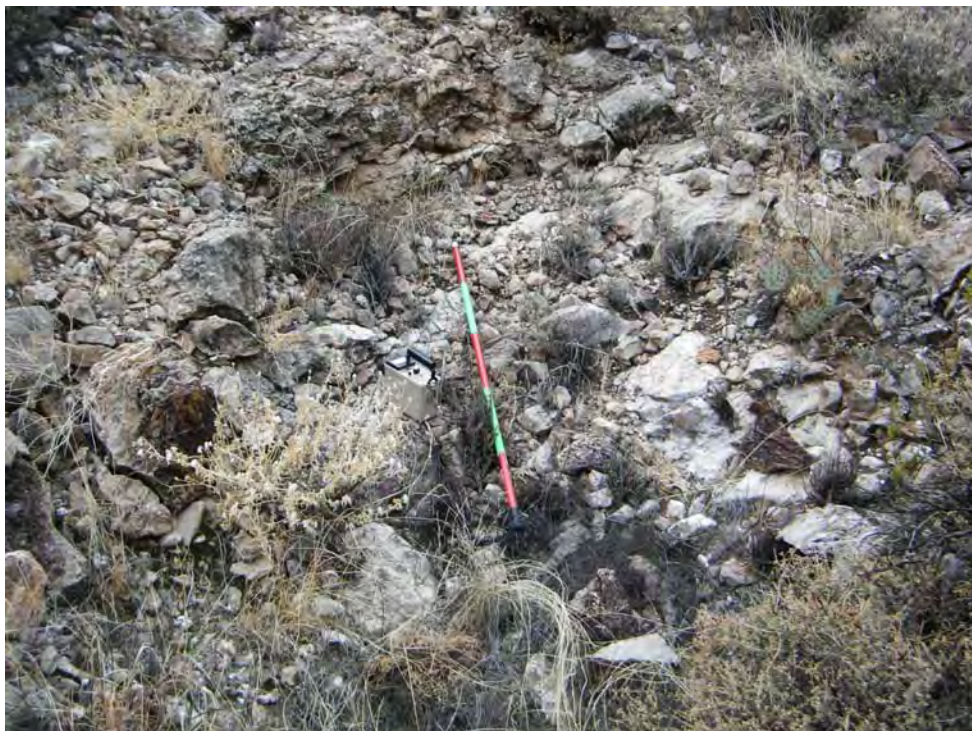
Photo 20-Looking west at Pit-2.

Pit-2 - 8' wide, 10' long, 1-3' deep

Rad 3 - Pit-2 - 0ft - 3 uR/hr, 4ft - 3 uR/hr

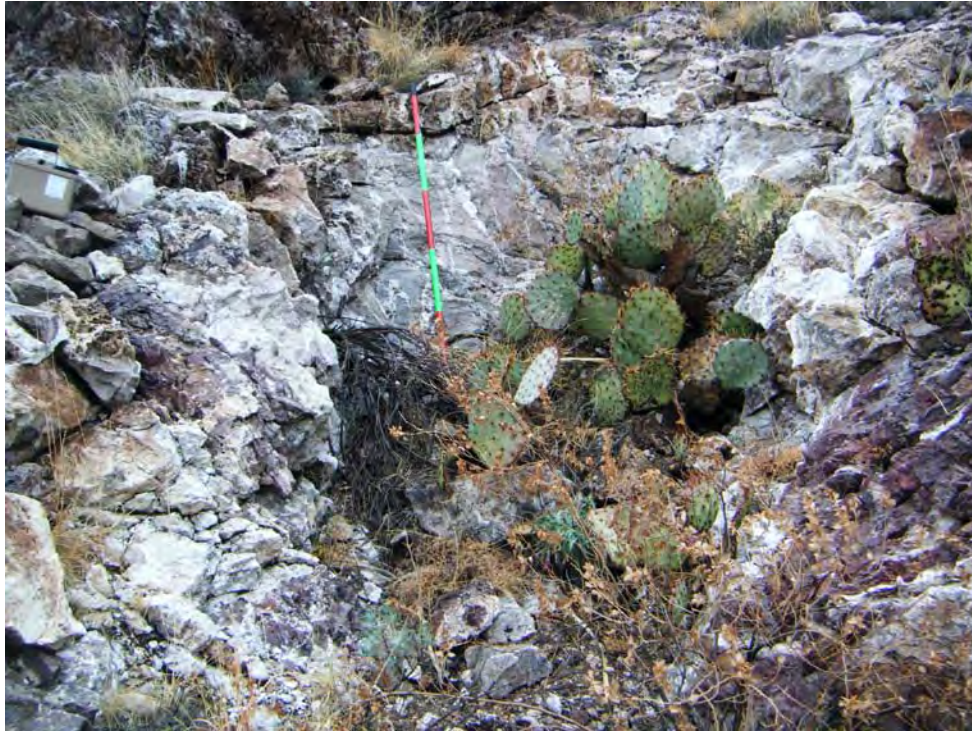
Photo 25-Looking west at Cutply-2.

cutPly-2 - 6' wide, 15' long, 5' deep

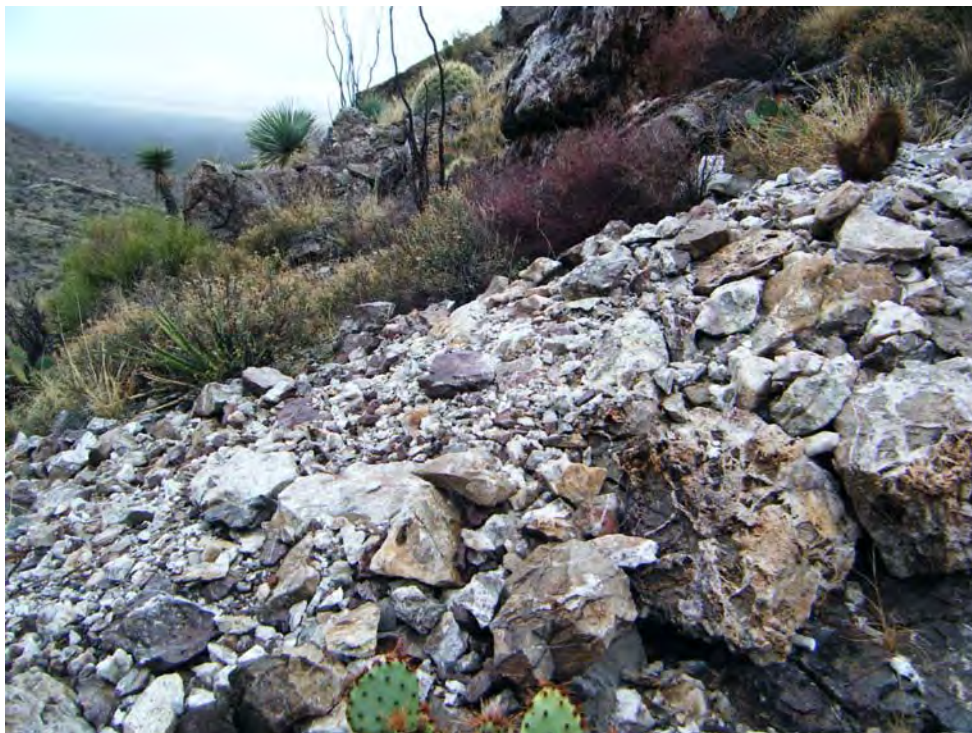
Photo 26-Looking south at Pileply-1.

Photo 26 - PilePly 1 - white, calcite mineralization
looking south

Rad 5 - PilePly 1 - 0ft - 4 uR/hr, 4ft - 3 uR/hr

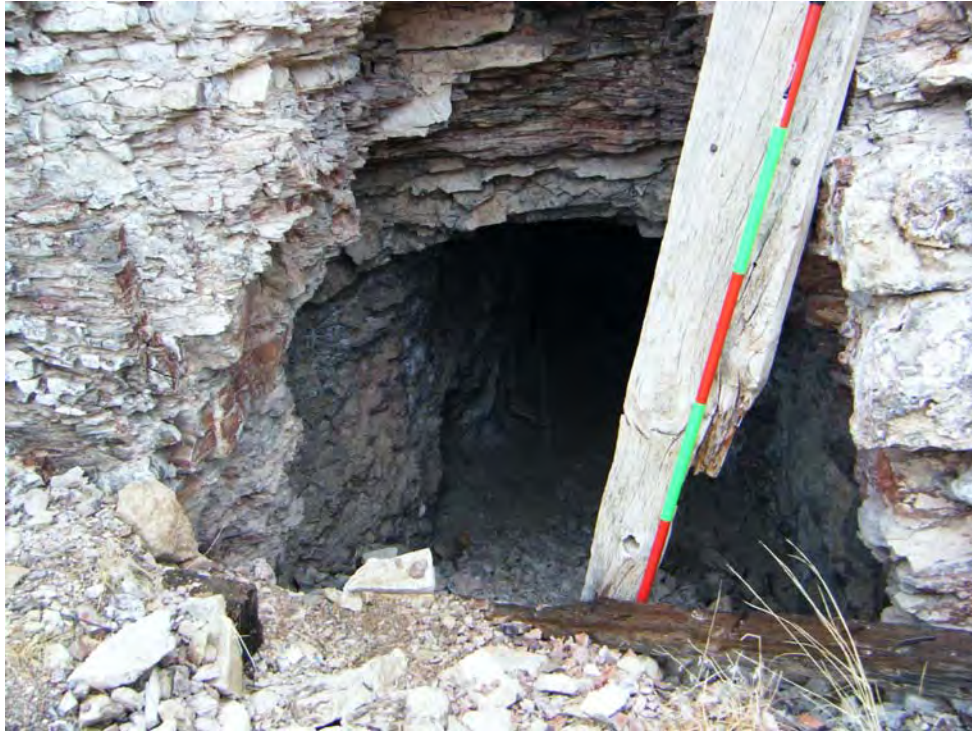
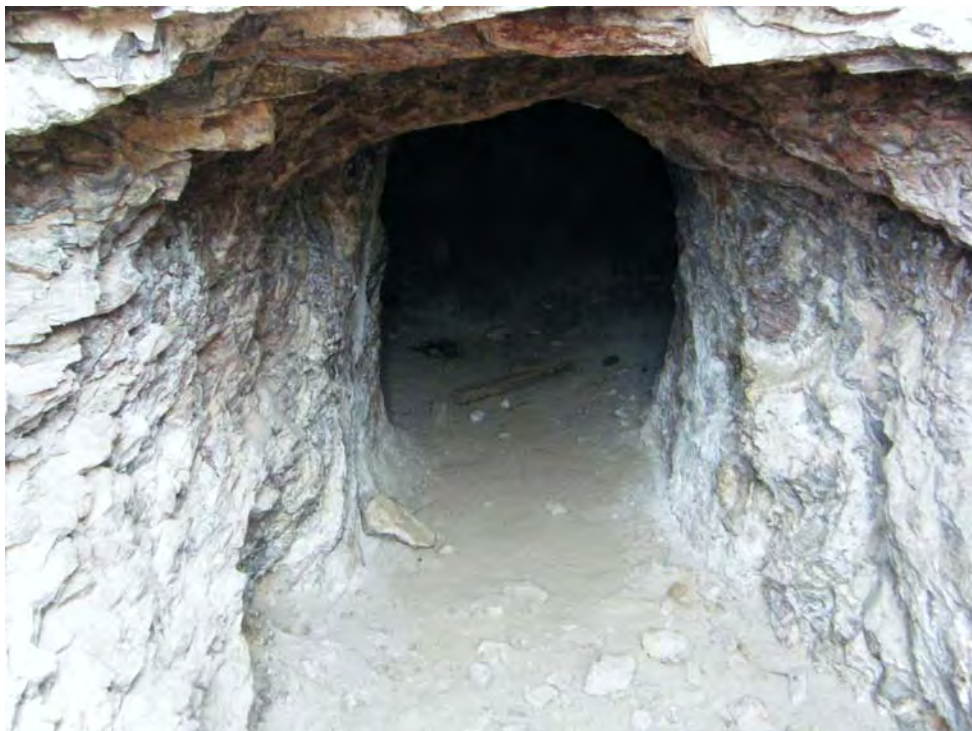
Photo 27-Looking west at Adit-1.

Photo 28-Closer view of Adit-1.

Adit 1 - aspect trends north

7' tall, 4' wide, 50' deep, curves to the east
cut leads into the adit - 20' long

Rad 6 - Adit 1 entrance - 0ft - 8 MR/hr, 4ft - 6 MR/hr

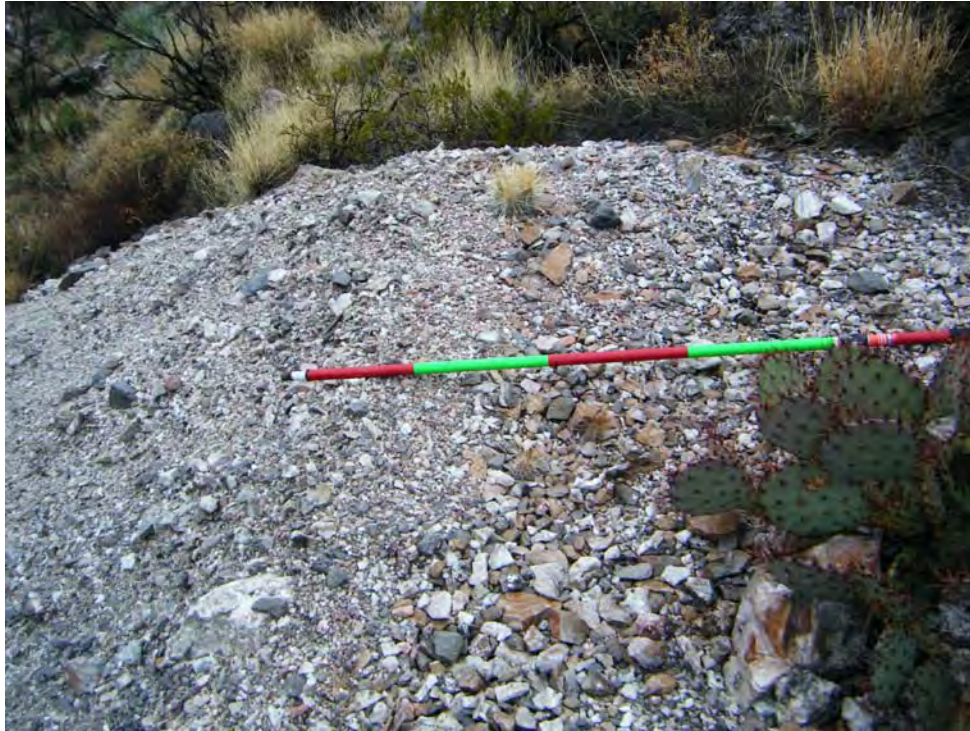
Photo 29-Looking south at Pileply-2. This pile is associated with Adit-1.

Pileply 2 - associated with Adit 1 - 1' deep, 15' wide,
20' long

Rad 7 - Pileply 2 - 0ft - 4 MR/hr, 4ft - 4 MR/hr

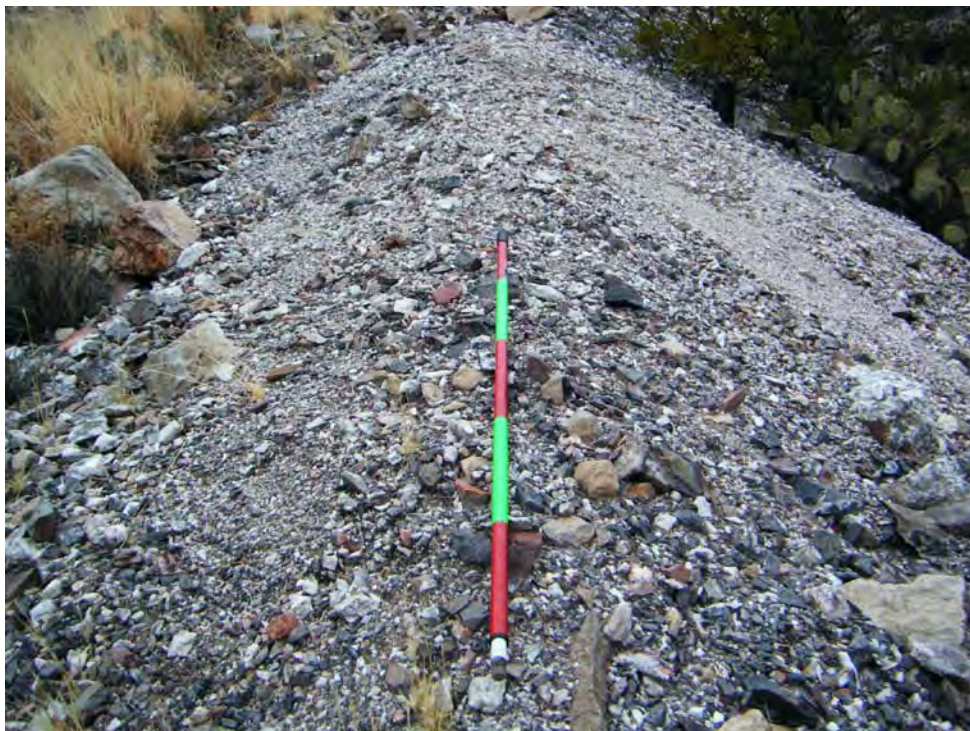
A pile of waste rock (pileridge-1) is located inside the drainage and may have been constructed to protect the mine road (Rd-2) from erosion. However, rocks from this waste pile do not appear to be migrating further down the drainage.

Photo 31-Looking north at Pileridge-1.

PileRidge 1 - Below Adit 1 along road; 15' long,
10' wide, ~2' high

Rad 8 - PileRidge 1 - 0ft - 3 MR/hr, 4ft - 4 MR/hr

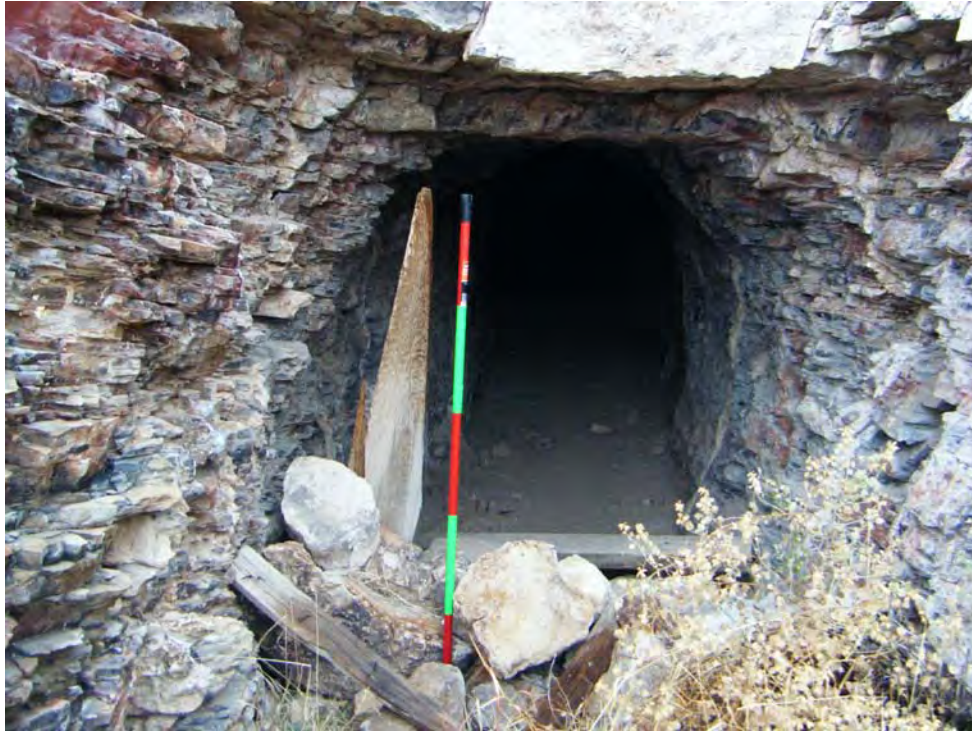
Photo 34-Looking west at Adit-2.

Adit 2 - 6' tall, 6' wide, ~50' deep - trends north

Rad 9 - Entrance to Adit 2 - 0ft - 5 MR/hr, 4ft - 5 MR/hr

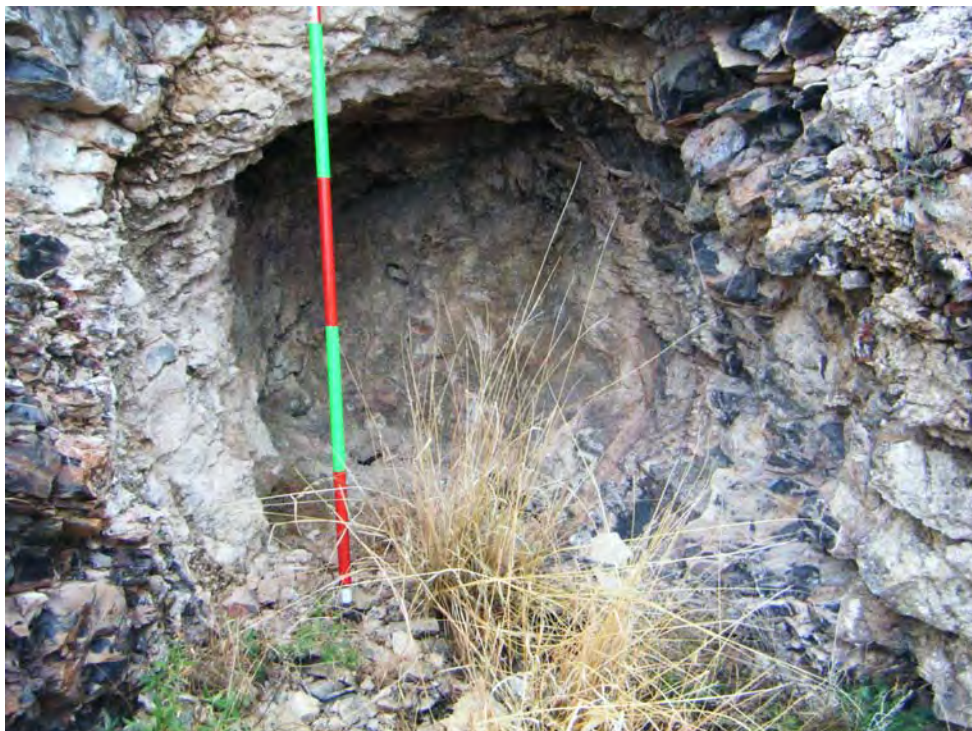
Photo 35-Looking west at Adit-3.

Adit 3 - 4' tall, 4' wide, 3' deep, Above Adit 2

Rad 10 - entrance to Adit 3 - 0ft - 3 MR/hr, 4ft - 3 MR/hr

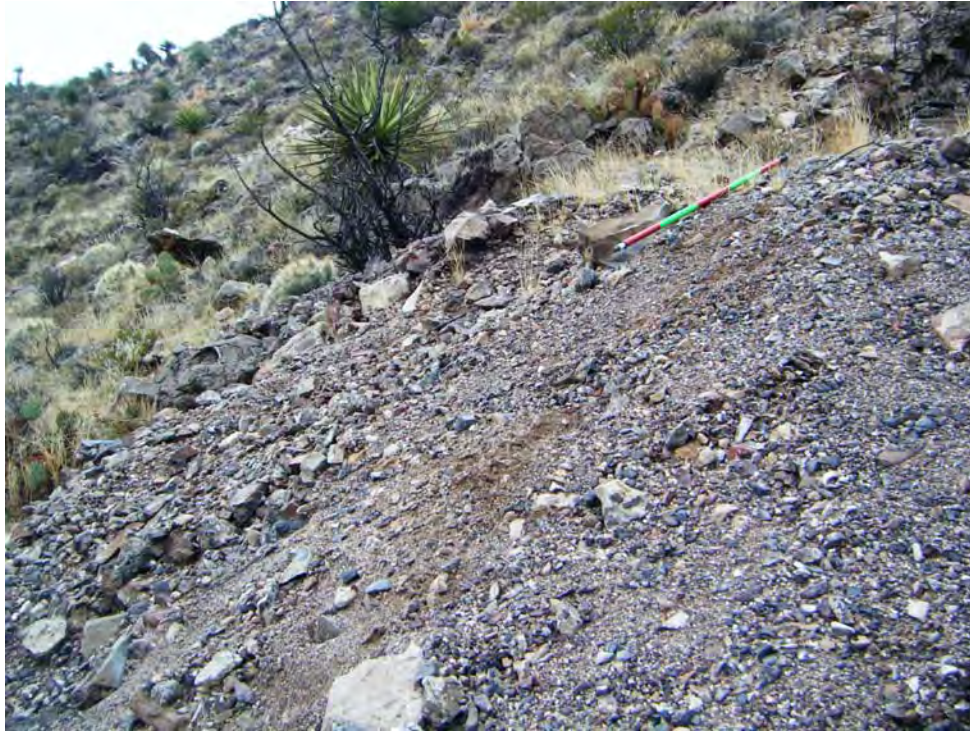
Photo 36-Looking south at Pileply-3.

Pileply 3 - associated with Adit 3 - 13' wide, 25' long,
3' high

Rad 11 - Pileply 3 - 0ft - 5 MR/hr, 4ft - 4 MR/hr

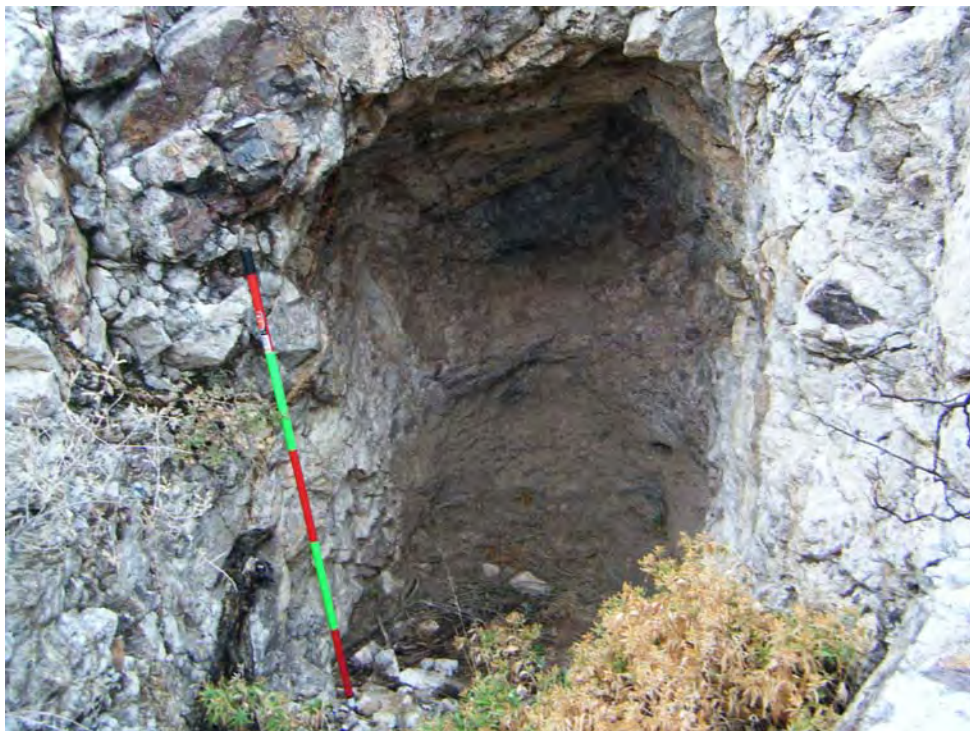
Photo 37-Looking west into Adit-4.

Adit 4 - 7' tall, 5' wide, 7' deep; east of Adit 3, above
Adit 2

Rad 12 - Adit 4 entrance - 0ft - 2 MR/hr; 4ft - 2 MR/hr

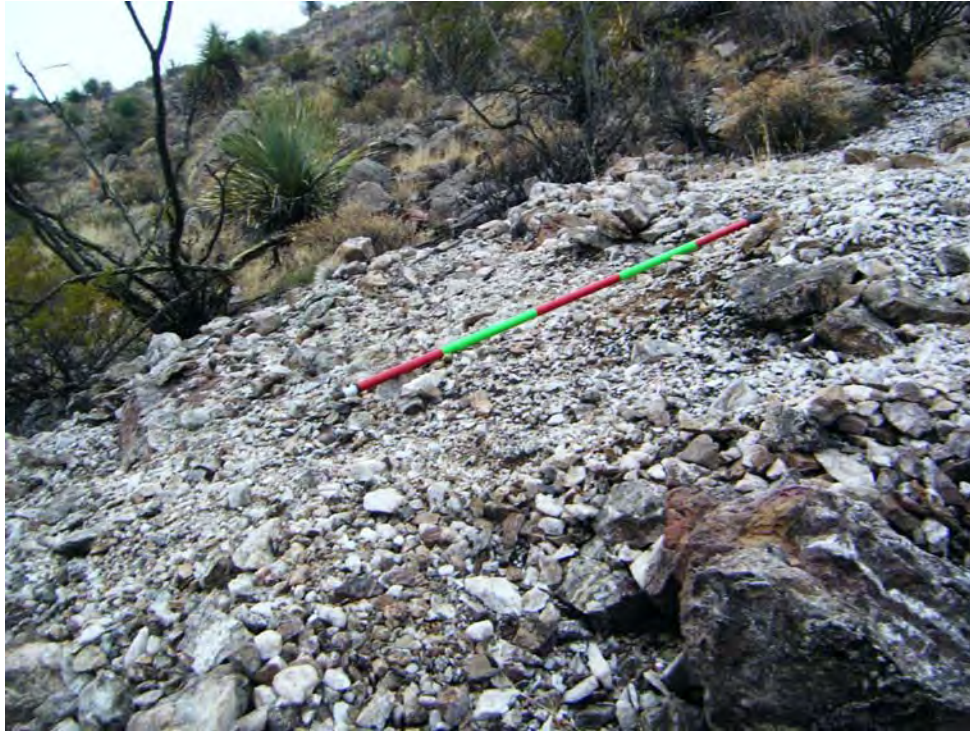
Photo 38-Looking south at Pileply-4.

Pileply 4 - associated with Adit 4 - 10' wide, 20' long, 1' high

Rad 13 - Pileply 4 - 0ft - 3 MR/hr; 4ft - 3 MR/hr

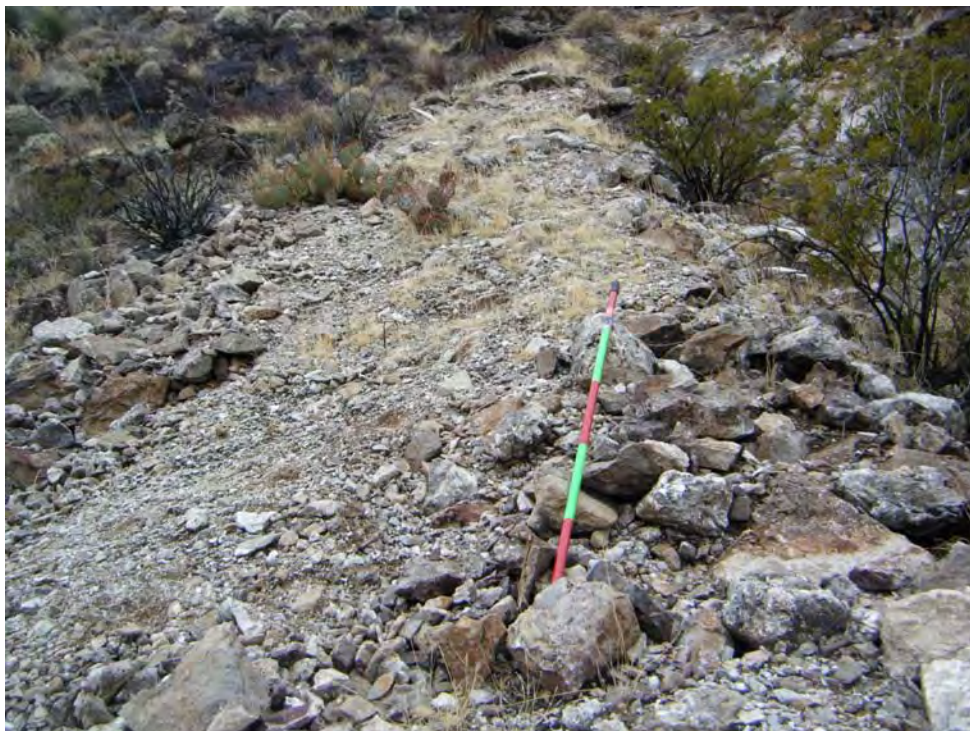
Photo 39-Looking downslope at Pileridge-2.

PileRidge 2 - east of Adit 4, west of cutIn
6' wide, 40' long, 2' high

Rad 15 - PileRidge 2 - 0ft - 3 MR/hr; 4ft - 3 MR/hr

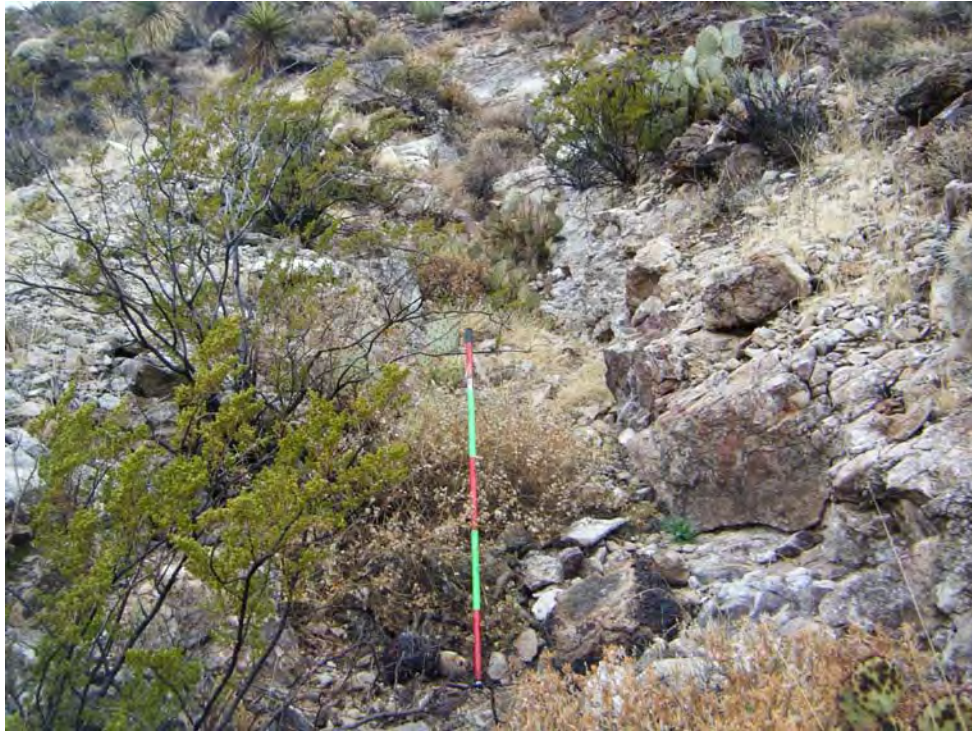
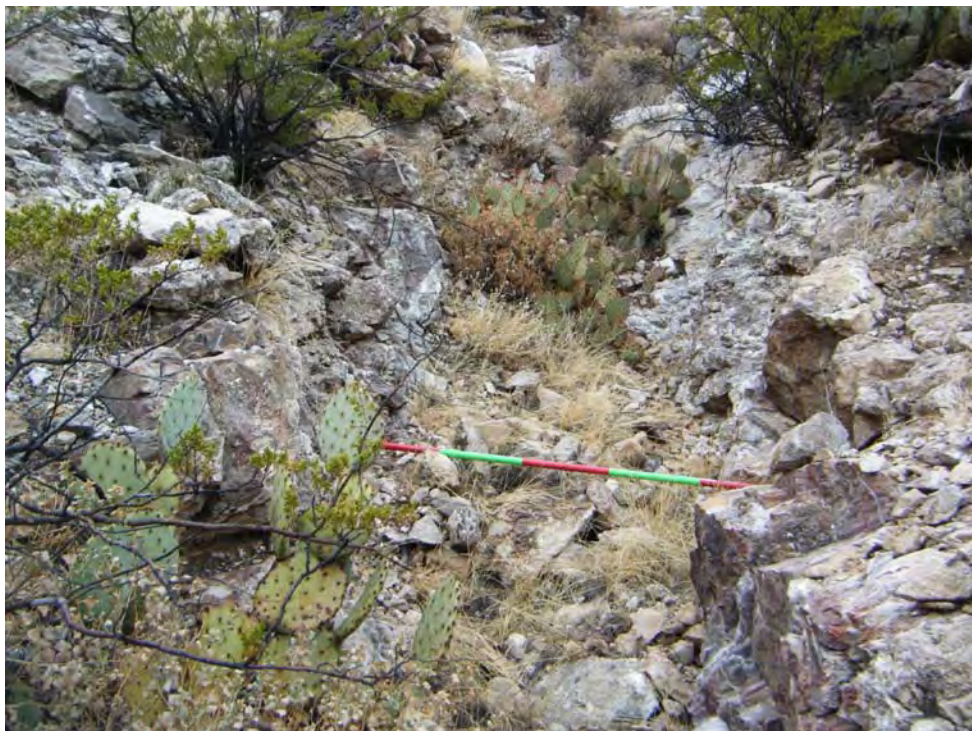
Photo 40-Looking downslope at CutIn-1.

Photo 41-Looking west at CutIn-1.

CutIn-1 - 7' wide, 5' deep, ~40' long
east of PileRidge 2

Rad 14 - CutIn-1 - 0ft - 3 MR/hr; 4ft - 3 MR/hr

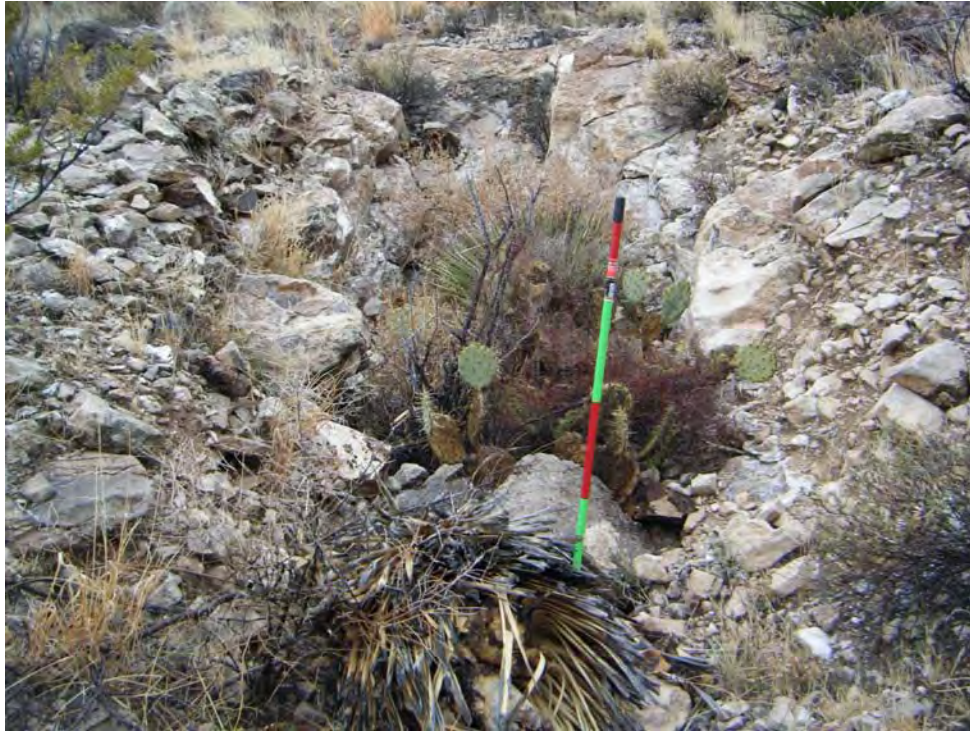
Photo 42-Looking west at Cutply-3.

CutPly 3 - 6' wide, 20' long, 5' deep

Rad 16 - CutPly 3 - 0ft - 4 MR/hr; 4ft - ~~MR/hr~~ - 3 MR/hr

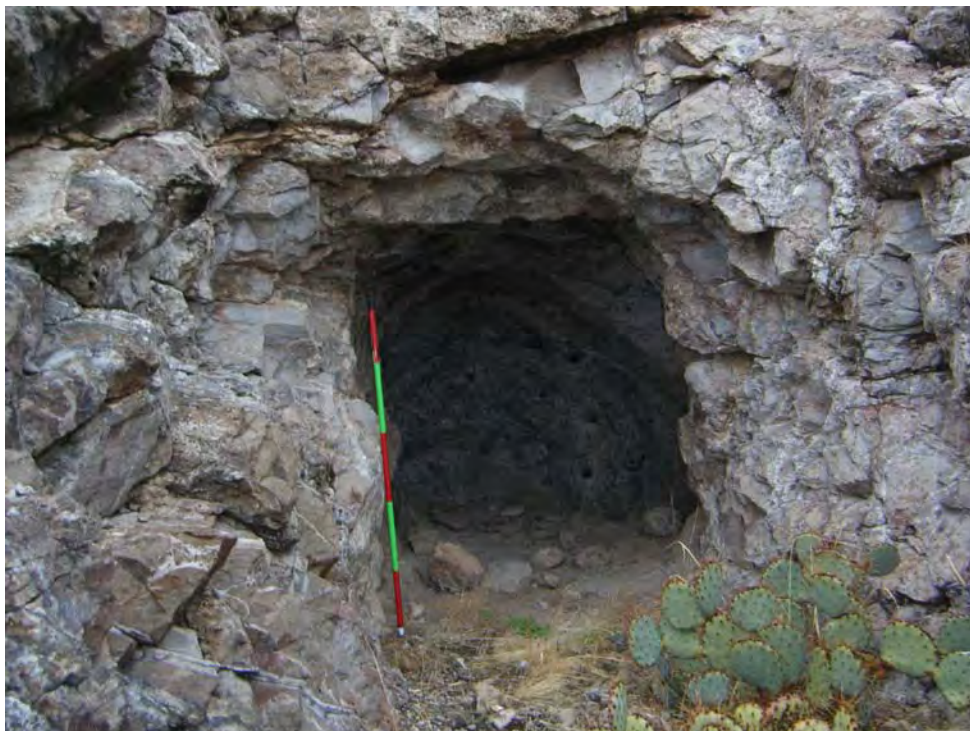
Photo 43-Looking west at Adit-5.

Adit 5 - 7' tall, 5' wide, 10' deep

Rad 17 - Adit 5 entrance off - 2 MR/hr; 4ft - 3 MR/hr

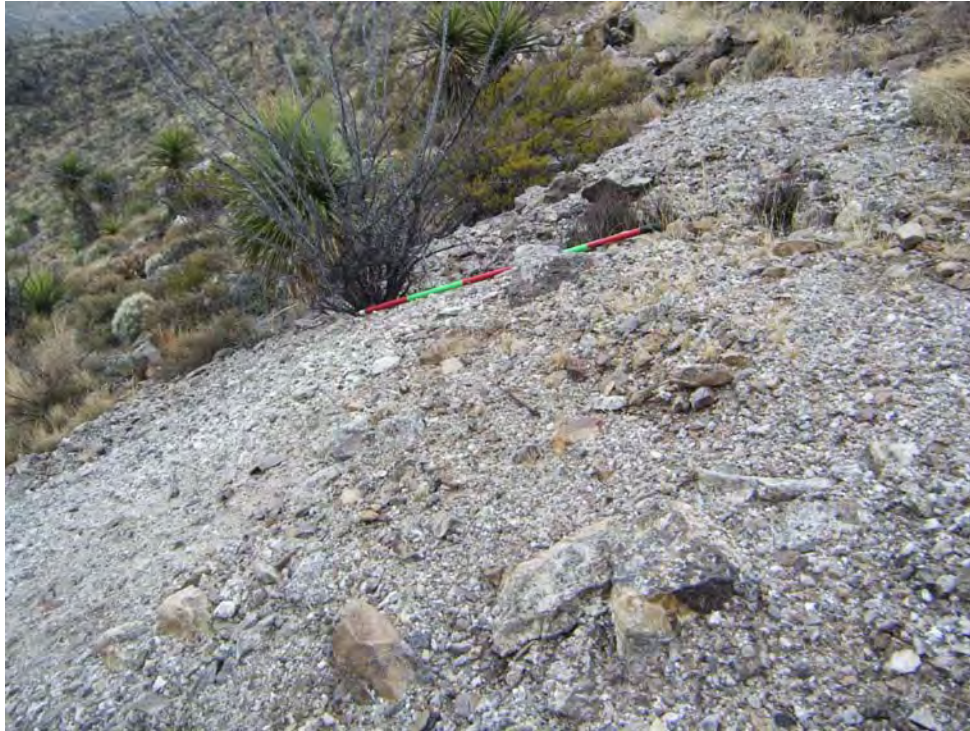
Photo 44-Looking south at Pileply-5.

Pile Ply 5 - below Adit 5 - 20' wide, 40' long, 2' high

Rad 18 - Pile Ply 5 - Off - 3 MR/hr; 4ft - 3 MR/hr

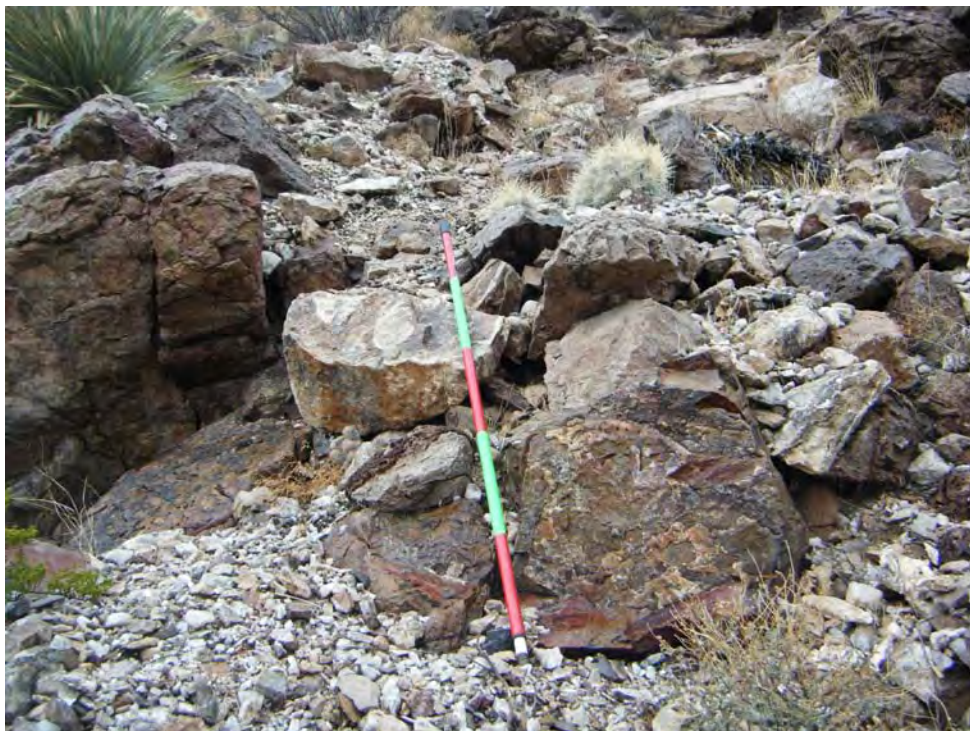
Photo 45-Looking west at Pileridge-3.

Pile Ridge 3 - 4' wide, 25' long, 1' high

Rad 19 - Pile Ridge 3 - Off - 3 MR/hr; 4ft - 3 MR/hr

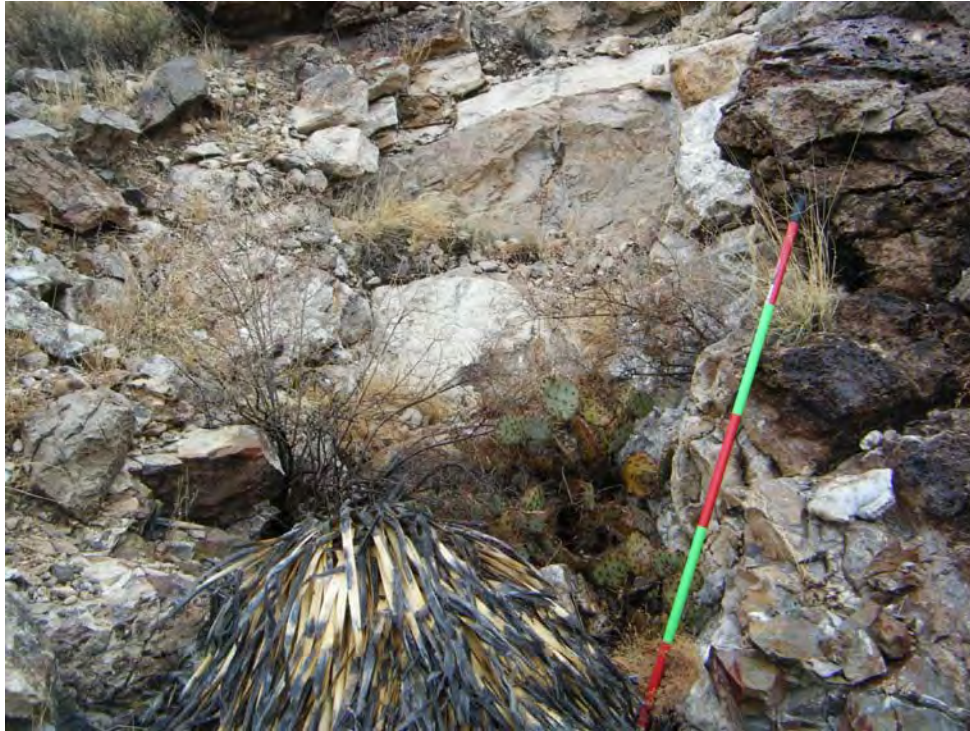
Photo 46-Looking west at CutIn-2.

Cut In 2 - 4' wide, 10' long, 5' deep

Rad 20 - Cut In 2 - Off - 3 MR/hr; 4ft - 3 MR/hr

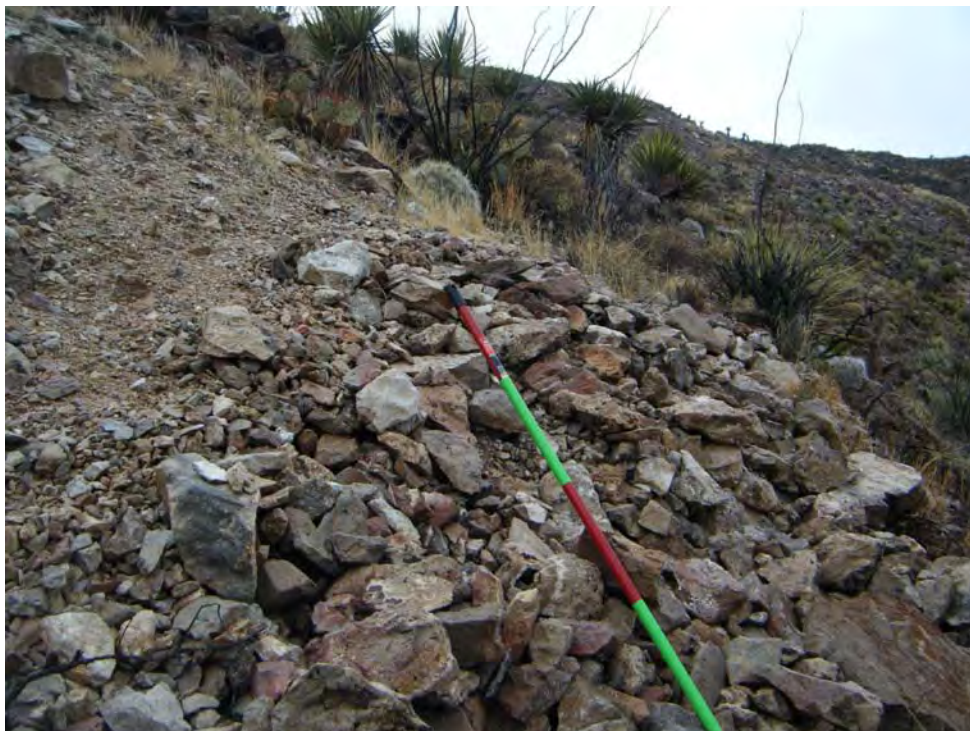
Photo 50-Looking northwest at Pileply-6.

Pile Ply 6 - 10' wide, 15' long, 1' high

Rad 21 - Pile Ply 6 - Off - 3 MR/hr; 4ft - 4 MR/hr

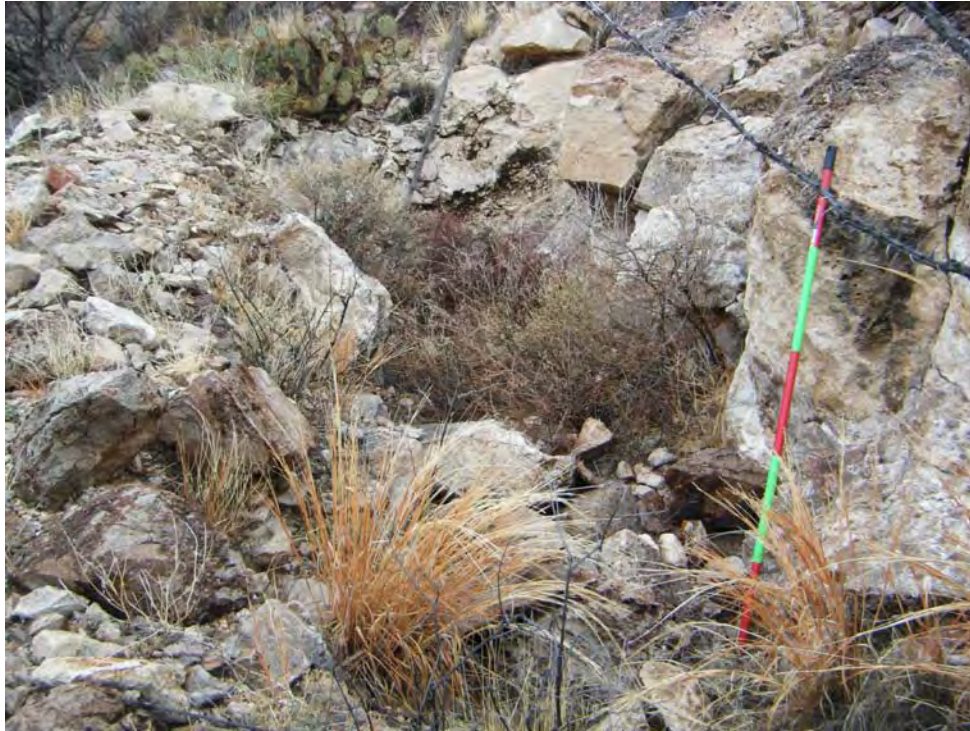
Photo 51-Looking west into CutIn-3.

Cut In 3 - 4' wide, 12' long, 4' deep

Rad 22 - Cut In 3 - Off - 3 MR/hr; 4ft - 3 MR/hr

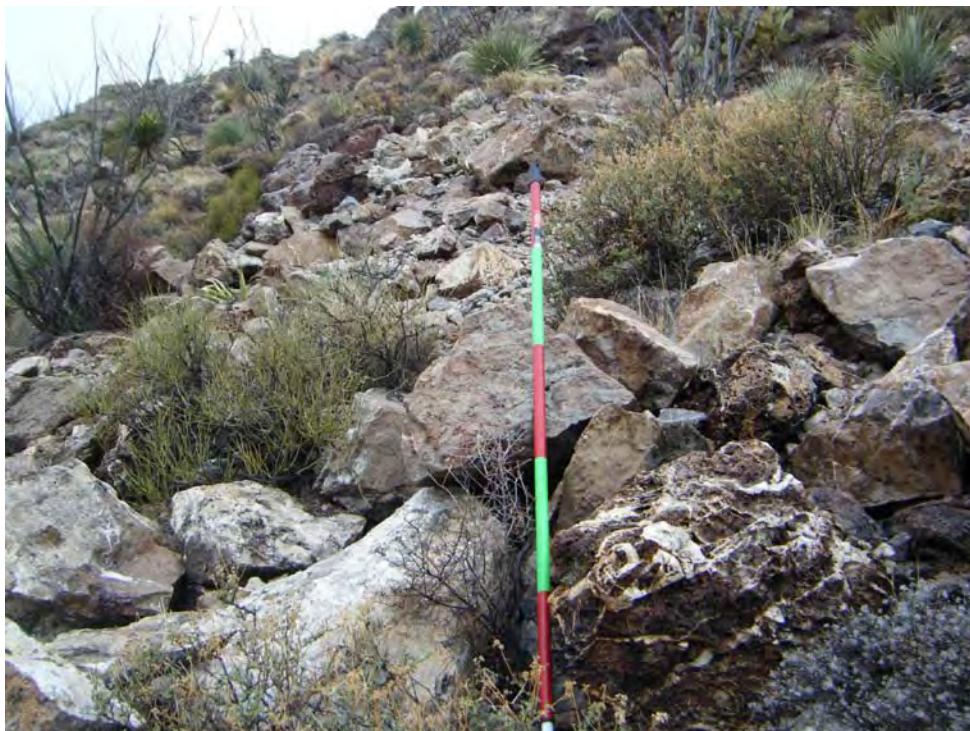
Photo 53-Looking southwest at Pileridge-4.

Pile Ridge 4 - 10' wide, 35' long, 2' high

Rad 23 - Pile Ridge 4 - Off - 3 MR/hr; 4ft - 4 MR/hr

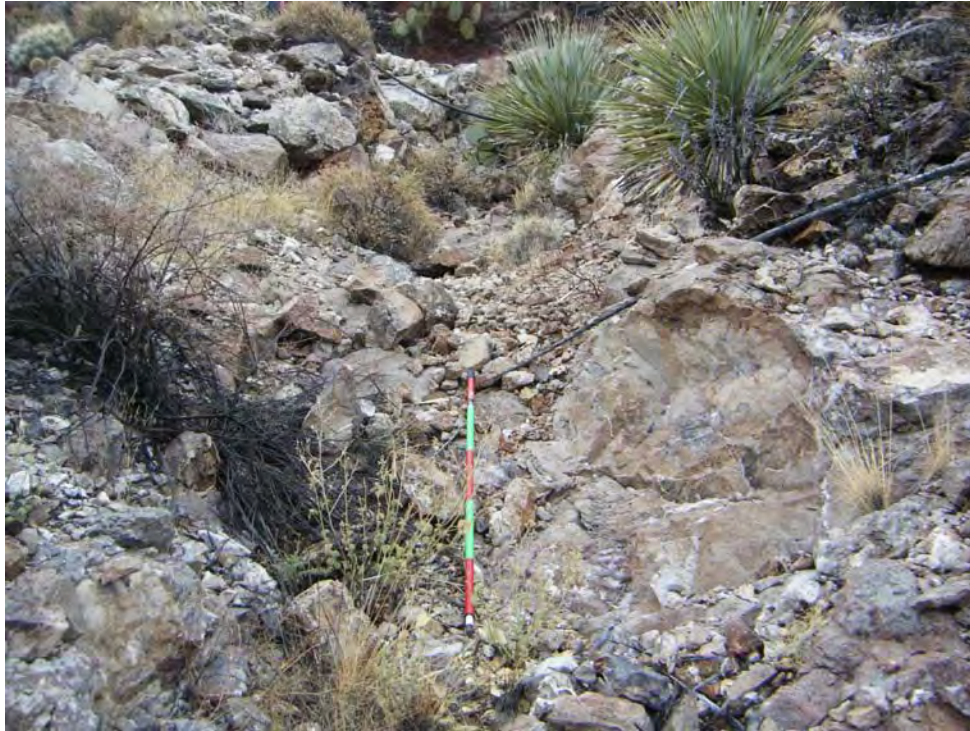
Photo 54-Looking southwest at CutIn-4.

Cut In 4 - 5' wide, 30' long, 3' deep; northeast of Pile Ridge 4

Rad 24 - Cut In 4 - Off - 3 MR/hr; 4ft - 3 MR/hr

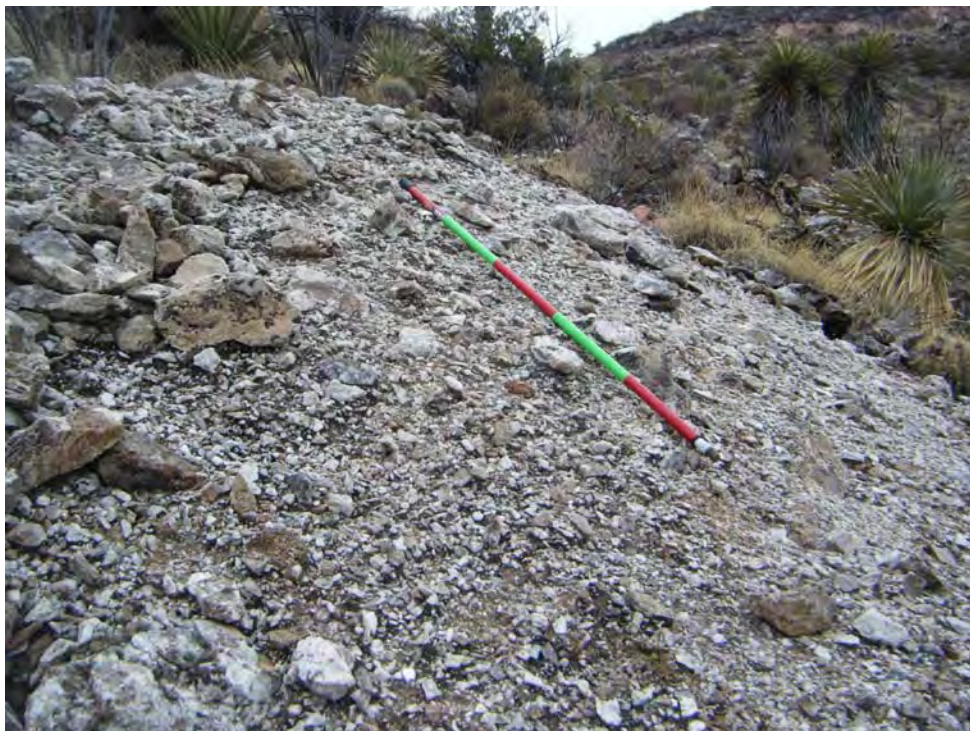
Photo 55-Looking northwest at Pileply-7.

Pile Ply 7 - 10' wide, 10' long, 1' high; below shaft 1

Rad 25 - Pile Ply 7 and shaft 1 - Off - 2 MR/hr; 4ft - 3 MR/hr
