Abandoned Uranium Mine Site Assessment for the Blue Star Site (NM0129)

FINAL REPORT

February 23, 2010

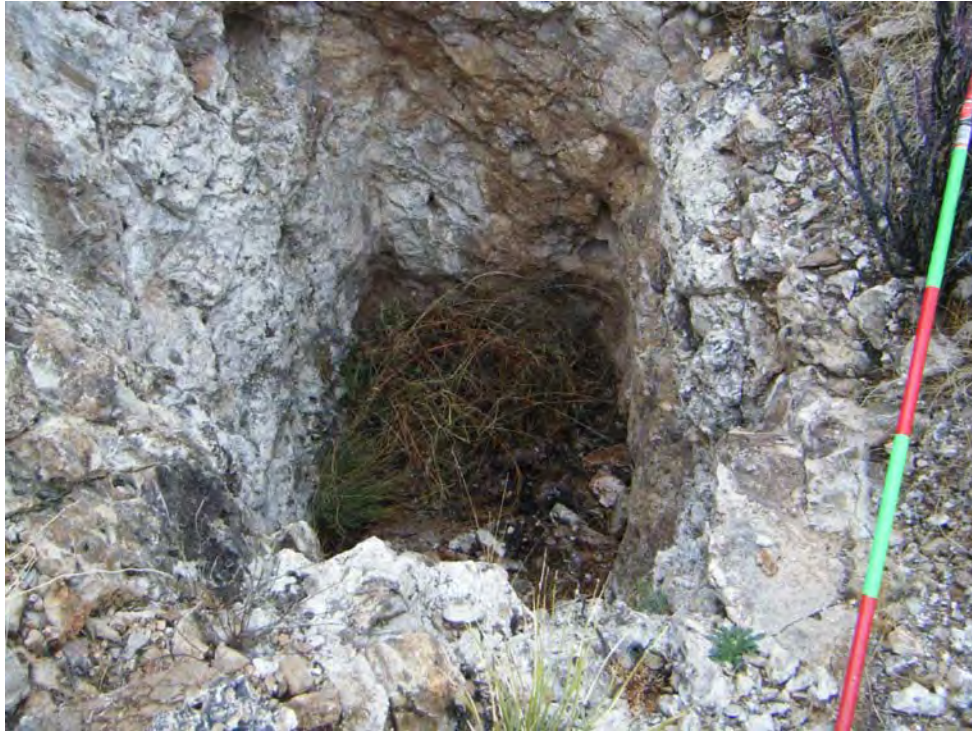
Photo 56-Shaft-1.

Shaft 1 - 5' wide x 7' long, 8' deep

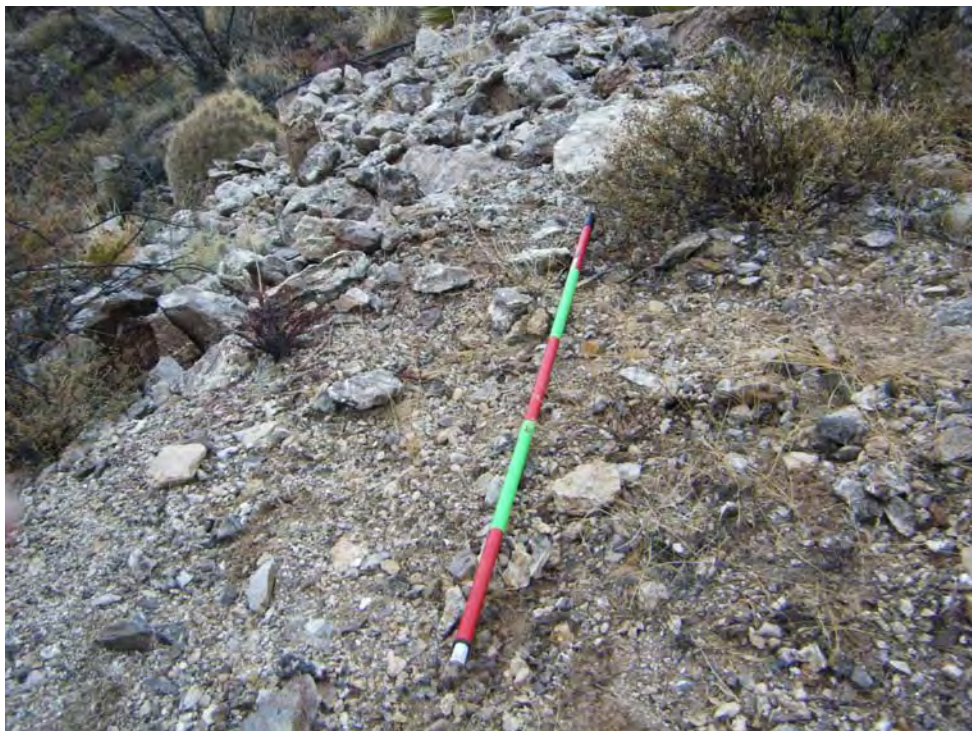
Photo 57-Looking west at Pileridge-5.

Pile Ridge 5 - 1' high, 25' long, 6' wide

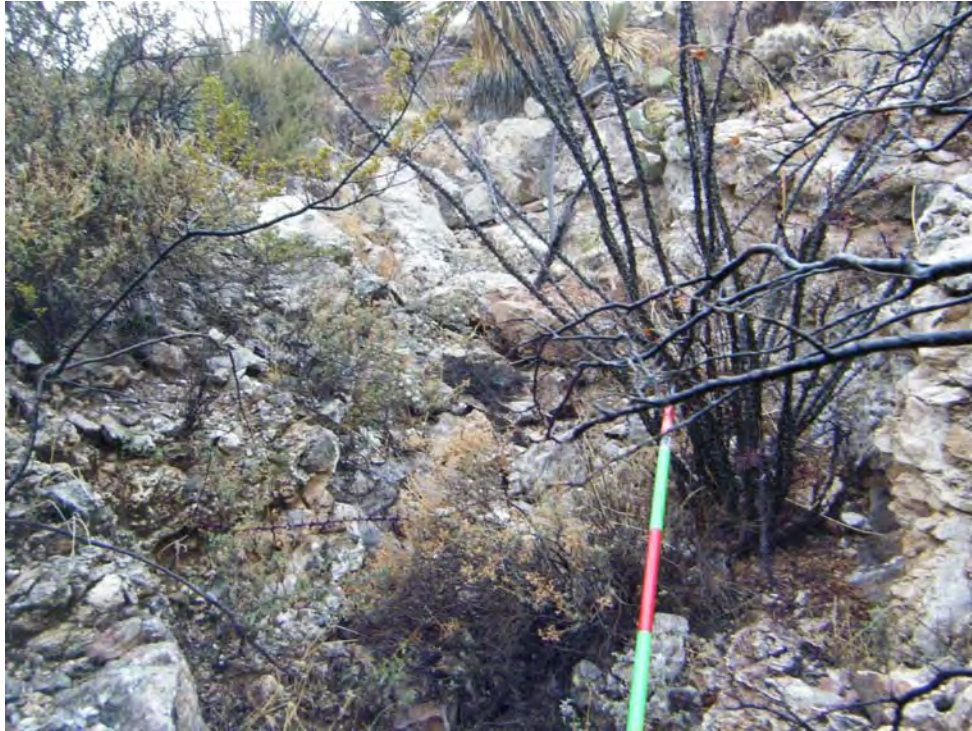
Photo 58-Looking southwest at CutIn-5.

Cut In 5 - 5' wide, 18' long, 3' deep

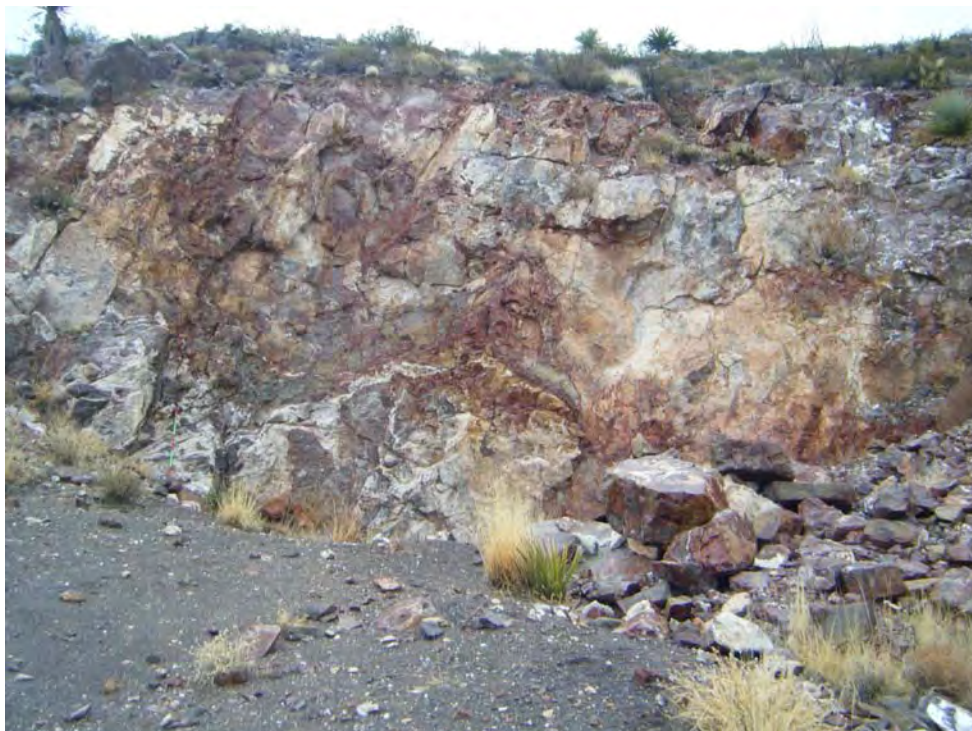
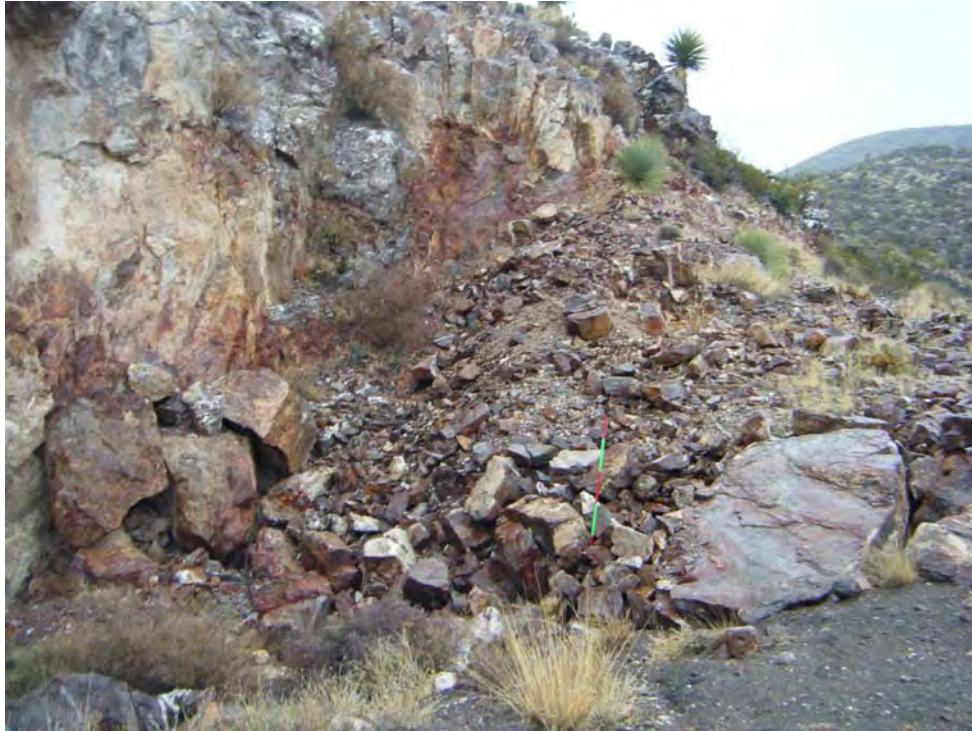
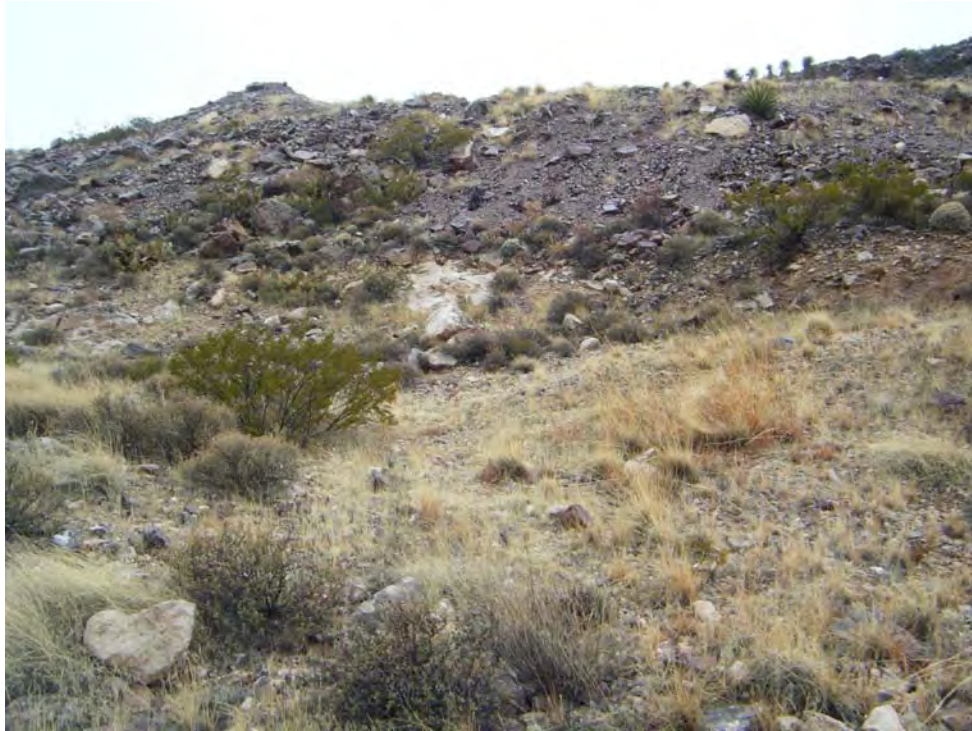
The gamma radiation readings at the AUM Site did not vary significantly above background levels except at Cutply-4, where a reading of 20 $\mu\text{R/hr}$ at contact was recorded. However, this reading may be due to the presence of a shale layer rather than any uraniferous materials. Please see Table 2 for details.

Photo 59-Looking north at Cutply-4.

Photo 60-Looking east at Cutply-4.

Photo 64-Looking up towards Cutply-4 to the north.

Cut Ply 4 - top of hill, lots of roads surrounding - 50' high cut, 50' wide/long; continues northwest and northeast 50-80ft on both sides.

Rad 27 - cut Ply 4 - Off - 20 MR/hr; 4ft - 16 MR/hr

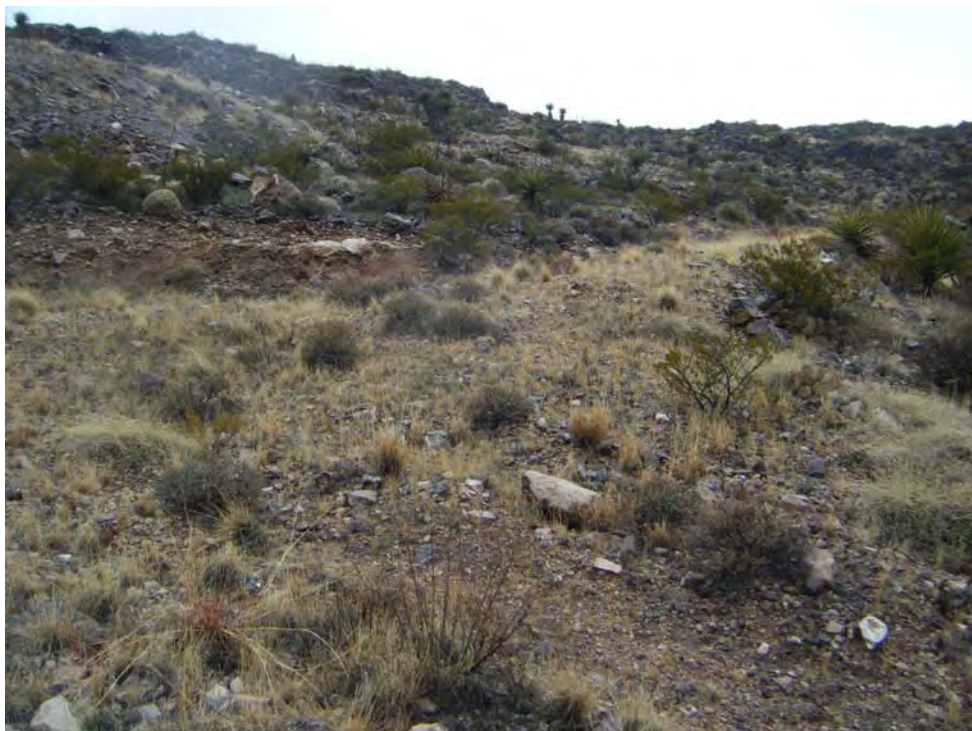
A mine road (Rd-1) exists at the northern end of the site in association with Cutply-4. Another mine road (Rd-2) runs from the southern end of the site northward, along the drainage. This may be the drill road mentioned in the Anderson report.

Photo 65-Looking eastward along Rd-1.

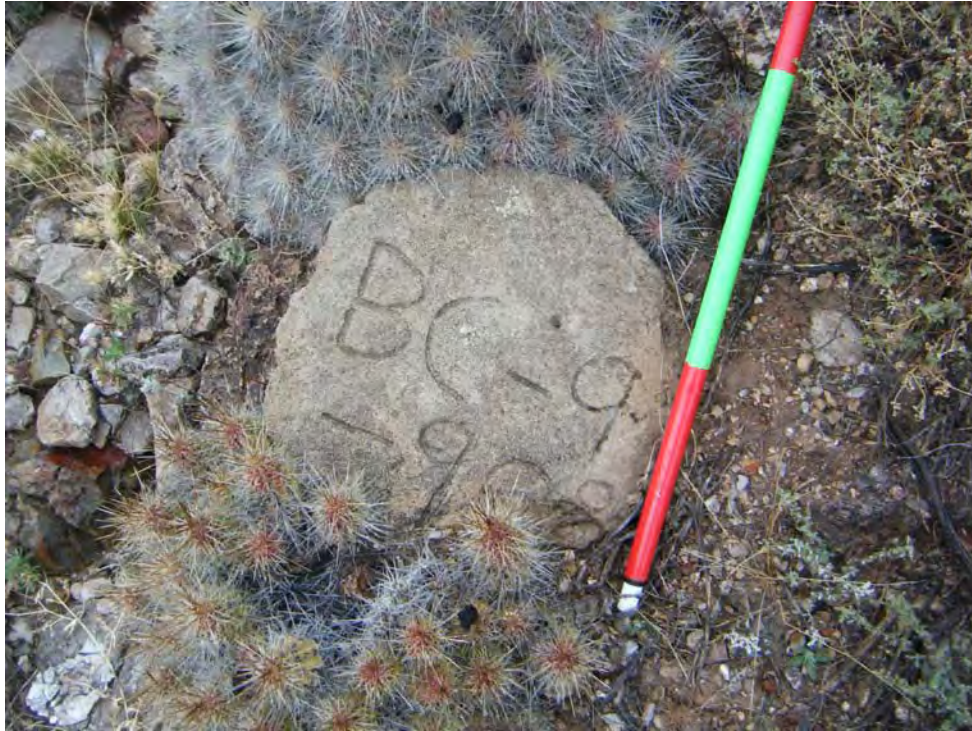
A claim marker (Claim-1) consisting of a small cement pad inscribed with "BC-9 -908" was found onsite.

Photo 66-Claim-1.

Claim 1 - "BC-9 -908
