# Abandoned Uranium Mine Field Survey Project

prepared for  
New Mexico Energy, Minerals and Natural Resources Department  
Mining and Minerals Division

## Haystack Mine

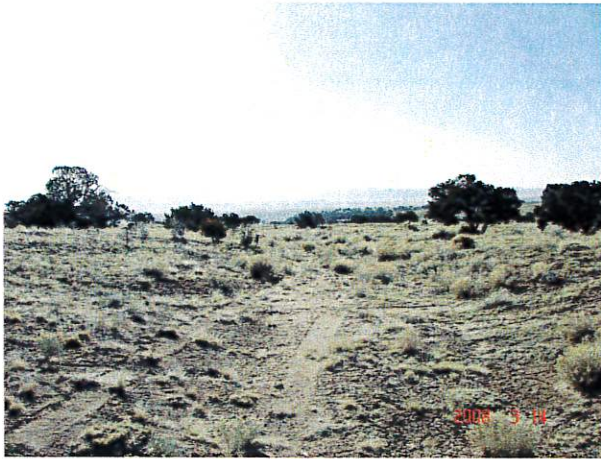
**2. Human Activity:** Several residences are present approximately 900 feet east of the eastern portion of the site which is located on BLM land.

View to east toward homes

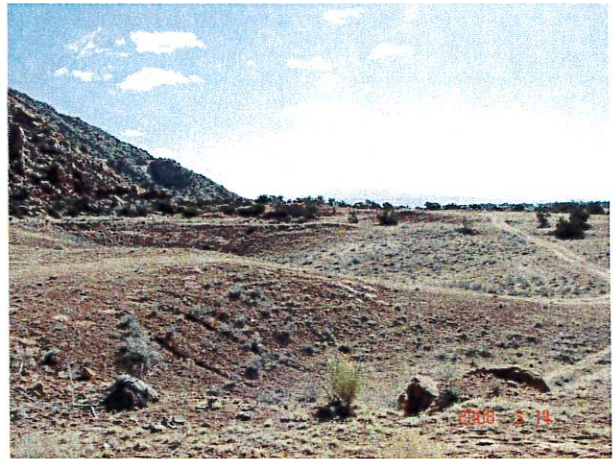
View to east at pit
