# The Lee Ranch Mine's Use Attainability Analysis for the San Isidro Arroyo and Its Tributaries

Peabody Natural Resources Company's Petition for Regulatory Changes

Peabody Energy Company

Water Quality Control Commission Hearing

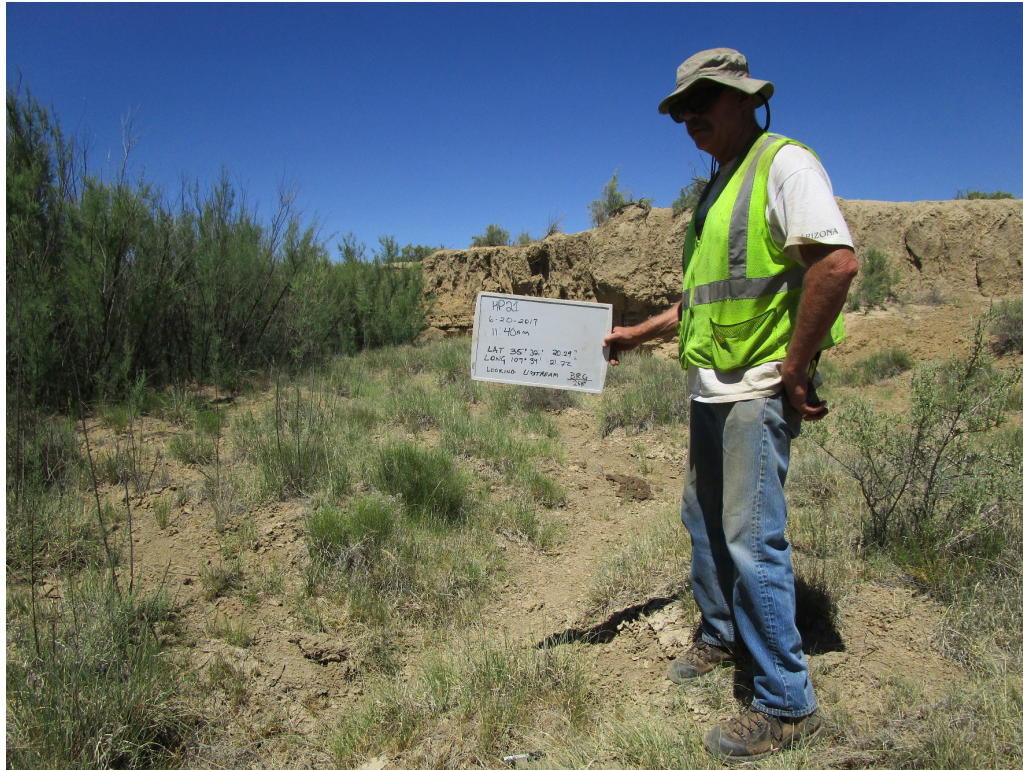
## HP21 Upstream

- Includes drainage from Tier 1 Watersheds 1A, 1B, and 1C
- HP 21: located in rolling hills topography following the confluence of three major tributaries, San Isidro, Tinaja, and Mulatto, where there is the highest potential for non-ephemeral flow
- PP152, PP153, PP154, PP170, PP286, PP287, PP281 a PP282, PP169, PP283, PP284, and PP285
- Results indicate that the San Isidro Arroyo is an ephemeral stream at this point in the watershed.
  - It displays classic ephemeral characteristics, with incised channels in areas of scour and nearly no visible channel in areas of fill or deposition.
  - The scores resulting from the Hydrology Protocol validate that the proper classification for this stream is ephemeral and the photo points verify that there are no isolated areas of abnormal hydrologic characteristics that are not already accurately represented by the HP sites that were chosen.

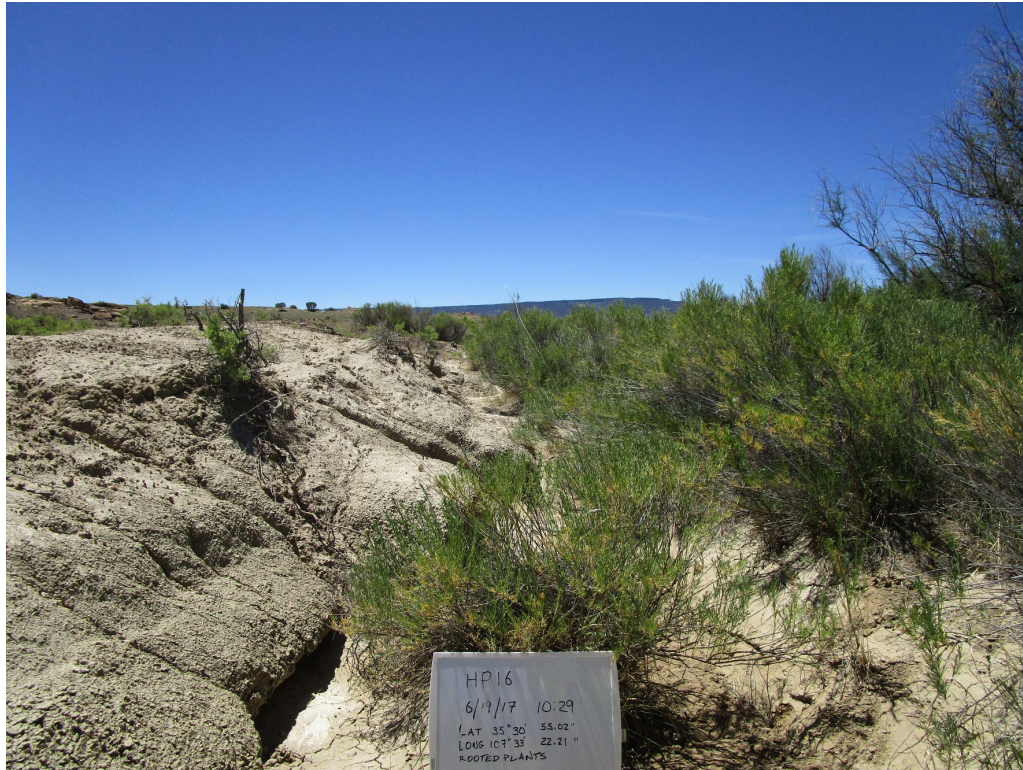
## HP16 Rooted Plants

- Tier 1 Watershed 1D: Doctor Arroyo
- From headwaters to mouth, this watershed is located in the lower valley and is characterized by the rolling hills topography
- Doctor Springs, located approximately midway between the headwaters and the confluence with San Isidro Arroyo, is not an ephemeral feature and has been excluded from this Hydrology Protocol evaluation
- HP 16, HP 17, HP 18
- PP159, PP160, PP161, PP290, PP291, PP168, PP292, PP163, PP164, and PP166
- These photos indicate that all intermediate portions of Doctor Arroyo and contributing tributaries exhibit consistent ephemeral characteristics and were accurately represented by the chosen HP sites.
- The only site that exhibited non-ephemeral characteristics is PP160, which is located immediately downstream of Doctor Springs and is being excluded from this UAA.

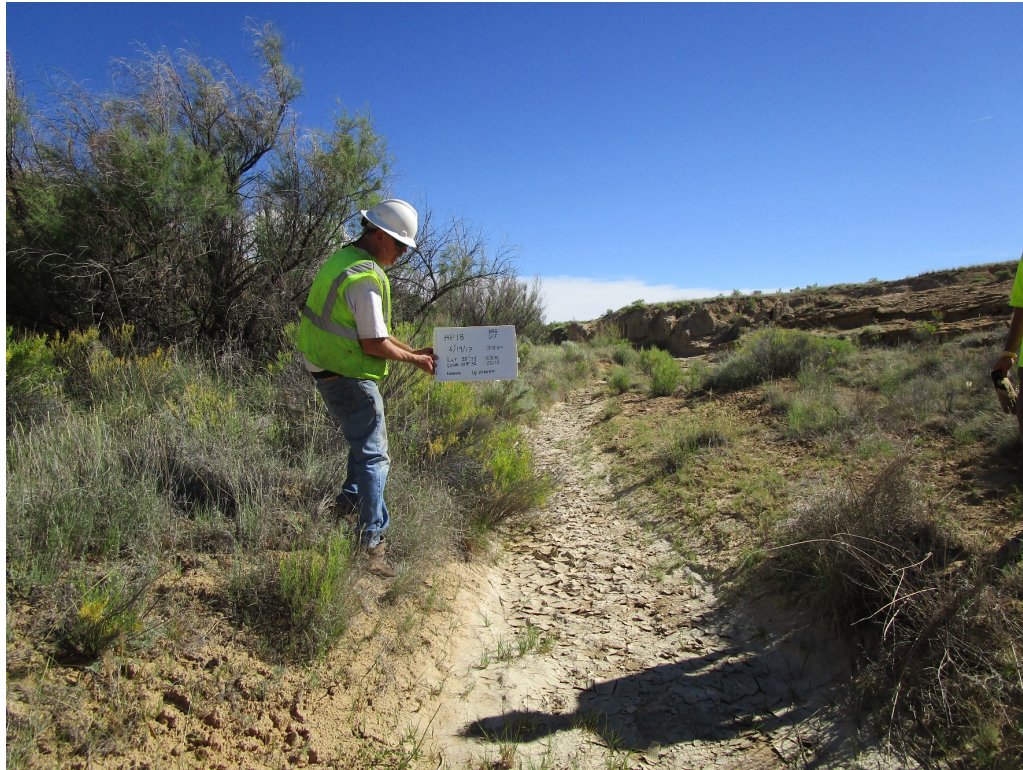
## HP18 Upstream

- Tier 3 Watershed 3ABCD: San Isidro Arroyo
- HP31: Characteristics consistent with HP21 and HP18
- Total score 7: Moderate scores for differences in vegetation, floodplain and channel dimensions, and absence of rooted upland plants. All indicators were characteristic of ephemeral streams.
- This site has a higher potential for showing intermittent characteristics due to the large drainage area capturing surface water runoff, with potential to sustain intermittent flows, and the lower position in the watershed, giving it a higher potential for intercepting the water table if alluvial groundwater exists.
