# Abandoned Uranium Mine Site Assessment for the Baby Site (NM0112)

**FINAL REPORT**

NM0112

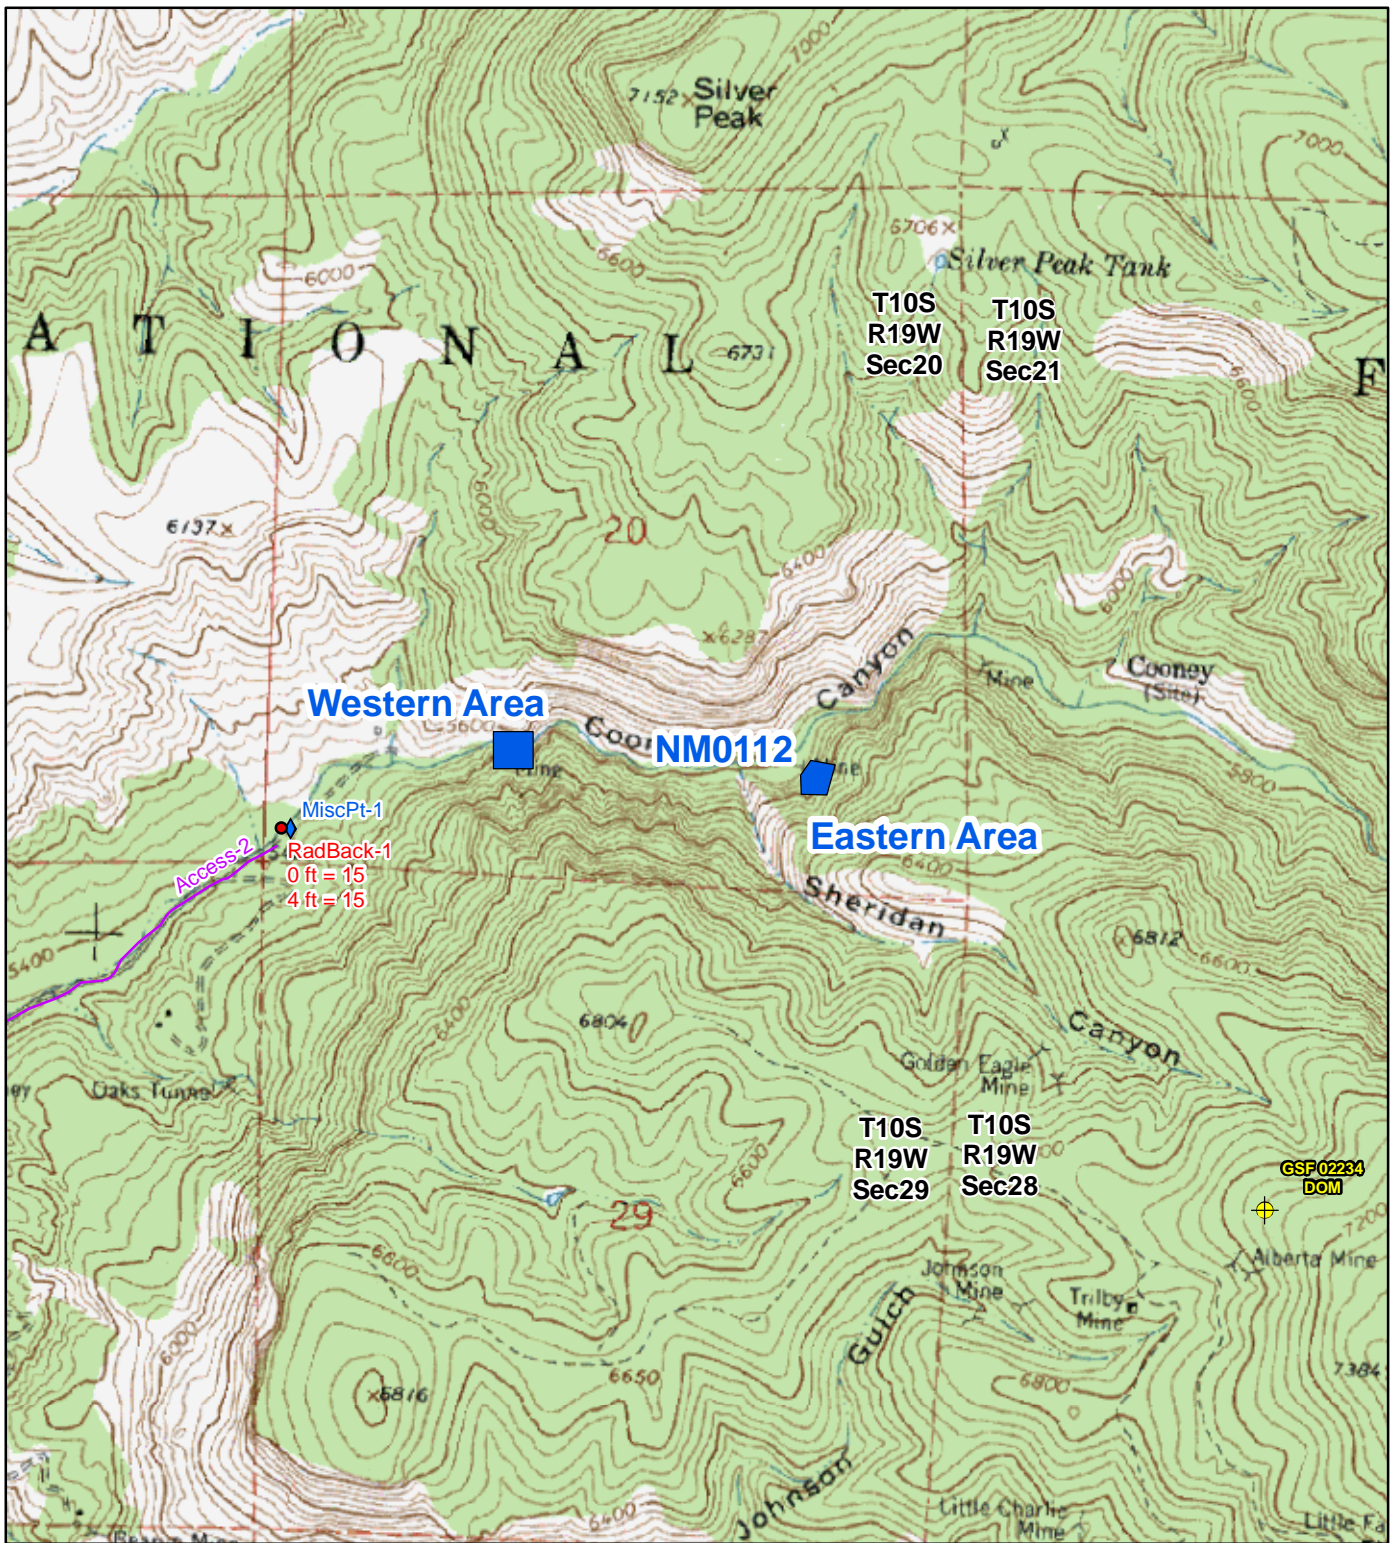
**Figure 2**  
**Topographic Map**  
**NM0112-Baby**  
 Abandoned Uranium  
 Mine Assessment

The AUM Site can be found on the Mogollon Quadrangle 7.5 minute United States Geological Survey topographic map at an elevation of approximately 5600 feet above mean sea level (Figure 2). The AUM Site is located in Cooney Canyon in the Gila National Forest. The broader region around the AUM Site consists of mountain ranges separated by narrow canyons. An aerial photograph of the terrain surrounding the AUM Site is shown in Figure 3.

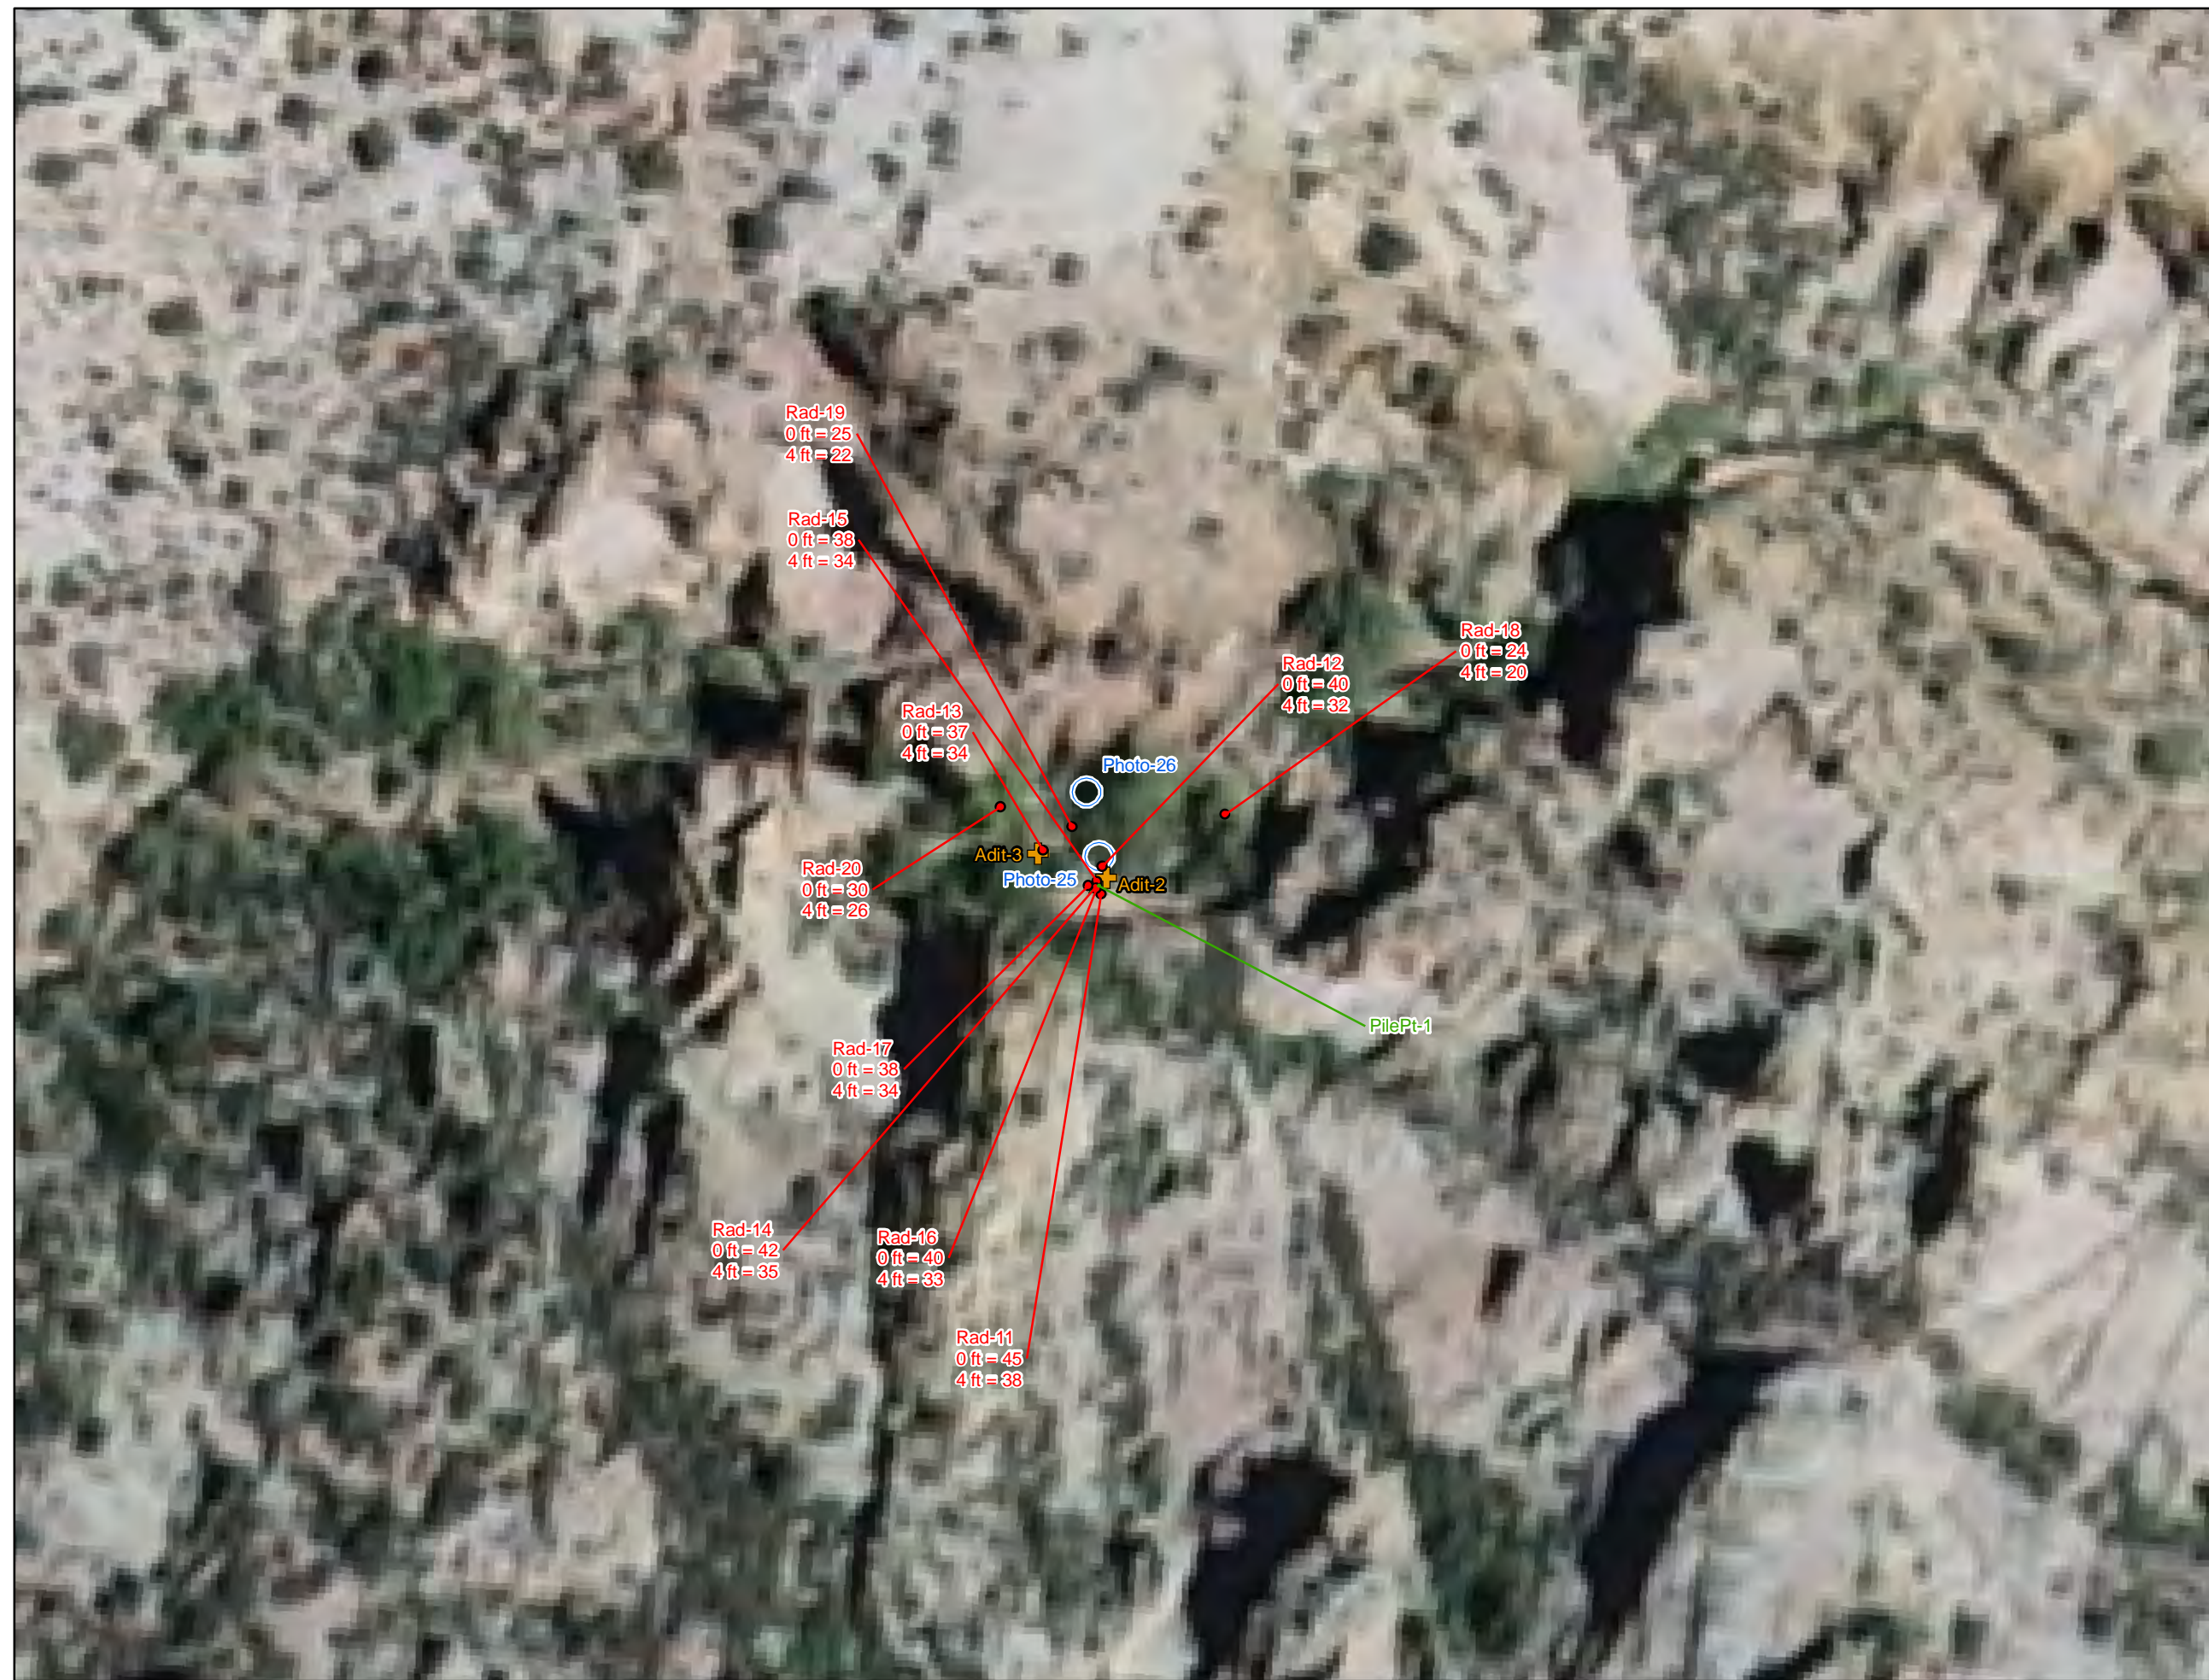
**Figure 4a**  
**Site Map on**  
**Aerial Photo**  
**Western Area**  
**NM0112-Baby**  
 Abandoned Uranium  
 Mine Assessment

The gamma radiation readings at the Eastern Area AUM Site did not vary significantly above background levels (Table 2). The gamma radiation readings at the Western Area AUM Site were slightly greater than background. The maximum readings at the Western Area AUM Site were recorded at the entrance of Adit-2 and were measured at 45  $\mu\text{R/hr}$  at the ground surface and 38  $\mu\text{R/hr}$  at 4 feet above the ground surface.

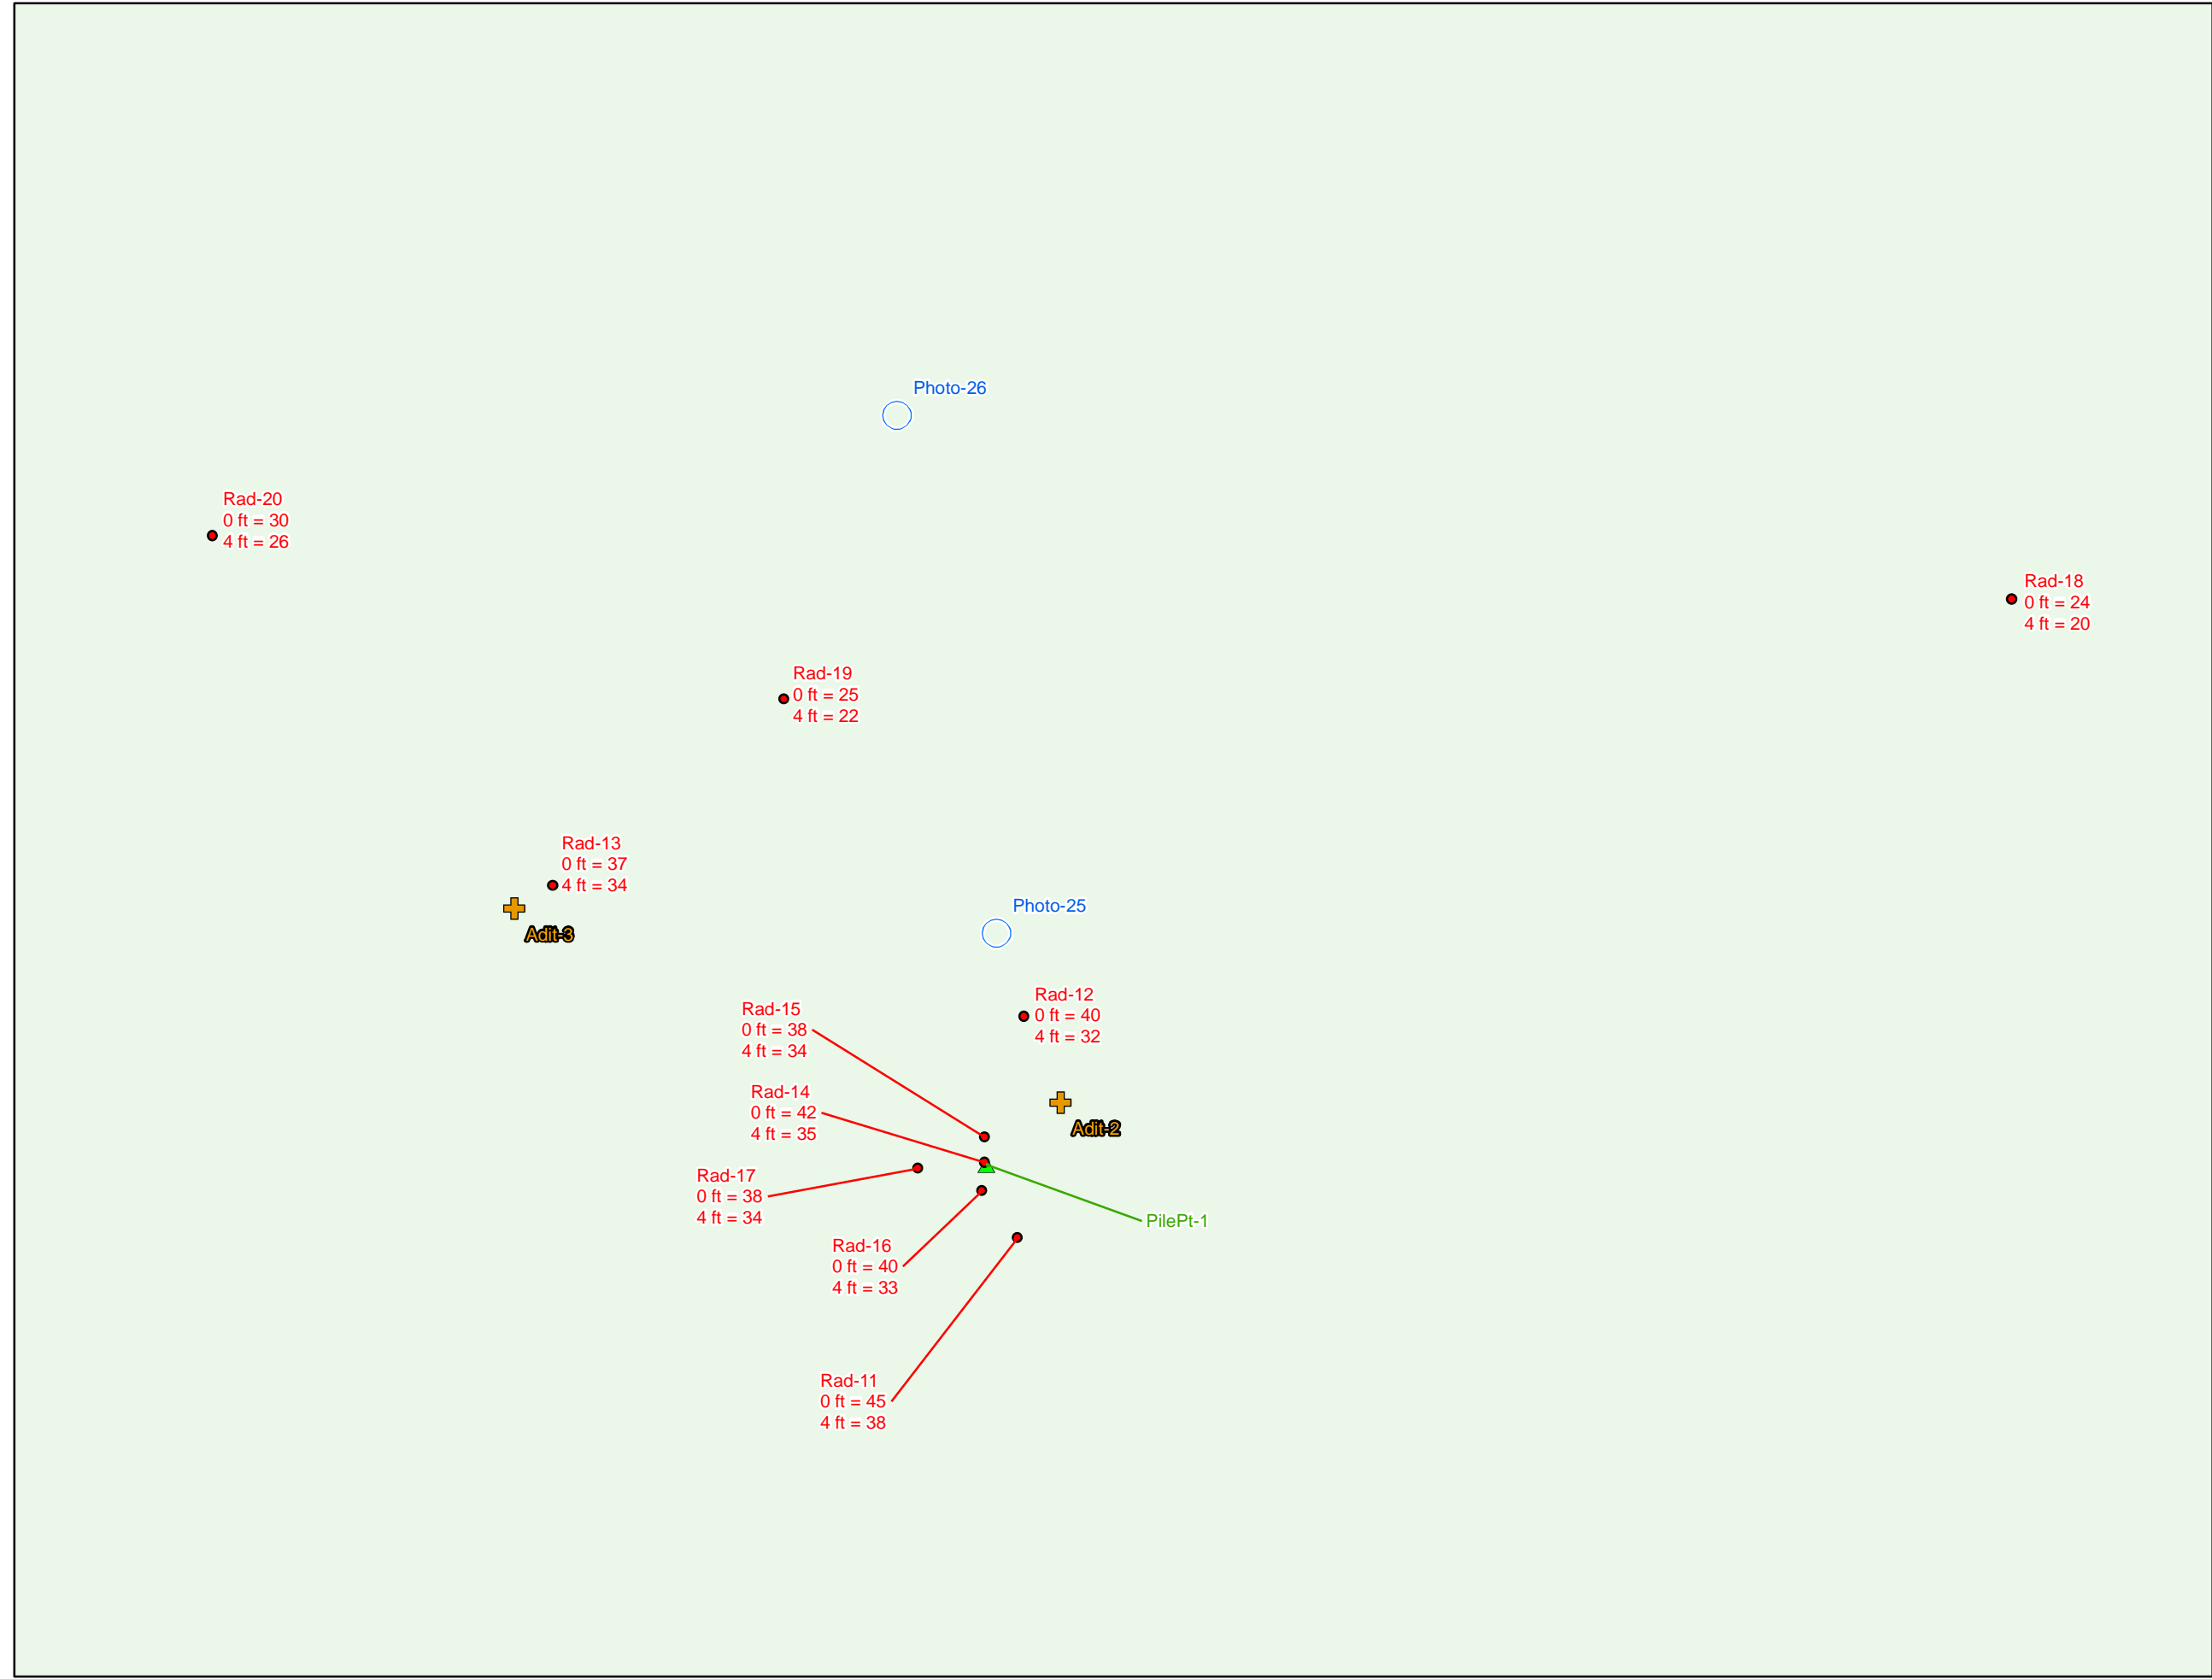
**Figure 4b**  
**Site Map with**  
**Surface Ownership**  
**Western Area**  
**NM0112-Baby**  
 Abandoned Uranium  
 Mine Assessment

One adit (Adit-1) was found at the Eastern Area AUM Site. Adit-1 was located at the top of a scree slope and entered the rock face approximately 1 foot. Two adits (Adit-2 and Adit-3) were found at the Western Area AUM Site. Adit-2 had a wooden door approximately 15 ft into the rock face. It is unknown how deep Adit-2 extends although the Anderson Report reported that Adit-2 extends approximately 30 ft into the rock face at which point it turns left for approximately 75 ft (Anderson, 1980). Adit-3 extended approximately 4 ft in to the rock face wall and contained wooden timbers and scrap metal. Adit-2 appeared to be similar to the lower adit described in the Anderson Report based on the photograph and the estimated depth and trend. The upper adit described in the Anderson report was not located; this adit potentially could be located farther up the slope although INTERA could not access this area safely.

One large waste rock pile was found at the Eastern Area AUM Site (PilePly-1). The entire slope of the Eastern Area AUM Site contained scree which could be a result of mining activities. One waste rock pile was found at the Western Area AUM Site (PilePt-1). Waste rock from PilePt-1 spills down the northern side of the pile down to the dirt trail.

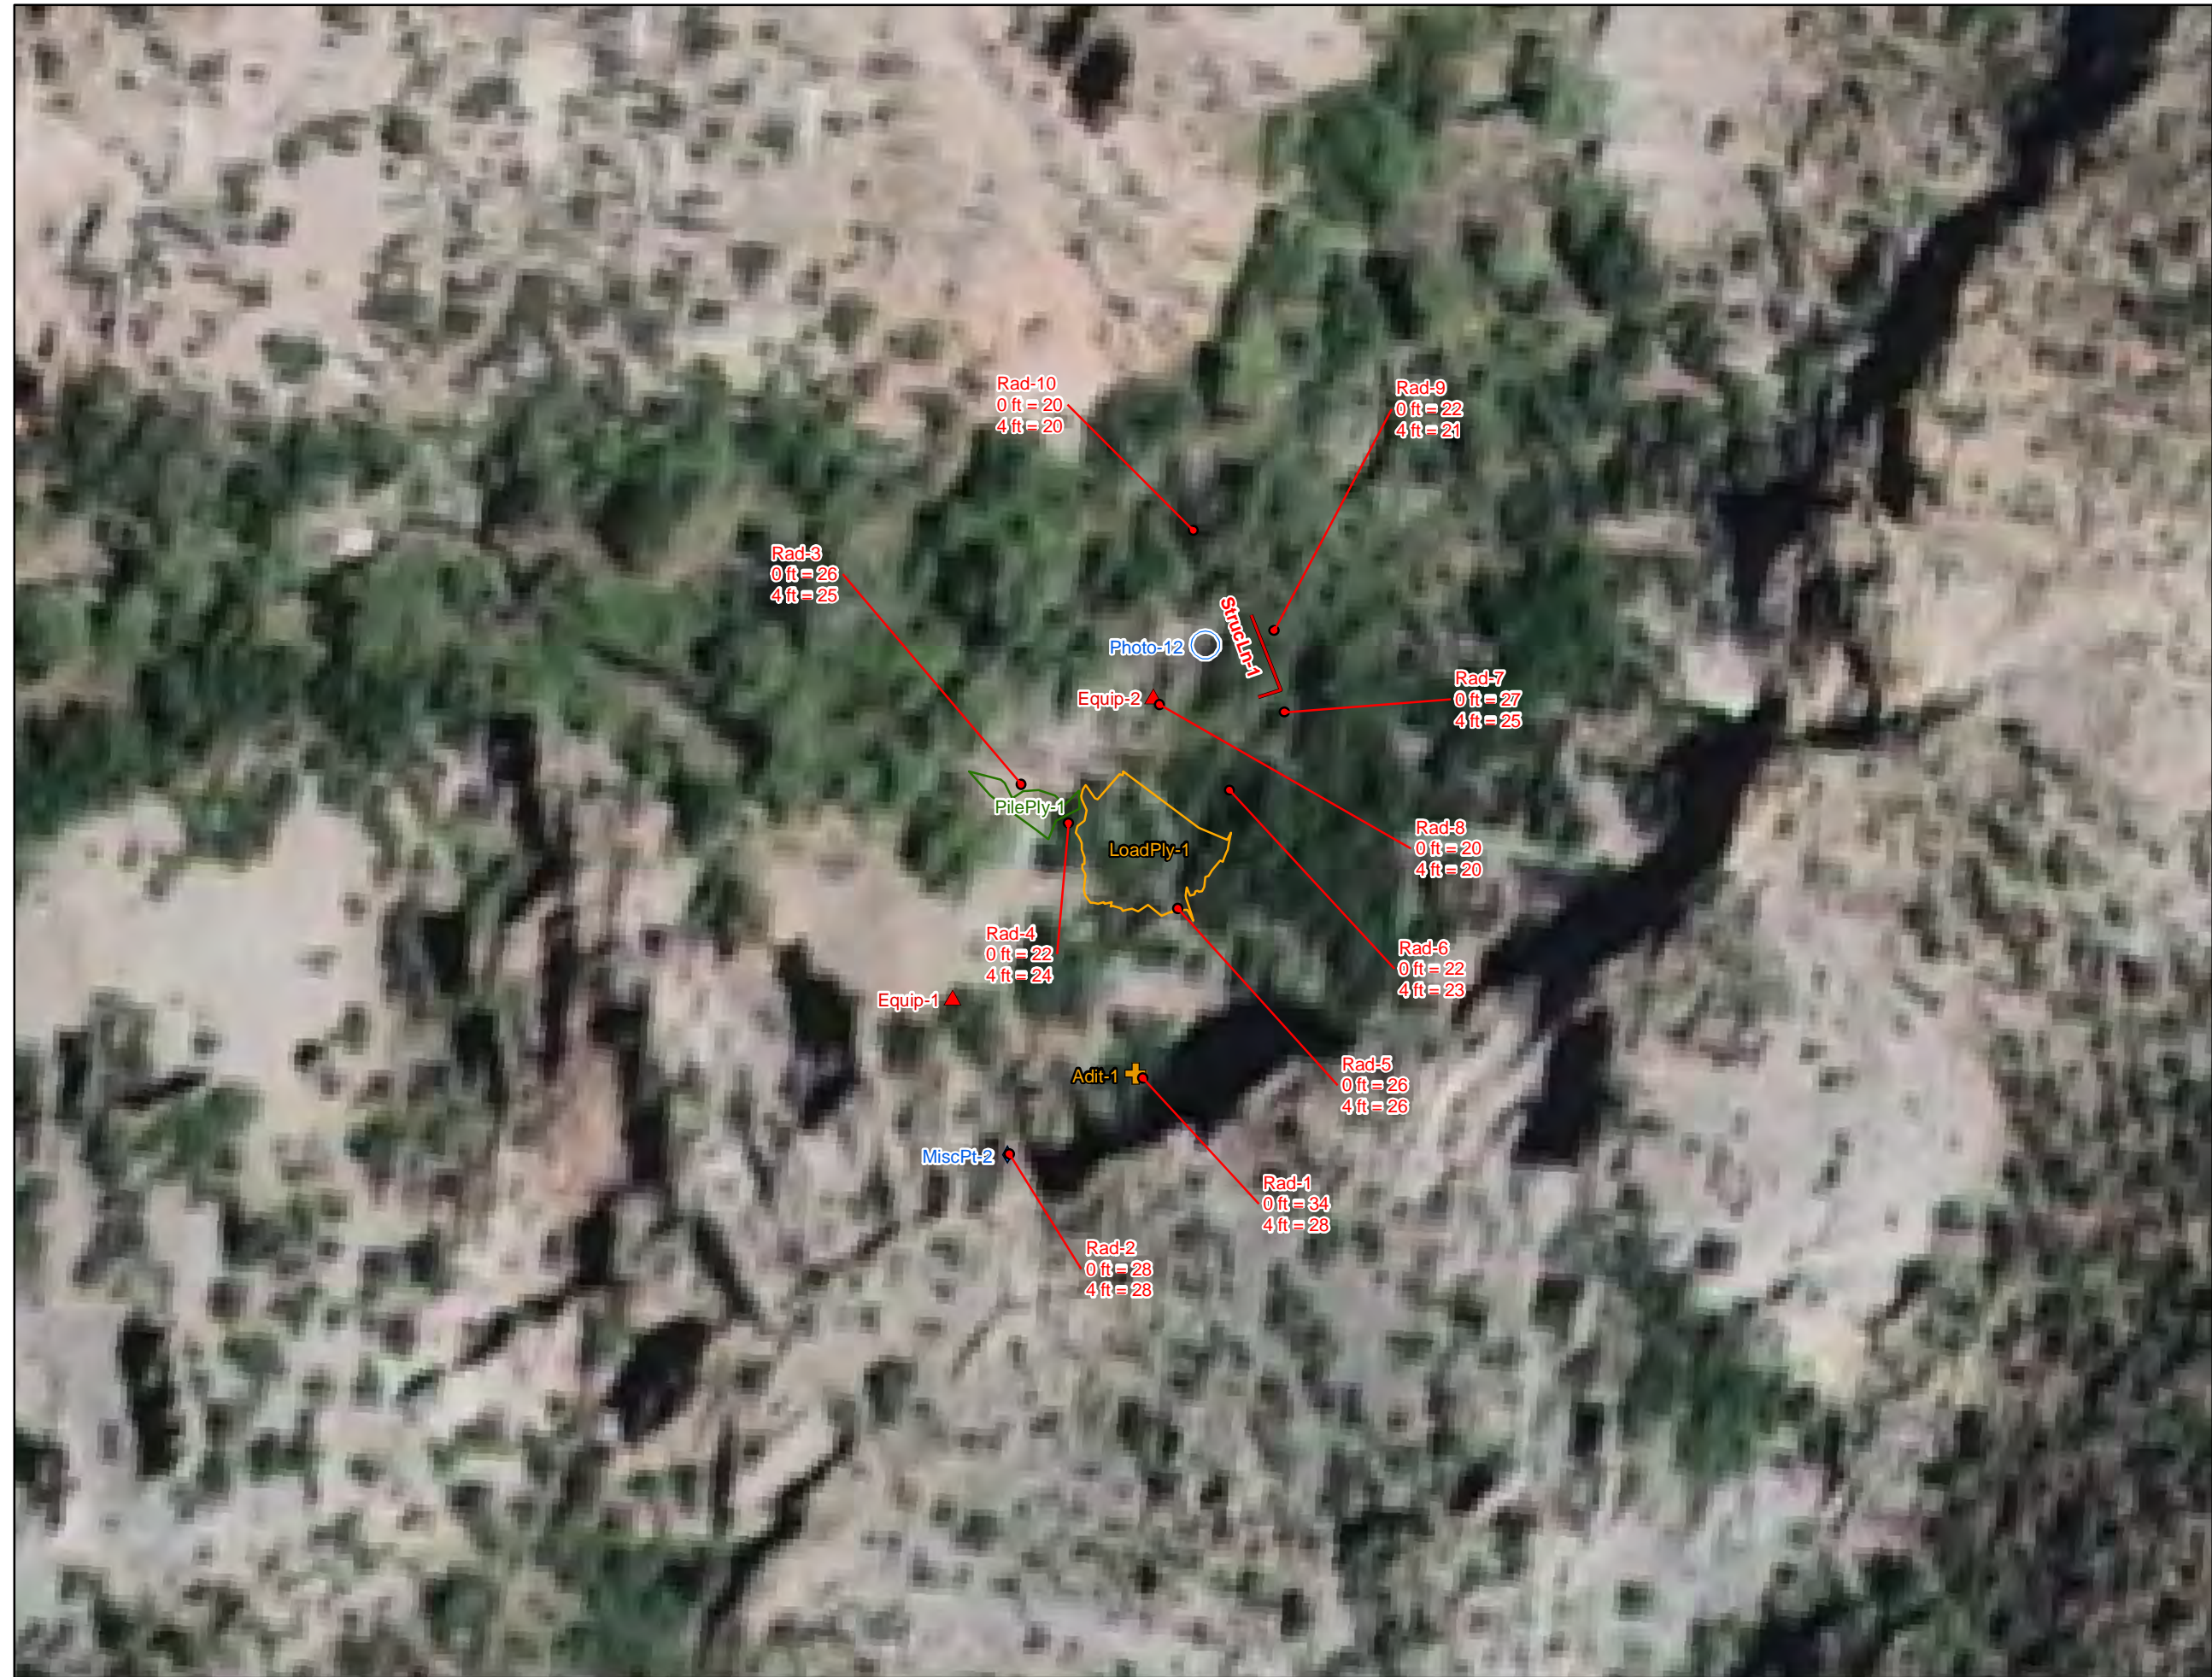
**Figure 5a**  
**Site Map on**  
**Aerial Photo**  
**Eastern Area**  
**NM0112-Baby**  
 Abandoned Uranium  
 Mine Assessment

A stone wall (StrucLn-1) was found at the Eastern Area AUM Site, a collapsed opening was located in the eastern portion of StrucLn-1. A load out (LoadPly-1) was found at the Eastern Area AUM Site. LoadPly-1 consisted of a stone wall and multiple metal pipes sticking out from the ground.

An eyebolt (Equip-1) was found in the rock face at the top of the scree slope in the Eastern Area AUM Site. Wooden beams and cables (MiscPt-2) were found on the scree slope in the Eastern Area AUM Site. A fabricated 55-gallon metal drum (Equip-2) was found in the Eastern Area AUM Site. Additional miscellaneous debris items were found throughout the Eastern Area AUM Site.

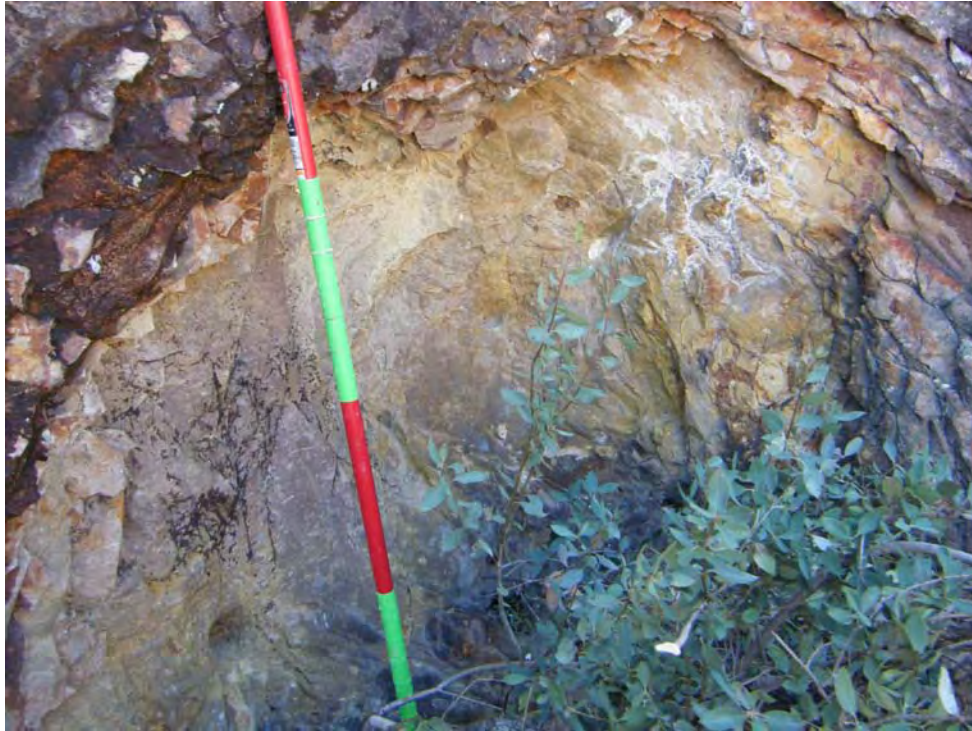
Photo 1-Looking south at Adit-1 located at the top of the scree slope in the Eastern Area.

1300 Adit 1 - beginning of an adit, 1' deep, 4' tall, 5' wide top of scree slope, blast holes

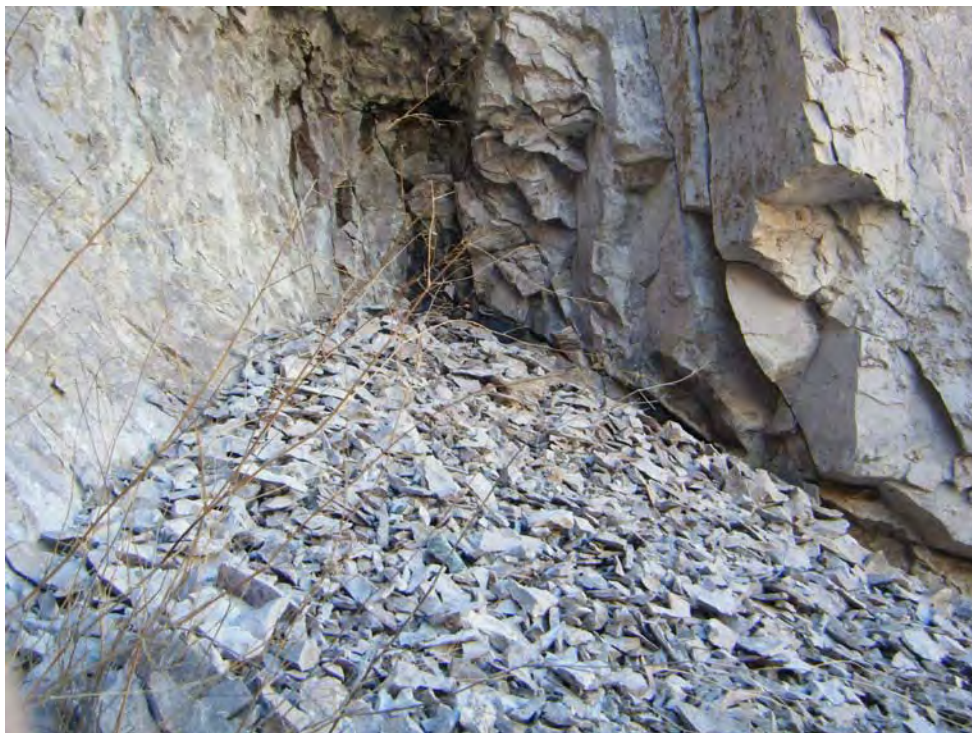
Photo 2-Looking west at the rock face (MiscPt-2) at the top of the scree slope in the Eastern Area.

Miscpt 2 - wood and cables along scree slope, may be location of adit (could be buried)

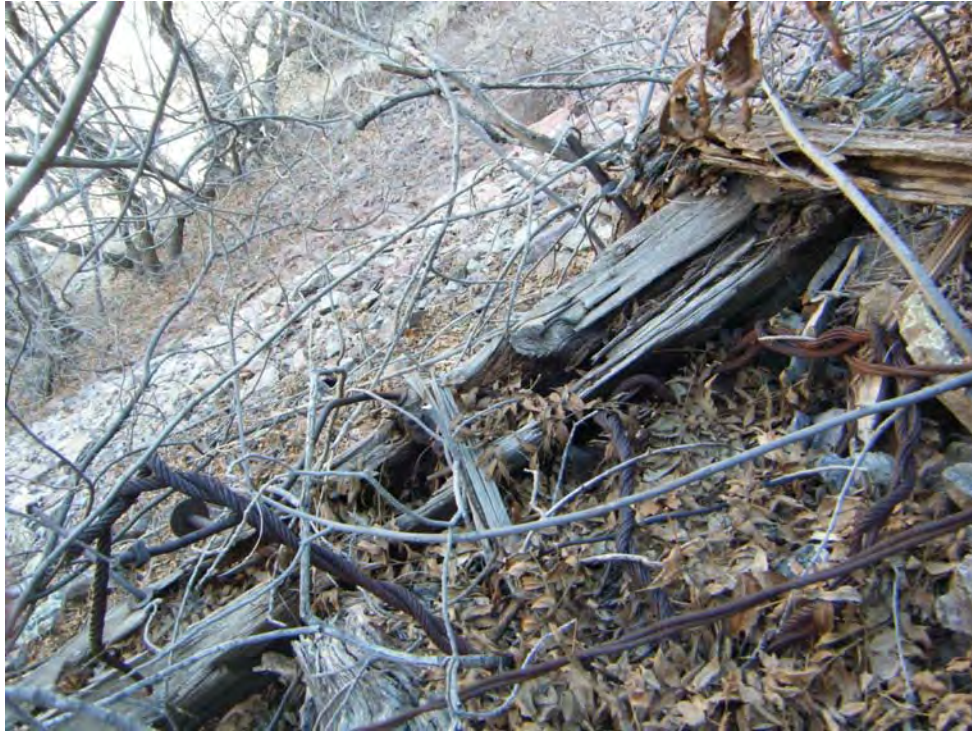
Photo 3-Looking north, down slope at wooden beams and cables in the Eastern Area.

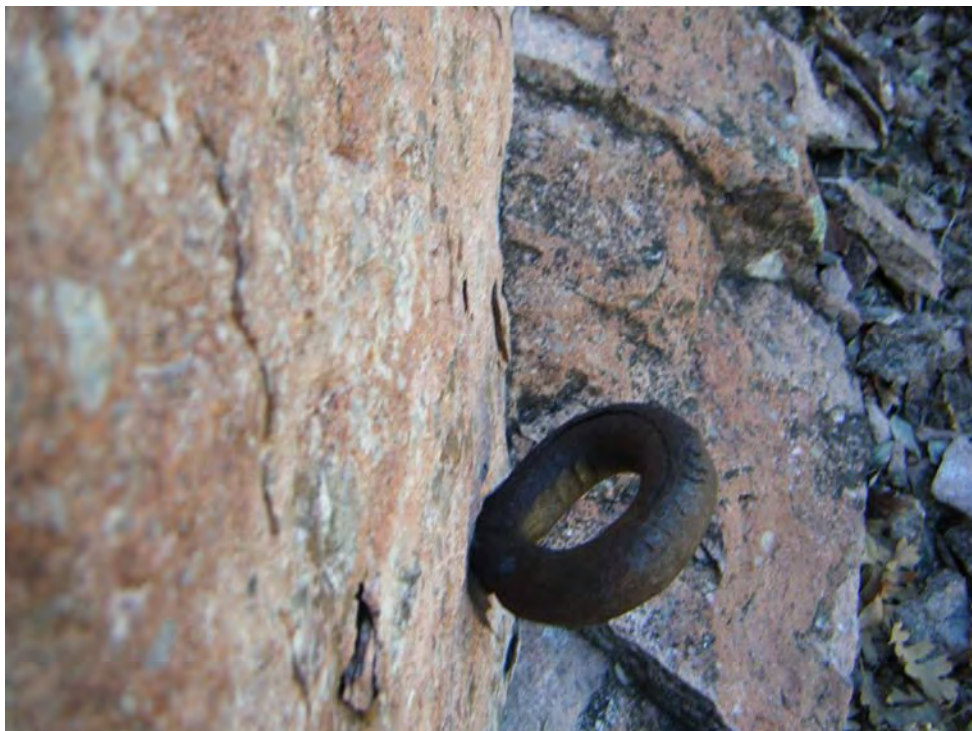
Photo 4-Looking west at an eyebolt (Equip-1) attached to the rock face in the Eastern Area.

Equip 1 - large eyebolt drilled in wall.

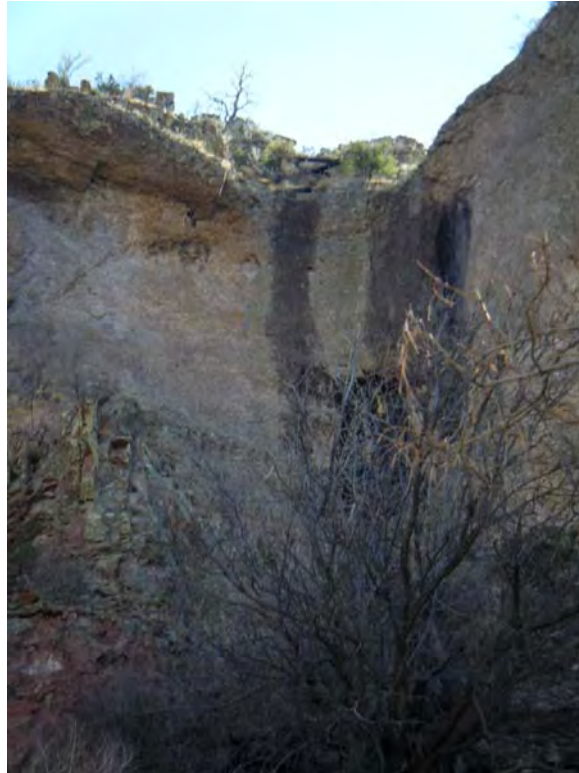
Photo 5-Looking north at wooden structure located at the top of the rock face above the Eastern Area.

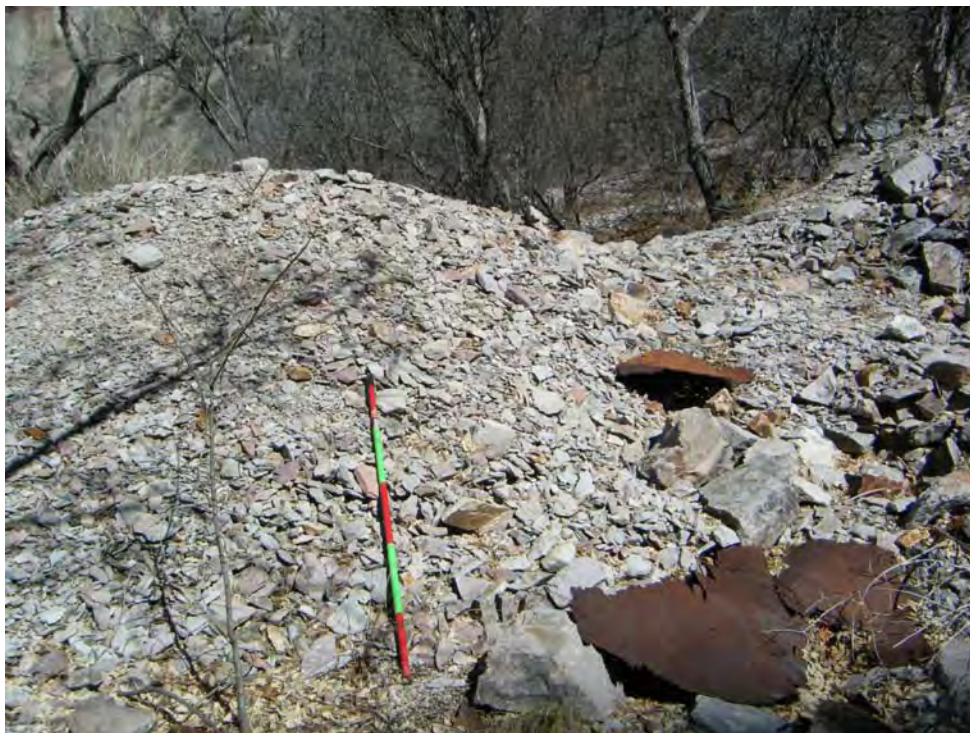
Photo 6-Looking northeast at a waste pile (PilePly-1) located in the Eastern Area.

Pileply 1 - 10' tall; 15' wide; 40' long; pieces of scrap metal

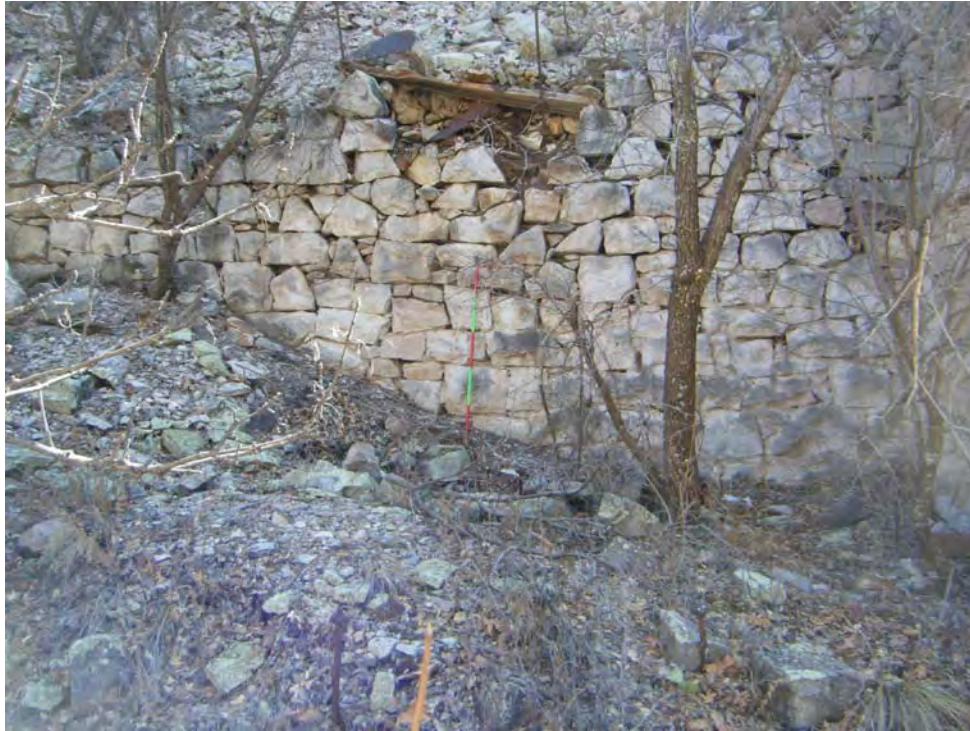
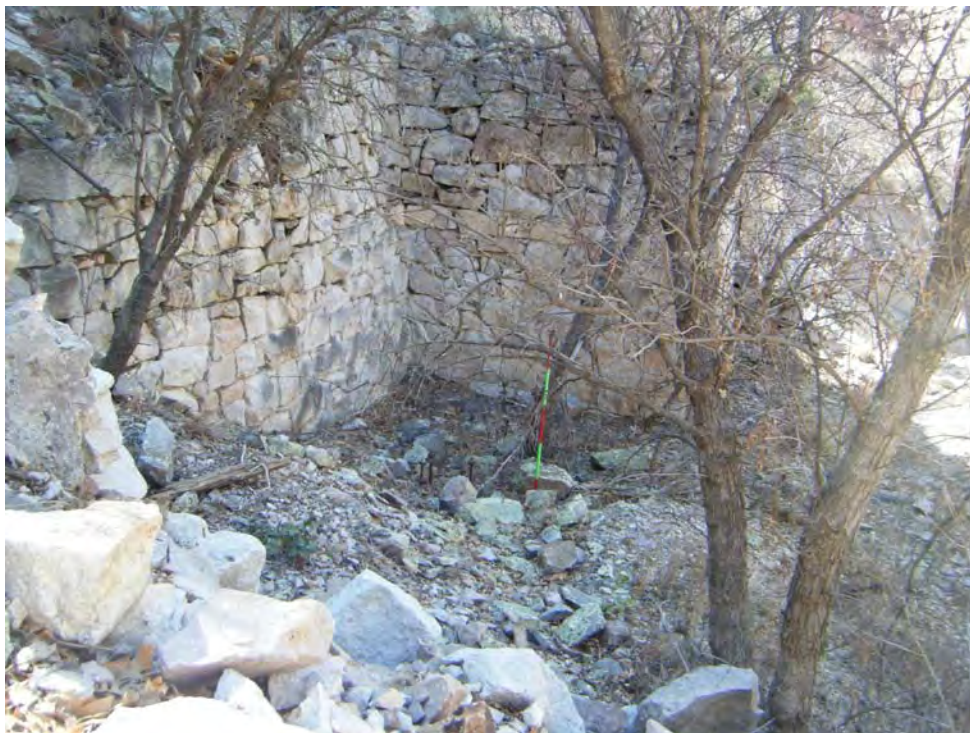
Photo 7-Looking south at LoadPly-1 located in the Eastern Area.

Photo 8-Looking west at LoadPly-1 located in the Eastern Area.

Loadout Ply 1 - load out structure; 15' high, 50' wide, 25' long

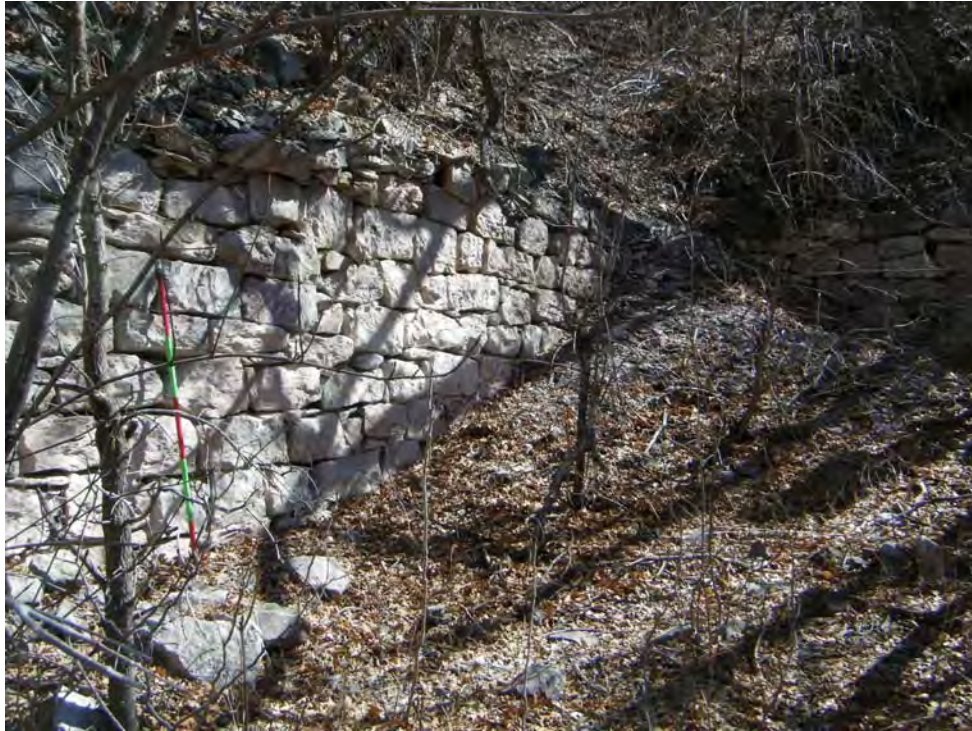
Photo 9-Looking east at StrucLn-1 located in the Eastern Area.

Wall 1 - 10' high; 35' long; 2' wide - satellite reception poor

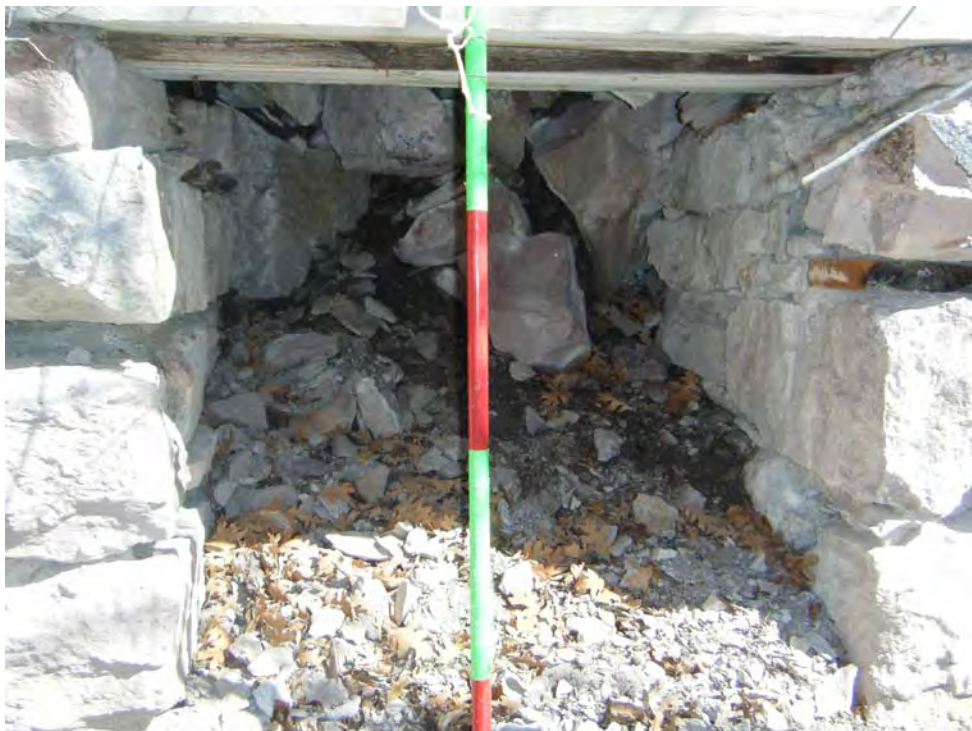
Photo 10-Looking at a collapsed hole in StrucLn-1 in the Eastern Area.

Photo 10 - hole in wall, collapsed; 3' wide, 3' deep,  
4-6' tall

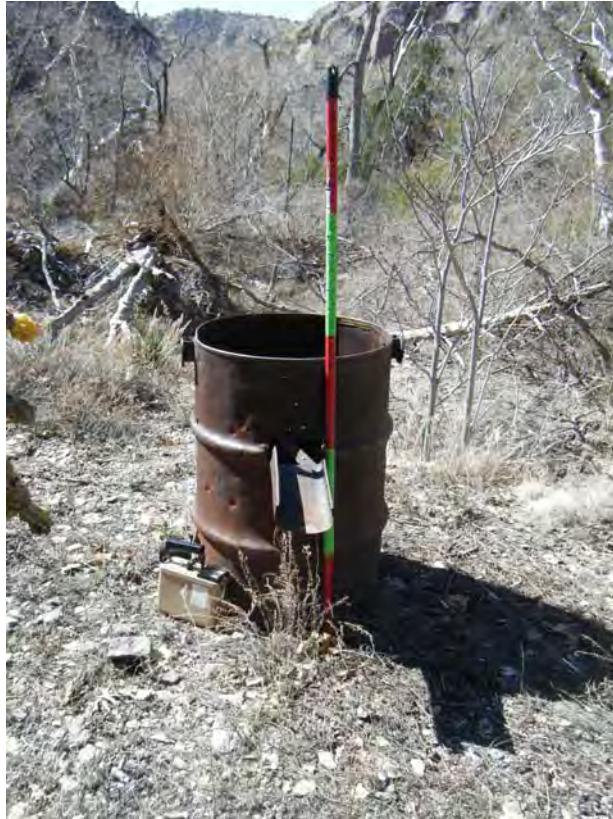
Photo 11-Looking at an altered 55-gallon metal drum (Equip-2) located in the Eastern Area.

Equip 2 - 55 gallon metal drum with spout

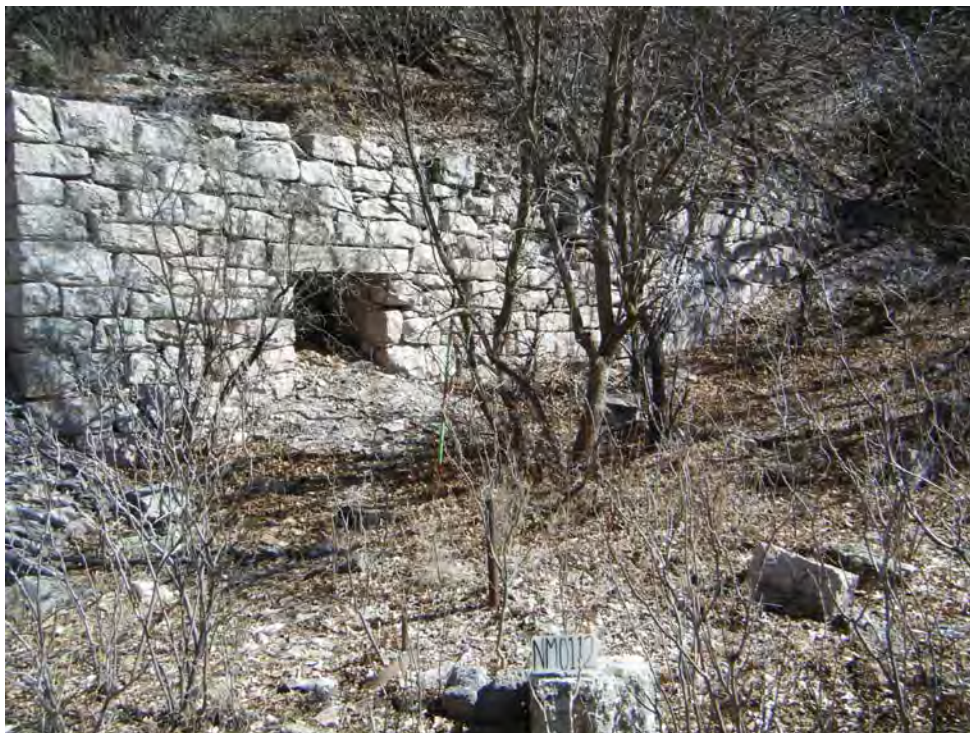
Photo 12-Looking southeast at StrucLn-1 with the Site name in the Eastern Area.
