# Abandoned Uranium Mine Site Assessment for the Baby Site (NM0112)

**FINAL REPORT**

NM0112

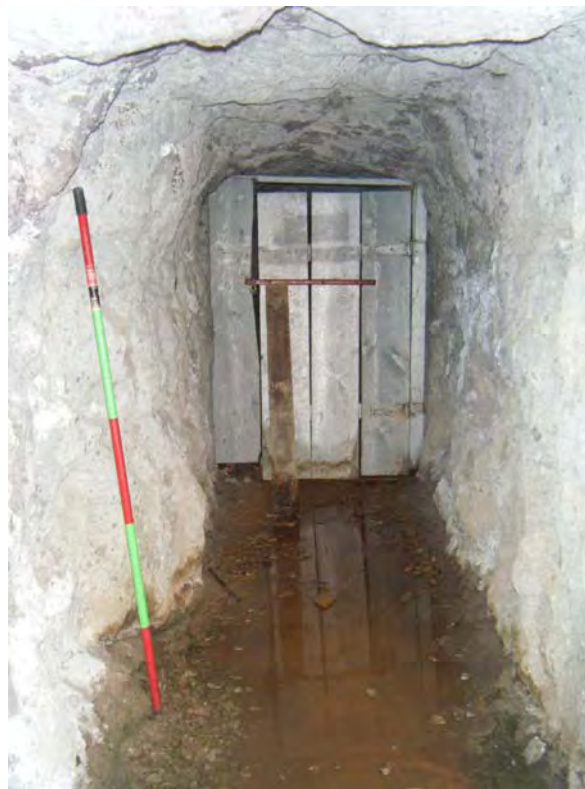
Photo 23-Looking south at Adit-2 in the Western Area. Photo is similar to photo in Anderson Report.

1515 - Found site described in Anderson Report.  
Adit has door on it about 15 feet. Adit-2  
is about 6' tall, 5' wide. Anderson  
describes it as extending another 25-35'  
and then turning to the left and extending  
another 75'. Adit on south wall of canyon  
and trending south.

Rad 11 - Adit 2 entrance; 0m - 45  $\mu$ R/h; 1m - 38  $\mu$ R/h

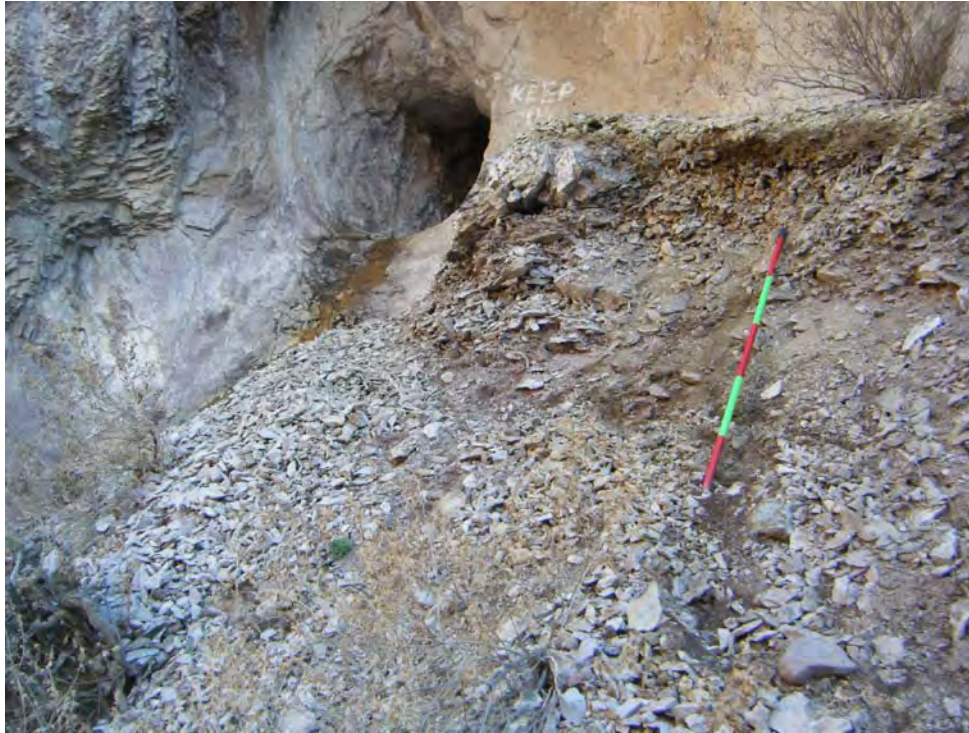
Photo 24-Looking southeast at the waste pile (PilePt-1) adjacent to the entrance of Adit-2 in the Western Area.

Pile Pt-1 - west of Adit. 7' wide, 1' tall; 20' long

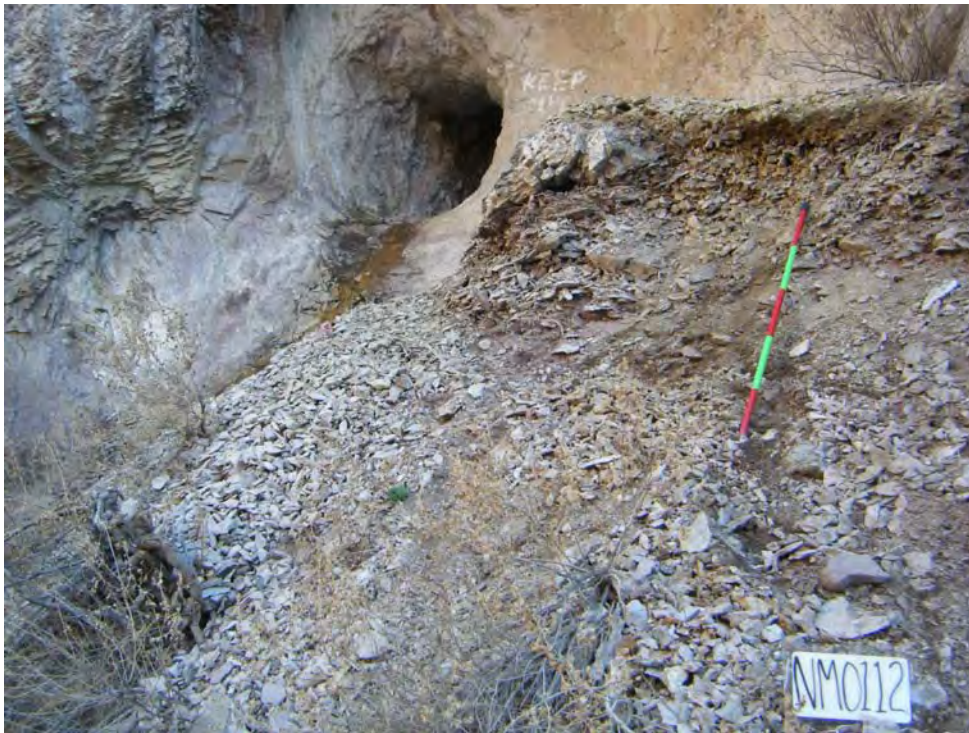
Photo 25-Looking southeast at PilePt-1 and Adit-2 with the Site name in the Western Area.

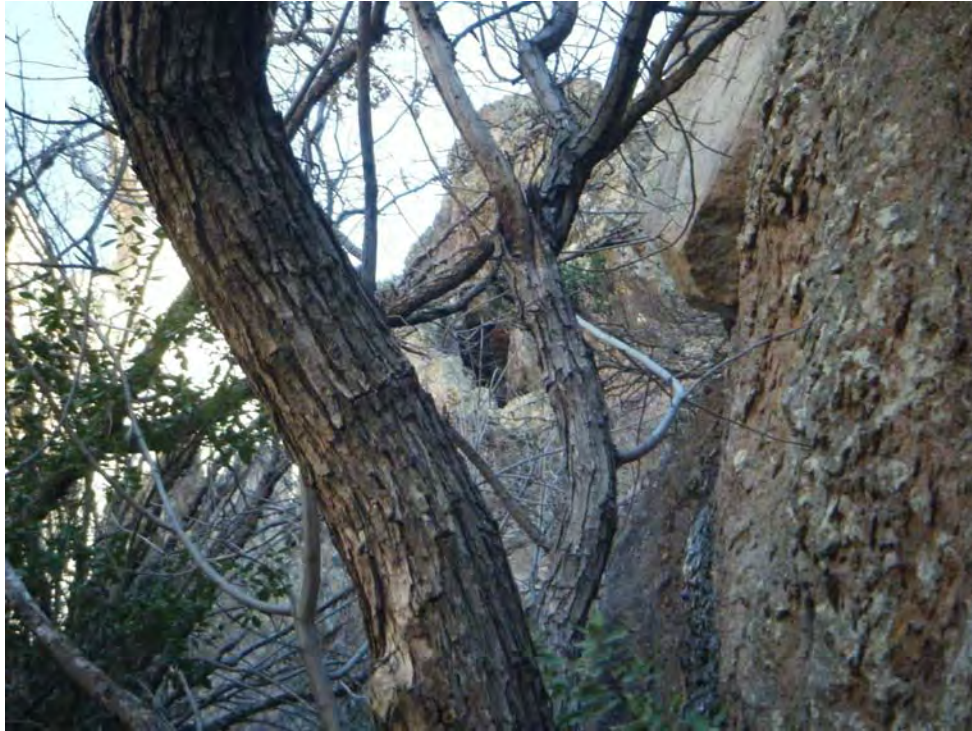
Photo 26-Looking southeast, up towards the potential adit referenced in the Anderson Report in the Western Area.

The second adit can be seen up a steep slope.

We tried to access it but the slope gets too  
steep to be safe.

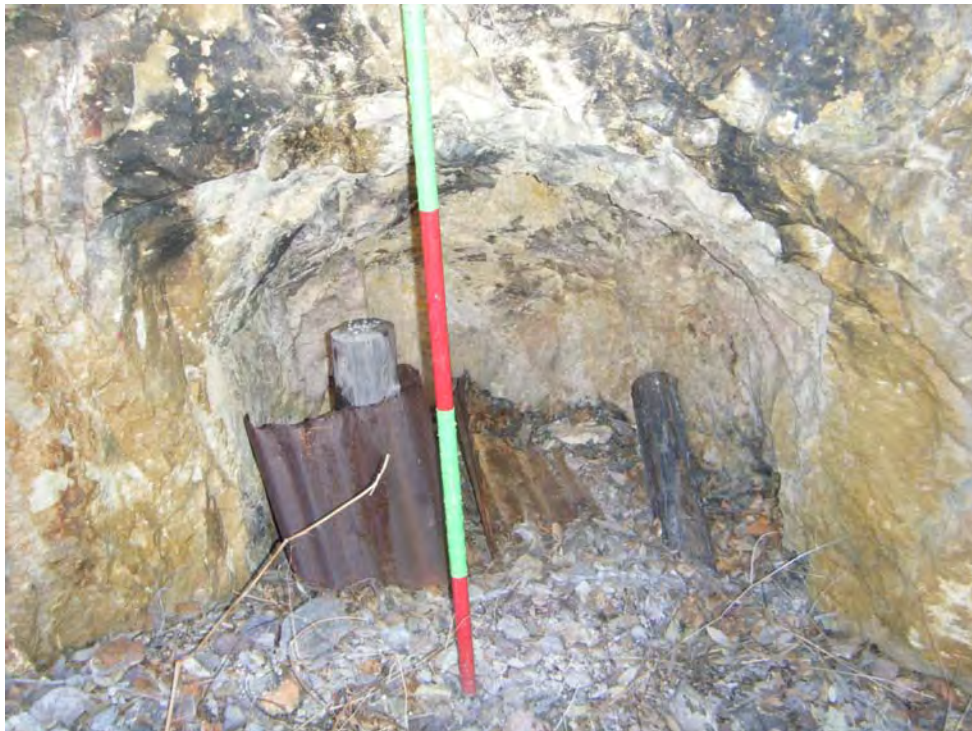
Photo 27-Looking south at Adit-3 in the Western Area.

Adit 3 - 3' tall, 4' wide, 4' deep; 2 pieces of timber  
and scrap metal in the Adit

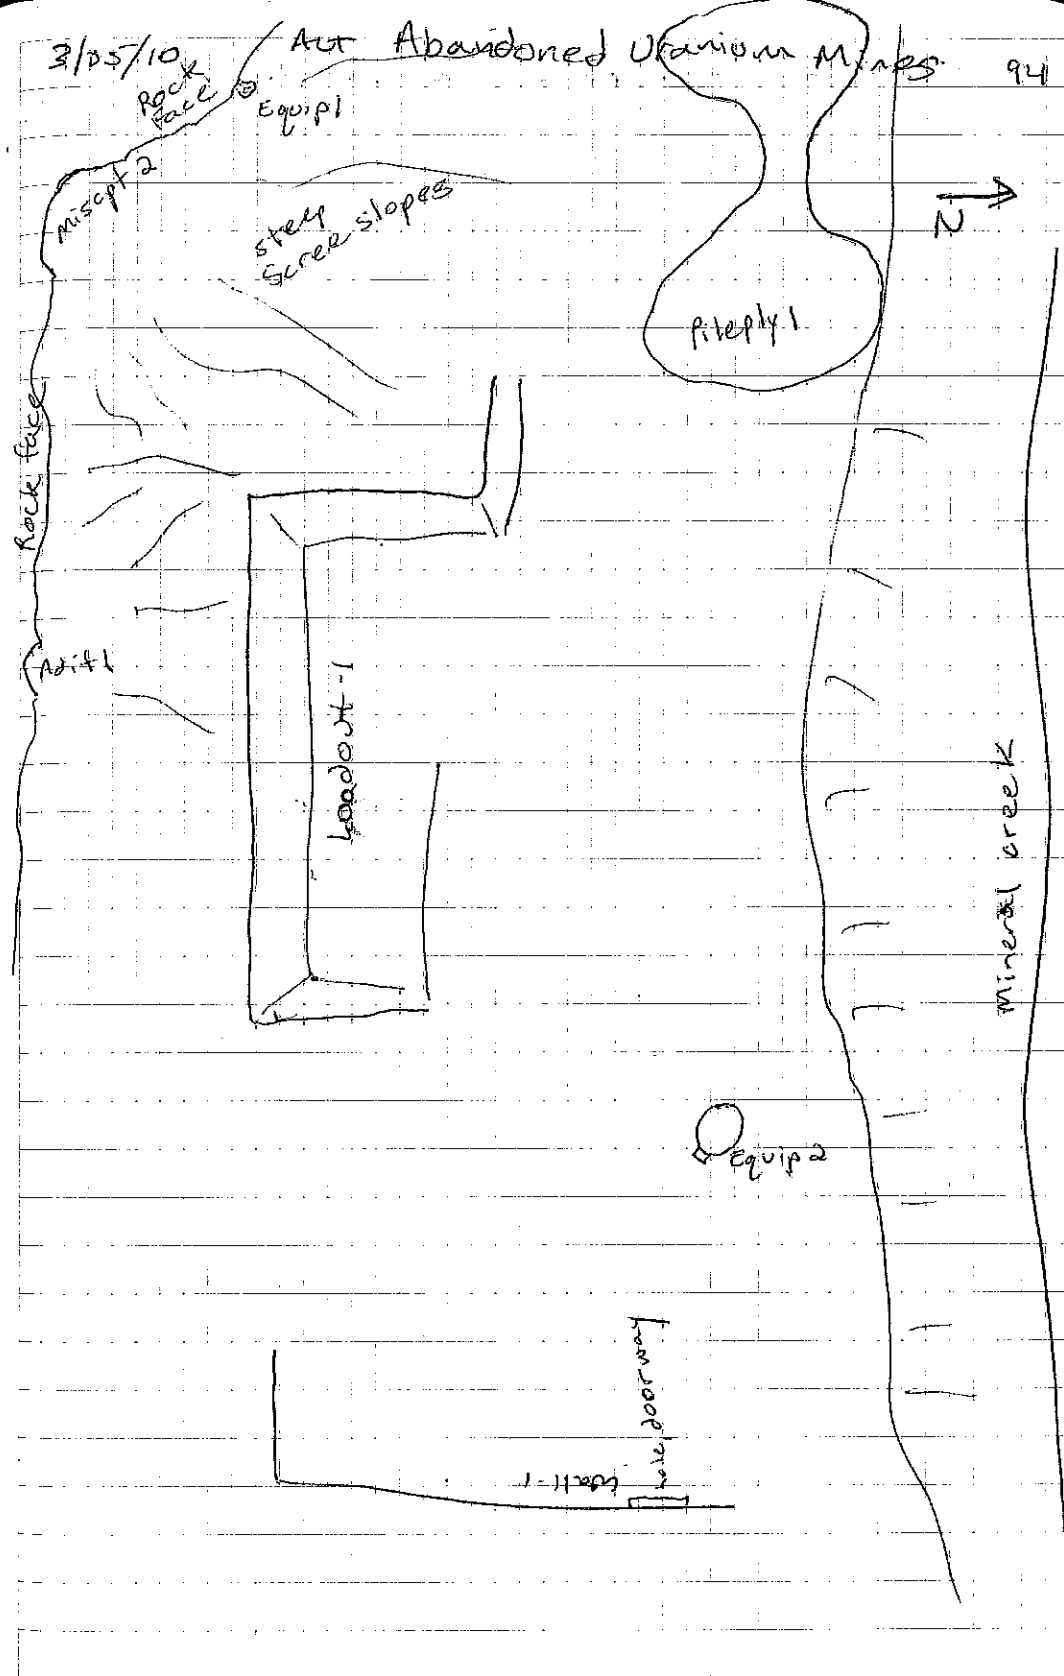
3/05/10 - At Abandoned Uranium Mines
