ABANDONED OR INACTIVE URANIUM
MINES IN NEW MEXICO

A report of investigation carried out
between August 1979 and May 1980 under
contract with the New Mexico Energy and
Minerals Department.

New Mexico Bureau of Mines and
Mineral Resources
Open-File Report 148

Mine name(s) Jeter (or Charley #2) County Socorro

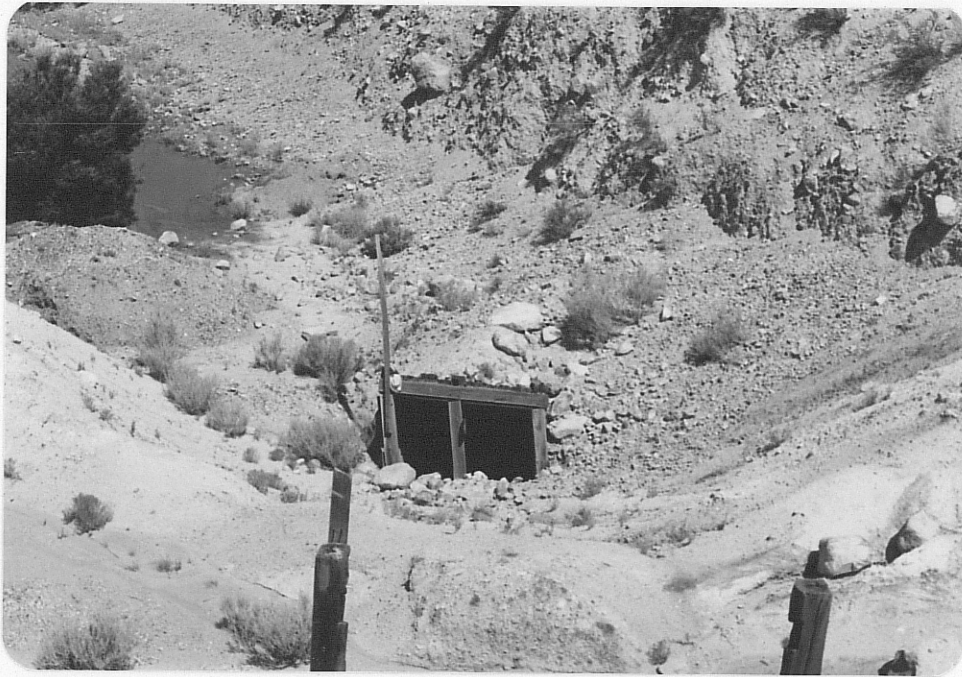
The mine consists of a decline and one open pit; (see photos a & b). The 12^o-15^o decline is oriented approximately N 80^o E, is well timbered, but caved in at 25' feet from portal. Portal dimensions are 6' high, 10' wide; a row of timbers leads down the center of the decline. Back is stable for the 25 foot distance to the cave in; although the timbers lean to the left danger appears minimal at this point.

Photo (a) Jeter Decline, looking east from hoist foundation area; note hat for scale.

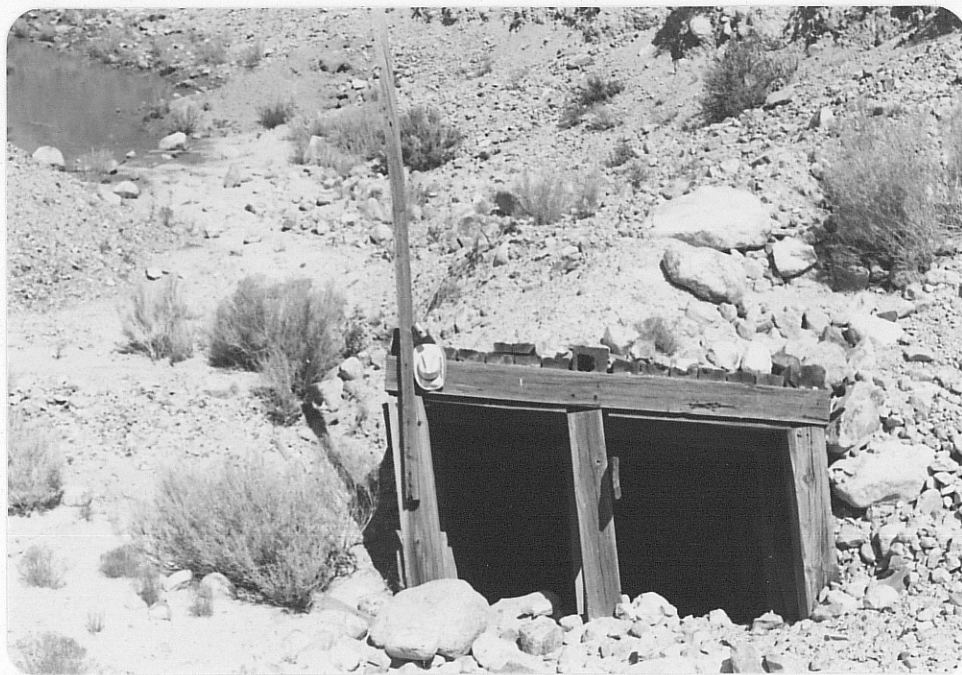
Photo (b) Close-up of Jeter Decline.

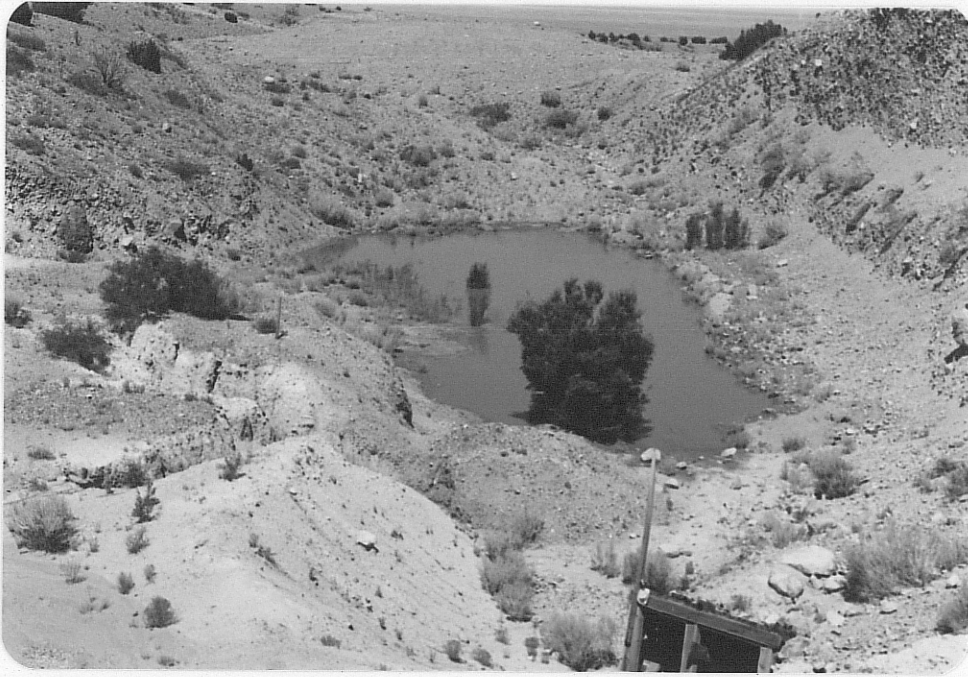
The open pit is about 125 feet to the north of the portal. It is approximately 150 x 300 feet, elongate N-S, and contained a shallow pond nearly 100 feet long at the time of the visit. Local rancher who grazes the section did not complain of stock hazards or the water quality.

Photo C - Jeter open cut, looking north.

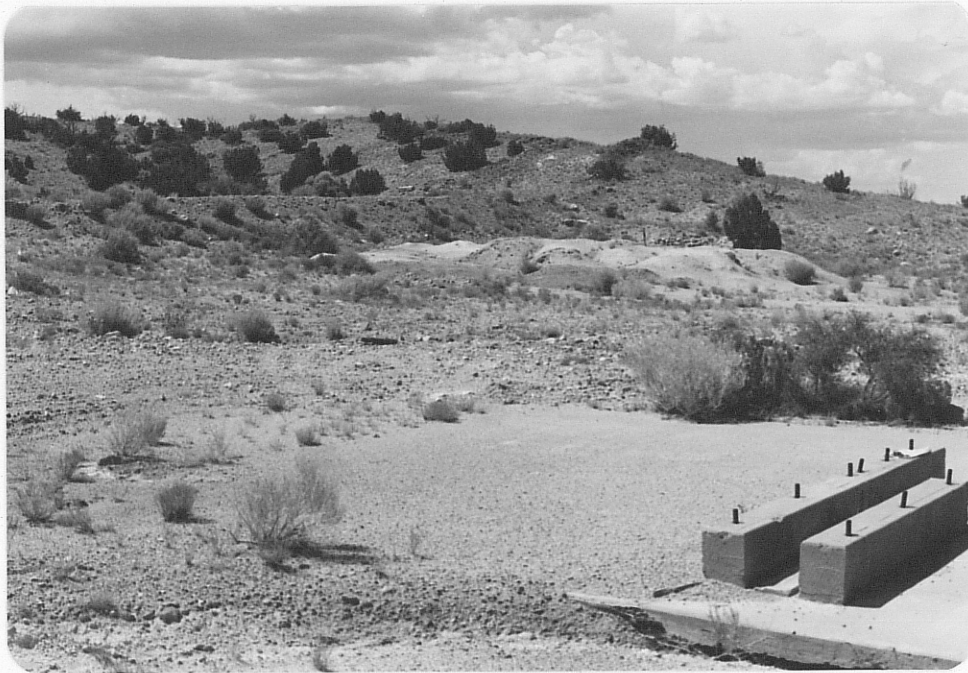
Directly out from the decline is a 25 x 25 foot concrete slab upon which rested the hoist and draw works; 1 $\frac{1}{2}$ in. diam. bolts remain anchored in the foundations, see photos. The mine dump is to the immediate NW of the concrete slab and shown in the same photo; it is about 4' high and up to 100' feet in maximum dimension. No scintillometer readings are available.

Photo D - Jeter hoist foundation and mine dump looking NW.
