Abandoned Uranium Mine Field Survey Project

prepared for
New Mexico Energy, Minerals and Natural Resources Department
Mining and Minerals Division

July 18, 2008

Glover Mine

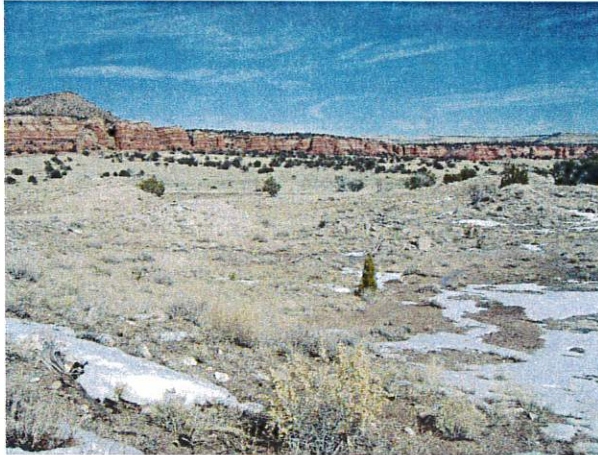
- 4. Mine Disturbance:** The mine consists of three shallow pits (dimensions 180ft by 70 ft., 100 ft. by 30 ft., and 80 by 40 ft., each a maximum of 6 ft. deep) and about 15 rock piles with an estimated total volume of 250 cubic-yards.

Shallow pit

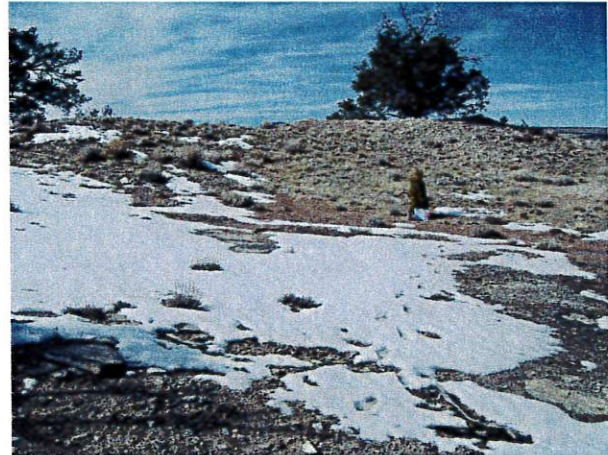
Shallow pit

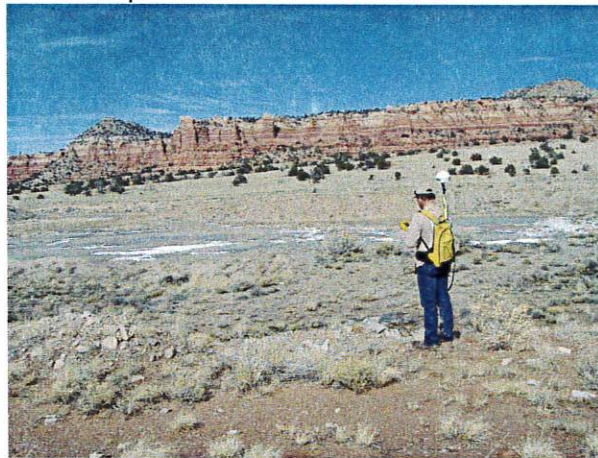
Shallow pit

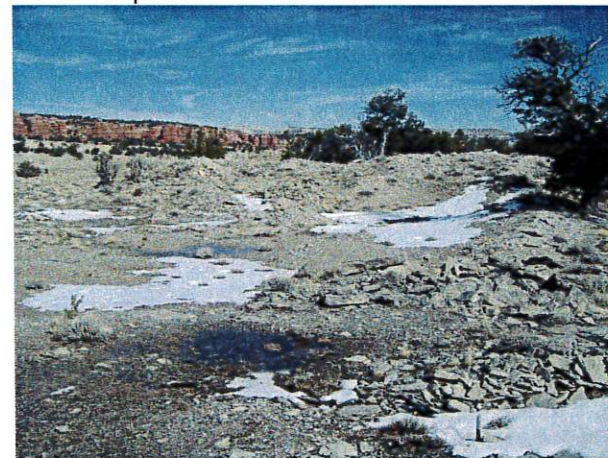
Shallow pit

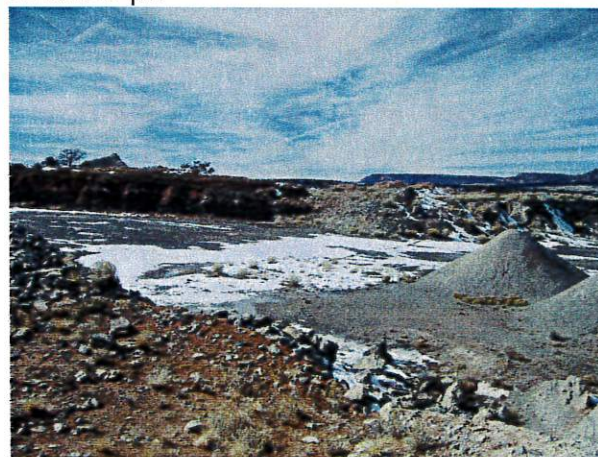
- 2. Human Activity:** An abandoned limestone quarry is located adjacent to the site to the north. Additionally, approximately 12 residences are located approximately 1,500 feet south of the site.

Limestone quarry to north

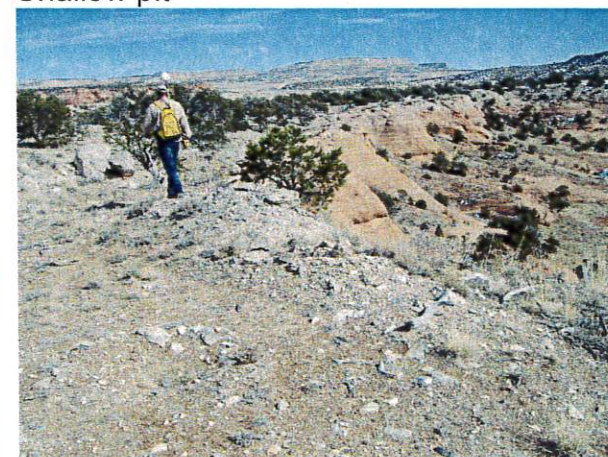
- 9. Off-Site Impacts:** No off-site impacts were noted.
- 10. Topographic Features:** The site is flat lying, with a cliff face adjacent to the south. No notable erosional features are present.

Cliff to south of site
