NEW MEXICO
ENVIRONMENT DEPARTMENT

Subject: Pre-CERCLIS Screening Assessment of Faith Mine, McKinley
County, New Mexico: Further action under CERCLA
recommended

Site name	Faith Mine				
City	not applicable	State	New Mexico	Zip code	not applicable
County	McKinley				
Latitude	35° 19' 41.30"	Longitude	107° 48' 50.46"

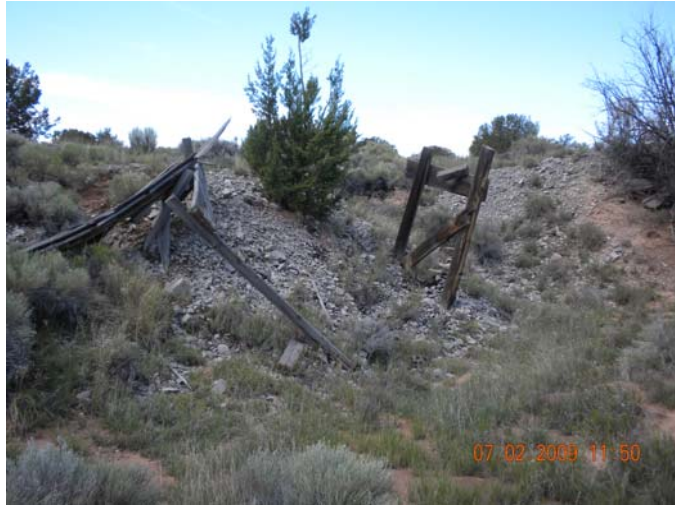
P1: Faith Mine Possible load-out structure remains along arroyo

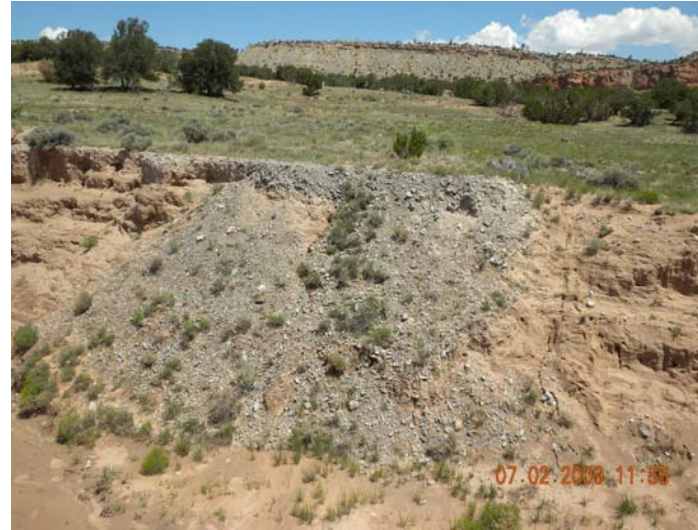
Site summary: Observations made during NMED's Site reconnaissance are shown on the accompanying figures. The waste piles examined had elevated radioactivity (highest

reading=578 counts per second (cps); background=15 cps). Contamination might be dispersed by precipitative erosion and wind, and may enter the bedrock ground water system through alluvial interconnections.

P2: Faith Mine view to northeast; waste cut by arroyo

1. Remove waste with elevated radioactivity.
