Abandoned Uranium Mine Site Assessment for the Charlotte Site (NM0143)

FINAL REPORT

NM0143

May 28, 2010

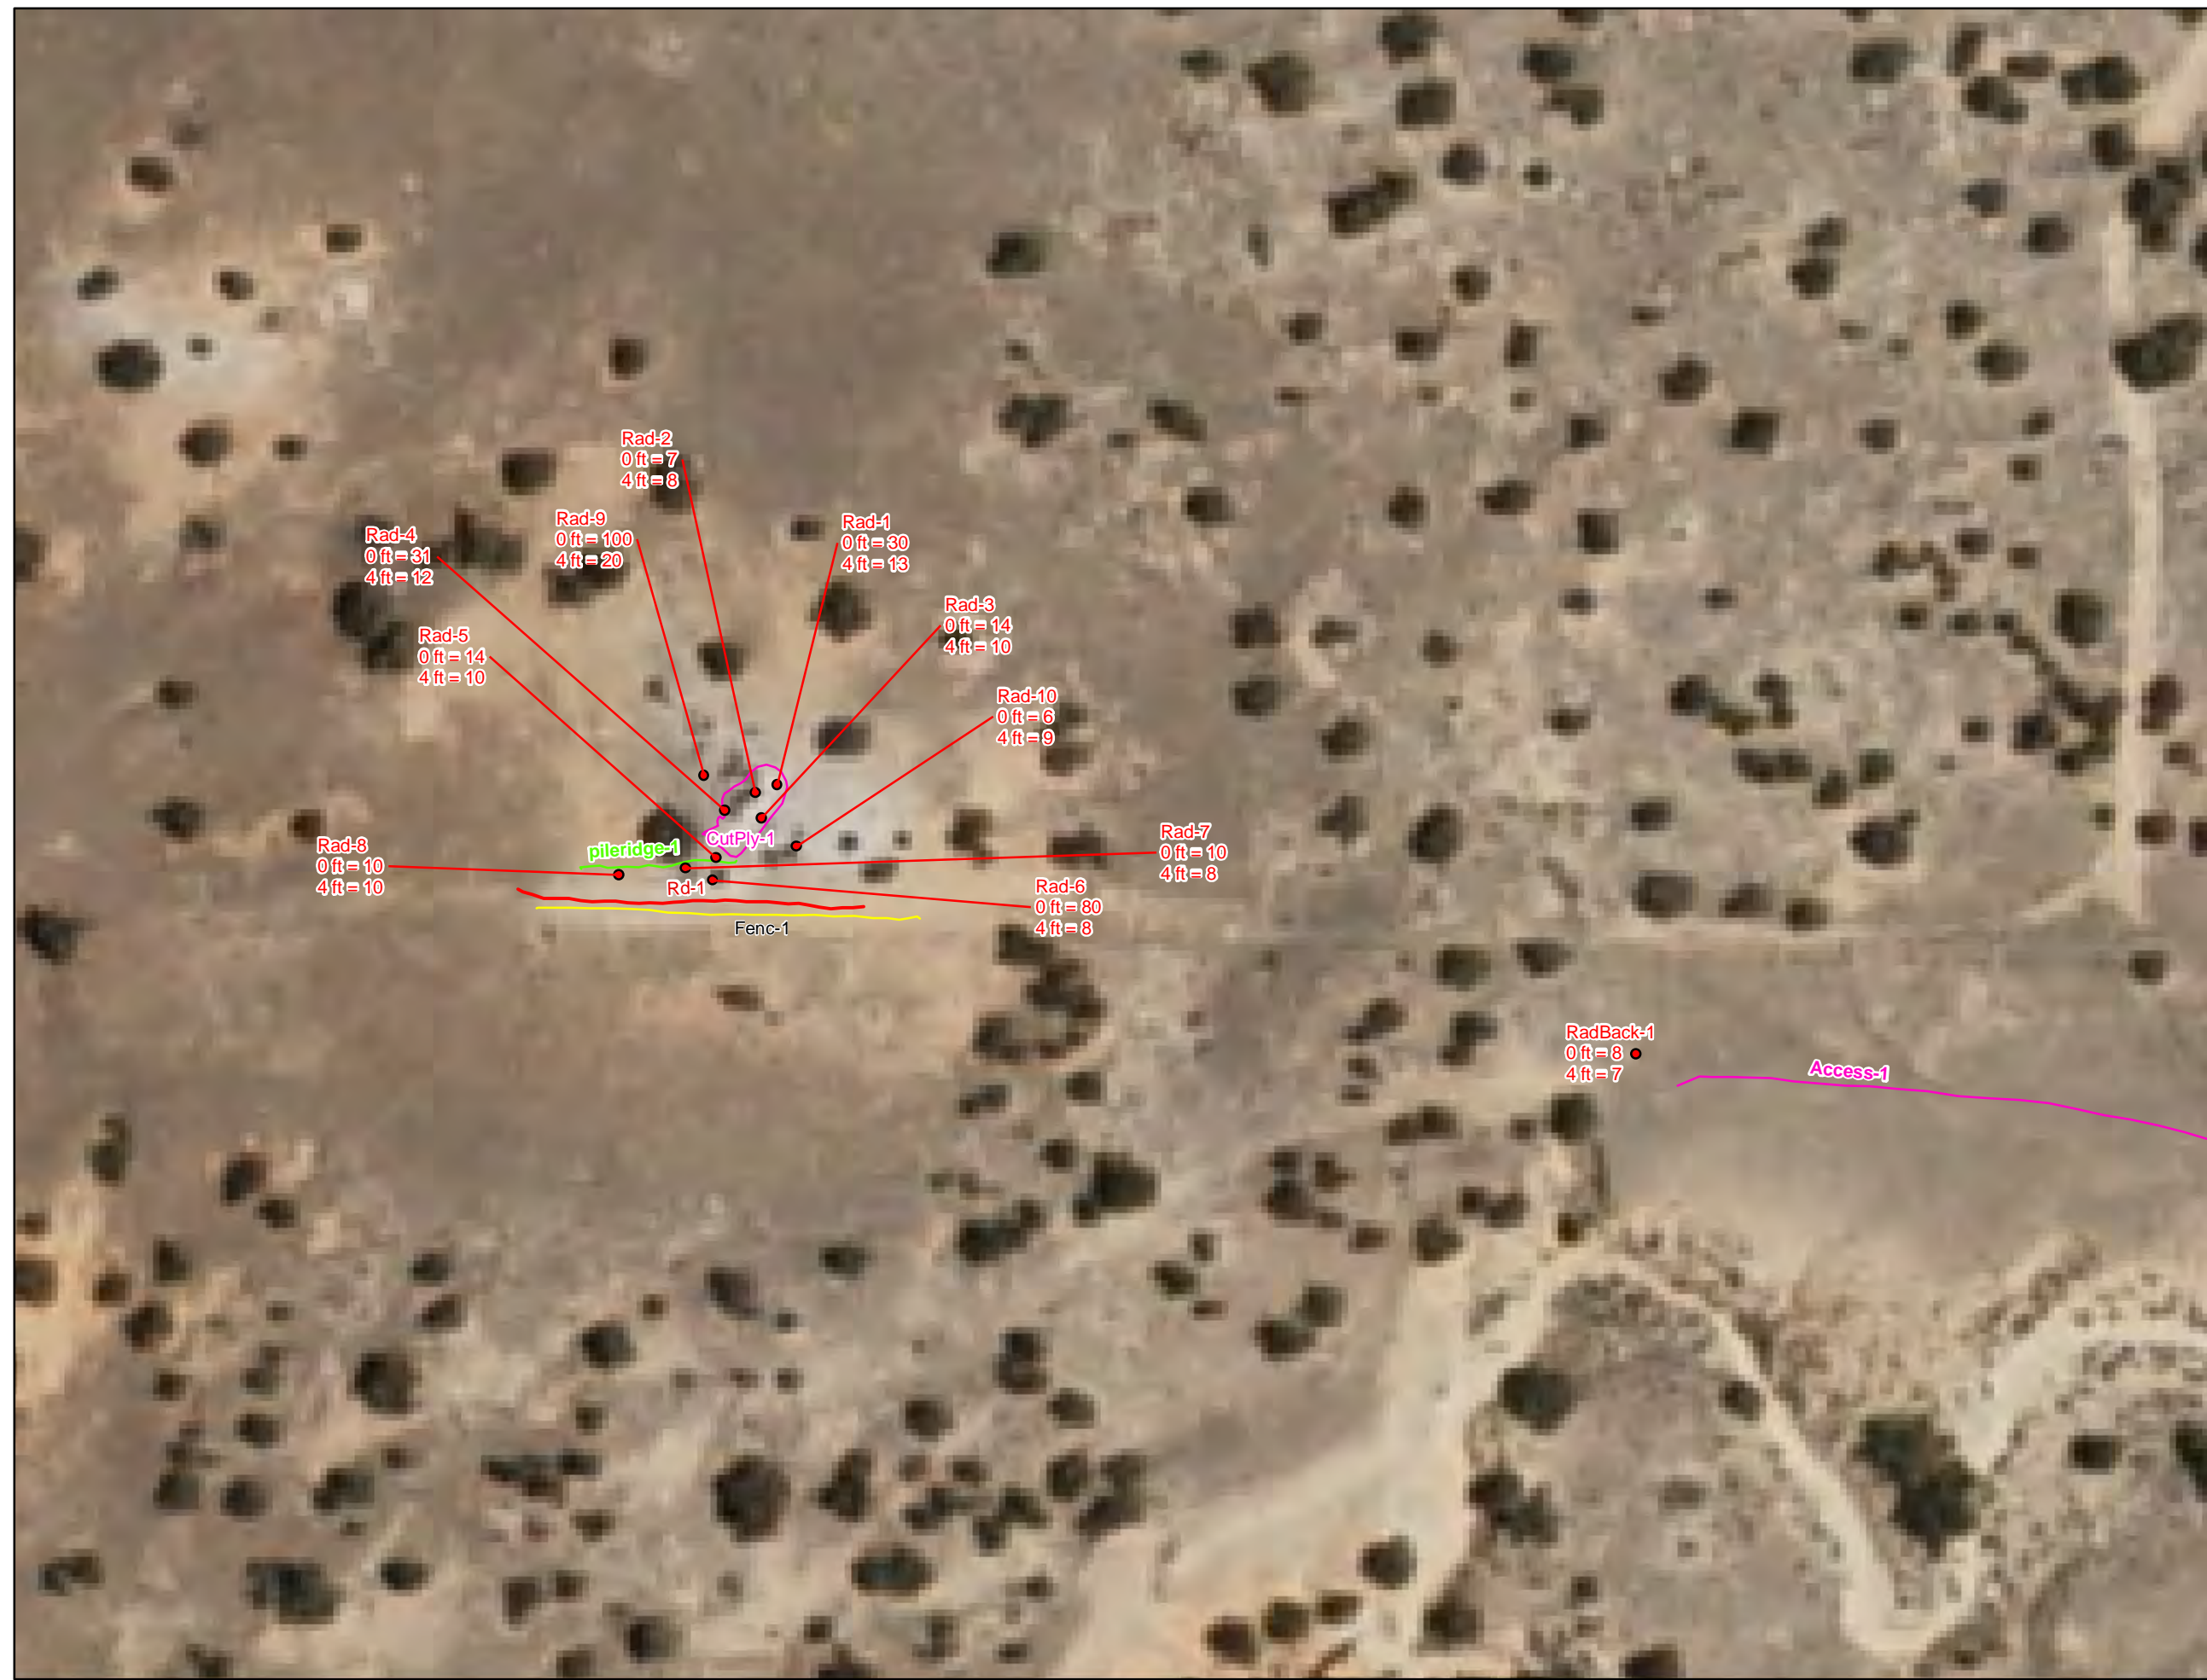
Figure 4a
Site Map on
Aerial Photo
NM0143-Charlotte
 Abandoned Uranium
 Mine Assessment

and Figures 4a and 4b for the locations of the AUM Site features. Note that the scale differs between Figure 4a (aerial photo) and 4b (ownership map).

radiation readings taken at the AUM Site and Figures 4a and 4b for the locations of the radiation readings.

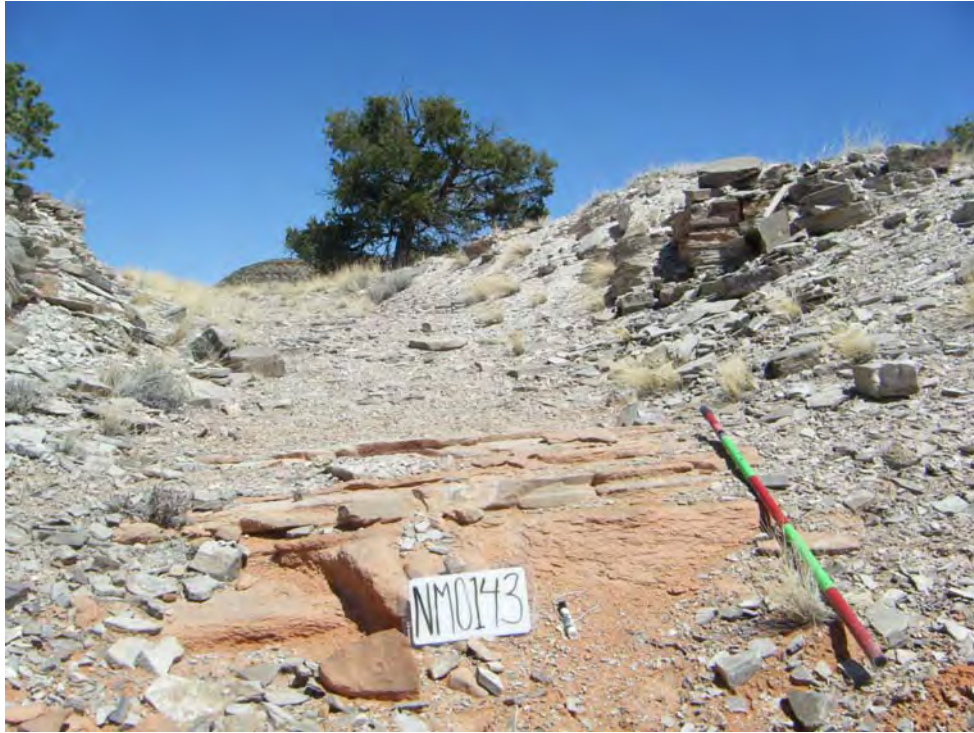
One open cut was found at the AUM Site (CutPly-1). This open cut is located at the top of an isolated hill capped by rocks of the Todilto Formation. The cut exposes both the Todilto Formation and the underlying Entrada Formation. The maximum gamma ray reading in this cut was 31 $\mu\text{R/hr}$ at 0 ft. This open cut appears in photo (a) in Anderson (1980).

Photo 1-Looking north at CutPly-1. This view is similar to photo (a) in Anderson (1980).

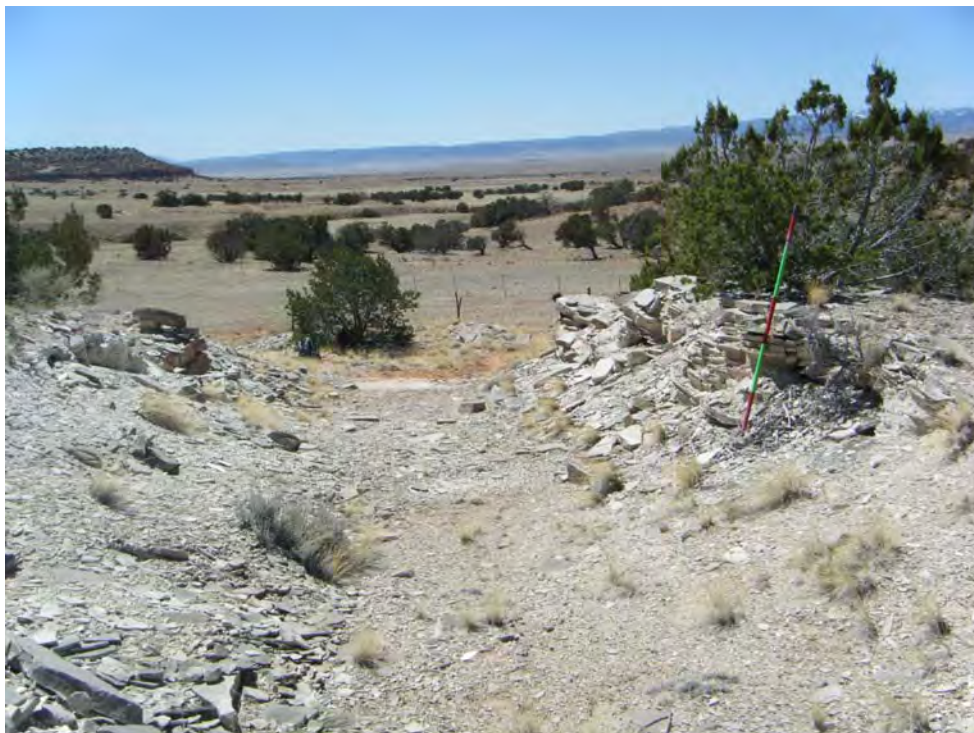
Photo 2-Looking south at CutPly-1.

CutPly-1 - 20' wide, 35' long, 5' deep; cut into Todi to
limestone cap on top of hill.

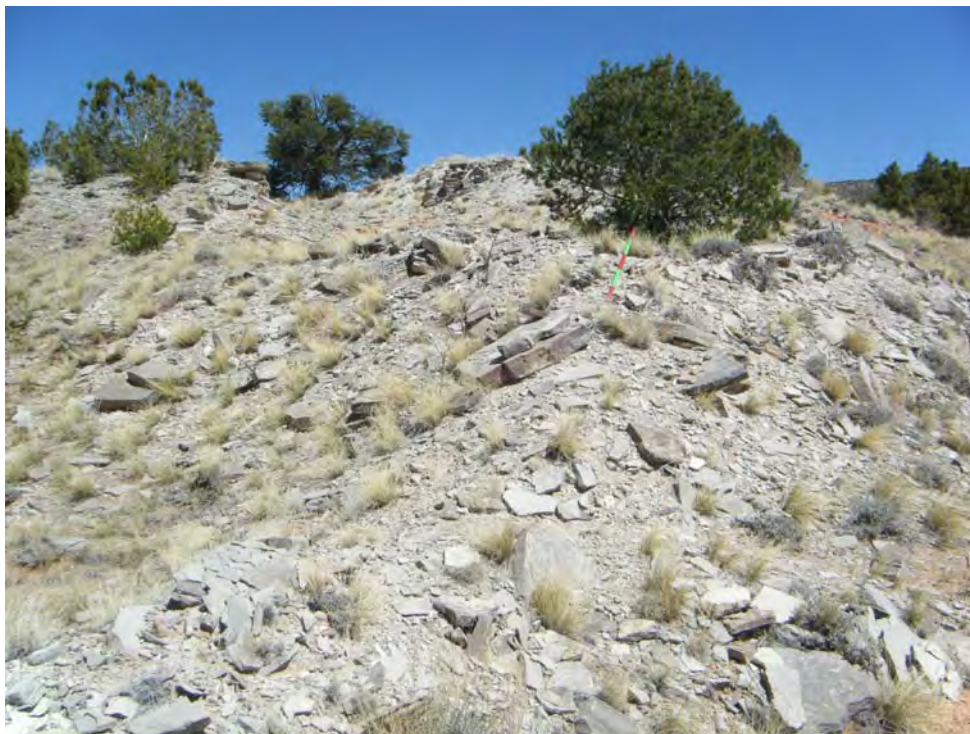
One pile (PileRidge-1) is located on the AUM Site. This pile parallels the mine road (Rd-1) to the south of CutPly-1. The maximum gamma ray reading on this pile was 80 $\mu\text{R/hr}$ at 0 ft above ground level.

Photo 3-Looking northeast at PileRidge-1.

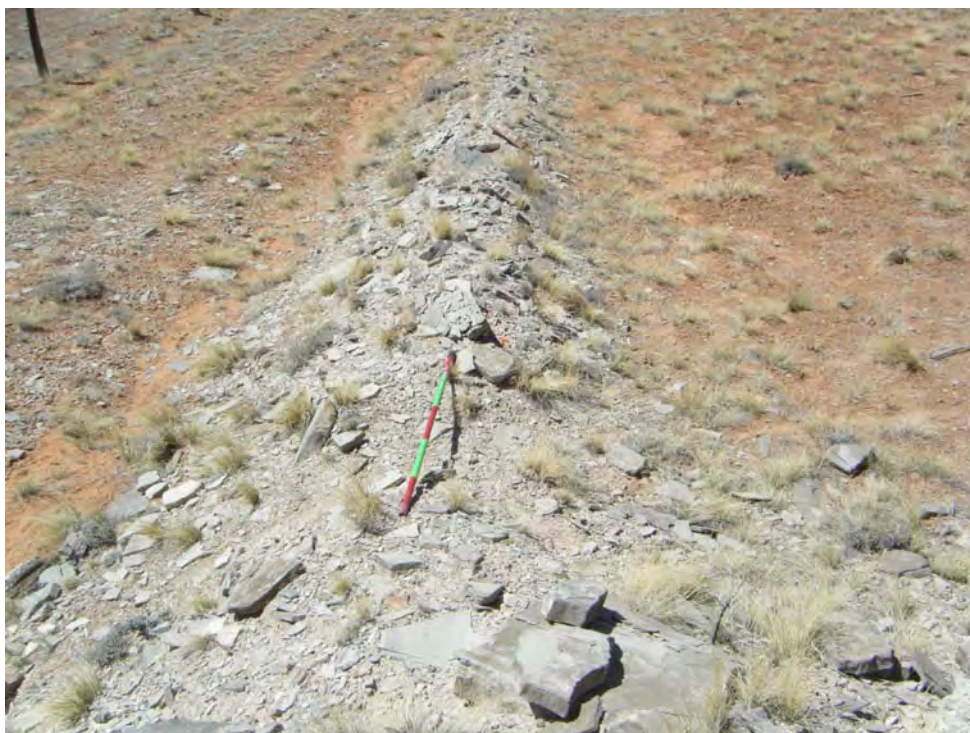
Photo 4-Looking west along PileRidge-1.

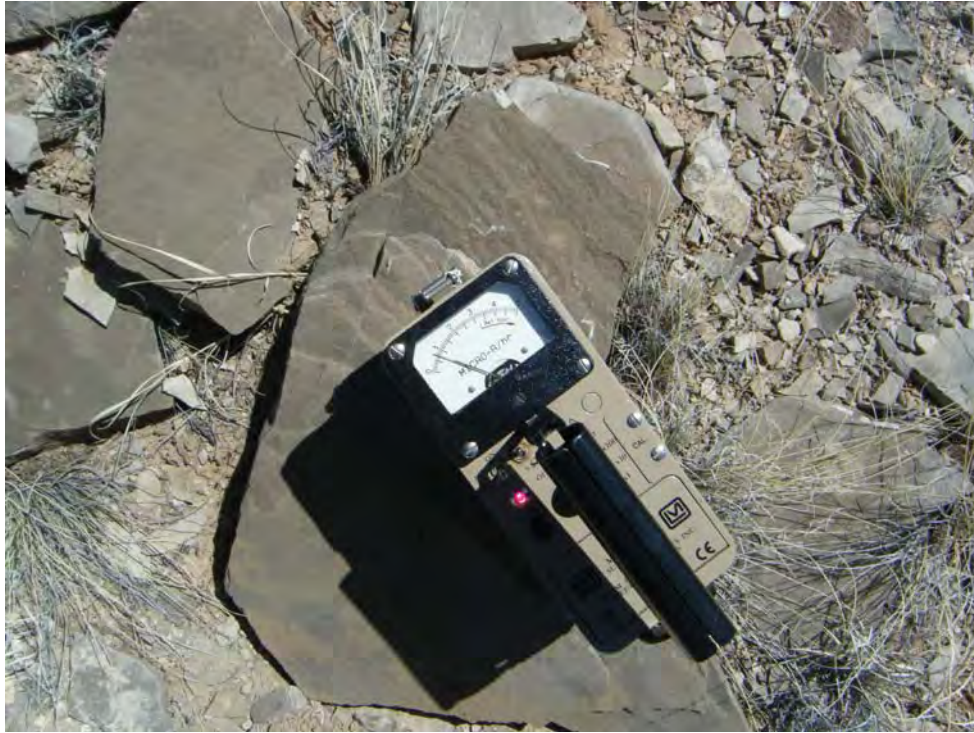
The maximum gamma radiation reading for the AUM Site was 100 $\mu\text{R/hr}$ at 0 ft above ground at radiation survey point Rad-9 (see Photo 5 in Appendix A). This reading was taken on a tabular slab of Todilto Formation limestone.

Photo 5-Radiation survey point Rad-9, taken on Todilto Limestone, measuring 100 μ R/hr at contact.

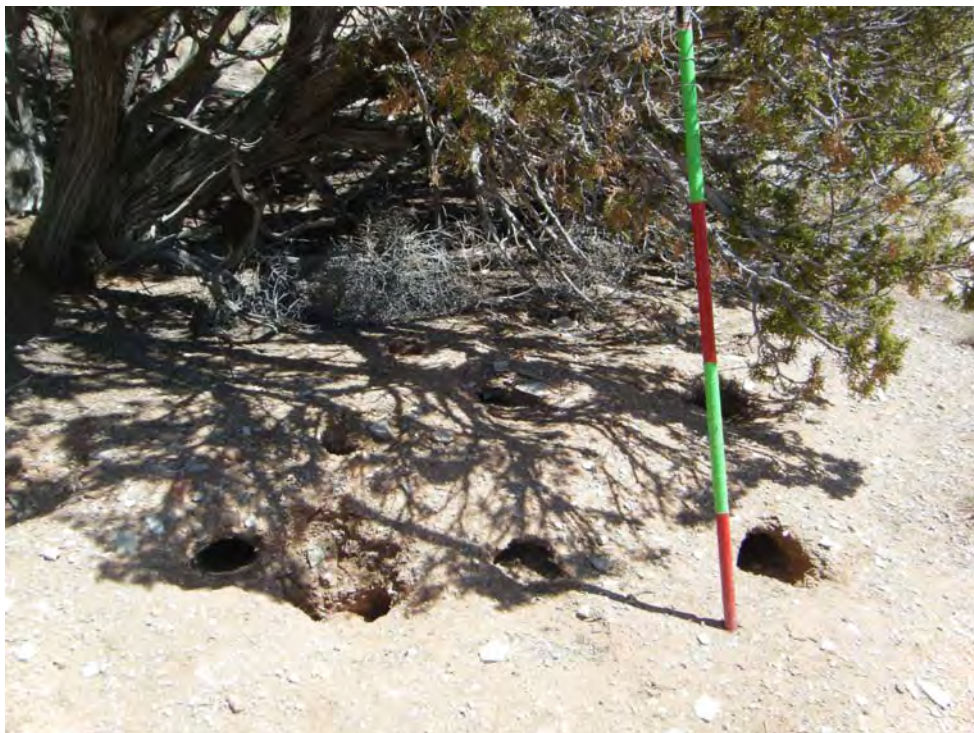
Wildlife burrows were noted onsite (see Photo 6 in Appendix A). The type of animal that produced these burrows is unknown. Deer scat was found onsite, and scrub jays were observed nearby.

Photo 6-Wildlife burrows west of CutPly-1.
