Abandoned Uranium Mine Site Assessment for the Section 21 Site (NM0135)

FINAL REPORT

NM0135

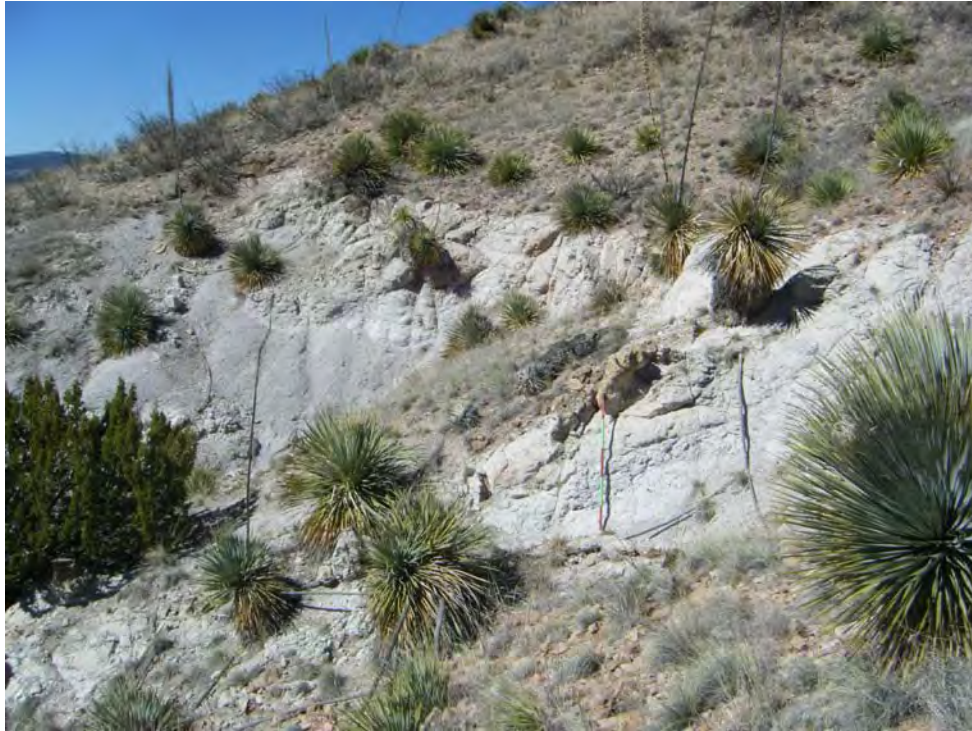
Photo 1-Looking southwest at the large erosion feature (ErosPt-1) located in the Northern Area.

Erosion pt. 1 - water erosion, 60' wide, 100' long
Photo 1 - looking south ^{west, AUL} at erosion pt. 1

Rad 1 - Erosion pt. 1; 0m - 20 mR/h; 1m - 20 mR/h

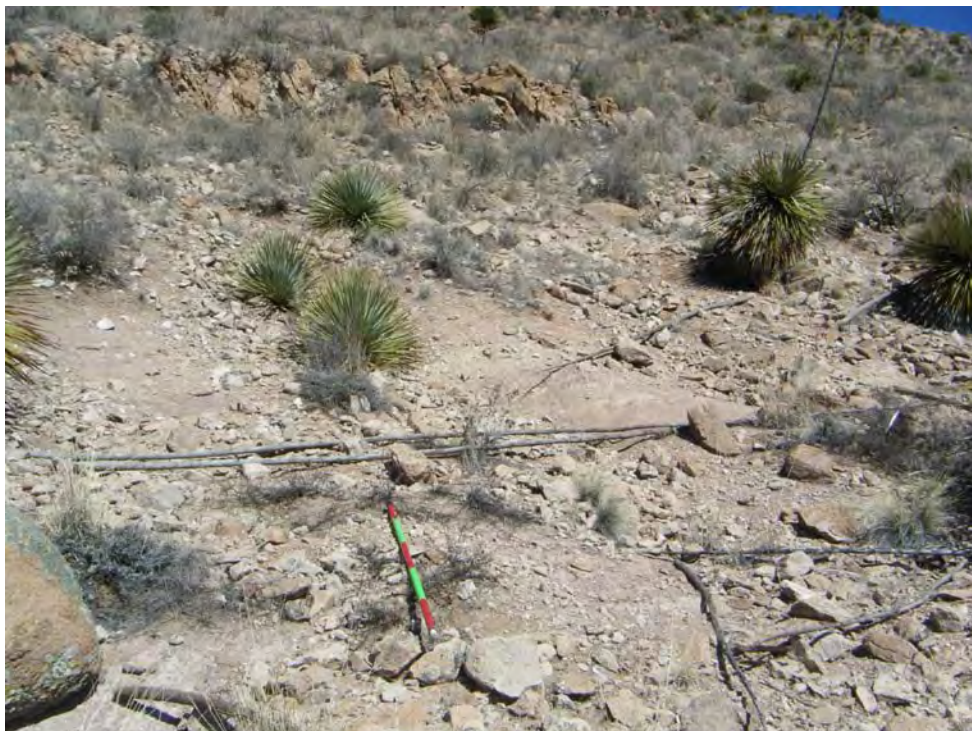
Two open cuts (CutPly-1 and CutPly-2) were identified at the Northern Area of the AUM Site; these cuts appeared to be only exploration cuts since no material appeared to have been removed from the site. Two open cuts (CutLn-1 and CutLn-2) were identified at the Southern Area of the AUM Site. CutLn-1 was a cut into the northwest side of the hill approximately 60 feet in length and the exposed rock face was about 15 feet high. CutLn-2 was a cut into the southeast side of the hill approximately 40 feet in length and the exposed rock face was about 20 feet high.

Photo 2-Looking north at the open cut (CutPly-1) located in the Northern Area.

Cut Ply 1 - Disturbed area, not radioactive

Rad 2 - cut Ply 1 - 0m - 15 μ R/h; 1m - 14 μ R/h

Photo 2 - looking north at cut Ply 1

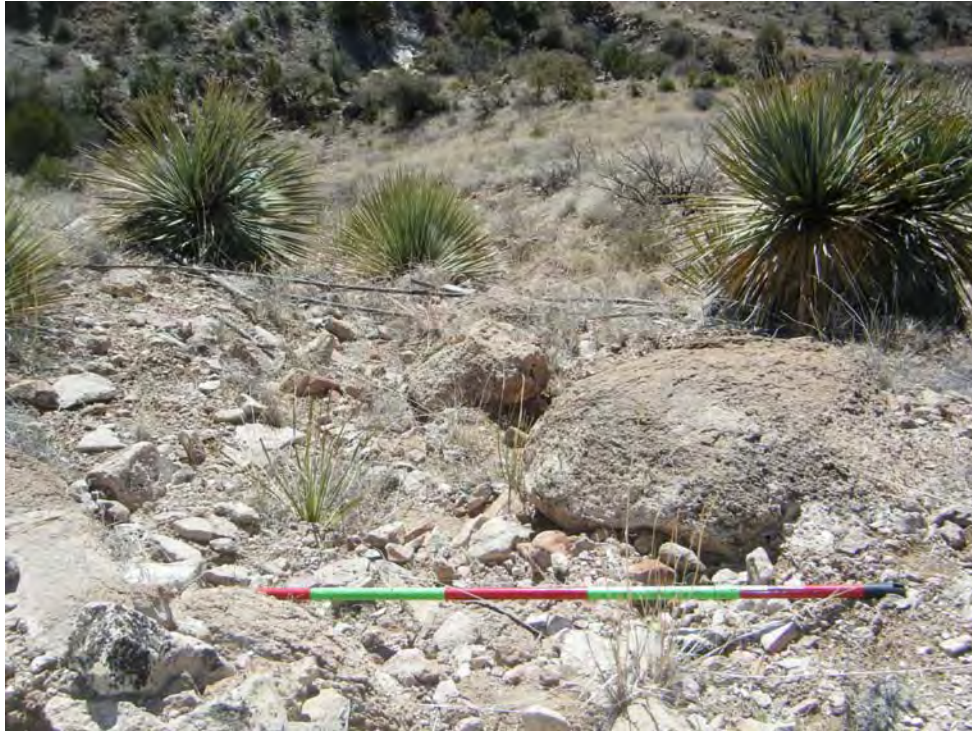
Photo 3-Looking south at the erosion feature (ErosPt-2) located down slope of CutPly-1 in the Northern Area.

Erosion Sp 2 - below, south of cut Ply 1; 70' long 10' wide

Rad 3 - Erosion Sp 2 - 0m - 17 μ R/h; 1m - 17 μ R/h

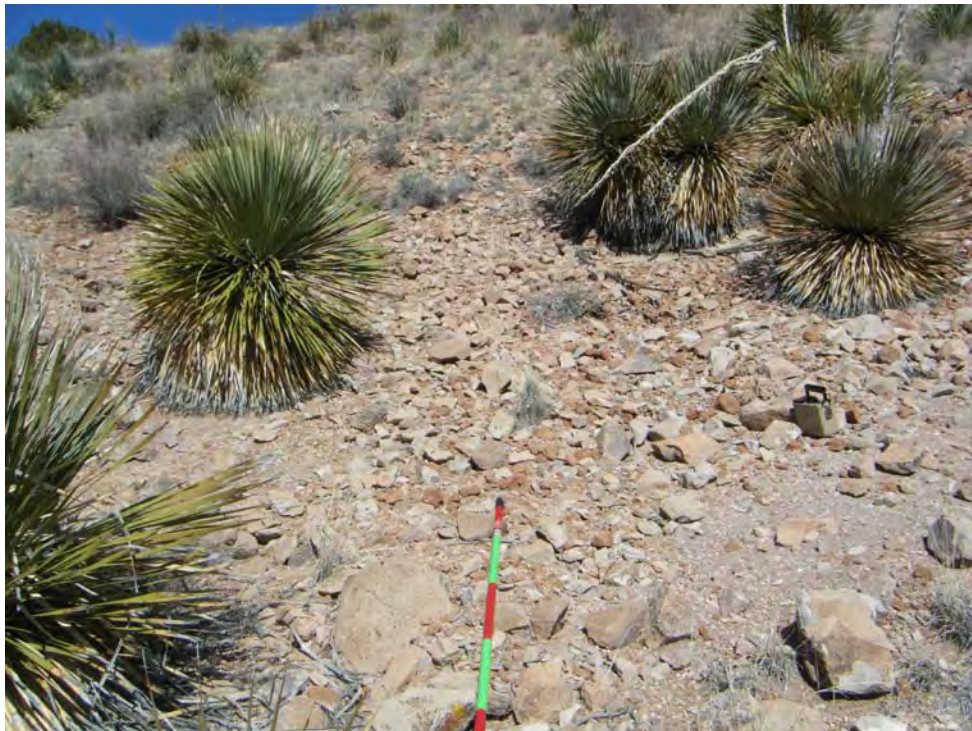
Photo 4-Looking north at the open cut (CutPly-2) located in the Northern Area.

Cut Ply 2 - Disturbed area, not radioactive

Photo 4 - looking north at cut Ply 2

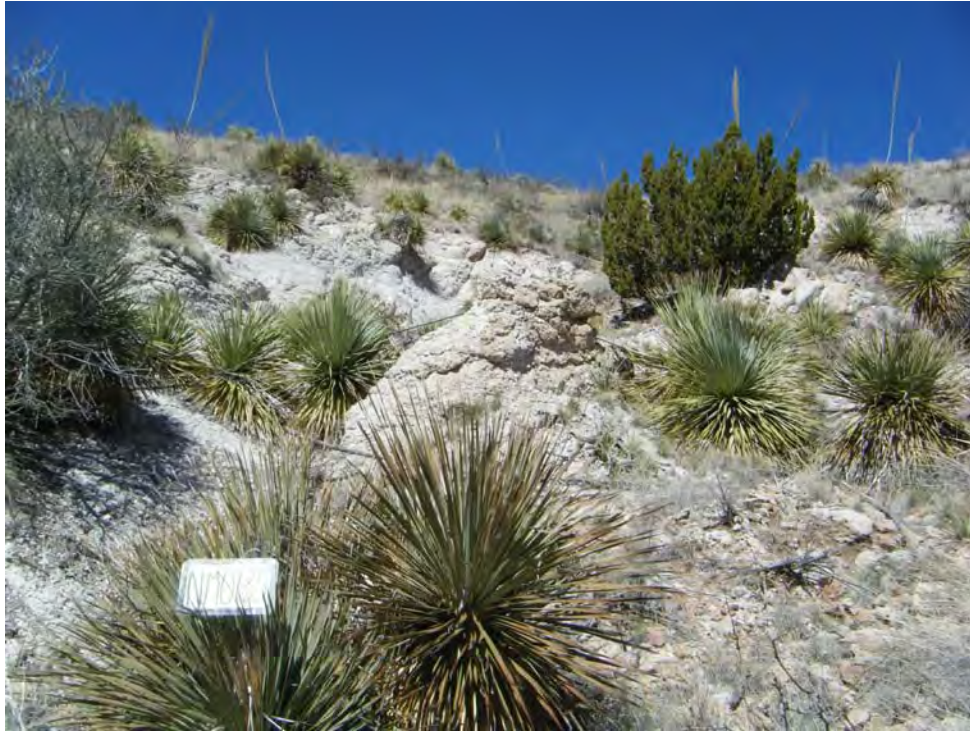
Photo 5-Looking northwest at the base of erosion feature (ErosPt-1), site name location in the Northern Area.

Rad 11 - base of erosion sp 1; 0m - 18 μ R/h; 1m - 18 μ R/h

Photo 5 - base of erosion sp 1, looking ~~southwest~~^{north} ~~with~~^{ALT} site name

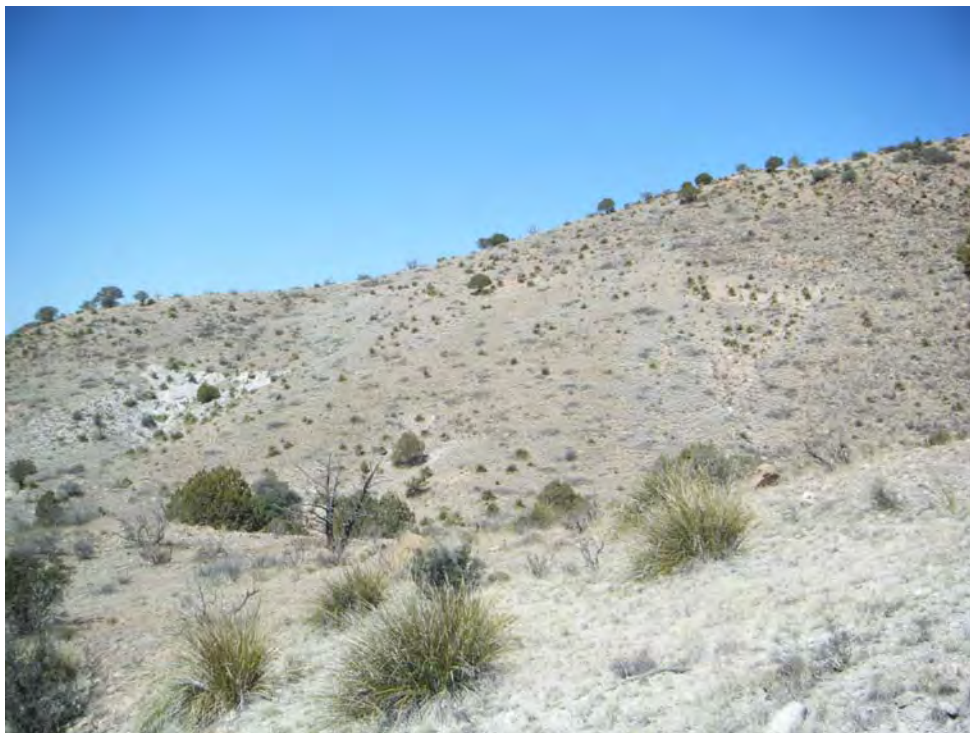
Photo 6-Looking north at the Northern Area AUM Site from across the arroyo.

Photo 6 - looking at Disturbed ply 1 & 2 and erosion sp 1 & 2 from across the valley, looking ~~south~~^{ALT} north

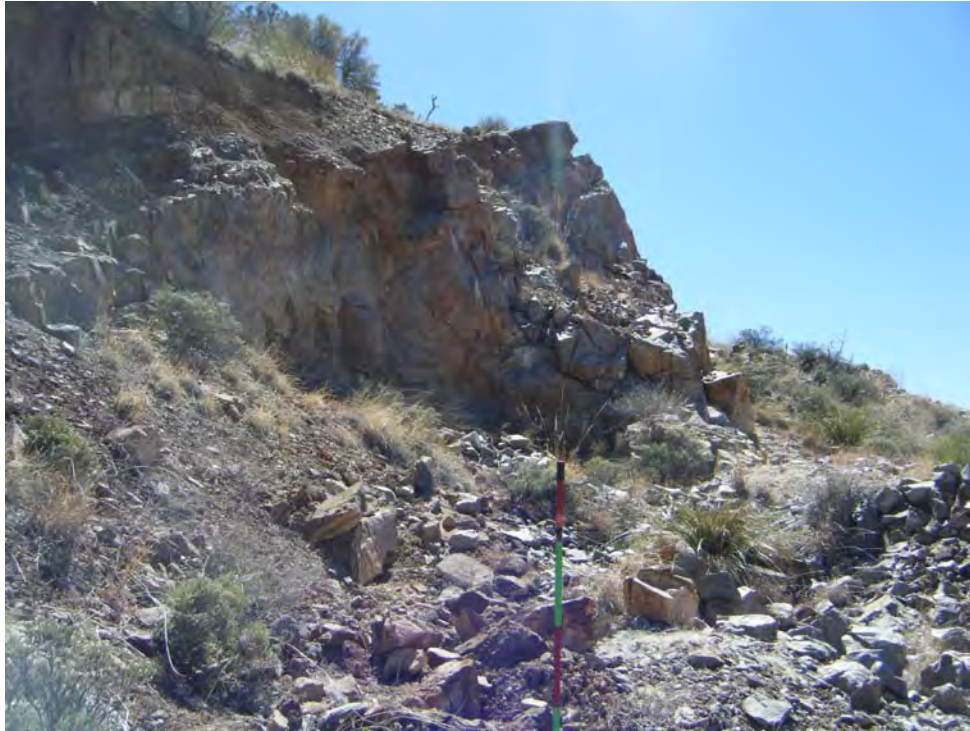
Photo 7- Looking south at an Open Cut (CutLn-1) located in the Southern Area.

Cutln 1 - ~60' long, 10-25' wide, rock face 15' high

Photo 7 - cutln 1, looking ~~west~~^{ALT} south

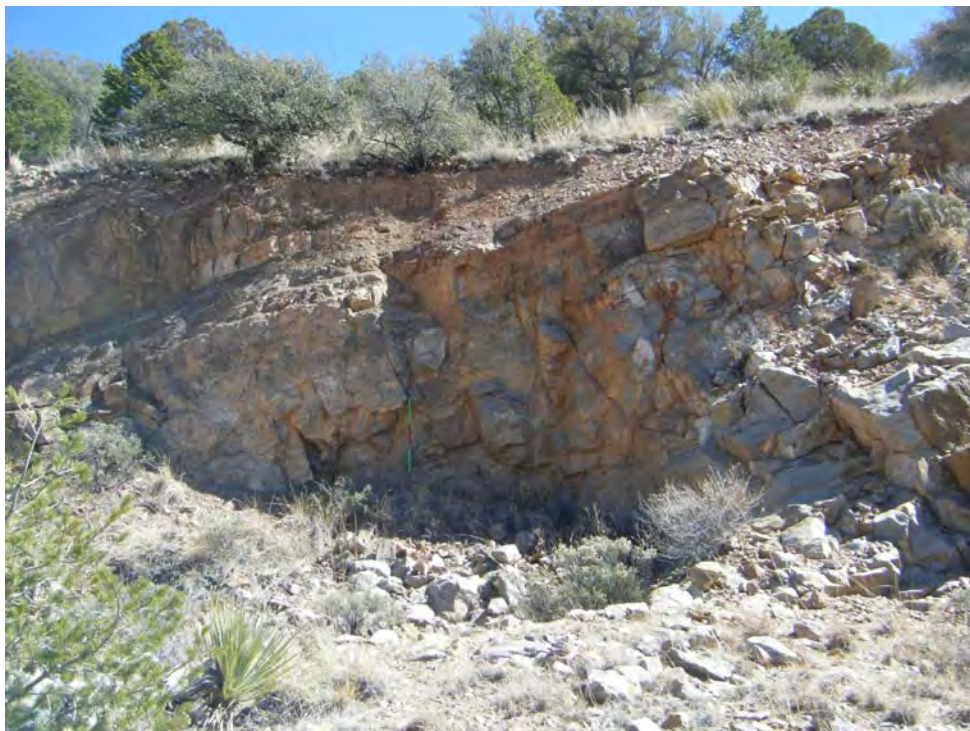
Photo 8- Looking east at an Open Cut (CutLn-1) located in the Southern Area.

Photo 8 - cutln 1, looking ~~south~~^{ALT} east

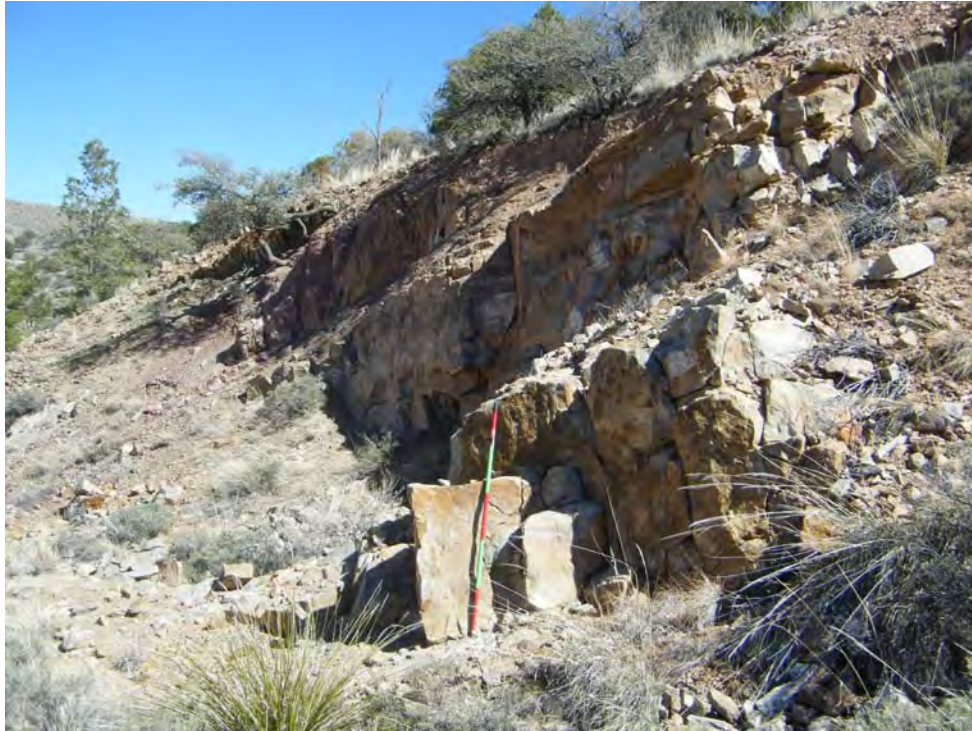
Photo 9- Looking north at an Open Cut (CutLn-1) located in the Southern Area.

Photo 9 - cutln 1, looking ~~east~~^{ALT} north

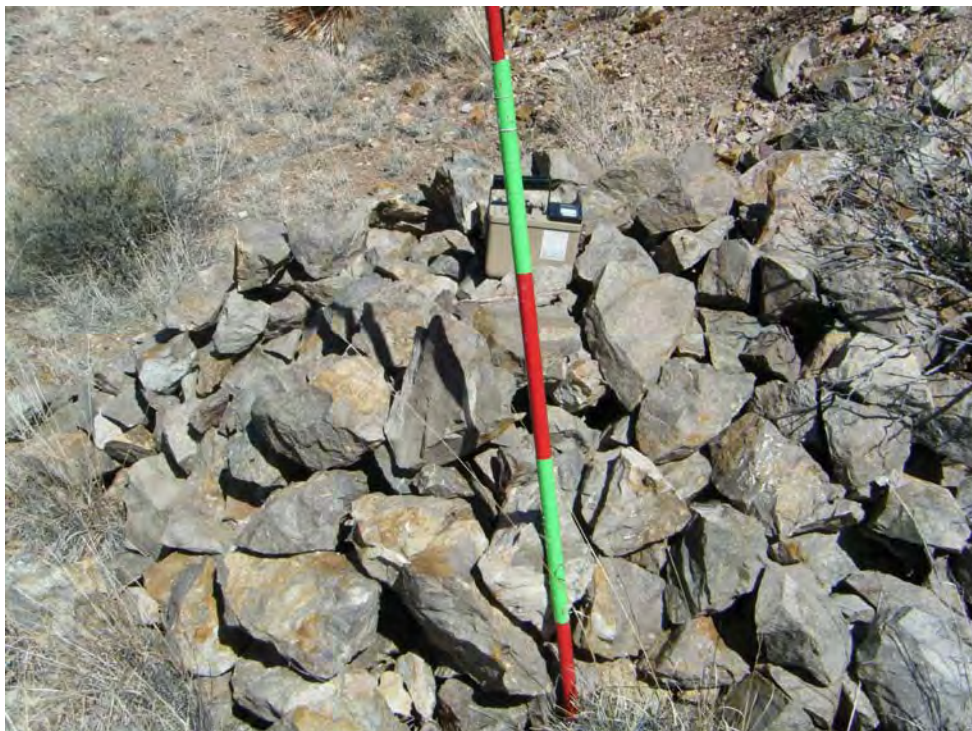
Photo 10-Looking east at a waste pile (PilePly-1) located in the Southern Area.

Pile Ply 1 - 3' high, 5' x 5'; large gray rock
 Rad 12 - Pile Ply 1 - 0m - 210 μ R/h; 1m - 38 μ R/h
 Photo 10 - looking east at Pile Ply 1
 Photo 11 - looking down at scintlemeter

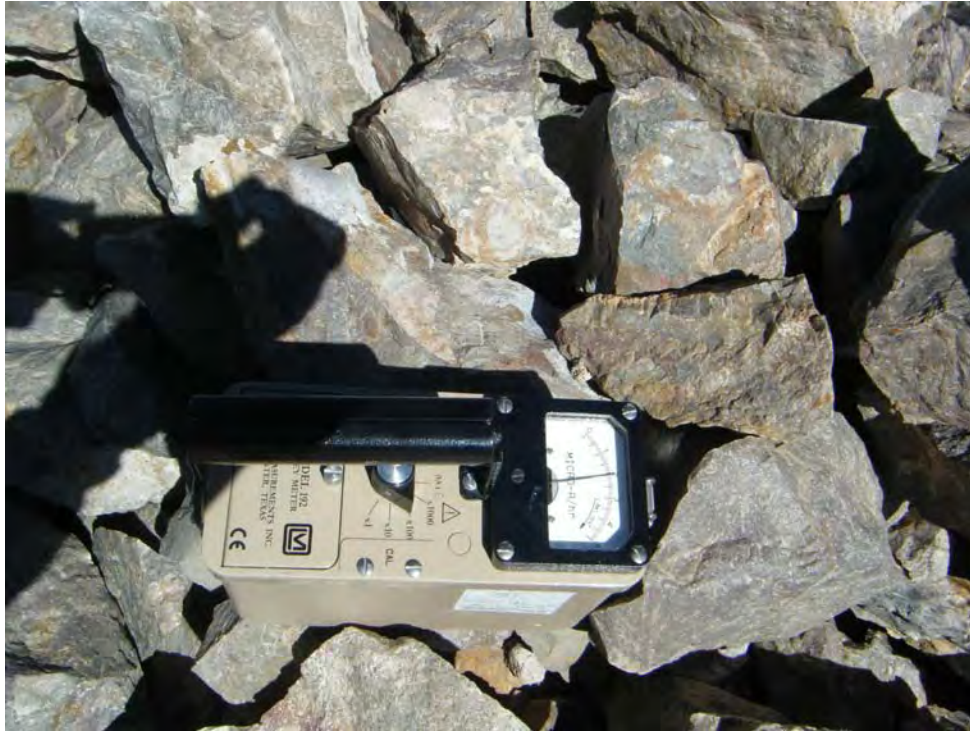
Photo 11-Looking down at PilePly-1 located in the Southern Area.

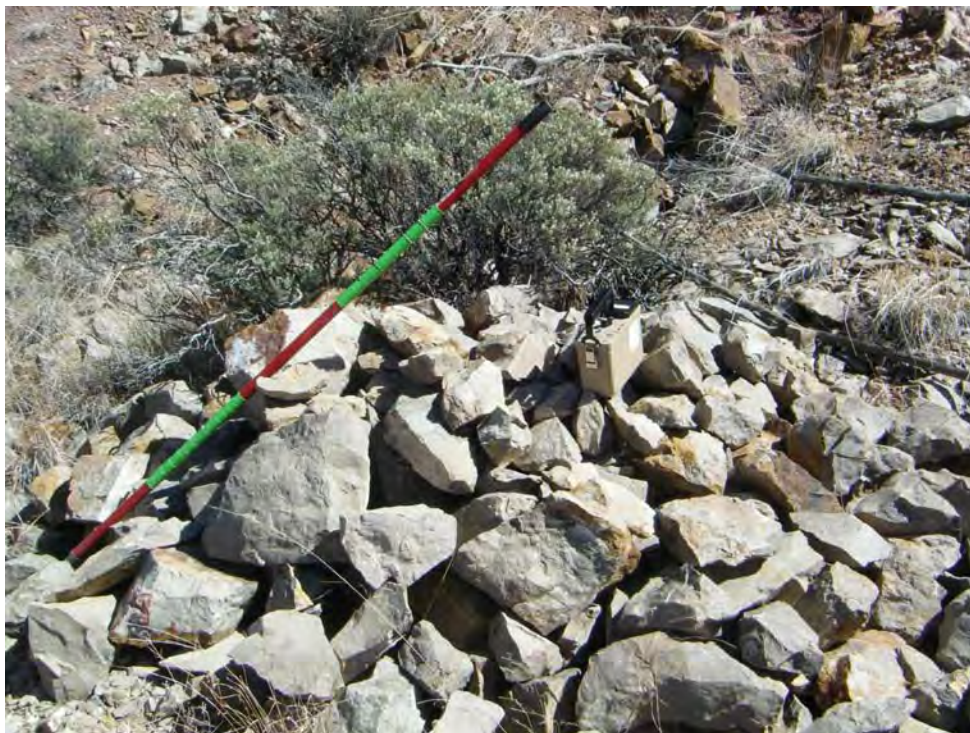
Photo 12-Looking southeast at a waste pile (PilePly-2) located in the Southern Area.

Pile Ply 2 - 2' high; 5' wide, 8' long; large gray rock
 Rad 13 - Pile Ply 2 - 0m - 100 μ R/h; 1m - 40 μ R/h
 Photo 12 - looking south east at Pile Ply 2

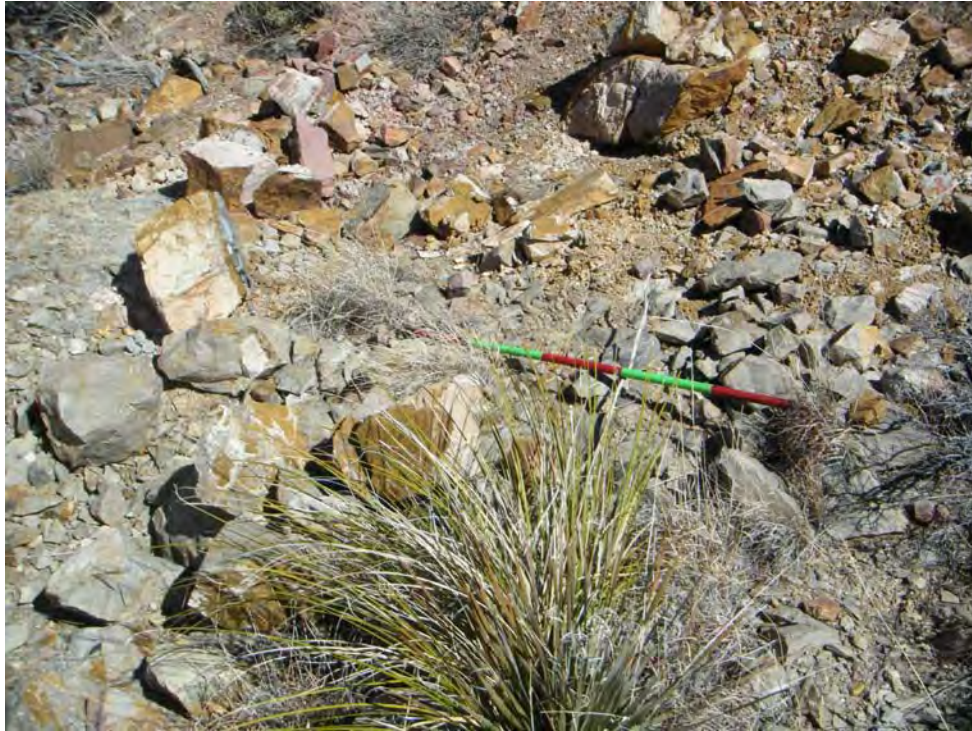
Photo 13-Looking southeast at a waste pile (PilePly-3) located in the Southern Area.

Pile Ply 3 - 2' high; 5' wide; 20' ~~long~~^{ACT} long;
 mixed size, large and small grey rock with
 brown rock

Photo 13 - looking southeast at pile ply 3
 Rad 14 - Pile Ply 3 - 0m - 70 μ R/h; ~~3~~^{ACT} 1m - 34 μ R/h

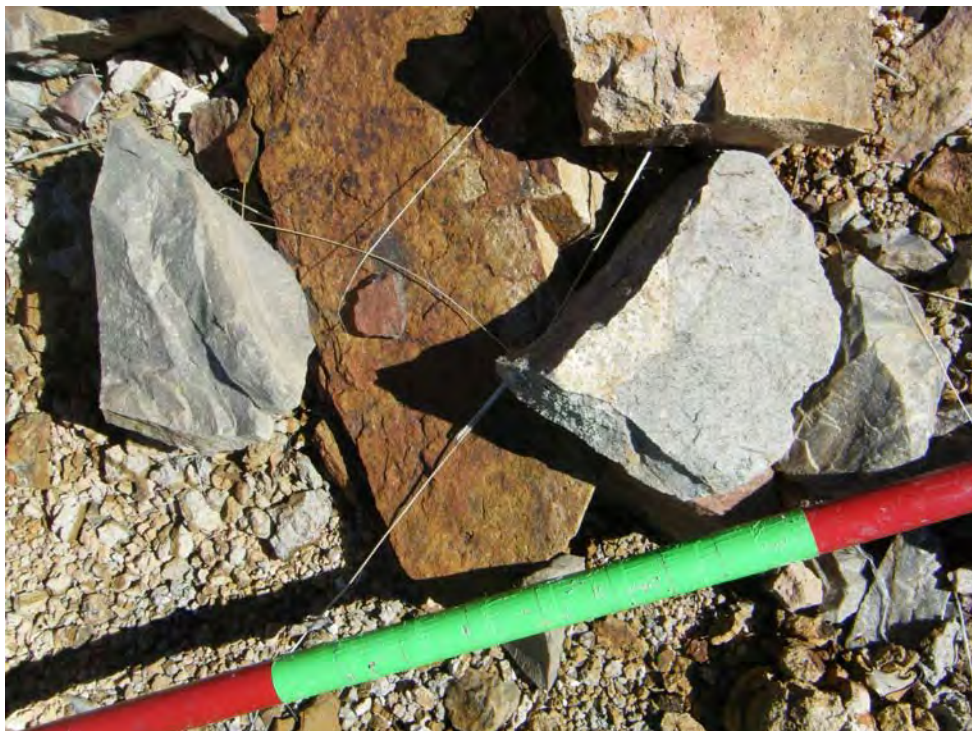
Photo 14-Looking at the rocks contained in a PilePly-3 located in the Southern Area.

Photo 14 - looking at gray and brown rock on
 pile ply 3

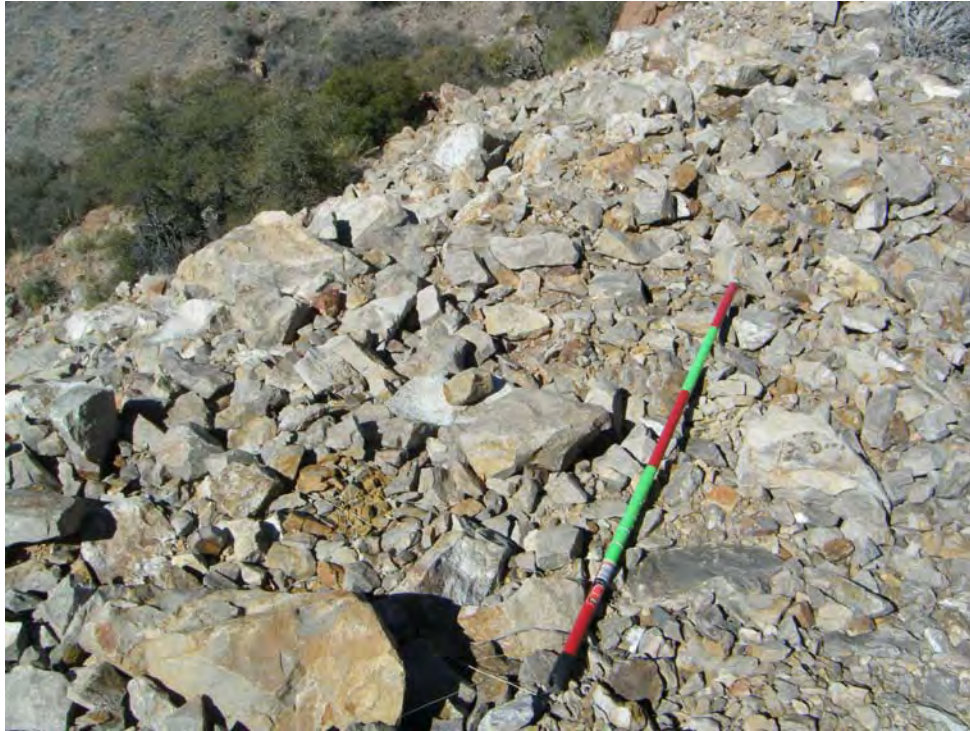
One disturbance (DistPly-1), three waste piles (PilePly-1, PilePly-2, and PilePly-3) and four pile ridges (pileridge-1, pileridge-2, pileridge-3, and pileridge-4) were found at the Southern Area of the AUM Site. The waste piles and pile ridges all consist of waste rock. PilePly-1, PilePly-2, PilePly-3, and pileridge-1 are associated with CutLn-1. Pileridge-1 spills down the west side of the ridge on which CutLn-1 is located.

Photo 15-Looking east at pileridge-1 located in the Southern Area.

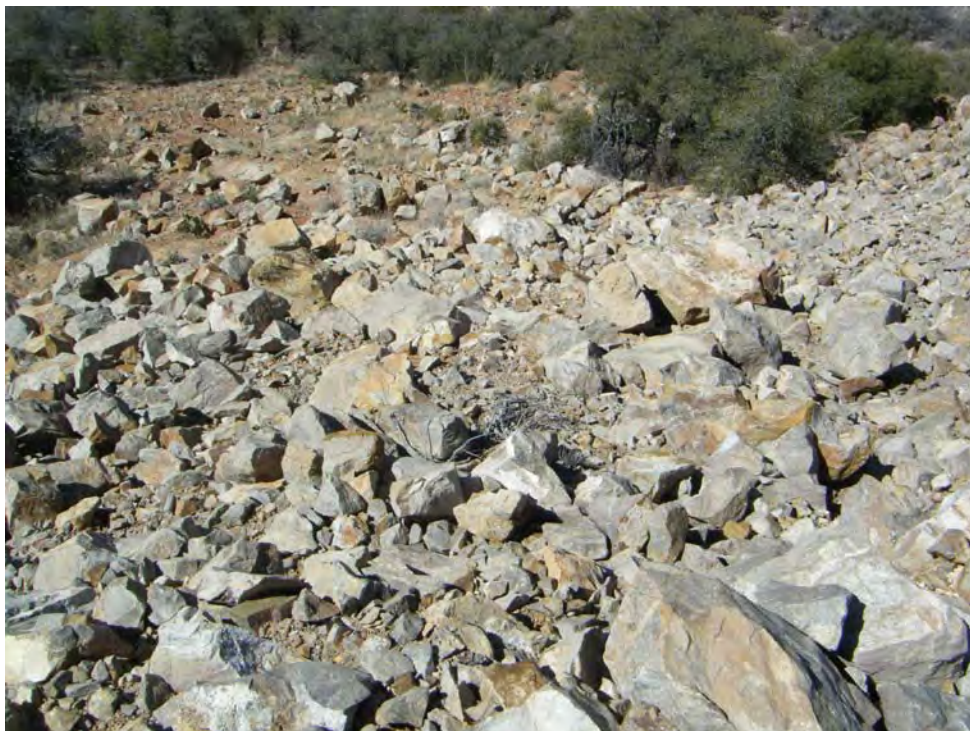
Photo 16-Looking north at the down slope of pileridge-1 located in the Southern Area.

Pile Ridge 1 - 1' high; 25' long; spreads down hill
 about 60'.

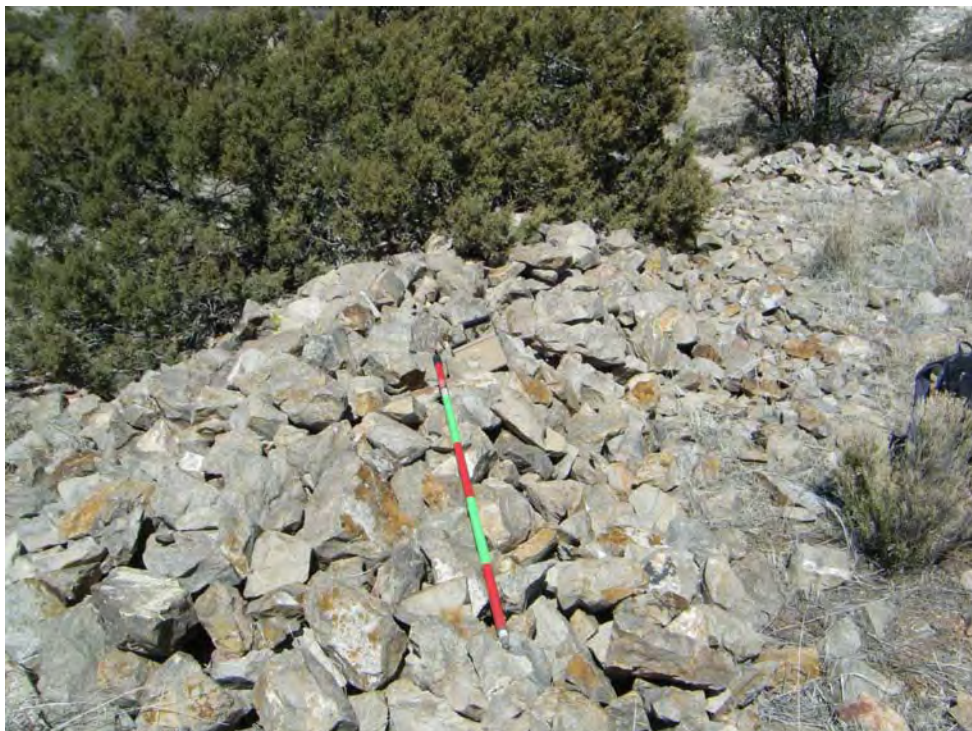
Pileridge-2 is associated with DistPly-1 which was flattened and was unvegetated. Pileridge-2 material appears to have originated from CutLn-1 and CutLn-2.

Photo30- Looking north at piledrill-2 located in the Southern Area.

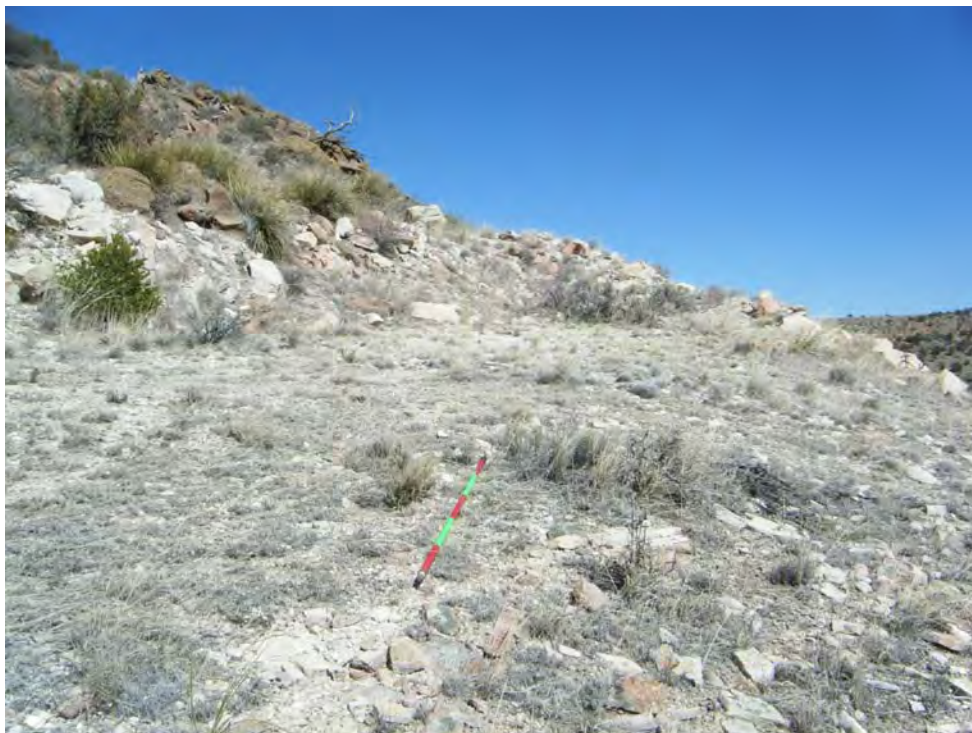
Photo 33-Looking northeast at DistPly-1 located in the Southern Area.

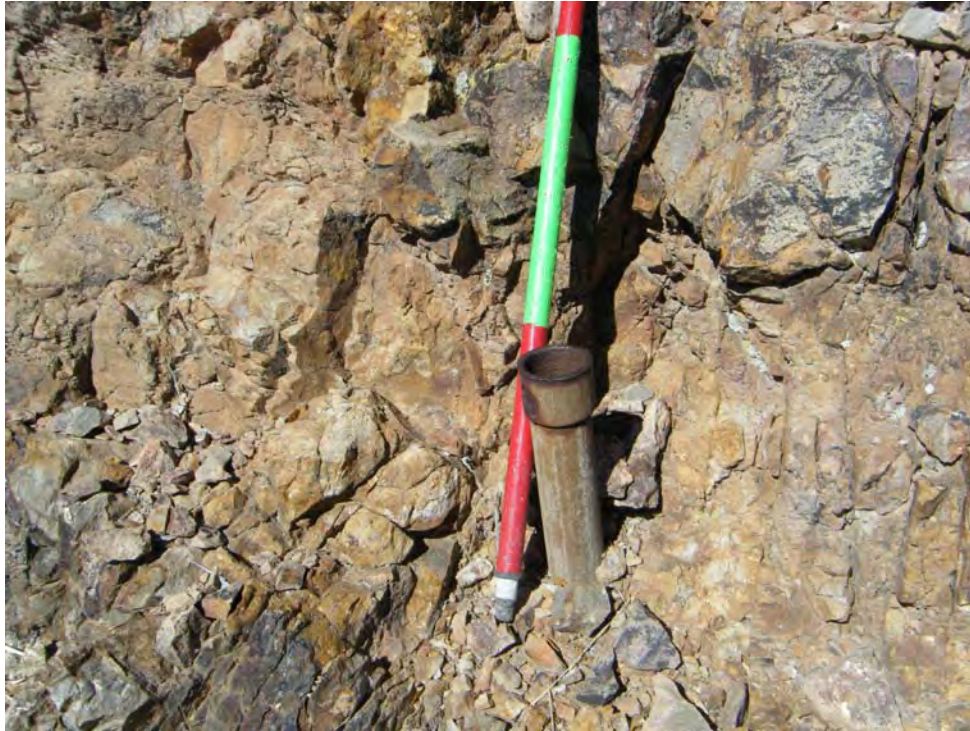
A metal pipe (Photo-7), potentially a drill rod, was observed at the northern end of CutLn-2. It was reported that the Southern Area AUM Site contained three diamond drill holes (Hedlund, 1978). No other evidence indicating boreholes was observed at the Southern Area AUM Site.

Photo 34-Looking at metal pipe (drill rod) located at the north end of CutLn-2 in the Southern Area.

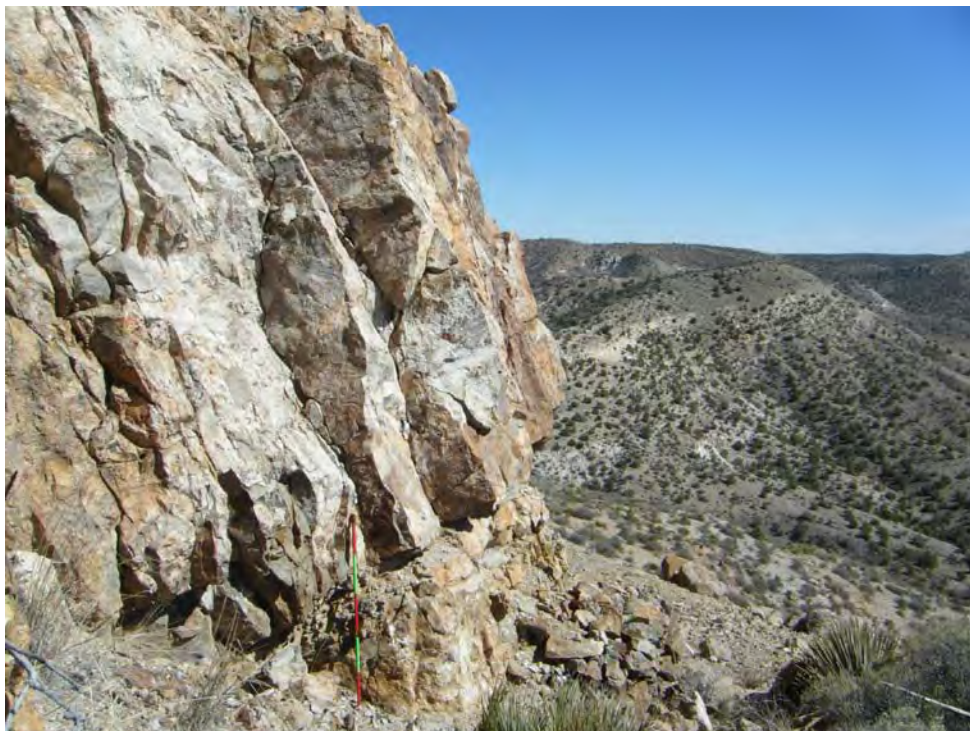
Photo 35-Looking east at CutLn-2 located in the Southern Area.

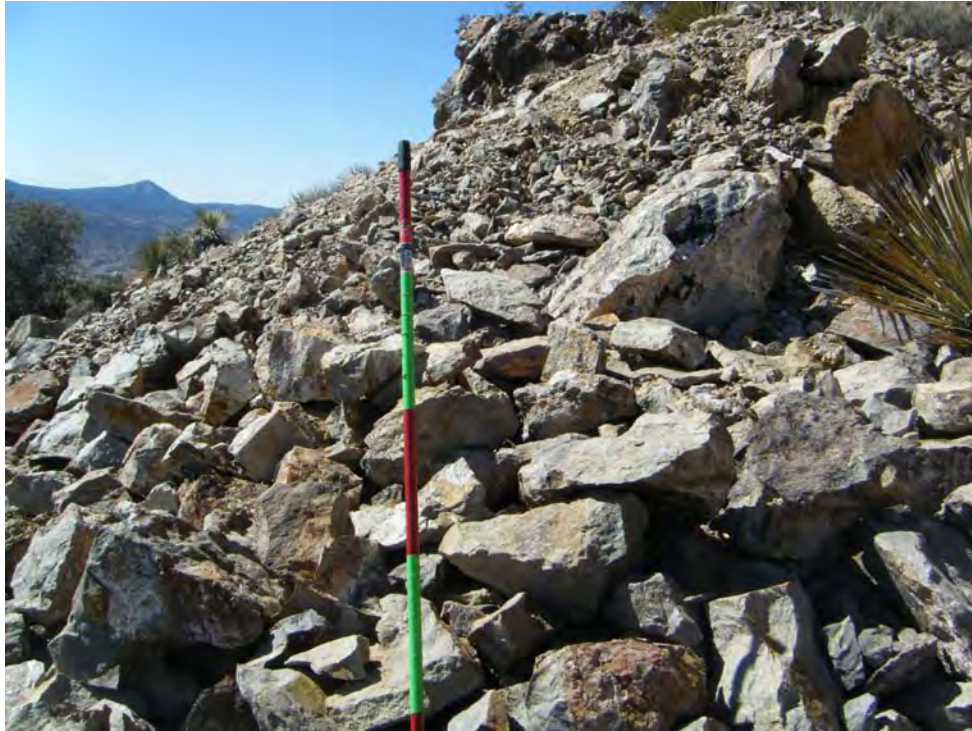
Pileridge-3 and pileridge-4 are associated with CutLn-2. Pileridge-3 spills down the south side of the ridge on which CutLn-2 is located. Pileridge-4 is the southern down slope boundary of pileridge-3.

Photo 36-Looking north at pileridge-3 located in the Southern Area.

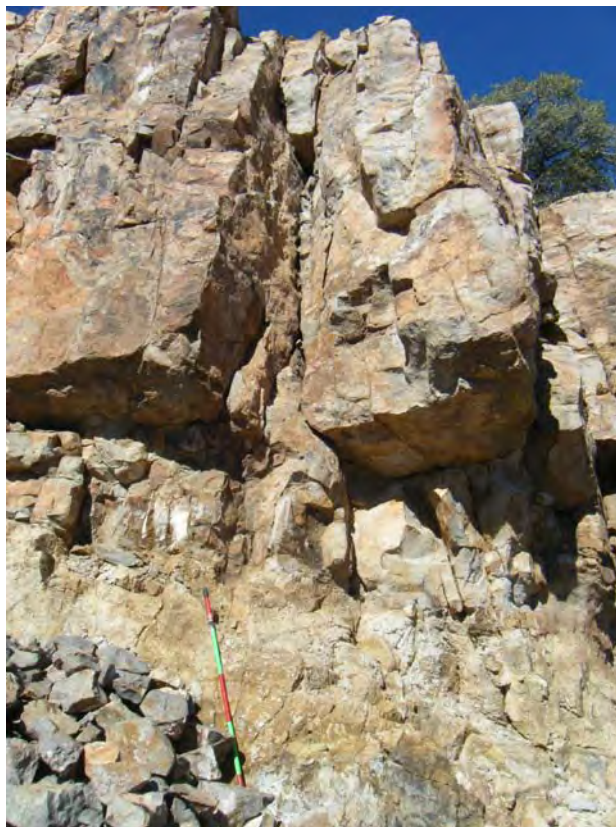
Photo 37-Looking north at the rock face of CutLn-2 located in the Southern Area.

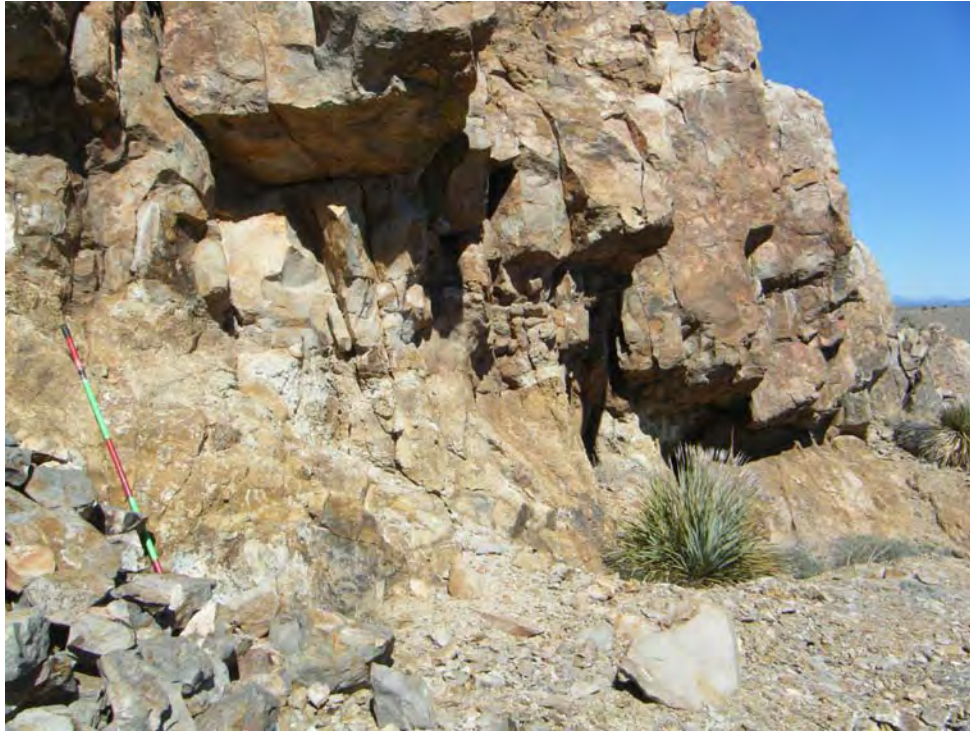
Photo 38-Looking southeast at the rock face of CutLn-2 located in the Southern Area.

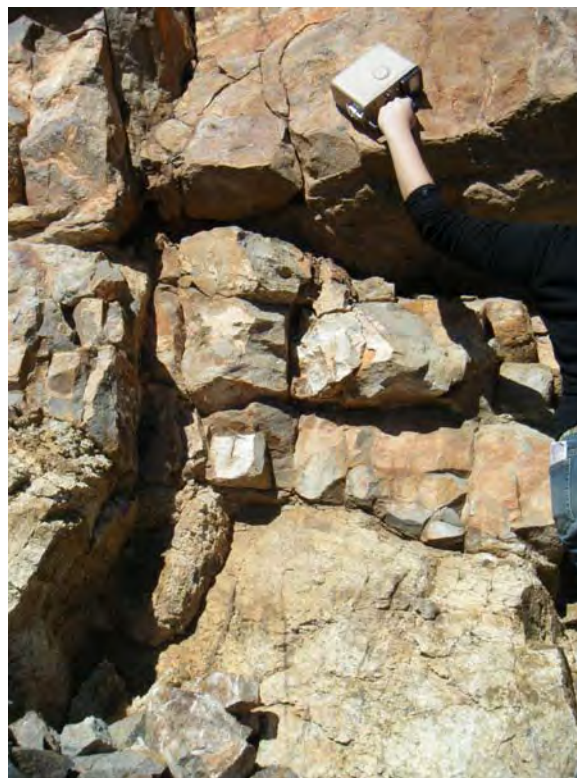
Photo 39-Taking a reading on the rock face of CutLn-2 in the Southern Area.

Rad 28 - base of rock face on cutln 2, loose gray rock
Om - ^{R60} ~~220~~ mR/h; 1m - 90 mR/h

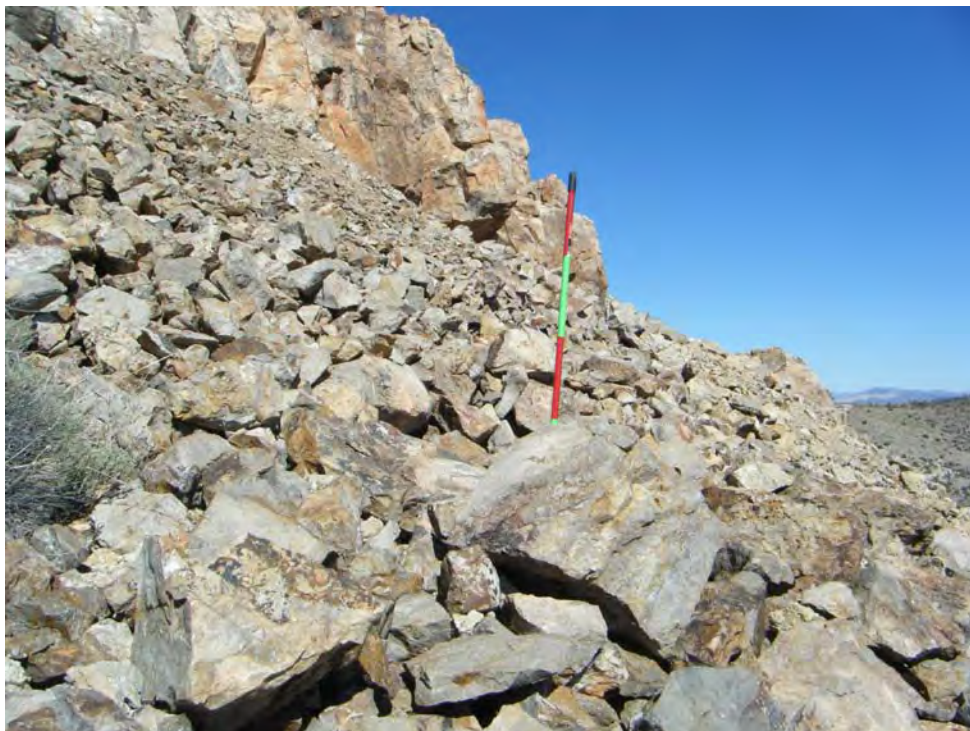
Photo 41- Looking northeast at the pileridge-4 which is the base of spill over from pileridge-3 located in Southern Area.

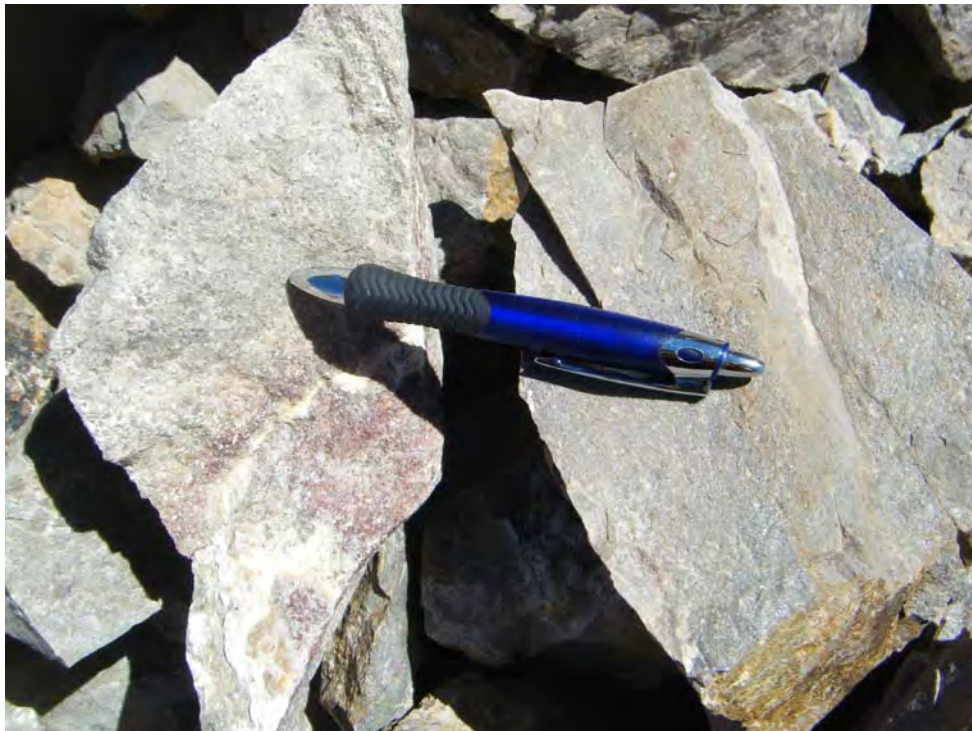
Photo 43-Looking at the type of rock found in the waste piles in the Southern Area AUM Site.
