Abandoned Uranium Mine Site Assessment for the San Lorenzo Mine (NM0254)

DRAFT REPORT

**San Lorenzo – NM0254
Abandoned Uranium Mine Assessments**

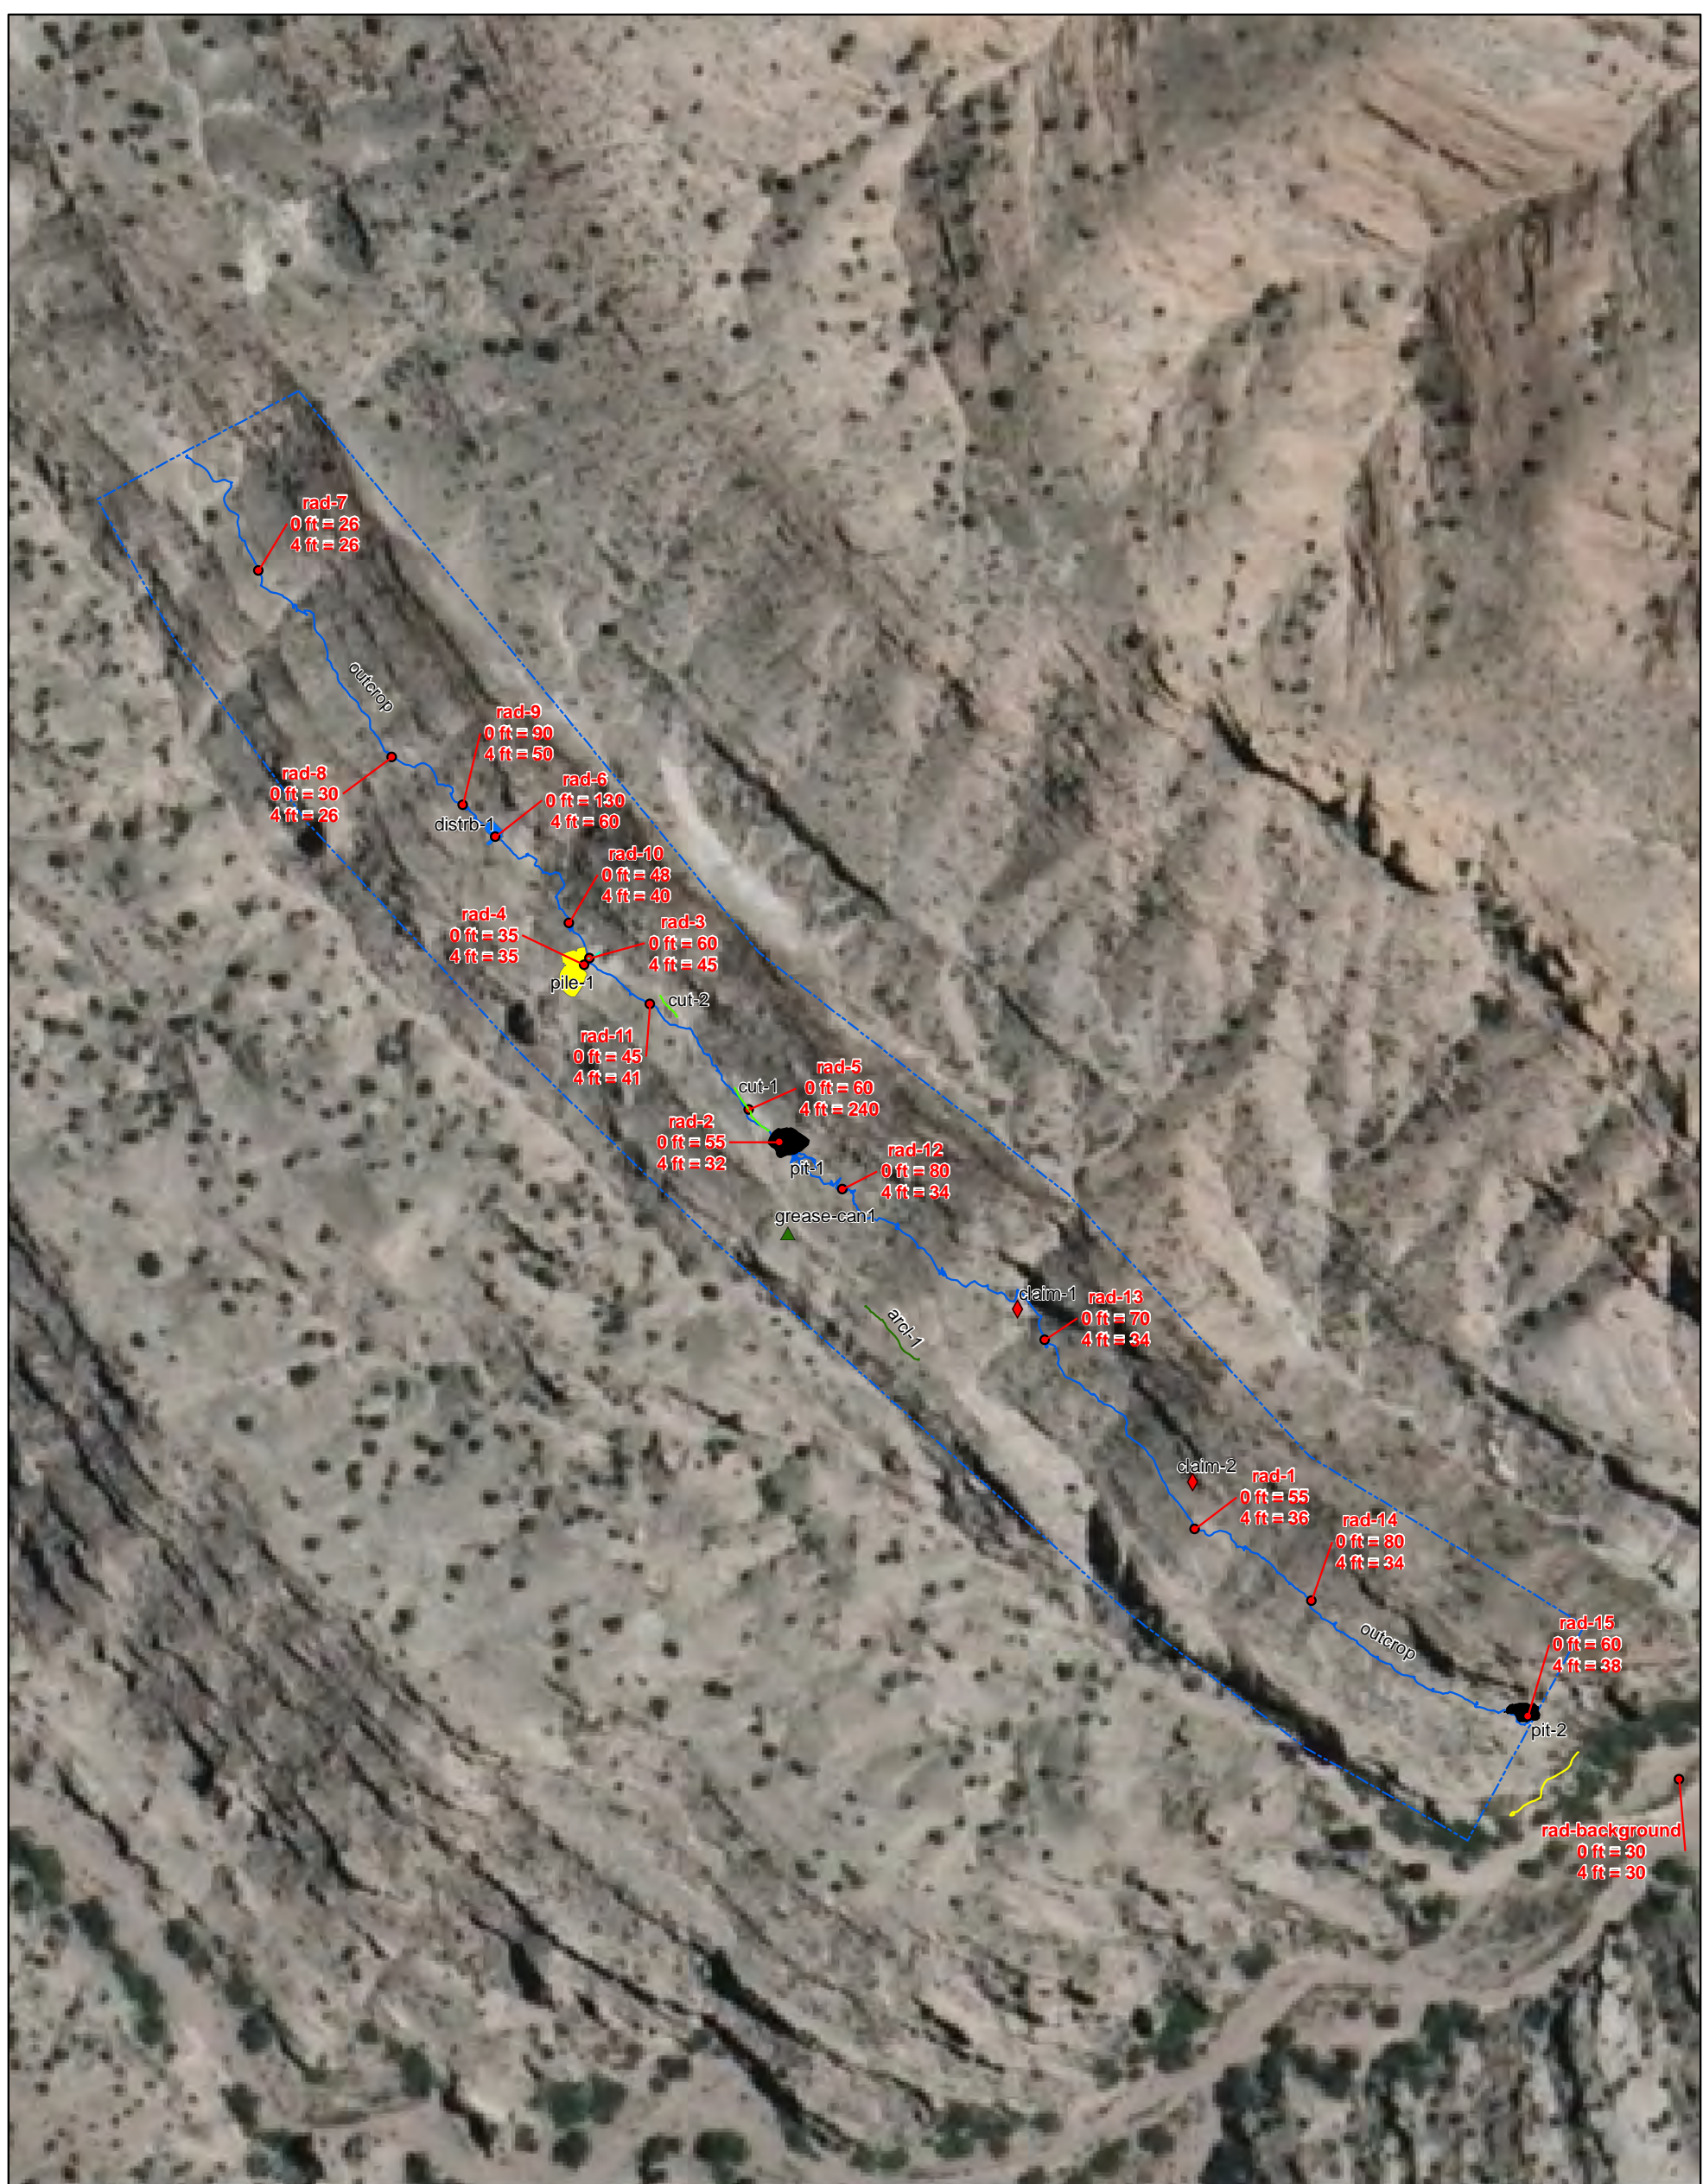
Figure 4a
Site Map on
Aerial Photo
NM0254-San Lorenzo
 Abandoned Uranium
 Mine Assessment

using a Trimble Global Positioning System (GPS), and entered details about the features into the GPS using the MMD data dictionary. The San Lorenzo AUM Site is a long narrow site running from northwest to southeast, that follows the radioactivity readings in the tuffaceous sandstone outcrop. The mine features include one decline, two claim markers, one disturbance, one foundation, one abandoned empty grease can, two open cuts, one waste pile, and one exploration pit. Please see the Photo Log in Appendix A, Table 1 for a list of all AUM Site features, and Figures 4a and 4b for the locations of the AUM Site features.

The gamma radiation readings at the AUM Site followed the tuffaceous sandstone outcrop that ran the length of the AUM Site. The highest reading was at location rad-5, which was recorded inside of an open cut (cut-1), and had readings of 240 $\mu\text{R/hr}$ at the ground surface, and 60 $\mu\text{R/hr}$ at 4 feet above the ground surface.

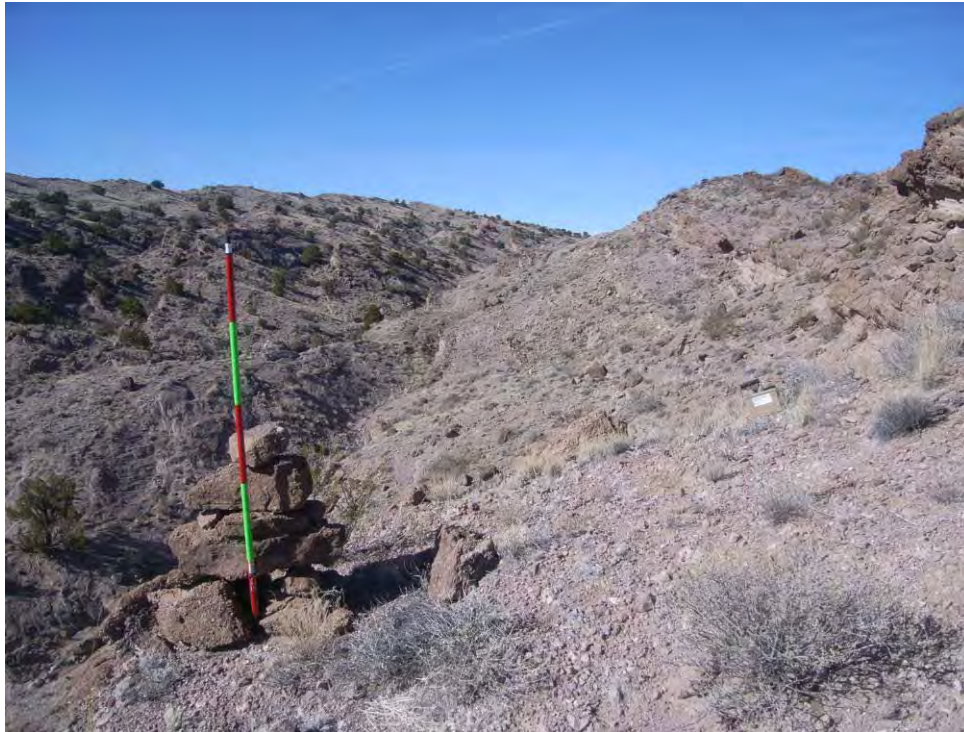
Photo 1 - Cairn (claim-2) on ridge east of mining activity, scale pole is 5 feet tall, looking north.

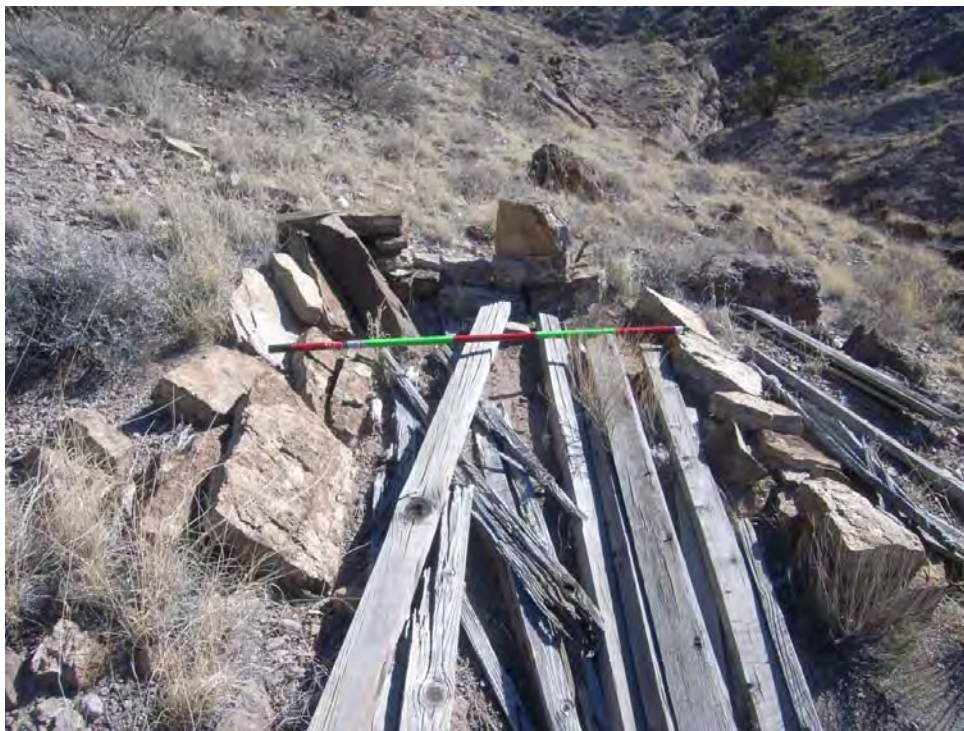
One mining related foundation was found at the AUM Site. This foundation was made of flat rocks, native to the area, built up as walls around three sides of a collapsed wooden structure.

The total dimensions of the foundation are approximately 6 feet wide by 6 feet long, and each of the walls is approximately 1-foot high. The boards of the collapsed wooden structure are 10 feet long. The intended use of this structure is not clear.

Photo 4 - Wood pile and foundation (fnd-1) just southeast of tuffaceous sandstone outcrop, looking south.

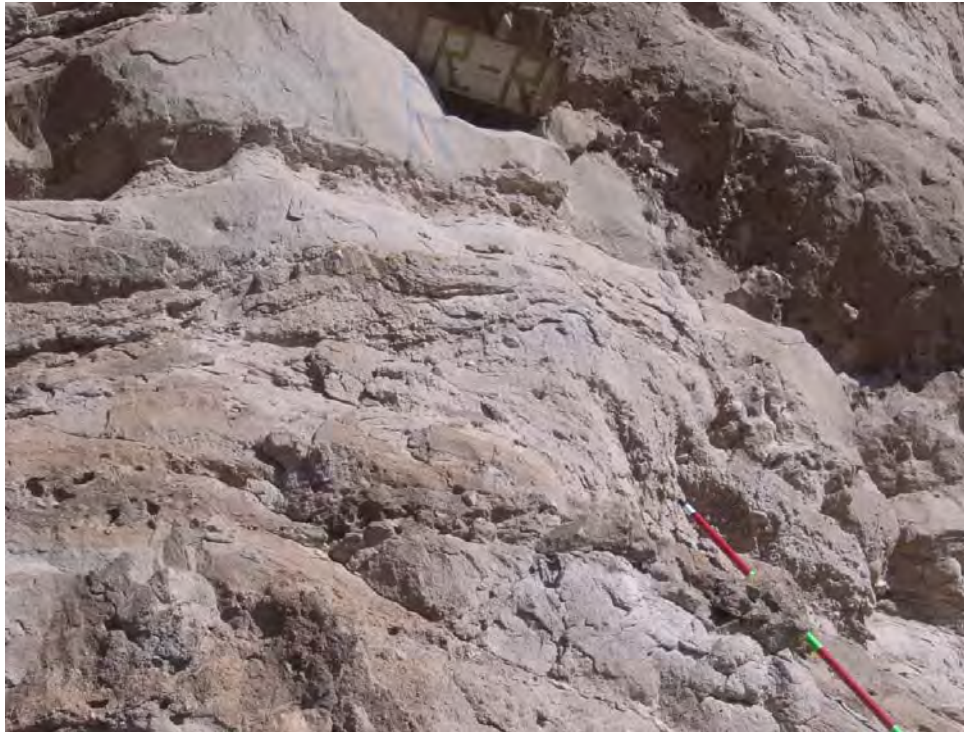
Other features that were found at the AUM Site include two possible claim markers and one empty grease can. The first item assumed to be a claim marker (claim-1) is represented by paint and a wooden sign 20 feet high on a rock face, just below a small hole in the rock face. The paint says “R+R” and just above that, wedged into a hole in the rock face, the wooden sign reads “R.-R.” The second item assumed to be a claim marker (claim-2) is a rock cairn just east of, and above, the tuffaceous sandstone outcrop. This cairn is approximately 3 feet high, 2 feet by 2 feet wide at the base, and 0.5 feet by 0.5 feet wide at the top. One rusted, empty grease can (grease-can1) was found west of the tuffaceous sandstone. There is no soil staining on the ground around it. The writing on the grease can says “Triangle Oil Co.”

Photo 5 - Writing on rock face and a wooden sign wedged into a hole in the rock face, above the uranium-bearing rock formation; assumed to be a claim marker (claim-1).

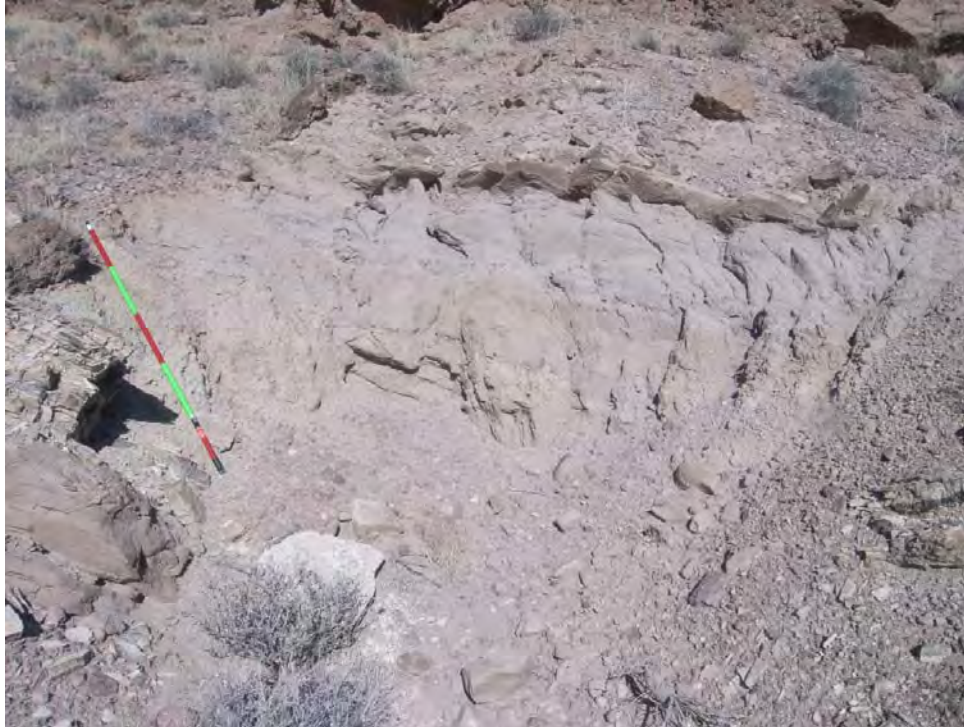
Two exploration pits were found at the AUM Site. The first pit (pit-1) is approximately in the center of the AUM Site, and has dimensions of 10 feet by 8 feet wide, by 6 feet deep. This pit was dug into the side of the hill, so one side of it is level with walking ground, and the other side is vertical. The second pit is at the very southeastern end of the AUM Site. It has dimensions of 10 feet by 8 feet wide, by 3 feet deep. This pit was also dug into the side of the hill, and the bottom of the pit is close to relatively level ground close to the arroyo in Cabra Canyon. Neither of these pits are a safety hazard, since they are shallow.

Photo 6 - A shallow prospect pit (pit-1). The uranium bearing formation is just left of the scale pole.

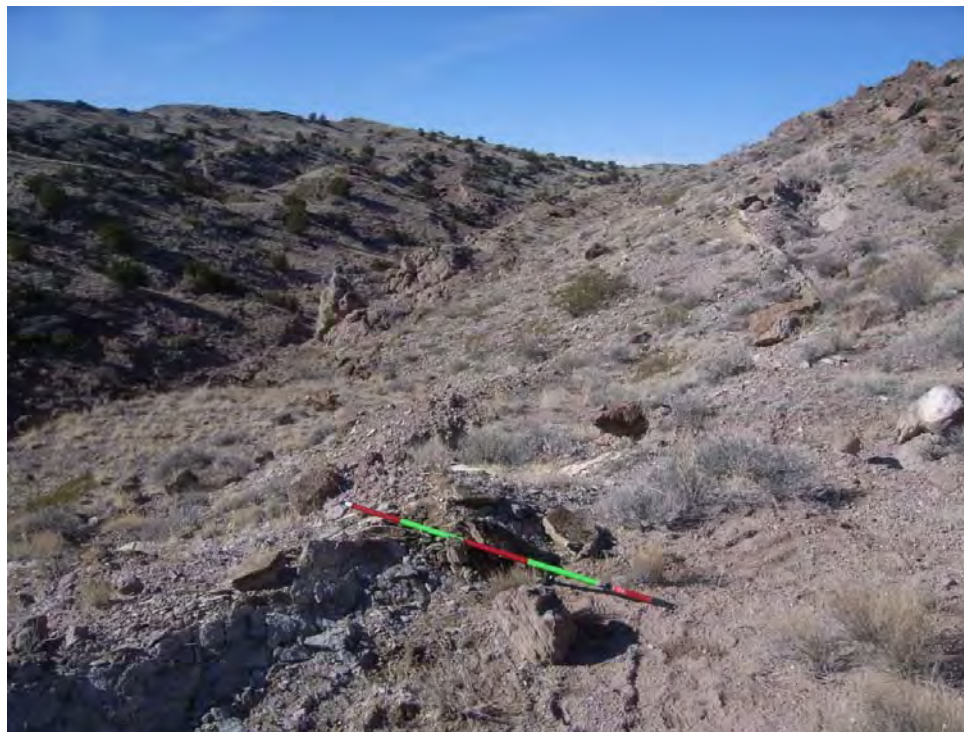
Two open cuts were found at the AUM Site. Both of these cuts parallel the tuffaceous sandstone outcrop. The first cut (cut-1) is 10 feet wide, 50 feet long, and 2 feet deep. The second cut (cut-2) is 5 feet wide, 30 feet long, and 5 feet deep. This cut (cut-2) has most likely been deepened by erosion from water runoff.

Photo 7 - A shallow cut (cut-1), possibly a bulldozer cut. The rocks scattered to the left of the scale pole have radioactivity readings of 240 μ R/hr.

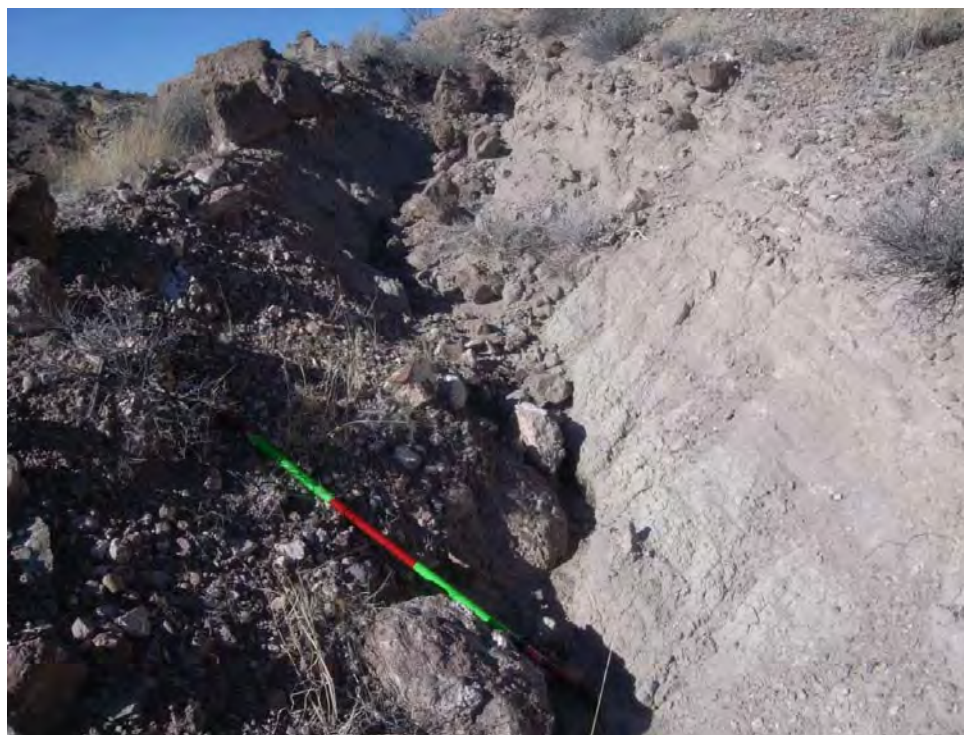
There is one notable erosional feature at the AUM Site, inside of one of the open cuts (cut-2). This cut was most likely originally dug using heavy equipment to a depth of around 3 feet and 30 feet long, and since the end of mining, the cut has become deeper due to water runoff.

Photo 8 - A shallow cut (cut-2), possibly from a bulldozer, appears to have been deepened by erosion.

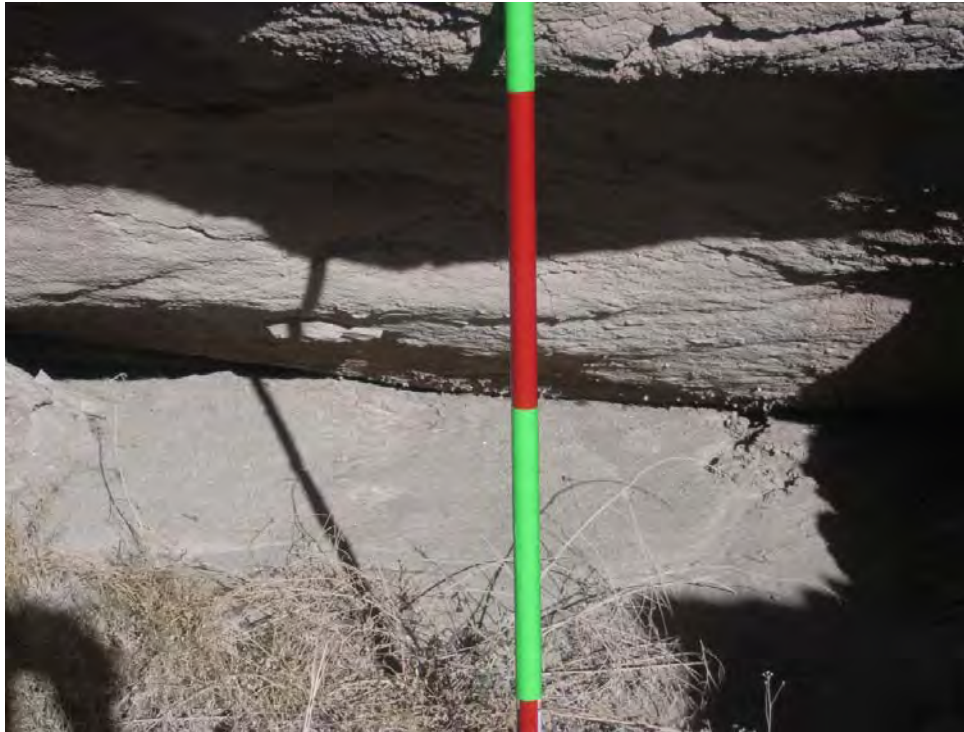
One decline (decl-1) was found at the AUM Site, with dimensions of 8 feet wide, 3 feet high, and 7 feet deep. This decline has been filled with soil, level with the ground surface. Erosion has washed the sediment into the decline, and there are small holes which allow water to carry more sediment into the decline cavity. The access holes into the decline are several inches in diameter, and are not large enough to allow human access to the mine. It is not evident how far the decline advances into the rock.

Photo 9 - Close up photo looking down into decline (decl-1), looking east.

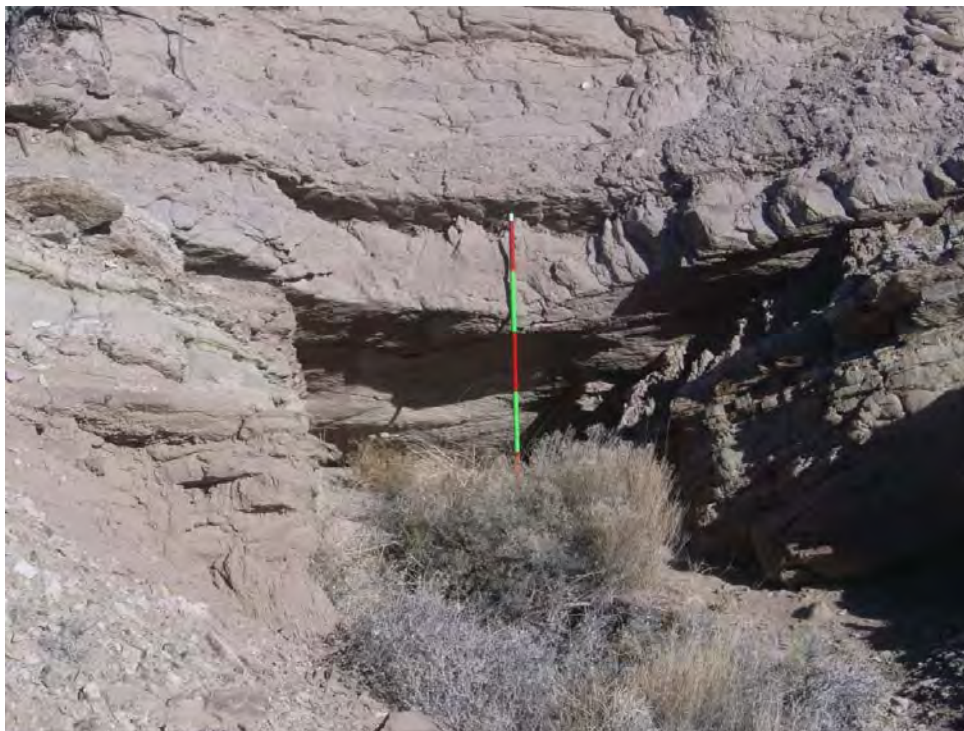
Photo 10 - Full view of decline (decl-1).

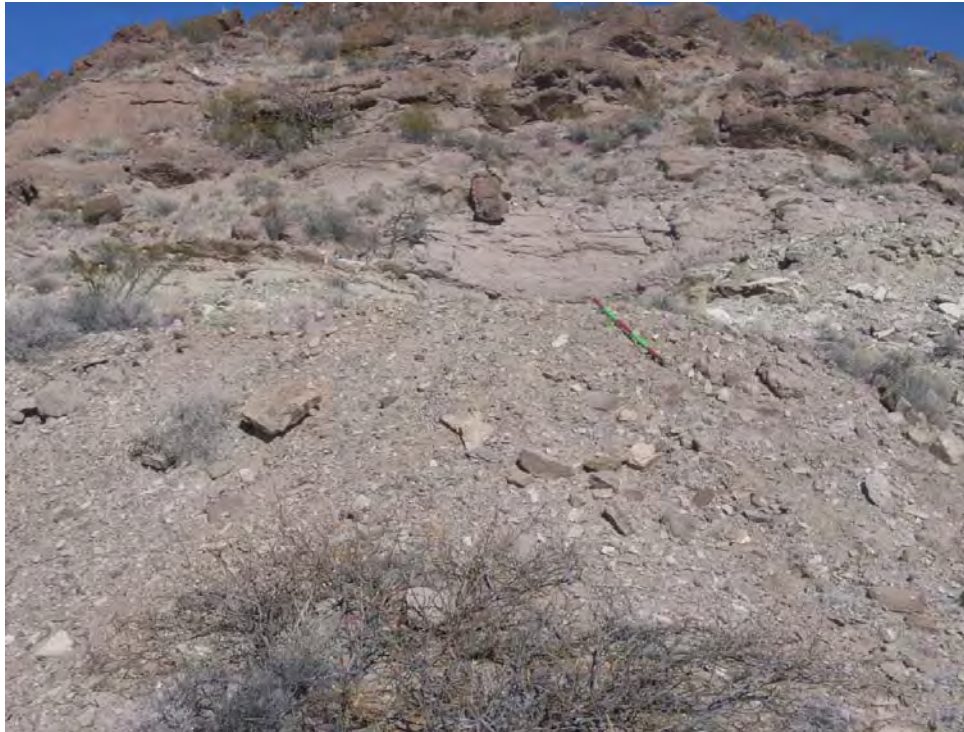
One waste rock pile (pile-1) was found at the AUM Site. This pile is located at the entrance to the decline, and the material was used to create a flat landing for people and equipment entering or leaving the decline. There is approximately 3 cubic yards of waste rock in this pile. There is no evidence of soil staining or runoff below this pile.

Photo 11 - Waste rock pile (pile-1) extending from scale pole downwards to mesquite bush in foreground, looking east.

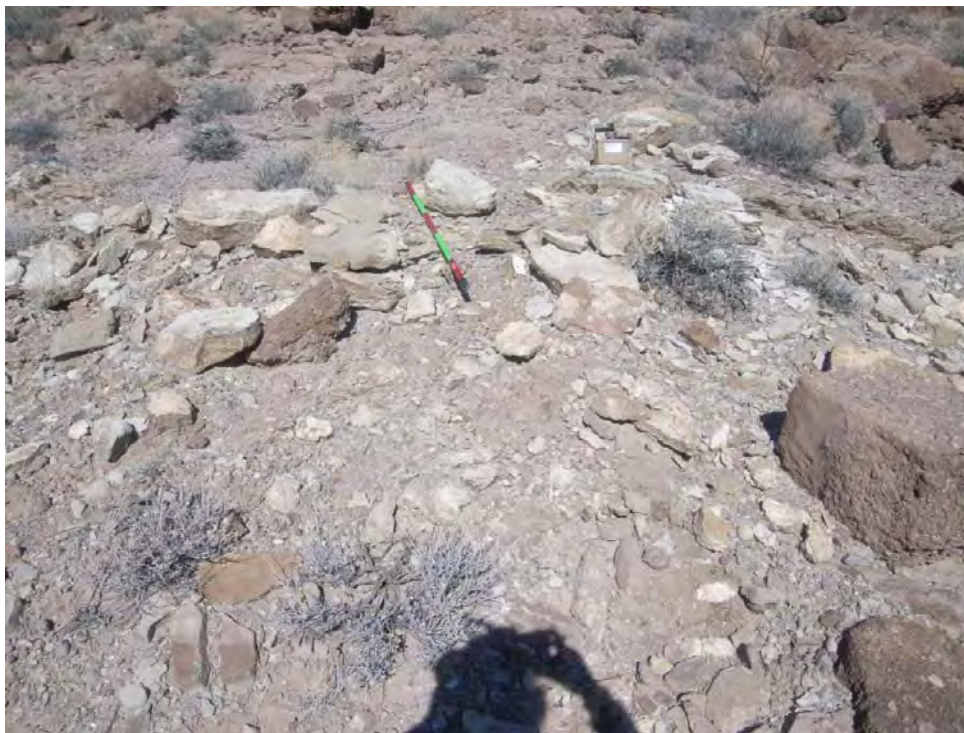
One disturbance (distrb-1) was found at the AUM Site. A disturbance is an area of ground that appears to have been disturbed by human activity or equipment, often characterized by rough soil, broken rock, and little to no vegetation. This disturbance was an area of 5 feet by 15 feet composed of broken rock scattered on the ground, disturbed soil, and little to no vegetation.

Photo 12 - Area of broken rocks and disturbed ground (distrb-1).

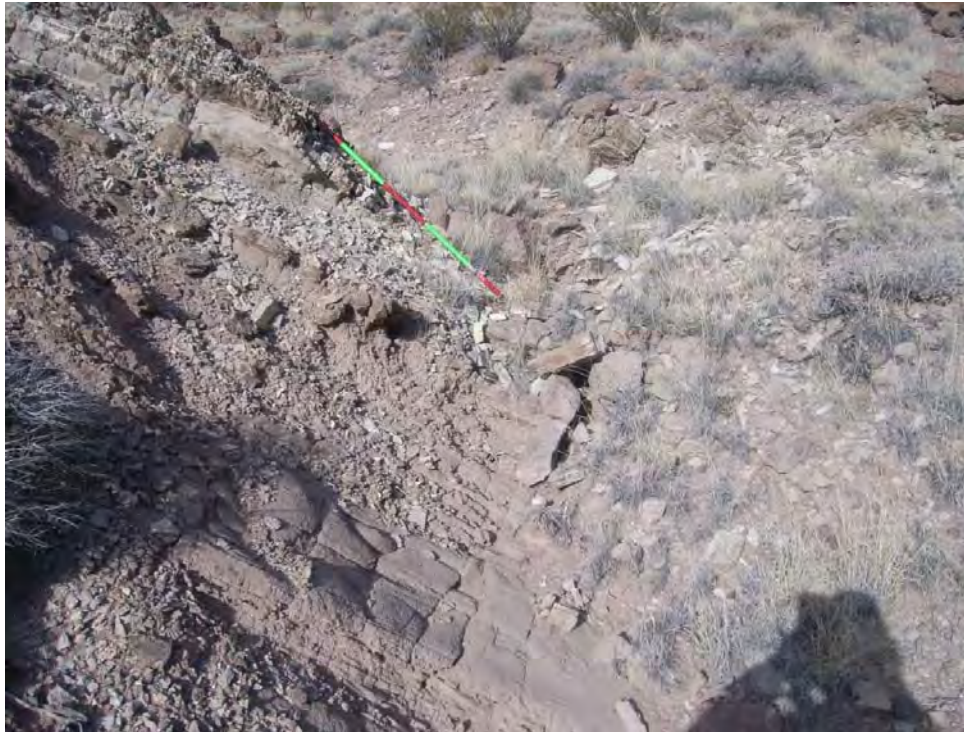
Photo 13 - Fault interpreted by INTERA to be the northern boundary of the AUM Site.

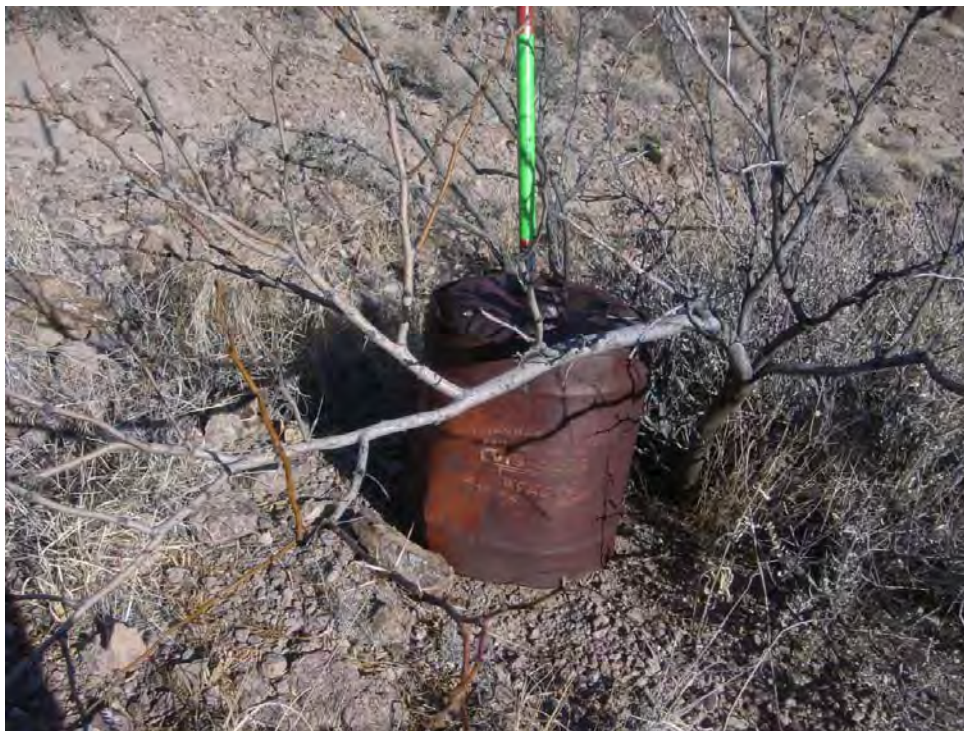
Photo 14 – Abandoned empty grease can (grease-can1) labeled “Triangle Oil Co.”

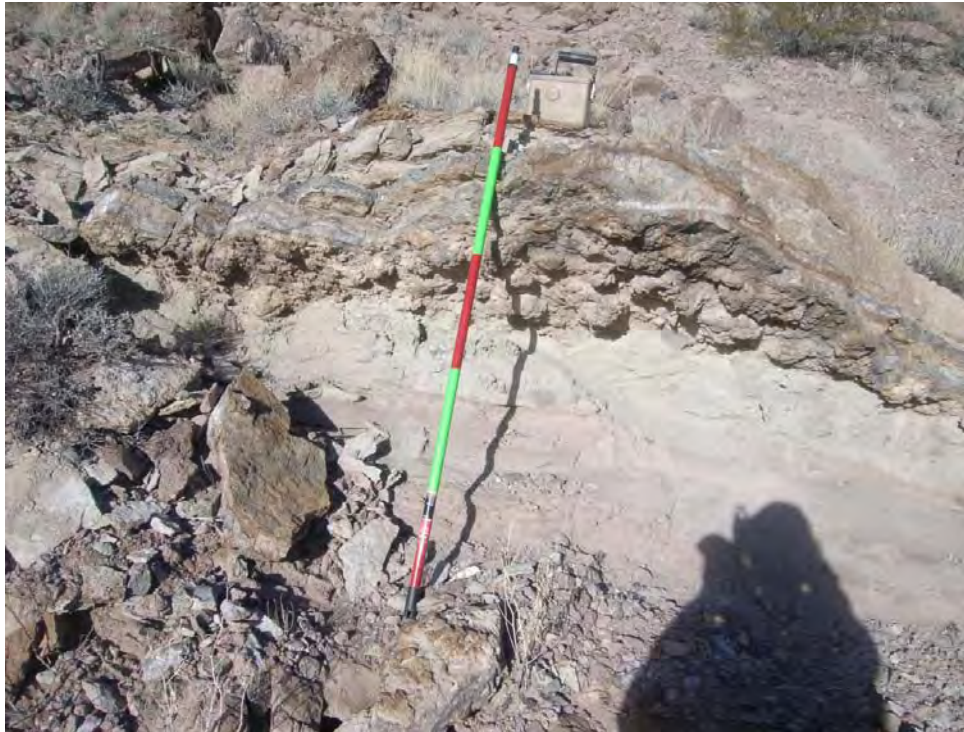
Radioactivity readings were found to originate from a 2-3 inch thick gray tuffaceous sandstone bed lying directly above a chert layer. This chert layer is more resistant than the surrounding deposits and projects up to a few feet from the hillside. The chert can be traced from the Cabra Canyon arroyo northwest for at least a third of a mile. Elevated radiation levels extend from the Cabra Canyon arroyo for about a quarter of a mile along this layer. The decrease in radioactivity to the north seems to correlate with an increase in carbonate material in the chert layer.

Photo 19 - A uranium bearing layer lies immediately above a weather resistant chert layer, which juts out from the hillside.

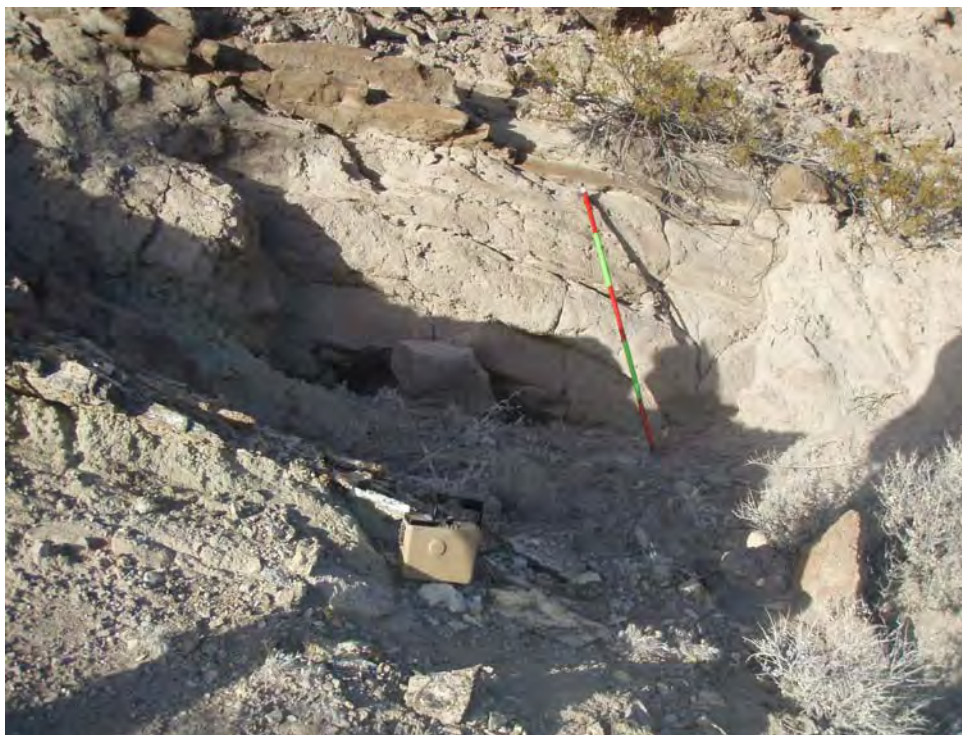
Photo 28 - A small exploration pit (pit-2) near the Cabra Canyon road. The scintillometer rests on the Uranium bearing tuffaceous sandstone.

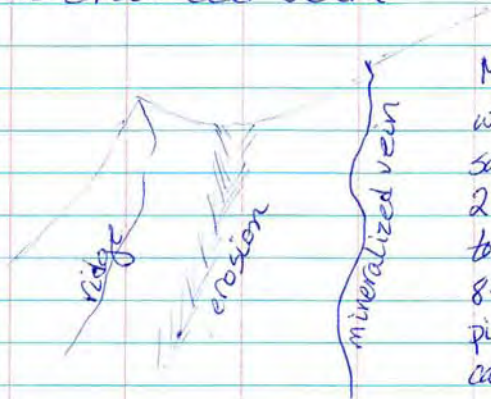
Mineralized vein is white-grey tuffaceous sandstone, med-fine grain, 2 in thick. Agate is grey to reddish brown to black, 8-10 in thick, multi layer, pinching & swelling. Intermittent calcareous sandstone or limestone
