# Abandoned Uranium Mine Site Assessment for the Bobcat Site (NM0141)

**FINAL REPORT**

NM0141

INTERA Incorporated (INTERA) has prepared this Abandoned Uranium Mine (AUM) Site Assessment Report for the Mining and Minerals Division (MMD) of the New Mexico Energy, Minerals and Natural Resources Department (EMNRD) in compliance with the Professional Service Agreement dated November 2, 2009. INTERA visited the Bobcat Mine Site (AUM Site), MMD ID: NM0141, on March 23, 2010.

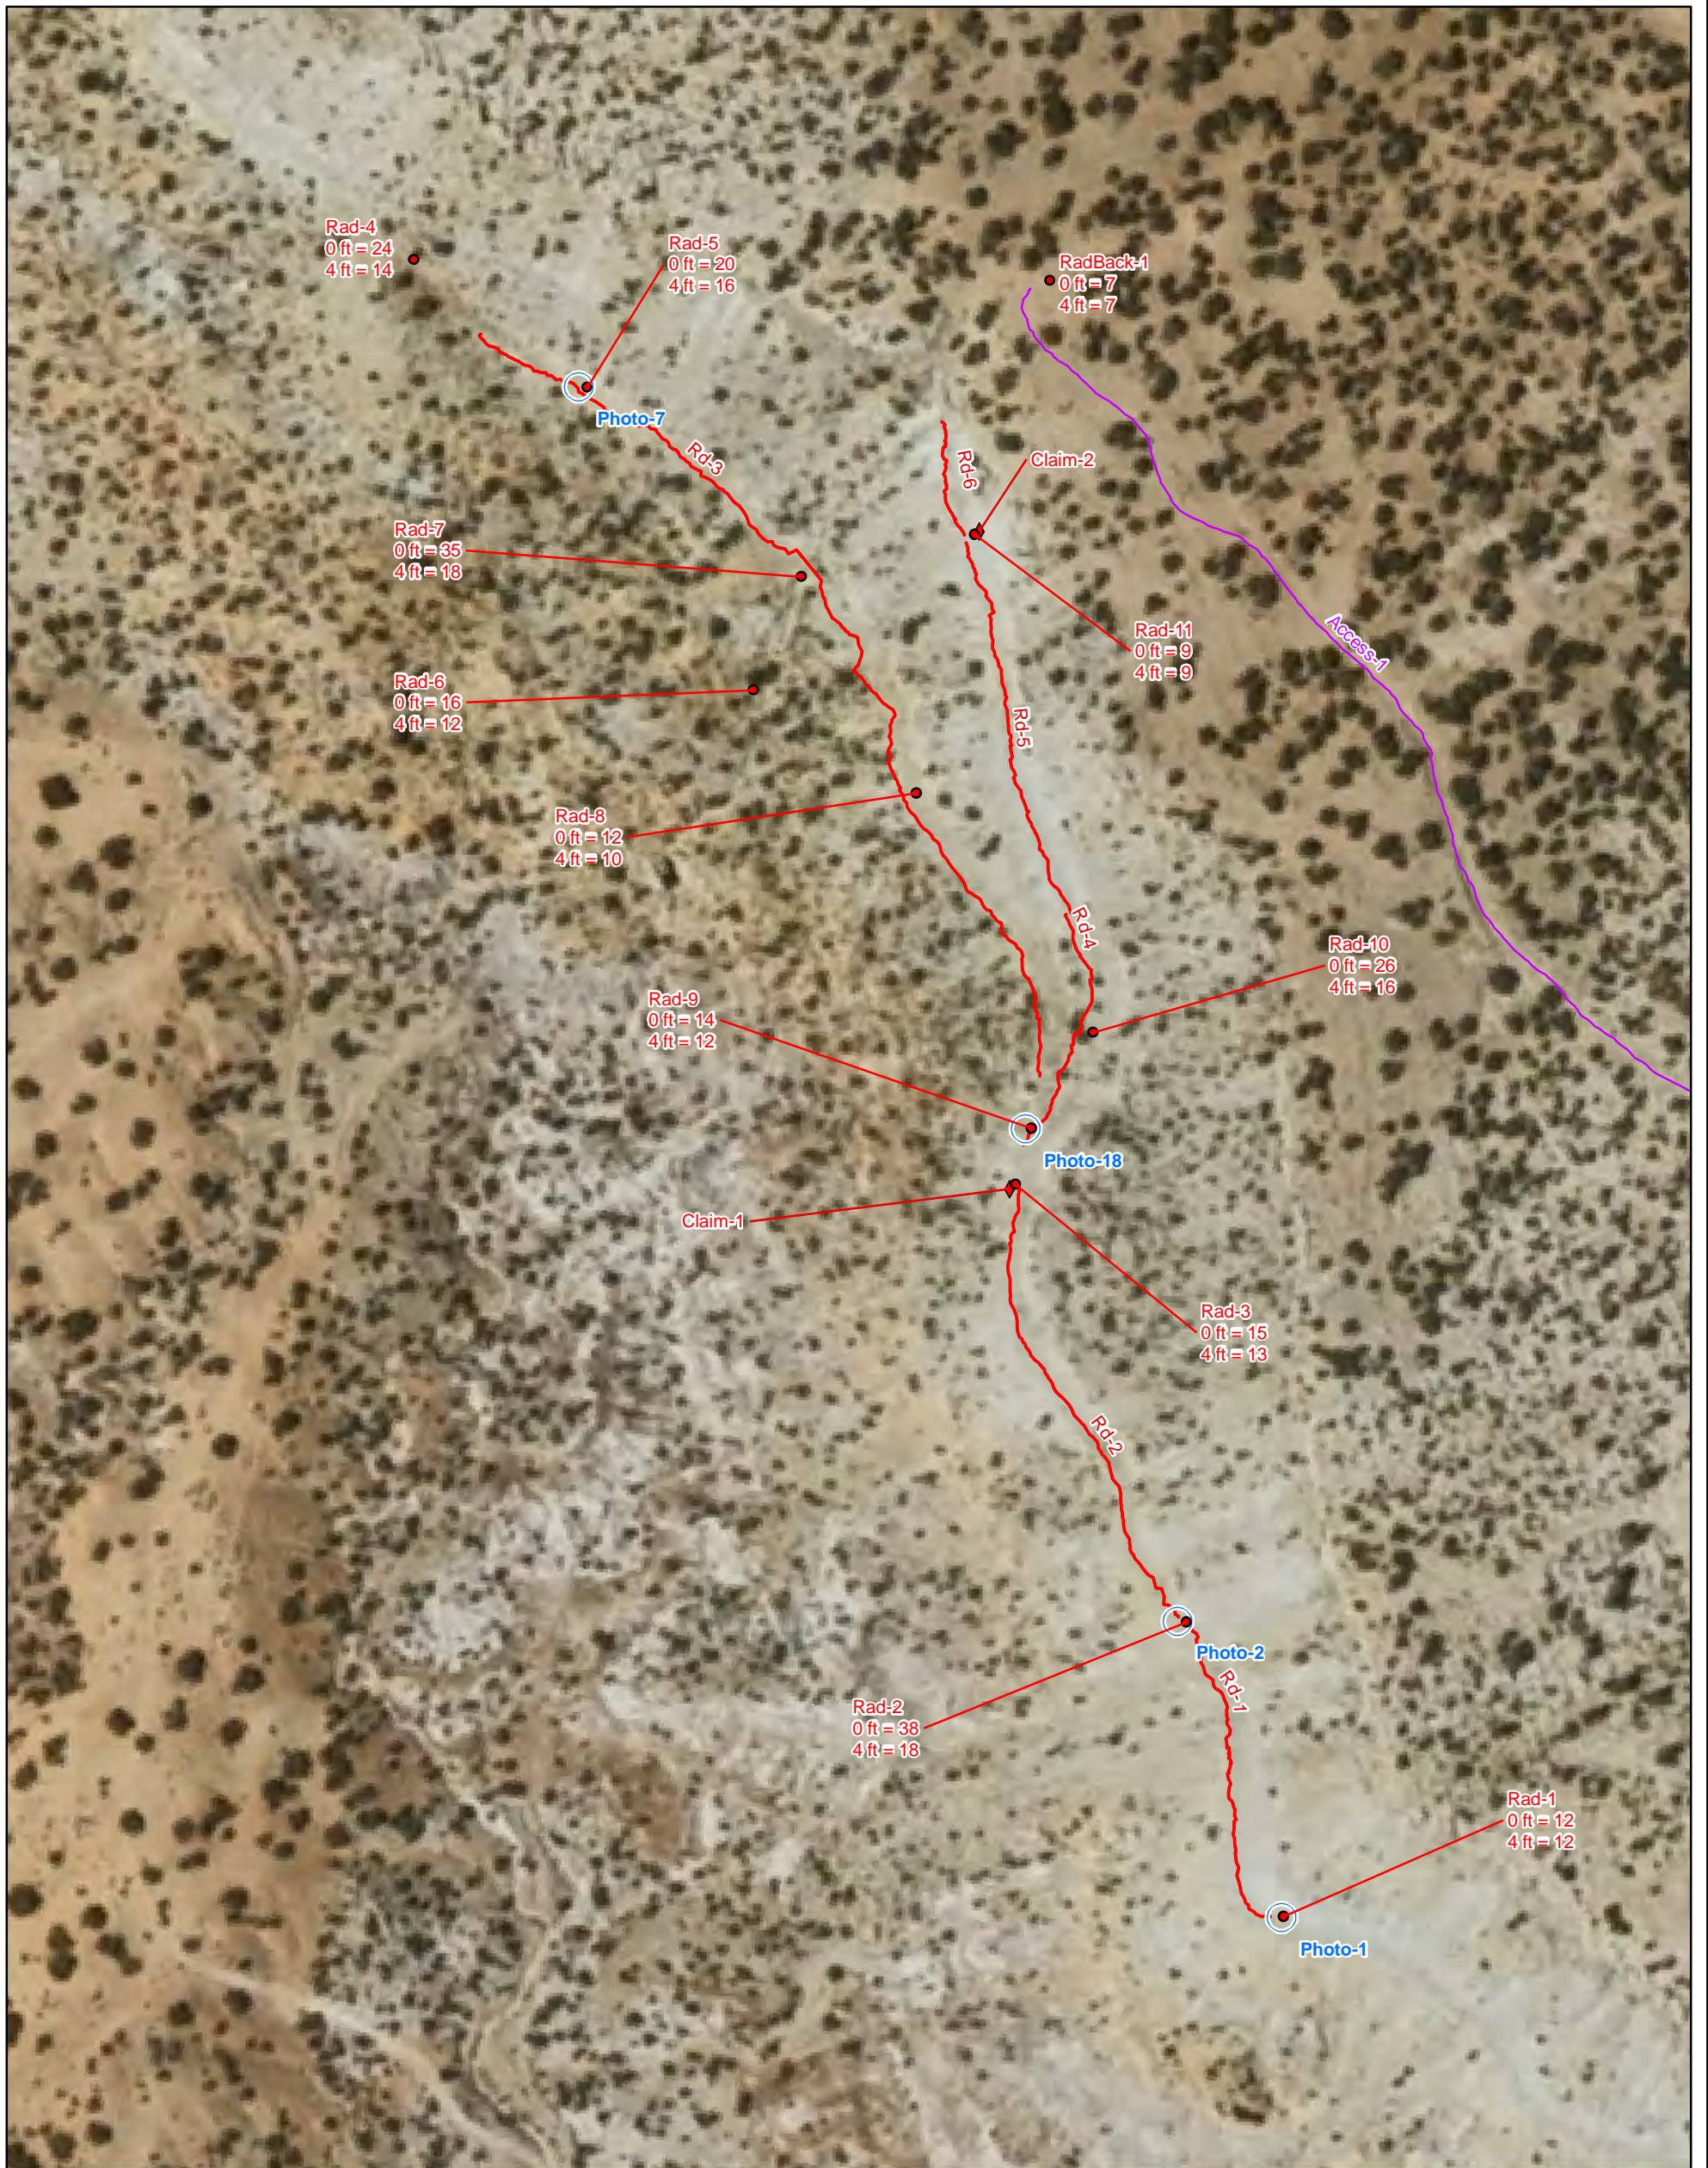
**Figure 4a**  
**Site Map on**  
**Aerial Photo**  
**NM0141-Bobcat**  
 Abandoned Uranium  
 Mine Assessment

Two mine roads were also identified at the AUM Site. One road (Rd-1, Rd-2, Rd-4, Rd-5, and Rd-6) extends from the mesa top down along the mesa face, continuing south along the west face to Poison Canyon; approximately 1 mile. Another mine road (Rd-3) extends north along the mesa face for approximately ½ mile. These mine roads are unmaintained dirt roads and are washed out in some locations.

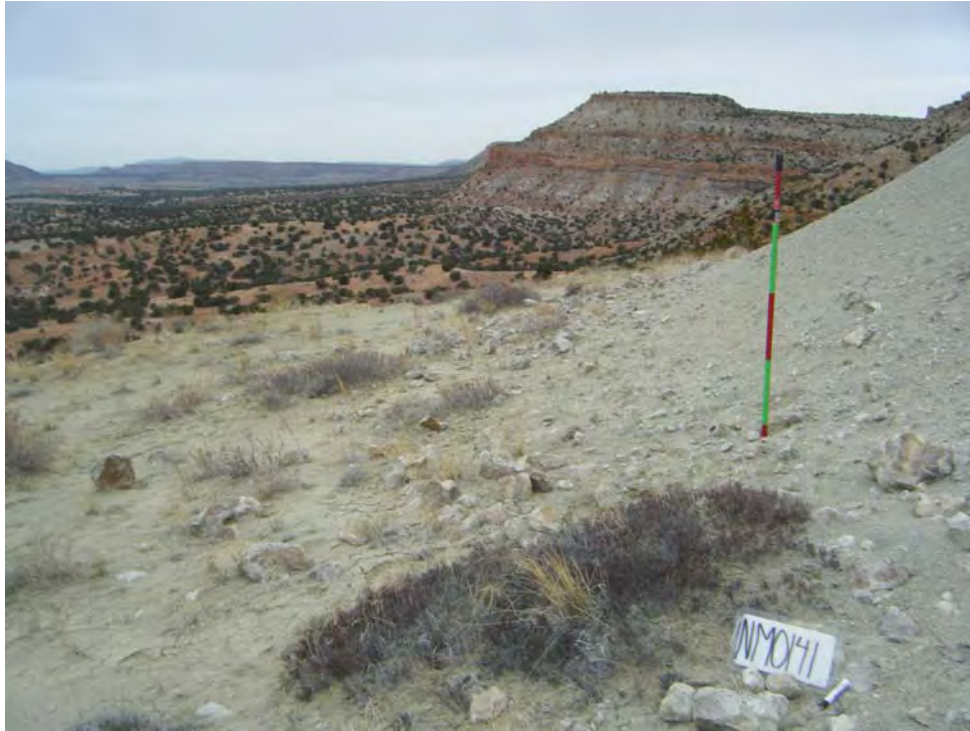
Photo 1-Looking northwest at the Site.

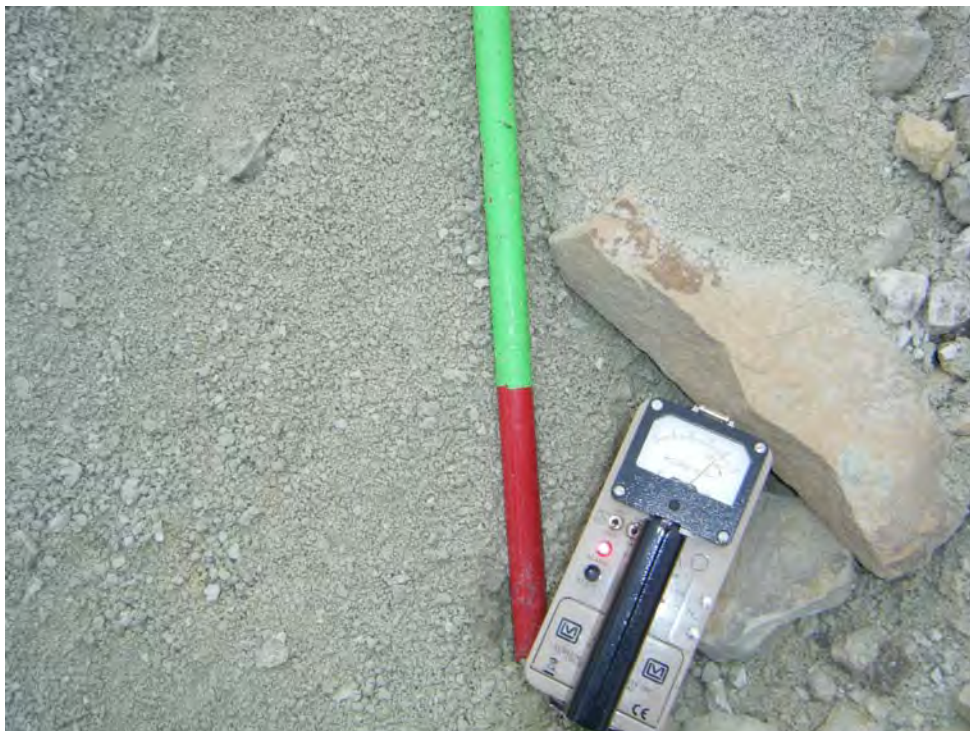
Photo 2-Looking at green-grey sediment along the mine road (Rd-1).

Road 2 - along Rd-1 at Photo 2 location, slope with  
<sup>ALT</sup> greenish-grey sediment  
0m - 38  $\mu\text{R/h}$ ; 1m - 18  $\mu\text{R/h}$

Photo 2 - Road 2, greenish-grey sediment, looking north

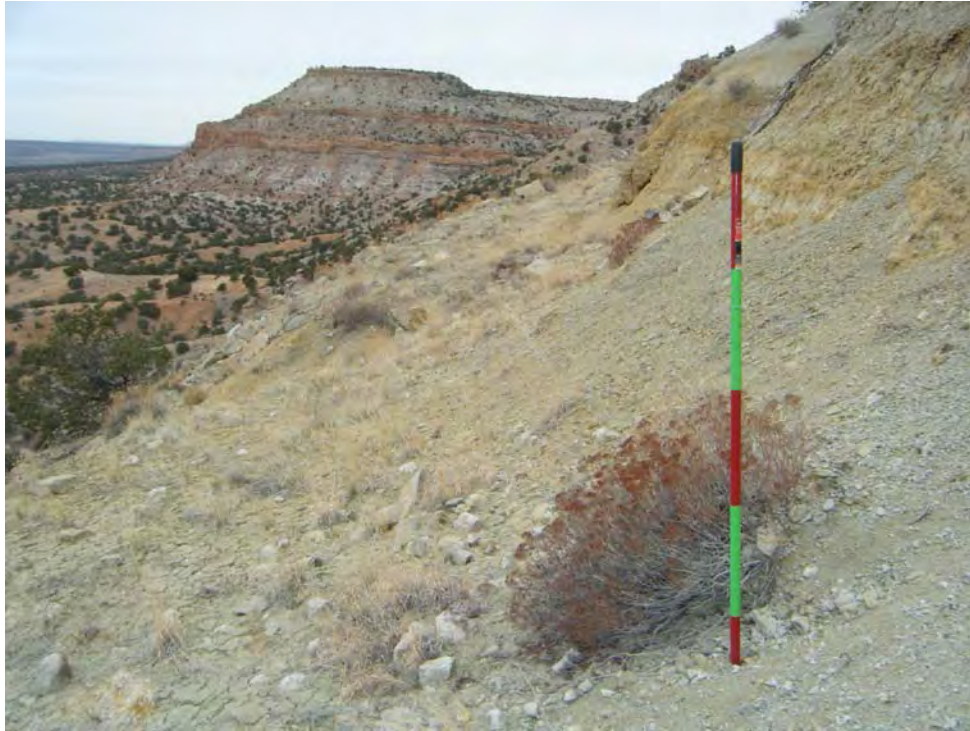
Photo 3-Looking northwest along the mine road (Rd-2).

Photo 3 - looking northwest along Rd-2  
Rd-2 - continuation of Rd-1

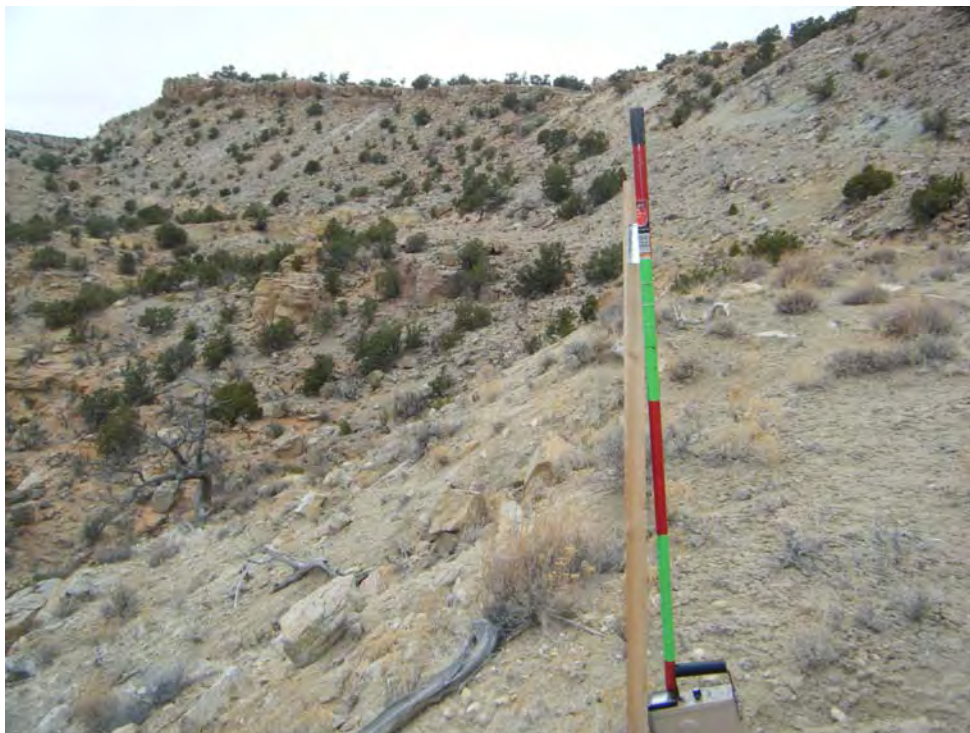
Two claim markers were identified along the mine roads. Claim-1, along Rd-1 and Rd-2, was identified with “Rick 28/29 Claims.” The second claim marker (Claim-2), along Rd-5 was identified with “Rick 27/28 Claims.” Both claim markers were metal stakes approximately 4 feet tall with no rust or damage.

Photo 4-Looking north at Claim marker-1 along the mine road.

Claimmark-1 - along Rd-2; "Rick 28/29 Claims"

Photo 4 - looking north at Claim marker - 1

Road 3 - claimmarker - 1 - 0m - 15  $\mu\text{R/h}$ ; 1m - 13  $\mu\text{R/h}$

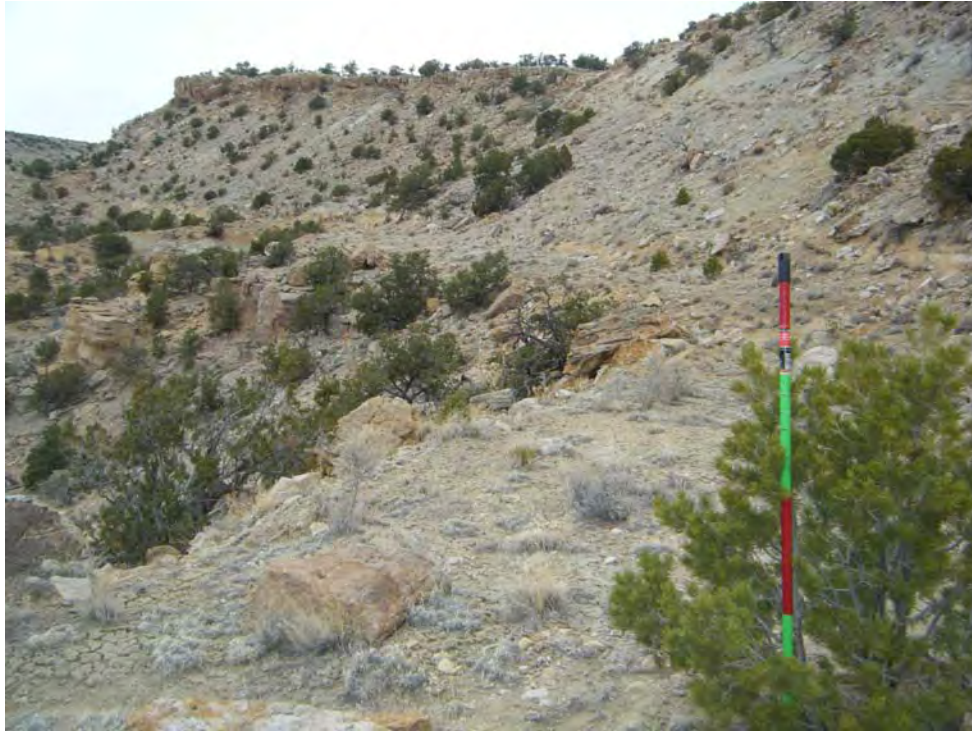
Photo 5-Looking north along the mine road (Rd-3).

Rd-3 - lower road along mesa side; 8 ft wide

Photo 5 - looking north at Rd-3

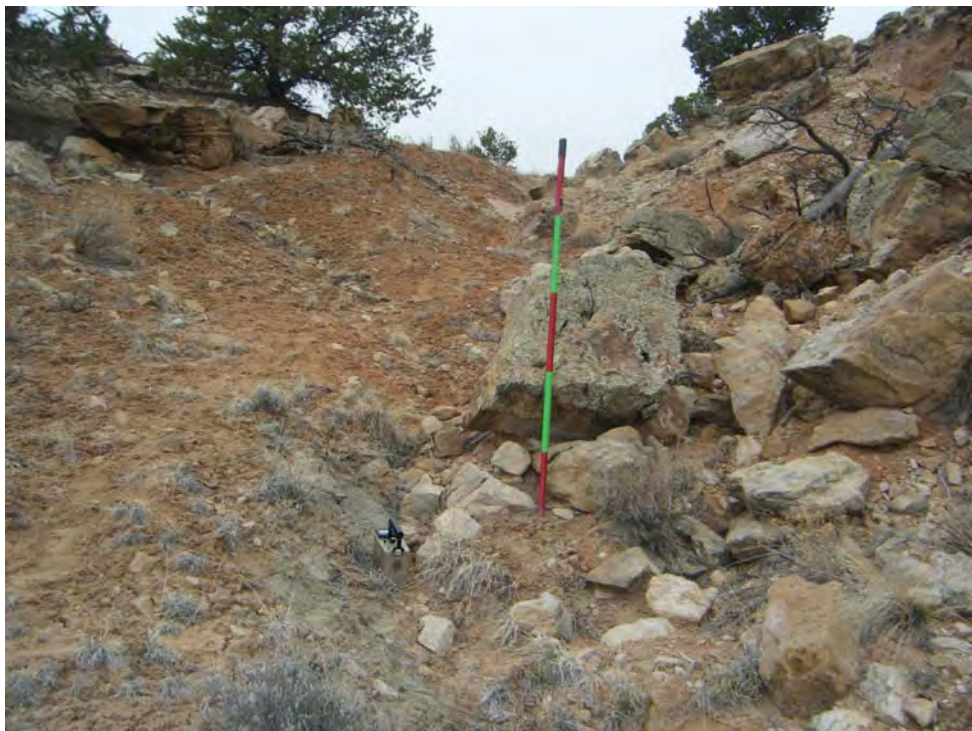
Photo 6-Looking northwest at Rd-3.

Rd-3 leads to what looks like it could be a  
trench, filling in.

Photo 6 - looking northwest at trench - 1

Road 4 - north end trench - 1 - 0m - 24  $\mu\text{R/h}$ ; 1m - 14  $\mu\text{R/h}$   
Trench-1 - 50 ft long; 7 ft wide; 3 ft deep

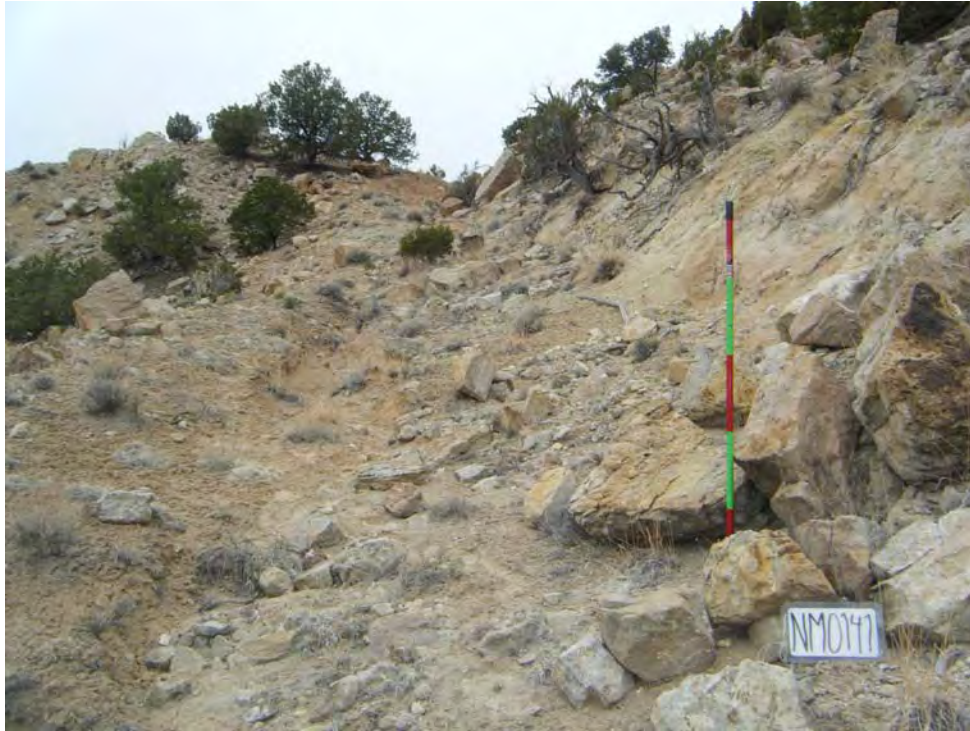
Photo 7-Looking northwest at the Site along the mine road (Rd-3).

Photo 7 - looking north west at site name, Trench 1  
in the background

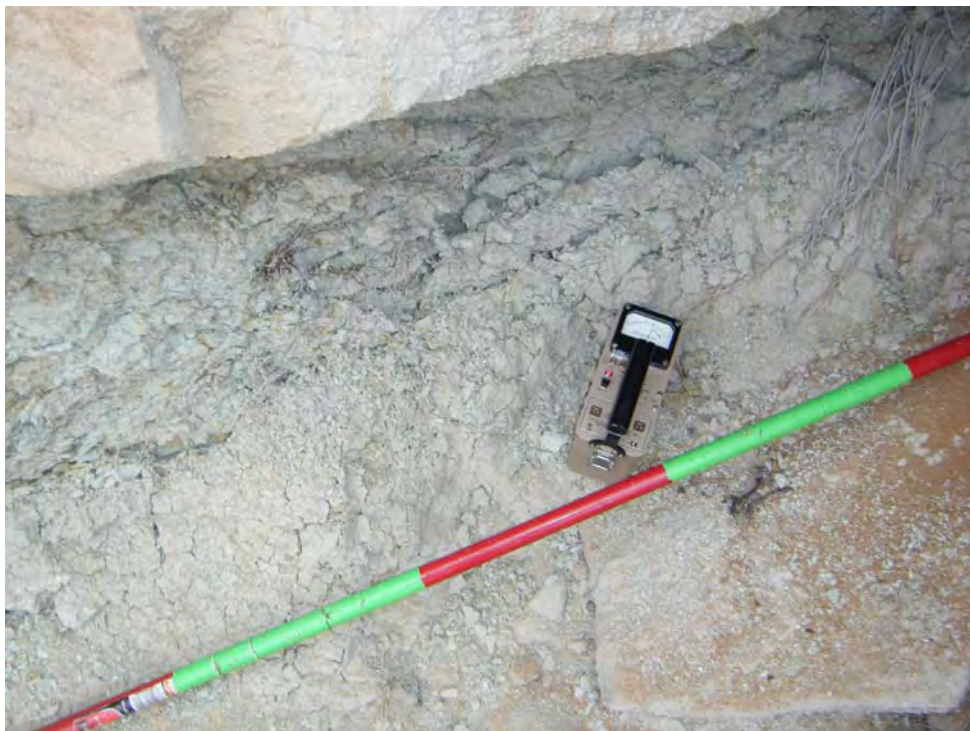
Photo 8-Green sediment, west of the mine road (Rd-3).

Rad 7 - west of Rd-3, greenish rock

0m - 35  $\mu$ R/h; 1m - 18  $\mu$ R/h

Photo 8 - greenish rock west of Rd-3

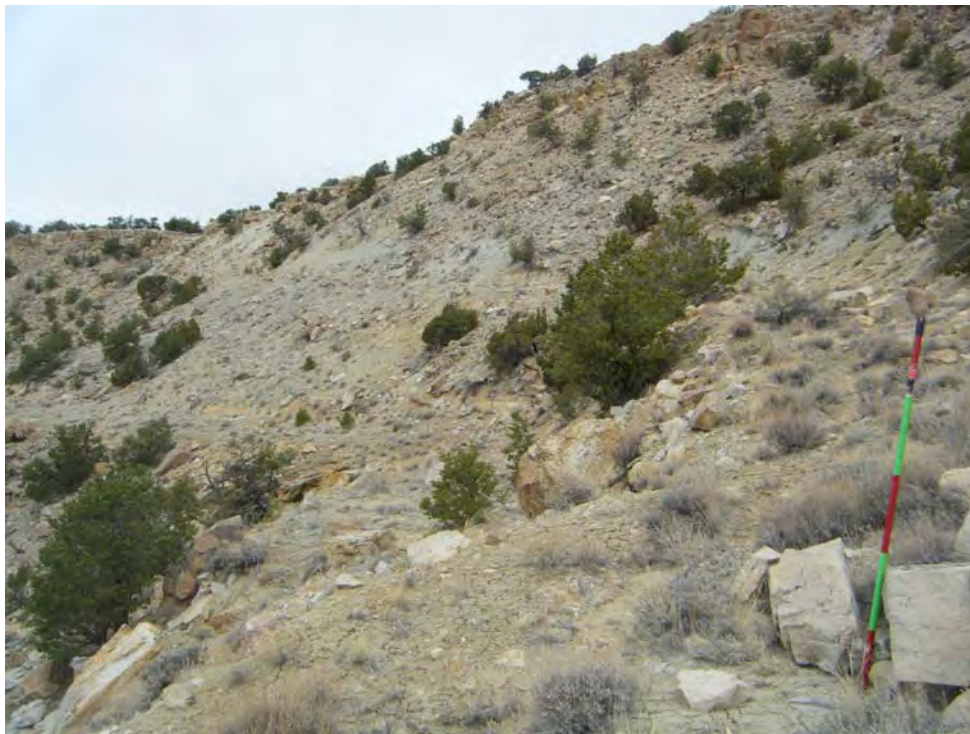
Photo 18-Looking northwest at the junction of mine roads (Rd-3, lower left, and Rd-4 and Rd-5 upper left).

Photo 18 - looking west at Junction of Rd-2, Rd-3 and Rd-4

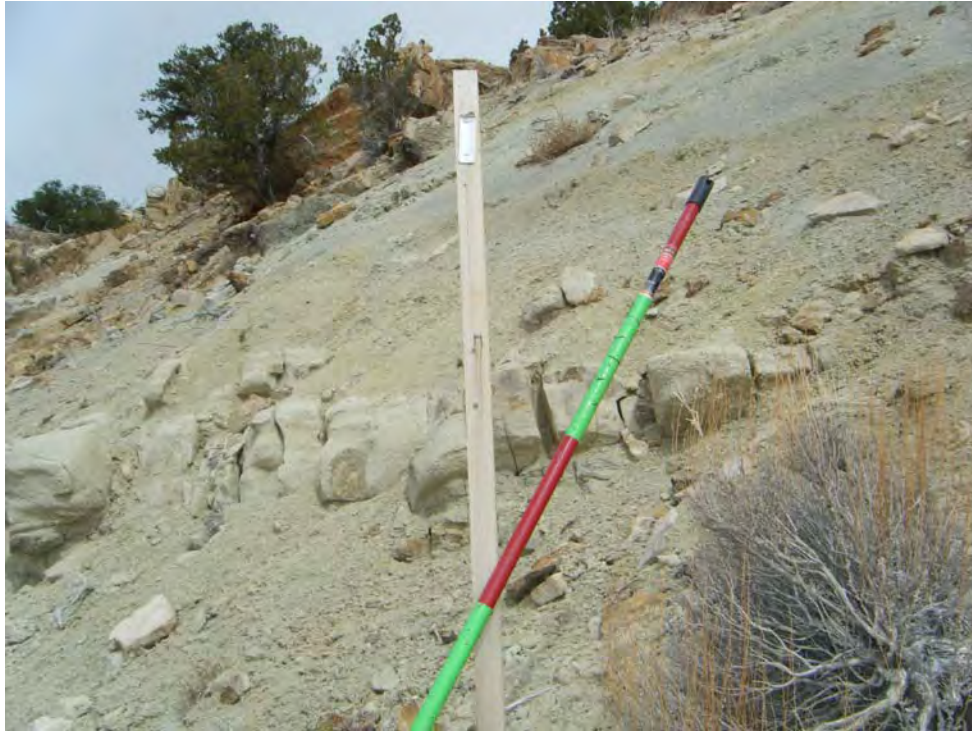
Photo 19-Looking northwest at Claimmarker-2 along the mine road (Rd-5).

Claimmarker-2 - along Rd-5 "Rick, 27/28 Claims"

Photo 19 - looking northeast at claimmarker-2

Rad 11 - claimmarker-2; 0m - 9  $\mu$ R/h; 1m - 9  $\mu$ R/h
